**YURUKAWA AUTOMOTIVE SYSTEMS LIMA PHILS. INC.**

## INCIDENT REPORT FORM

# i\_Alert Audit Report

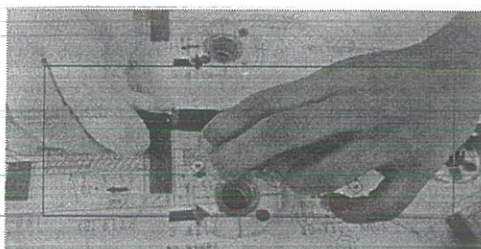
<b>Effect</b>  no traceability for the lacking wire encountered
<b>Not following STOP-CALL-WAIT</b> Did not attached red tag when encountered lacking wire during the process and continue the manual insertion without confirmation of Jr.Staff.		
<b>Car Model / Line No.</b> Mazda / 1110 <b>Date / Time</b> June 11, 2019/ 03:05am <b>Name / ID No.</b> Marife Mendrano / 18-04356 <b>Shift / Group</b> NS/A <b>Batch No.</b> 123 <b>Process</b> Dimension Process <b>FAS or Agency; specify</b> FAS (expert) <b>Person Informed</b> X. Kalaw <b>Audited by:</b> M.Dacuran Details

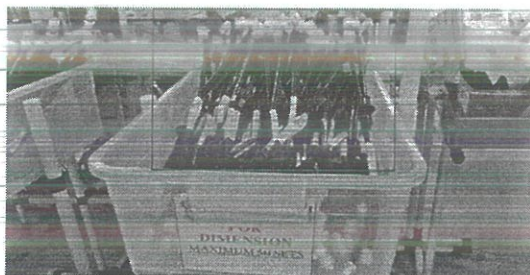
<b>Effect</b>  no traceability for the repair done on harness and may lead to worst defect

<b>Un-authorized Repair/ Hidden Repair</b> Conduct moving of clamp (YA-107-GR) on dimension process, near seq. 45. <b>Product:</b> GBJW-67-130 (6)-5 <b>Lot number:</b> 592N43 <b>Serial number:</b> 67		
<b>Car Model / Line No.</b> Mazda / 1032 <b>Date / Time</b> June 11, 2019 / 06:50am <b>Name / ID No.</b> Eloisa Quejada / 14-01823 <b>Shift / Group</b> NS/A <b>Batch No.</b> 134 <b>Process</b> Dimension Process <b>FAS or Agency; specify</b> FAS (acting Jr. Staff) <b>Person Informed</b> X. Kalaw <b>Audited by:</b> M. Dacuran Details

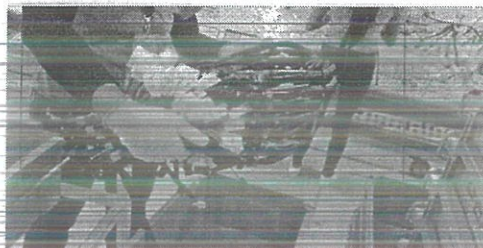
<b>Effect</b>  damaged parts
<b>Not following maximum sets on inspection process.</b> <b>Product Number:</b> GHR9-67-290(2)-5 <b>Lot Number:</b> 592P59 <b>G:</b> 50sets <b>NG:</b> 72 sets		
<b>Car Model / Line No.</b> Mazda / 1121 <b>Date / Time</b> June 11, 2019 / 09:30pm <b>Name / ID No.</b> Acosta Glecelyn / 16-PK08851 <b>Shift / Group</b> NS/A <b>Batch No.</b> 137 <b>Process</b> Appearance Process <b>FAS or Agency; specify</b> PKIMT <b>Person Informed</b> J. Magpayo <b>Audited by:</b> M.Casama Details

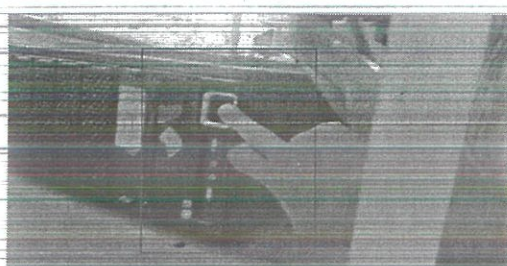
<b>Effect</b>  harness may fall and cause damaged parts

<b>Not following SOP</b> No good way of transferring harness to another polybox due to encountered NG polybox.		
<b>Car Model / Line No.</b> Mazda / 1114 <b>Date / Time</b> June 11, 2019 / 09:30pm <b>Name / ID No.</b> Cecilia Serio / <b>Shift / Group</b> NS/A <b>Batch No.</b> 220 <b>Process</b> Sub-Assy Process <b>FAS or Agency; specify</b> ADD EVEN <b>Person Informed</b> C. Diaz <b>Audited by:</b> C.Redondo Details
