FURUKAWA AUTOMOTIVE SYSTEMS LIMA PHILS. INC.

INCIDENT REPORT FORM

iAlert Line Audit Report

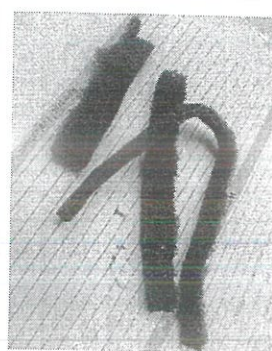
Jr. Staff conducted repairing of master sample which is removing of STU during inspection of good harness at appearance inspection board.
