FORWARD BAGGAGE COMPARTMENT PARTITION - REPAIR

TASK 25-27-02-300-801-A

2. FORWARD BAGGAGE COMPARTMENT PARTITION - PATCH REPAIR

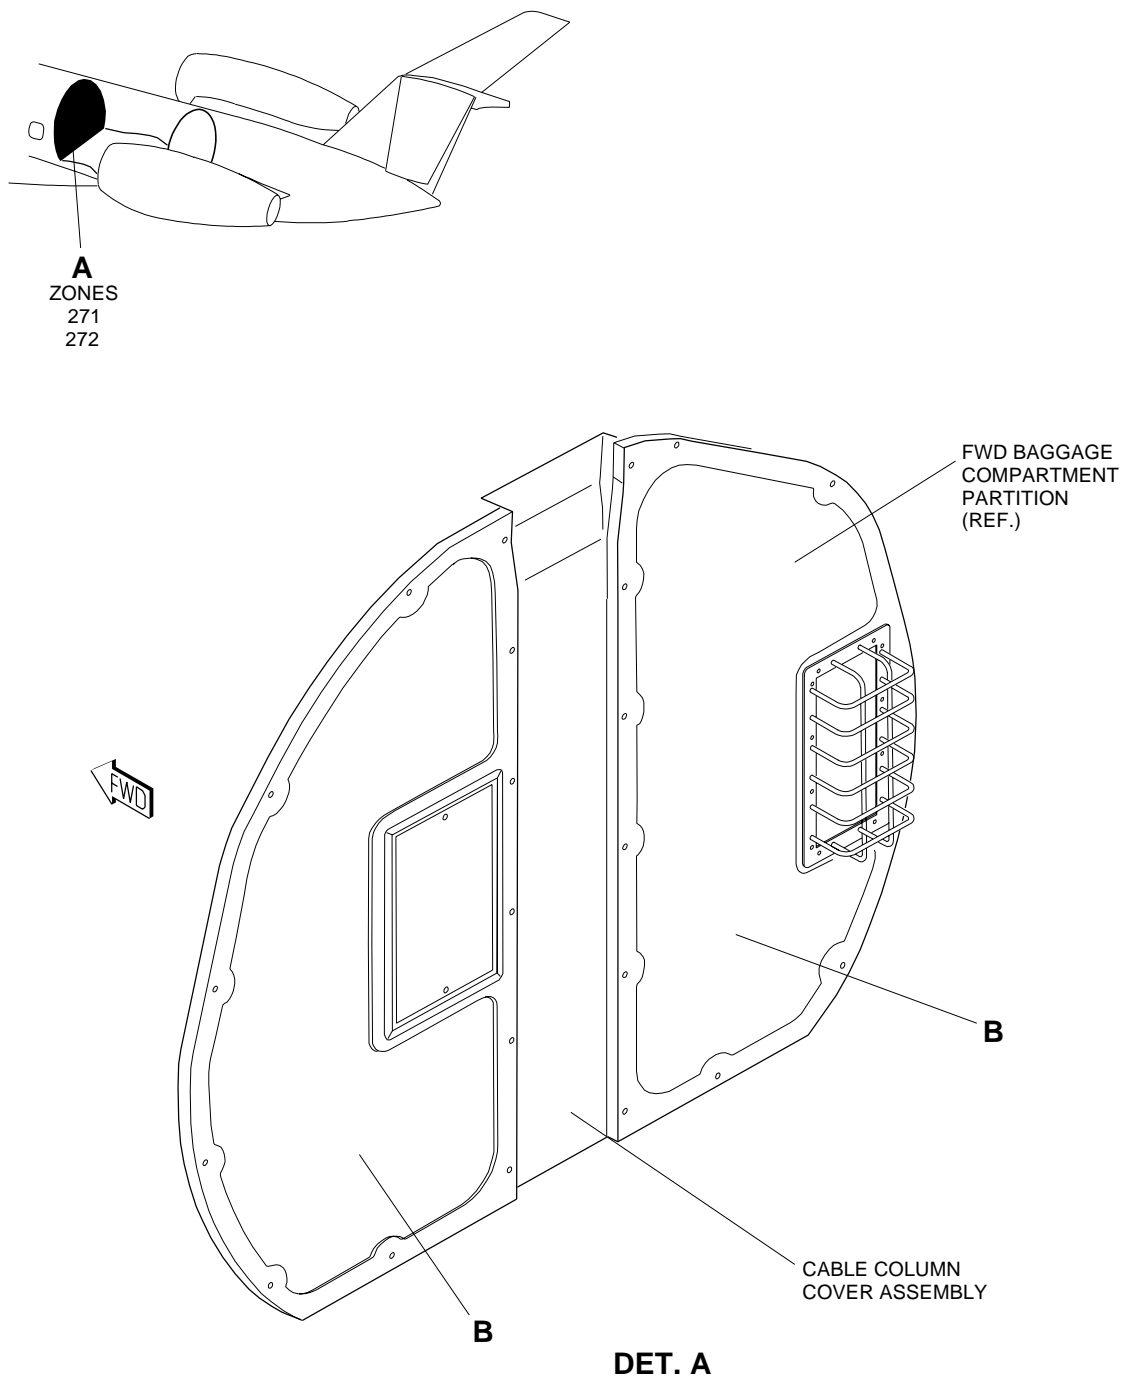
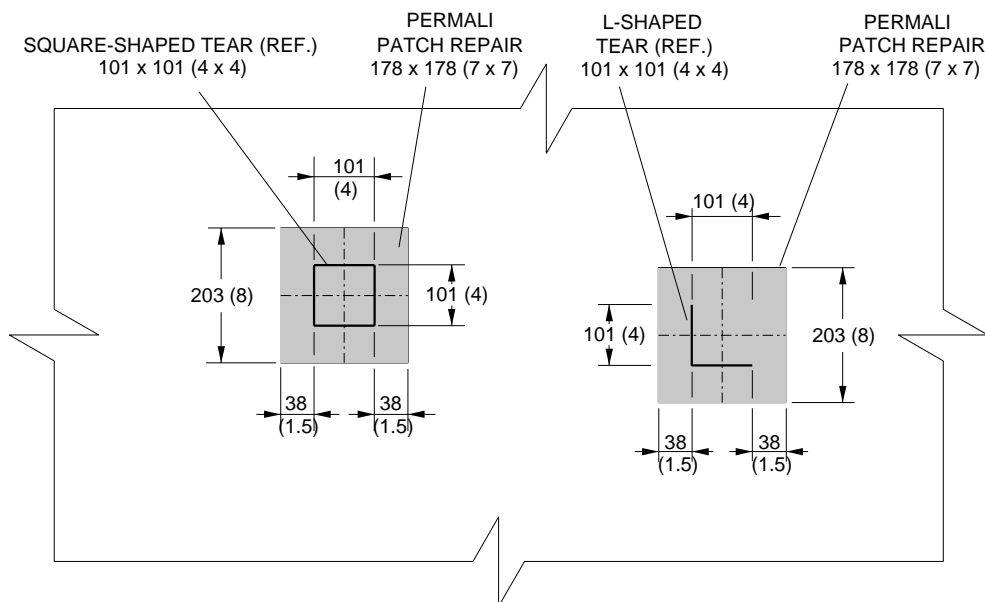
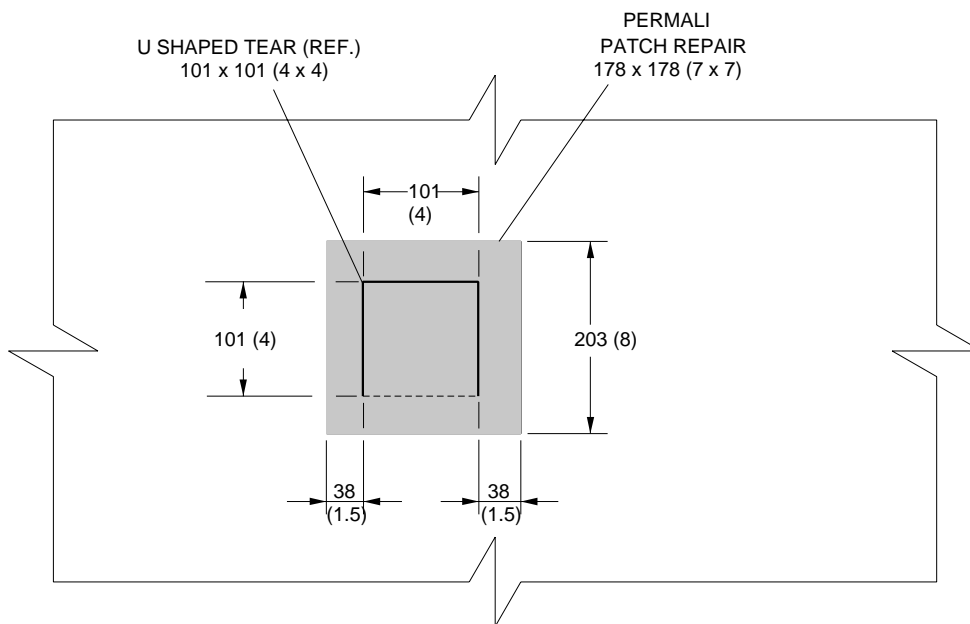
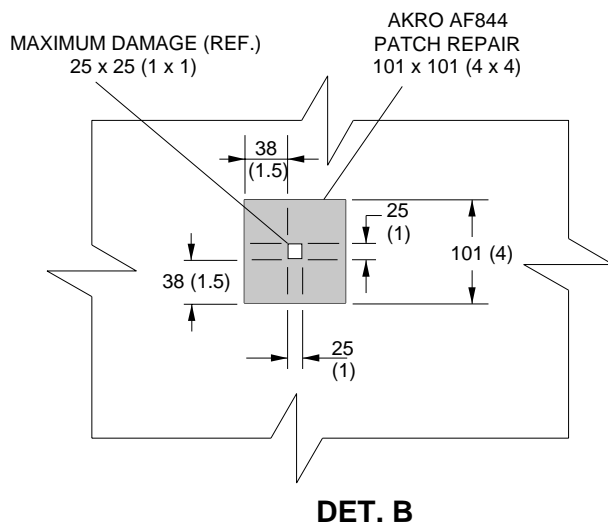
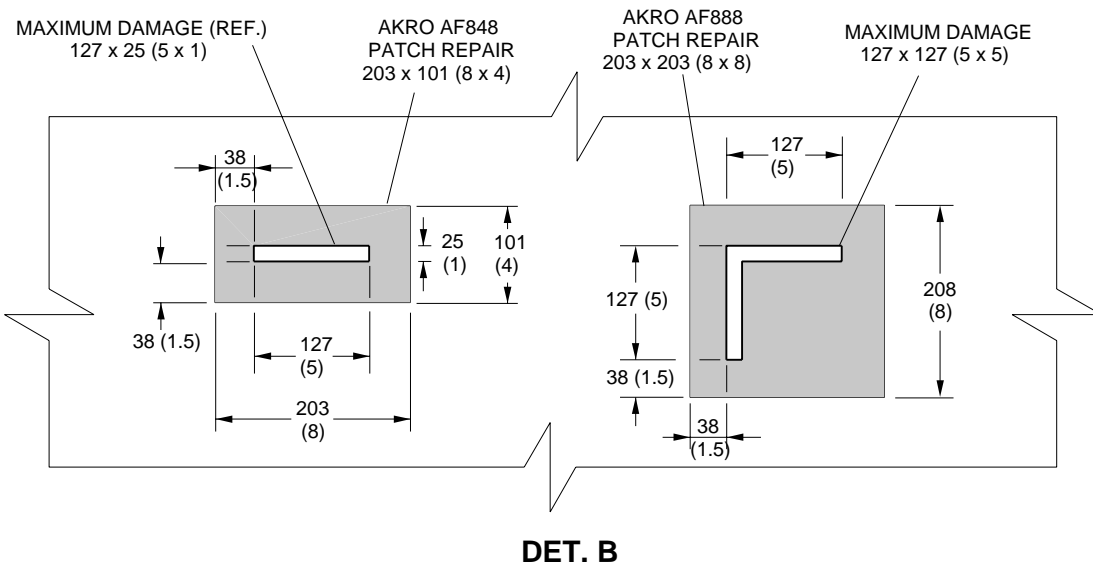
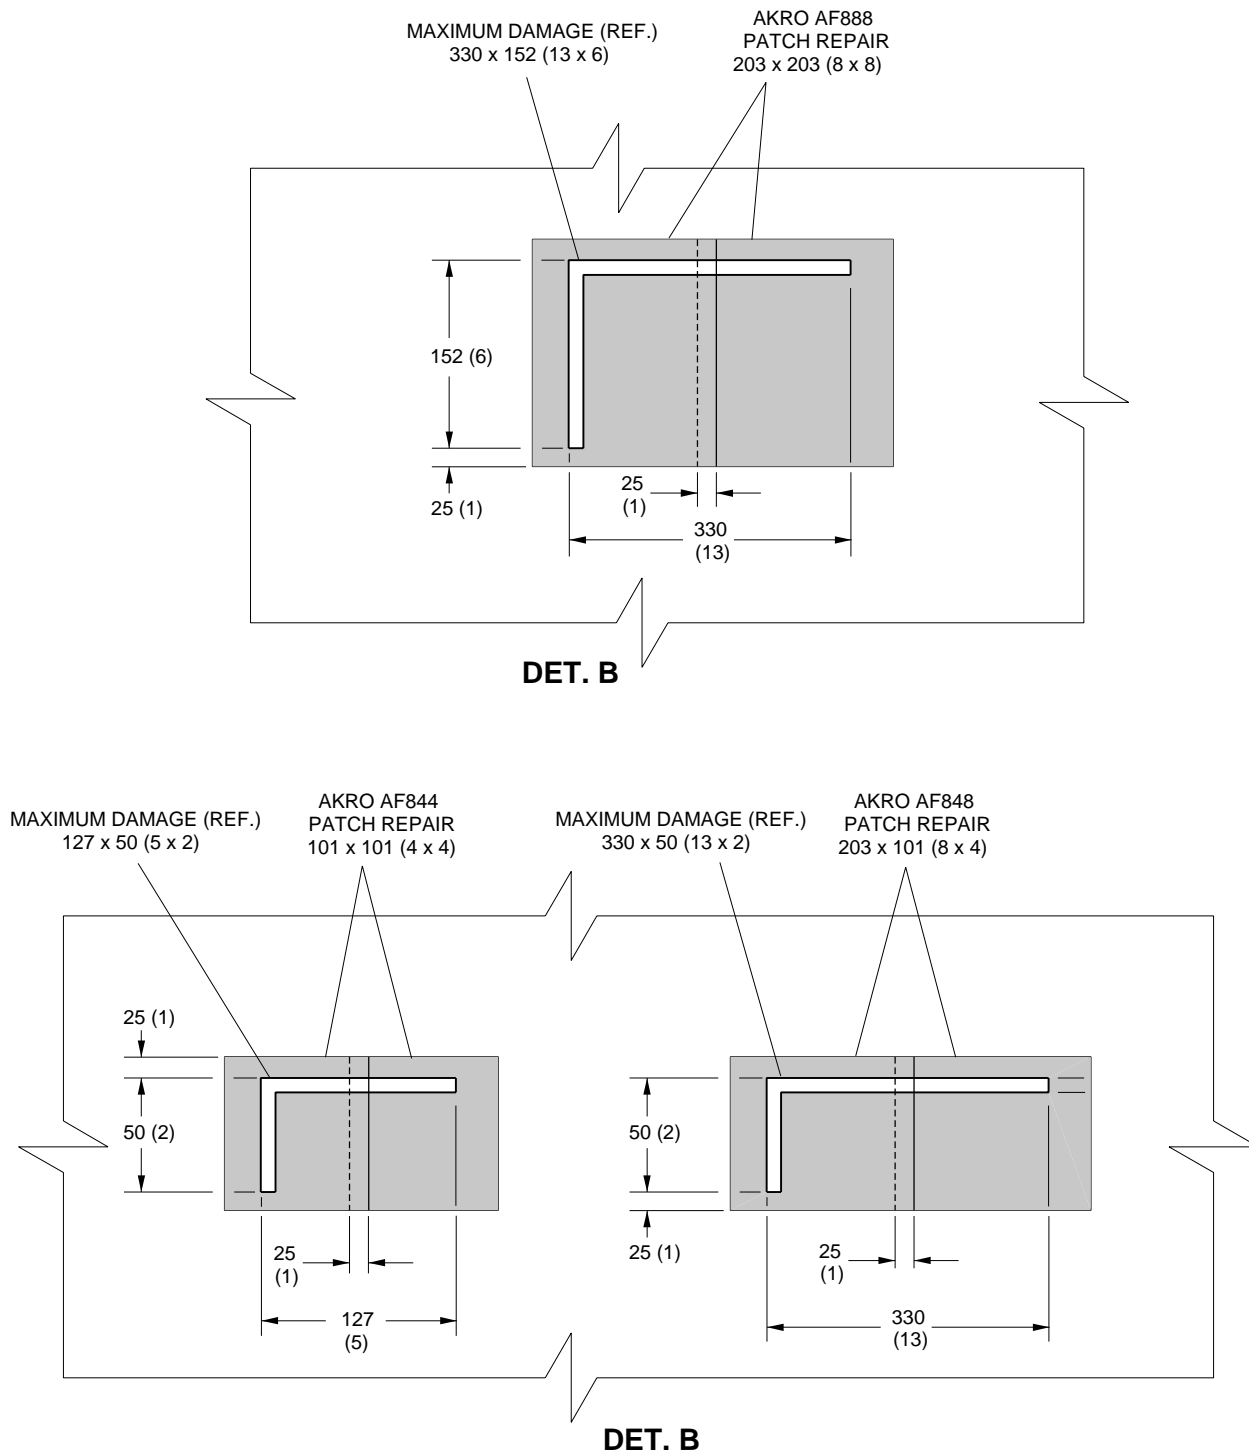
Forward Baggage Compartment Partition - Maximum Damage

PATCH REPAIR	QUANTITY OF PIECES	TYPE OF DAMAGE	MAXIMUM DAMAGE length x width mm (in)
PERMALI	one	square-shaped and L-shaped tears	101 x 101 (4 x 4)
		U-shaped tear	101 x 101 (4 x 4)
AKRO AF 844	one	Any type of damage (hole in liner) ^[1]	25 x 25 (1 x 1)
AKRO AF 848			127 x 25 (5 x 1)
AKRO AF 888			127 x 127 (5 x 5)
AKRO AF 844	two ^[2]		127 x 50 (5 x 2)
AKRO AF 848			330 x 50 (13 x 2)
AKRO AF 888			330 x 152 (13 x 6)

[1] Straight slits are not approved for repair with patches. Cut/Notch straight slits into "U" section.

- (5) If these requirements cannot be obeyed, the damaged forward baggage compartment partition must be replaced.
- (6) The forward baggage compartment partition that has other type of damage than that specified in table 801 (or with damage larger than the dimensions in table 801) must be replaced.

- (2) For these patch repairs, no set-up or cure time is necessary. The aircraft can be put back into service immediately.
- (3) The minimum distance between two patch repairs must be 38 millimeters (1.5 inches).
- (4) Refer to table 801 and [Figure 801](#) for the maximum and types of damage that can be repaired.

- (5) Find the patch that correctly agrees with the damage and periphery area (see table 801) ([Figure 801](#)).

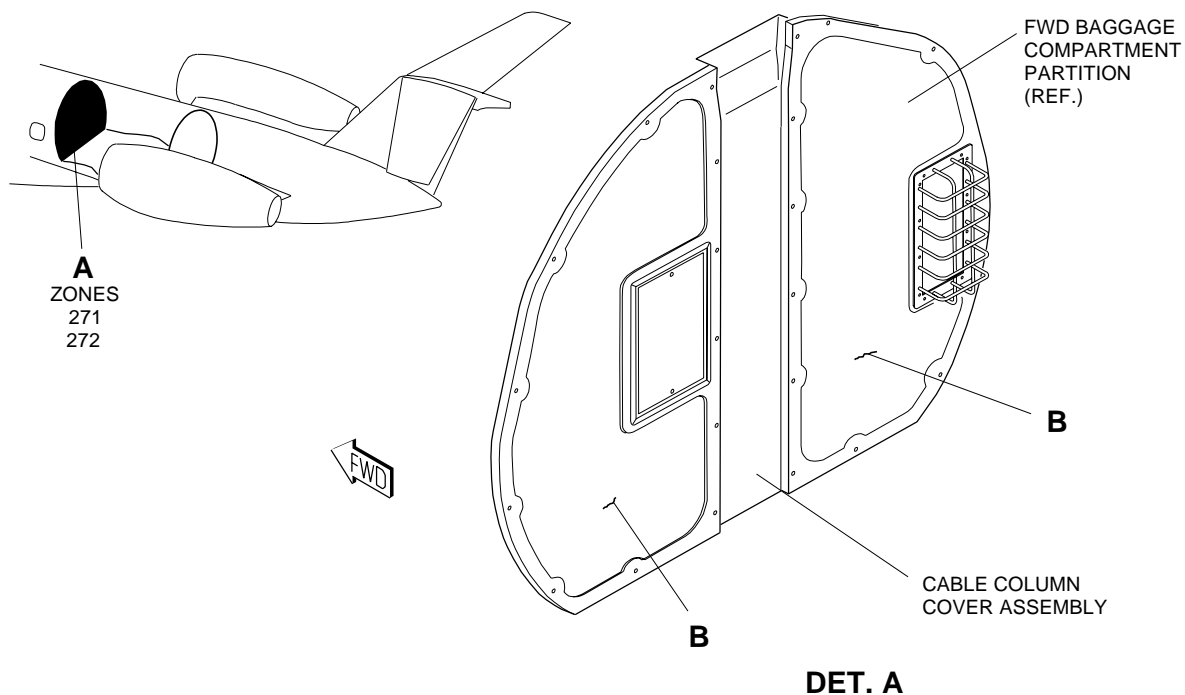
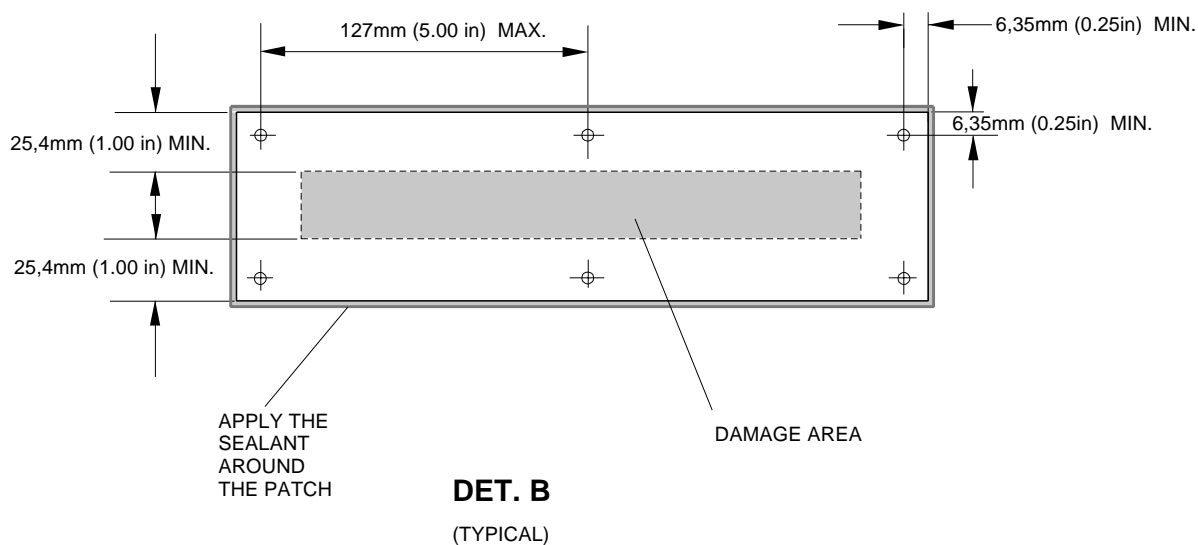
EFFECTIVITY: ALL
Rigid Patch Repair
Figure 803

- (a) To apply patch repairs bonded without rivets the damage can not be larger than 12,7 x 12,7 mm (1/2 x 1/2 in) square in size.

- (b) To apply patch repairs with hard rivets the damage can not be larger than 103 cm² (16 in²).

- (10) Obey the conditions below to drill holes in patch for rivet locations.
- (a) Match drill through the partition skin for blind rivets.
- (b) Make sure that on each patch, the center of rivet holes has a minimum of 6,35 mm (0.25 in) from all edges.
- (c) Make sure that there is on each patch, a minimum of 1 rivet every 127 mm (5 in) of length.
- (11) On a mixing tray, container or cardboard palette, put some P/S 870 courtaulds adhesive.
- (12) Mix with a large spatula or knife.

(14) Apply the the metal patch over the damage surface.

(16) Install the rivets on the forward baggage partition repair to apply pressure.
