Bank Stability Procedures  
Pipeline Water Crossings

October 10, 2023

30113936 Task 1.5

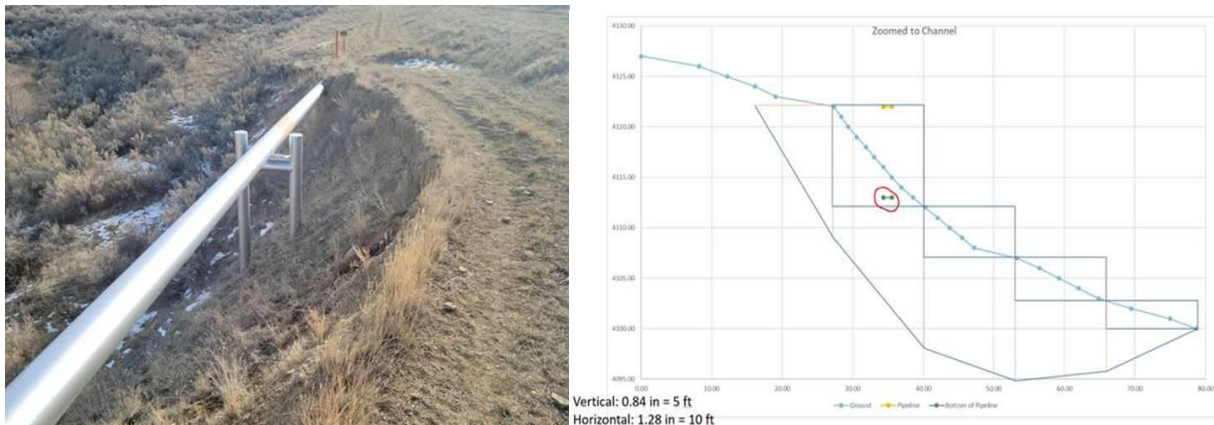
**Figure 1. Crossing US-00169 with Intermediate Support Structure**

US-00169 is an extreme example of a crossing with an elevated pipeline where the pipe support embedment depth can determine whether the pipe support can become dislodged in the event of bank failure. The pipeline and failure surface are shown in Figure 1.

The Professional Survey Water Crossing Inspection Report (PL-2388) form has a section with the support bearing depth (which typically is unknown) but it is unclear how this information is usually found in the EMPCo database. In this case, an embedment depth of only 2 feet does not extend past the projected failure plane and the support

may become dislodged if the bank fails. We need to verify embedment depths in these cases but currently do not know how.

Arcadis recommends creating another slope stability hazard matrix that addresses elevated or suspended pipelines that takes the shallow DOC and pipe supports into account. Based on our experience, plans with pipeline support embedment depths are not readily available. A setback rule may be established for failure surfaces intersecting or encompassing embedded pipe supports.

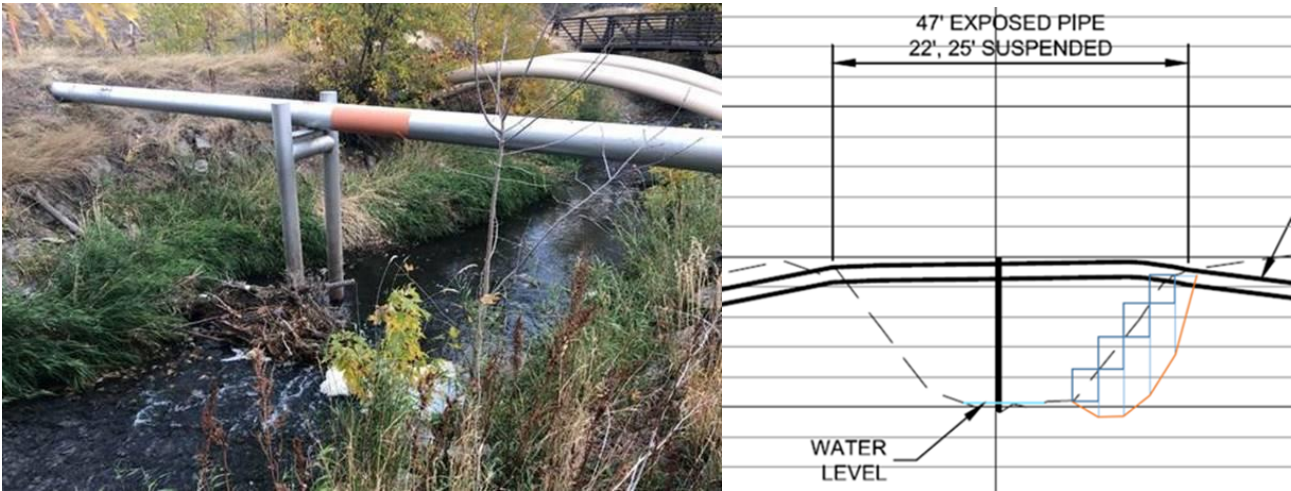
Figure 3. Crossing US-00145 is an Elevated Pipeline

Figure 3 shows US-00145 as an example of a crossing with an elevated pipeline where soil spring analysis is not needed due to minimal soil load. The length of pipeline effected by the failure plane used in the bank stability assessment is small and it would be better to use the bank erosion rate from the hydrotechnical assessment to evaluate the expected amount of time before the allowable USL may be reached.
