## Update "With-Site-Visit" Reserve Study

### HMC Water System Lakebay, WA

**Report #: 26621-3**  
**For Period Beginning: October 1, 2017**  
**Expires: September 30, 2018**

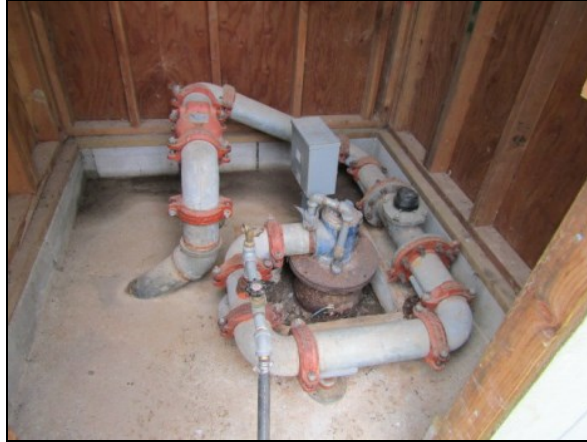
**Comp #: 901 Well Pumps/Motors - Replace****Quantity: (2) 5 HP submersible, 4"**

History: Replaced last in September 2012

Evaluation: Both well pumps/motors were replaced last in September 2012. Previous research with installing contractor indicated replacement at the typical useful life projection of between 15-30 years for most applications, with longer end of this range for these systems. Going forward, regular testing and inspection should be factored within the operating budget. Minor repairs/replacements (below \$2,000) of miscellaneous valves, piping, hardware, etc... should also be considered maintenance items.

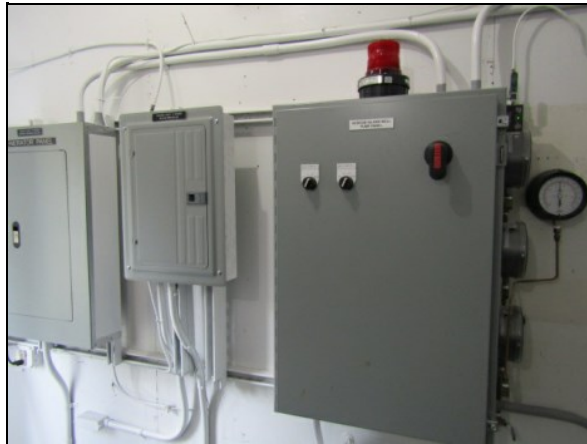
**Comp #: 904 Well Controls - Replace****Quantity: (1) two-motor control**

Evaluation: Well control panel without reported problems. Assumption for eventual intervals of controller system replacement to ensure functionality and offset potential parts obsolescence.

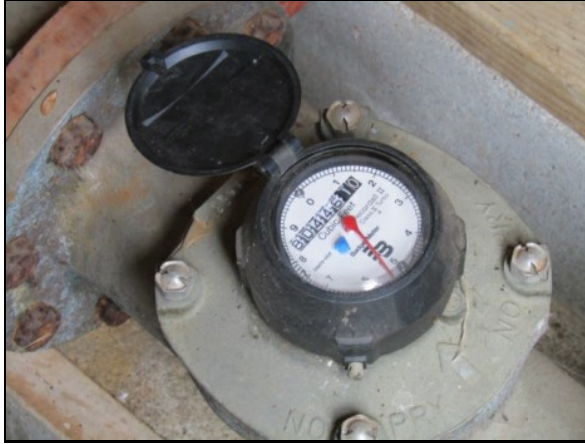
**Comp #: 905 Source Flow Meters - Replace**

Evaluation: Age and model appear to vary but no reported problems; both are assumed to be within allowable accuracy tolerances. Typical life is in the 10-20 year range. Roughly \$1,000-\$1,300 expense for individual replacements, when needed, do not merit reserve designation.

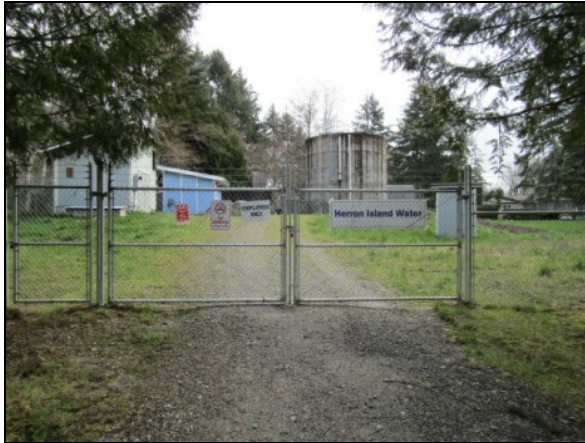
Evaluation: Good water quality reported; historically water has met applicable health standards without apparent needs to add filtration or treatment systems. Incorporate any significant changes or predictable expense in future reserve study updates as conditions merit.

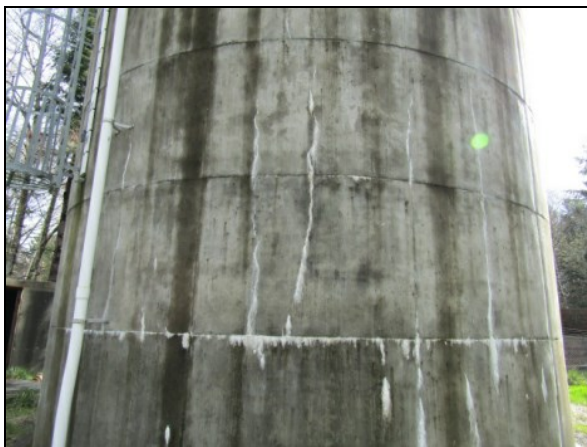
**Comp #: 910 Storage Tank, Concrete - Replace****Quantity: (1) 99,000 gallon**

Evaluation: This above grade concrete tank was reportedly installed in 2005. It is our understanding that water storage capacity is 94,000 gallons for this 99,000 gallon reservoir. No significant cracking, damage or spalling was apparent during our limited scope visual inspection. As before, local efflorescence (mineral staining) was noted. This condition is reportedly consistent since initial 2005 construction and not indicative of significant water loss. We assume ongoing evaluation for stability and leak detection will occur. Interior of concrete tank is without any liner requiring renewal or replacement. Our research suggests planning for typical service life of between 60-80 years for concrete tanks. Continue to monitor closely and perhaps have engineer evaluate if cracking/spalling, or actual leaks become prevalent. Also, inspect access metal work and keep in good repair as ongoing maintenance. Note; some possibility of increased storage needs may exist for future years, as well as multitude of other design criteria - adjust in future reserve updates as conditions merit.

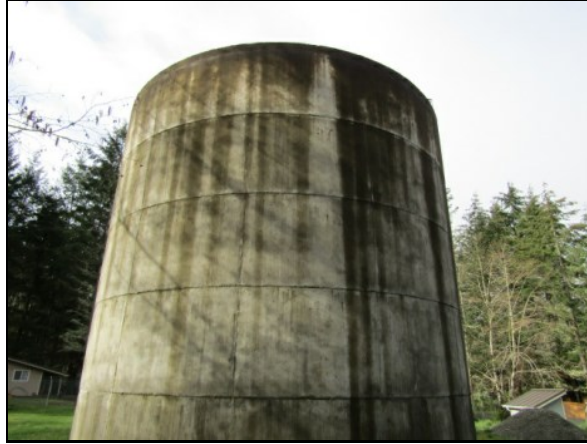
Evaluation: Interior was not inspected. Research for this update informed us regarding your current plans for interior cleaning project to occur in FY 2018/2019 and then every 10 years or so going forward. Track any other significant needs and expense patterns carefully; adjust in future reserve study updates.

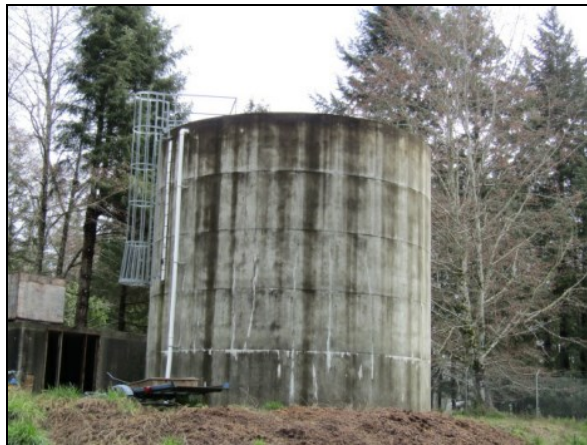
Evaluation: Exterior surface is without any protective coating (as typical for concrete reservoir). General grime, mildew and staining was illustrated. Last exterior cleaning project reportedly occurred in FY 2014/2015 project at expense of \$2,800. As before, we have factored an allowance for cleaning intervals every 4-5 years to benefit aesthetics.

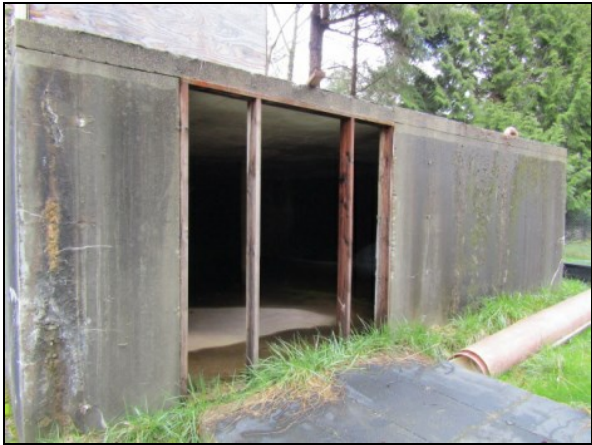
Evaluation: Decommissioned, old concrete reservoir in process of being repurposed since FY 2015/2016. Conversion to utilization as storage space is planned; expense for project from operating funds at present. Incorporate into future reserve study update as conditions warrant.

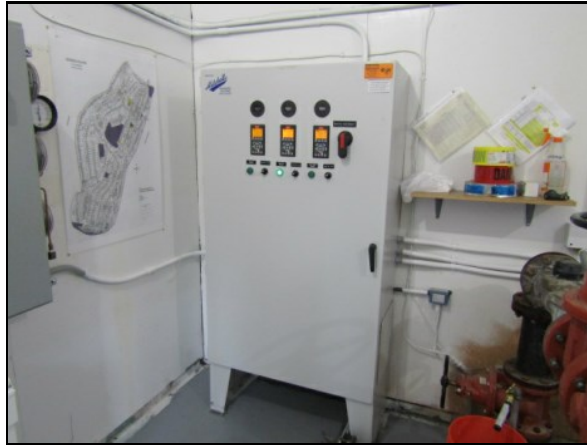
**Comp #: 924 Booster Pumps VFD Control - Replace**

Evaluation: Significant electricity savings is reported since installation of VFD (Variable Frequency Drive) controls. Assume integrated replacement along with booster pumps replacement intervals to maintain contemporary efficiency.

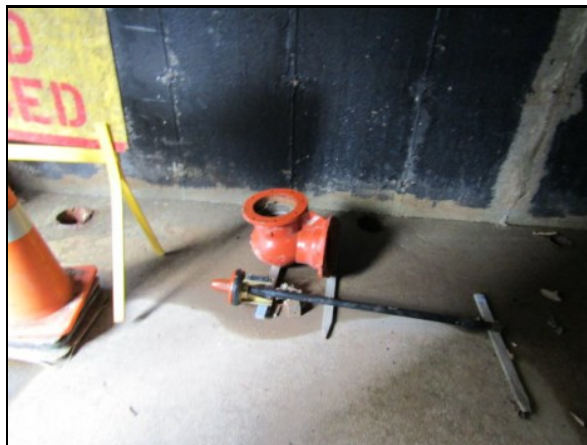
**Comp #: 929 System Components, Small - Replace**

Evaluation: There are numerous small connections, meters, gauges, valve assemblies, etc... These ancillary water system components will need rebuilding or replacement from time to time but are expected to also be below the reserve funding threshold cost and therefore should be expensed as general maintenance from within the operating budget per occurrence.

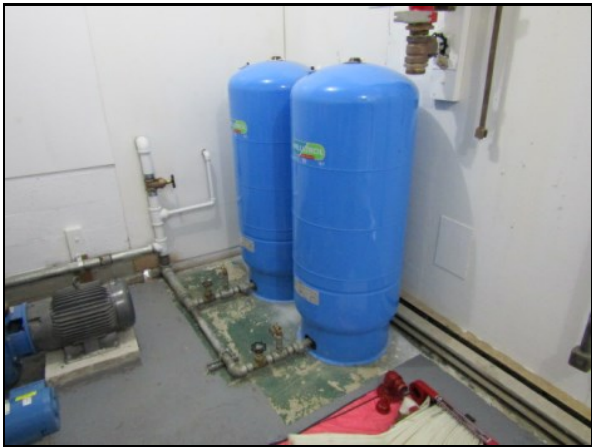
**Comp #: 930 Pressure Tanks - Replace**

Evaluation: These small steel pressure tanks appear to be in fair condition. Replacement cost is minimal (~\$1,500 for both) so replace if needed from operating funds.

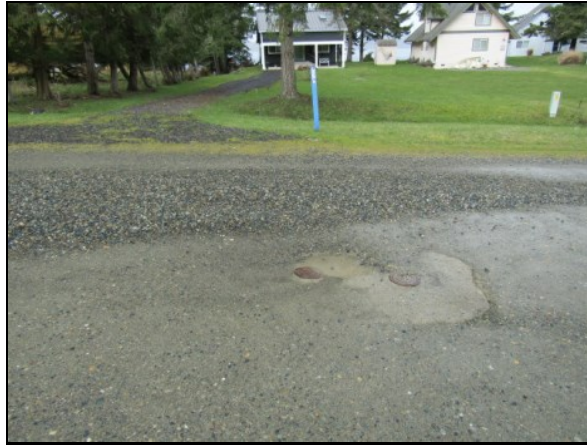
### Comp #: 940 Distribution Lines, 6"-8" - Replace

Evaluation: No reported problems at present. We noted provided NWS 2011 water line project report and maps indicated that PVC Schedule 40 was to be specified during FY 2012/2013 project. Instead, installation of primarily PVC C900 products was utilized. In any event, replacements were indicated primarily to replace deteriorated and leaking sections but also improvements to flow and fire protection. Majority of PVC C900 main line is now 6" (25,200 LF) with minor amount of 8" locations. Our previous review of provided materials and research with representative of your current SMA (Satellite Management Agency), Northwest Water Systems (NWS), confirmed anticipation for long replacement intervals factored below for existing PVC C900 piping. Although this is a extended life component, eventual and very significant expense is predictable and should be included in prudent planning. We noted 2012 project design and oversight by NWS and assume related connections, road repair, etc... are included in cost projections.s.

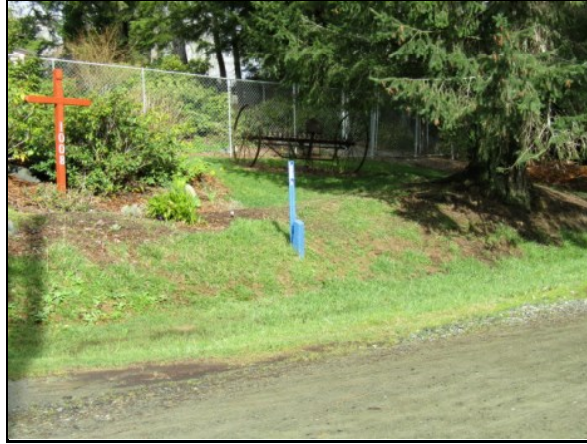
**Comp #: 941 Distribution Lines, 2" - Replace****Quantity: Approx 2,500 LF**

Evaluation: Some locations utilize smaller 2" (or less) PVC Schedule 40 with a useful life assumption of roughly 30-40 years as factored below. Track needs and any expense patterns that may emerge and adjust as conditions merit in future reserve study updates. Note, image is representative, not necessarily indicative of project locations.

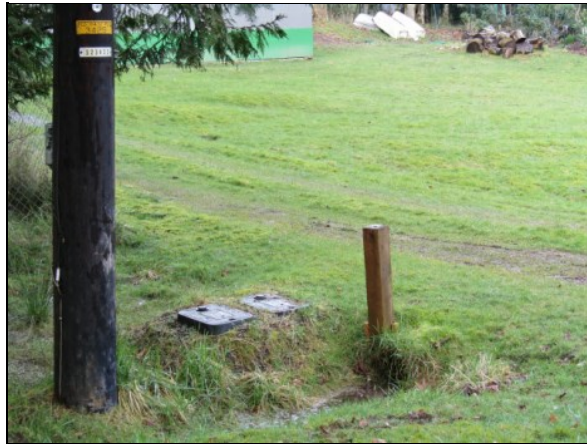
**Comp #: 945 Service Connect/Lines - Replace****Quantity: (397) connections**

Evaluation: The service lines off of the main water distribution lines are primarily 1.5" poly connecting lines and we have factored a service life of roughly 30-40 years for these lines and associated connections. Some local leak repairs since large project was completed. Continue proactive leak detection, treat minor repair/replacement as needed using operating funds. Note, image is representative, not necessarily indicative of project locations.

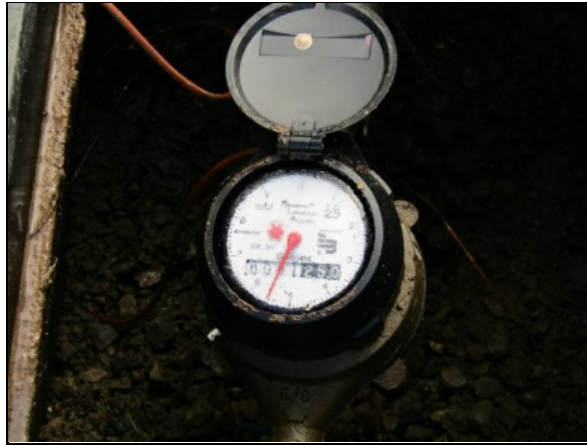
**Comp #: 946 Service Meters - Replace****Quantity: (397) meters**

Evaluation: Water meters with sensors were installed as part of FY 2012/2013 improvements. Estimated useful life of meters is roughly 10 years with proactive replacement scheduling recommend to help ensure minimal leakage, function and accuracy. Anticipate some local replacement needs in between large scale projects; treat such as ongoing maintenance items.

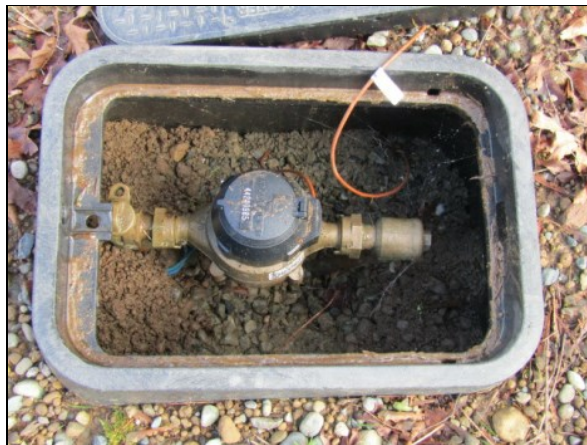
**Comp #: 947 Service Meter Box/Setters - Replace****Quantity: (397) boxes/setters**

Evaluation: Note that associated water meter boxes, setters/shut-off valves are life limited as well. Unless more urgent needs arise, we recommend integrated replacement timed to coincide with every other meter replacement project.

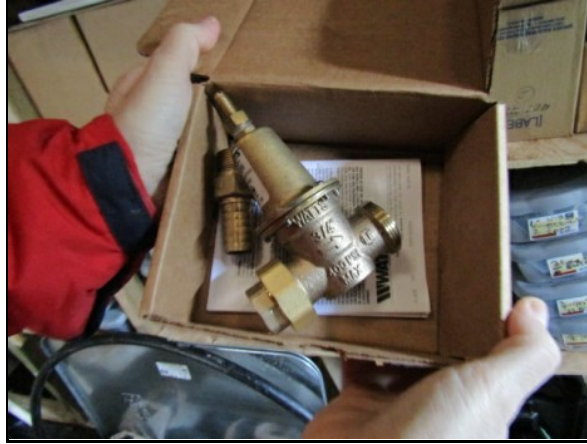
**Comp #: 950 Pressure Reducing Valves - Replace****Quantity: (60) metal**

Evaluation: PRV's (pressure reducing valves) were installed in select service locations. For general planning purposes, assume estimated useful life of roughly 20 years. Document/track history of any replacement and adjust in future reserve study updates as conditions merit.
