Automatic Register Cloning Avoidance

Arm[®] Partner Enablement Group

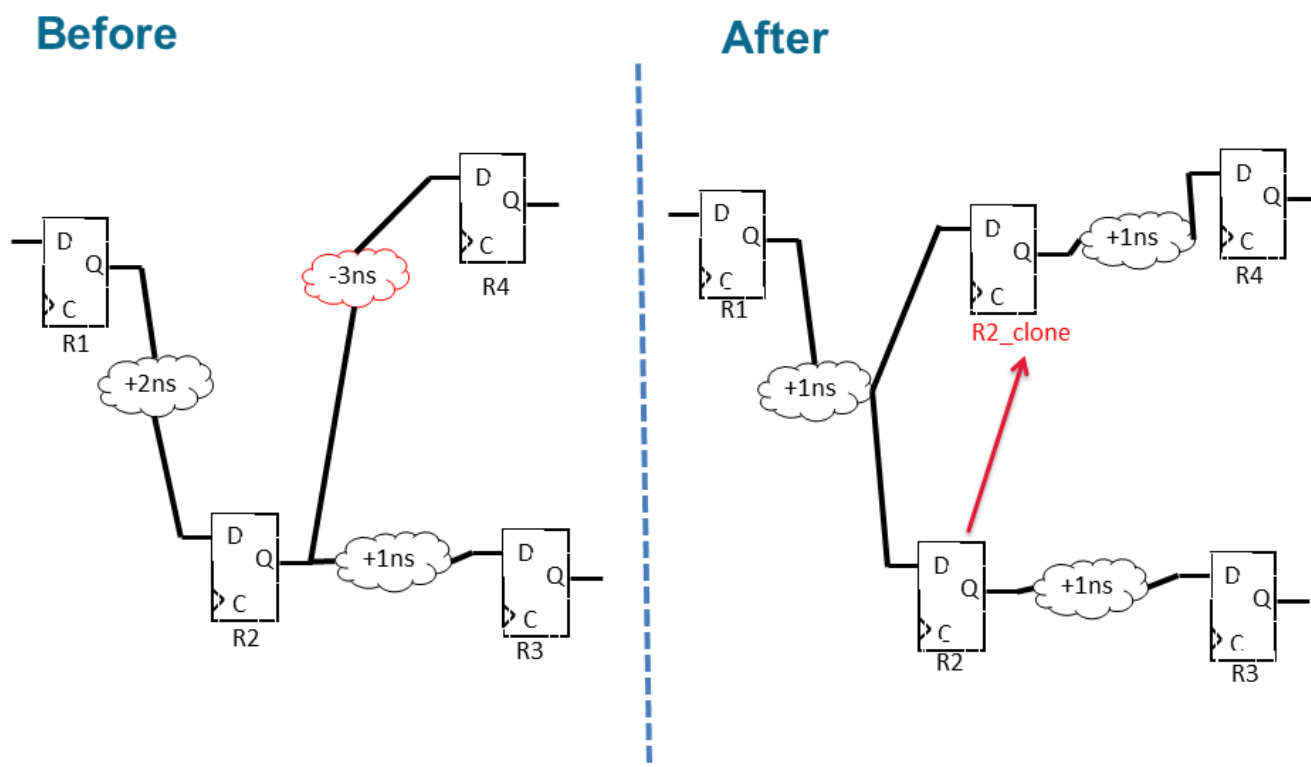
As shown in Figure 1 – Example of Register Cloning for Timing Closure below, synthesis tools can split a heavy load on the output of register R2 by creating a copy R2_clone which is then placed closer to the logic it drives and away from the original R2 location. A timing violation of -3ns thus becomes a timing path with a positive slack of 1ns.

A cloned register might not necessarily initialize to the same state as its master on power-up, and that would contradict the LEC match assertion made by synthesis. Additionally, there are other concerns related to register cloning that are not addressed by EDA tools:

When non-reset registers are cloned, synthesis tools would ideally guarantee that these identical copies result in exactly the same functionality under all conditions – especially on power-up. Depending on how the tools transform local cones of logic independently with each copy, one branch of a clock tree might be turned off if a cloned register initializes with a 0 and was factored into the clock enable of an ICG (integrated clock gate) while the other copy of the same register might initialize with a 1, presenting a conflicting value to its downstream logic.

Many factors contribute to whether a pair of original/clone registers initialize differently on power-up: their location on the die, power grid layout, drive strength, V_t , process conditions, on-chip variation, clock tree, etc. A mismatched initialization injects a new state into the original FSM (finite state machine) that can potentially produce a dead lock, hang, or other unforeseen failures since verification did not account for this additional state.

For these reasons, Arm recommends that automatic non-reset register cloning feature is explicitly disabled in partner physical implementation work.

Because the exact conditions assumed by the EDA tools in cloning a register are not documented and because a pair of cloned non-reset registers initializing differently on power-up can cause problems on silicon, **Arm strongly recommends that our partners disable this feature.**
