DTC	B2775	INTERIOR VERIFICATION ABNORMAL (TO THEFT DETERRENT ECU)
------------	--------------	--

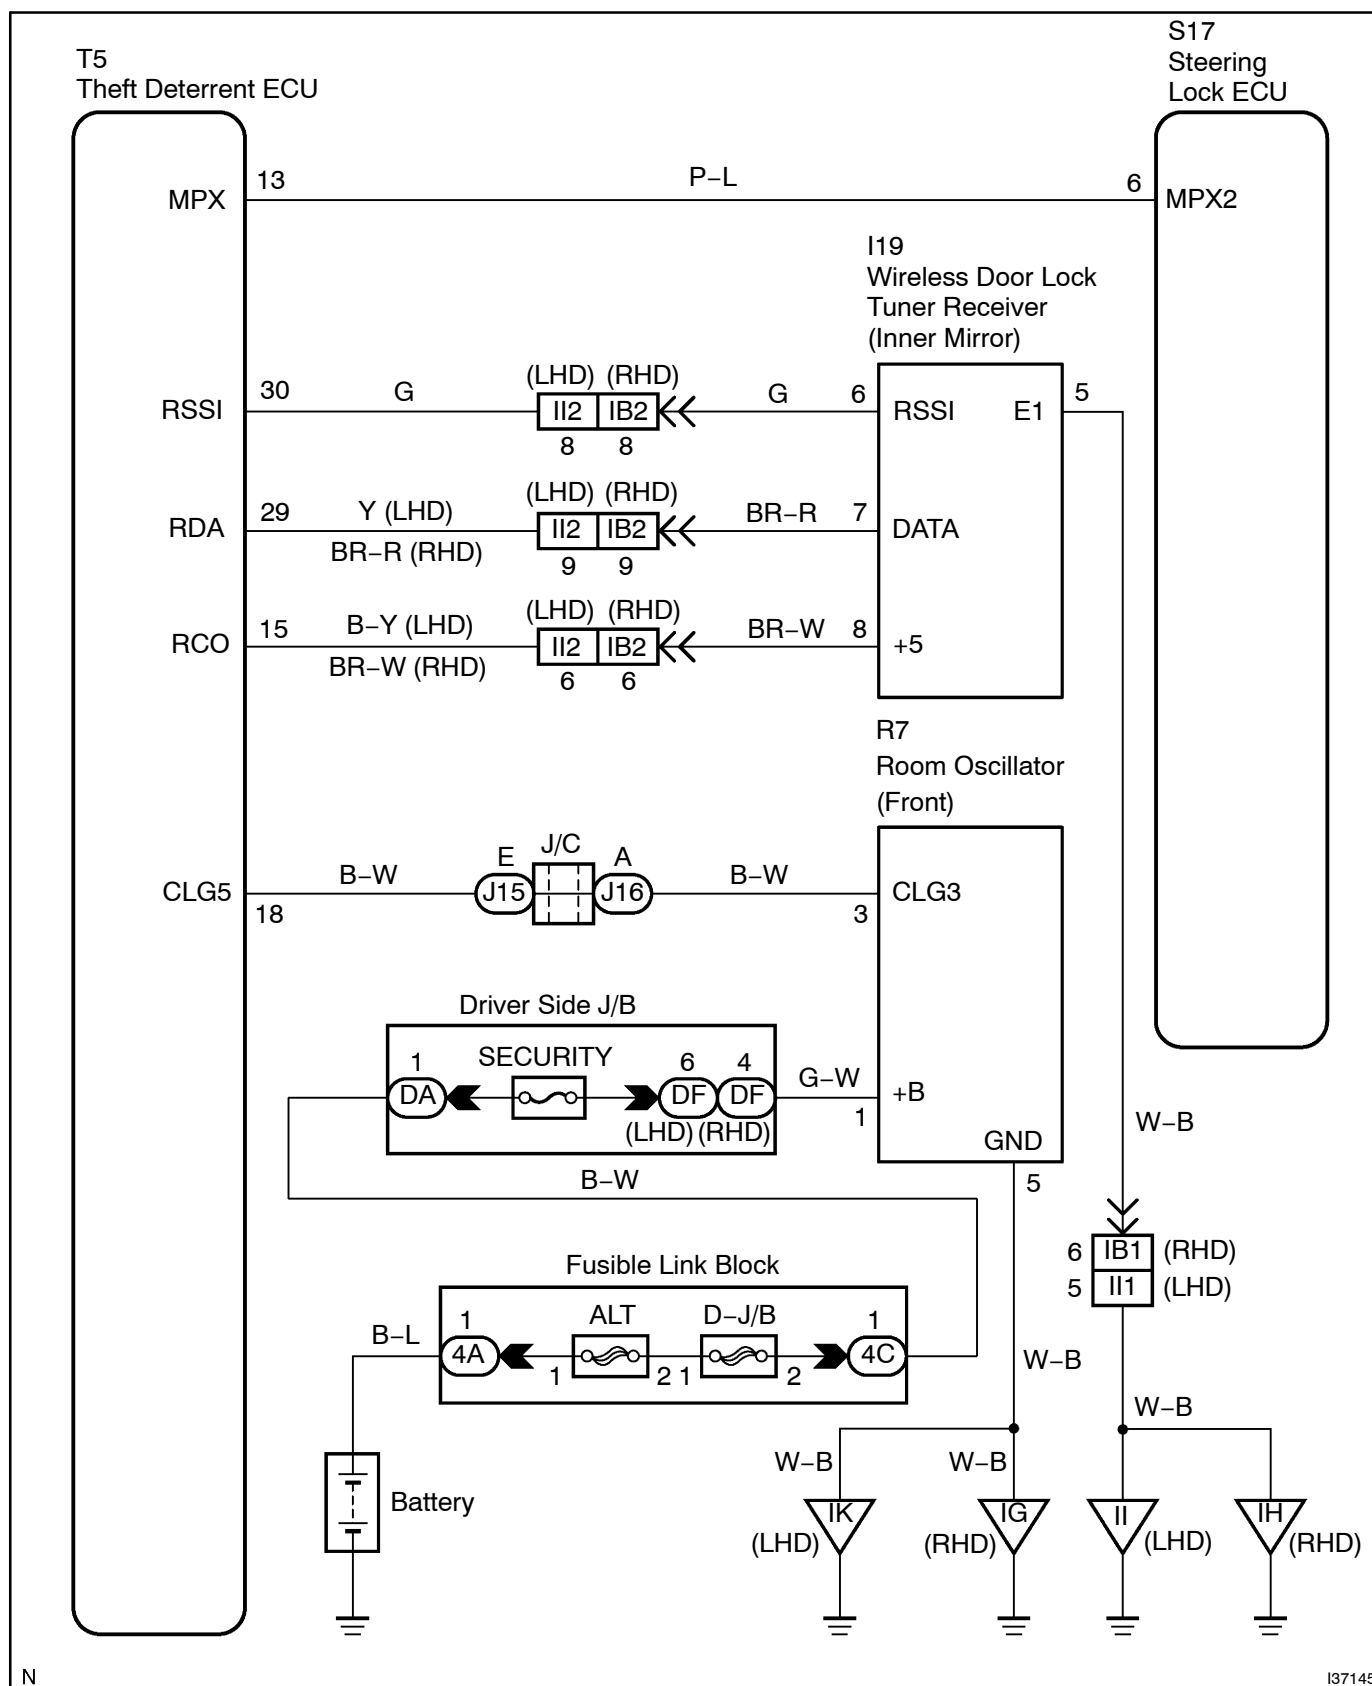
WIRING DIAGRAM

CIRCUIT DESCRIPTION

The steering lock ECU communicates through BEAN with the theft deterrent ECU on whether or not interior verification is performed. The steering lock ECU detects this DTC when a trouble is detected in this communication. The following conditions are also considered as communication errors and this DTC is output.
