## PRECAUTIONS FOR REPAIRING BODY STRUCTURE PANELS

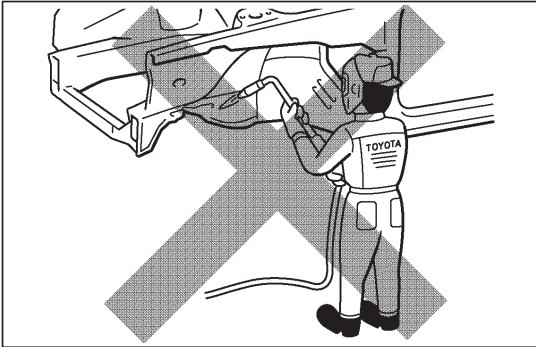
### 1. HEAT REPAIR FOR BODY STRUCTURE PANELS

Toyota prohibits the use of the heat repair method on body structure panels when repairing a vehicle damaged in a collision.

If a body structure part is heat repaired with an acetylene torch or other heating source, the crystalline organization of the steel sheet will change and the strength of the steel sheet will be reduced.

The ability of the body to resist rust is significantly lowered as well since the rust resistant zinc coating is destroyed by heat and the steel sheet surface is oxidized.

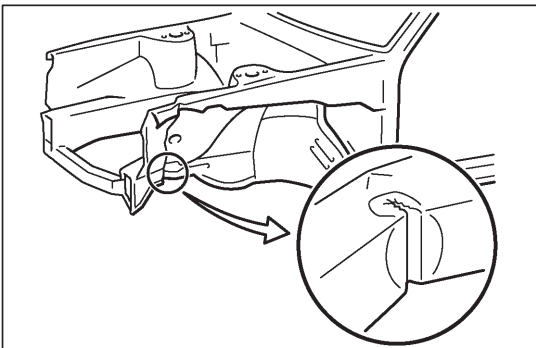
### 2. STRUCTURE PANEL KINKS

A sharp deformation angle on the panel that cannot be returned to its original shape by pulling or hammering is called a kink.

Since structure parts were designed to exhibit a 100% performance when they were in their original shape, if they are deformed in an accident, or if the deformed parts are repaired and reused, they become unable to exhibit the same performance as intended in the design.

It is necessary to replace the part where the kink has occurred.

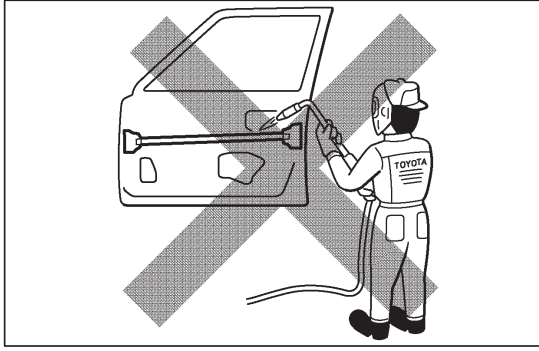
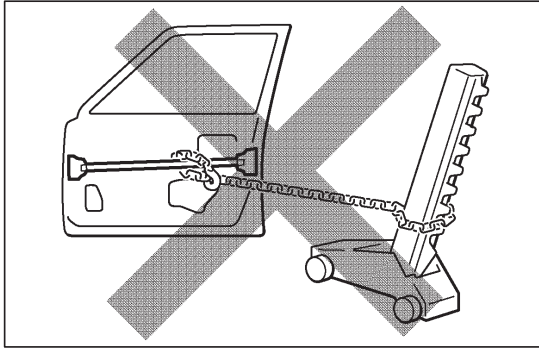
### 3. IMPACT BEAM REPAIR

The impact beam and bracket are necessary and important parts in maintaining a survival space for passengers in a side collision.

Since these parts were designed to exhibit a 100% performance when they were in their original shape, if they are deformed in an accident, or if the deformed parts are repaired and reused, they become unable to exhibit the same performance as intended in the design.

It is necessary to replace the door assembly when impact beam or bracket is damaged.
