Allegro Design Entry HDL Known Problems and Solutions

Product Version 23.1

September 2023

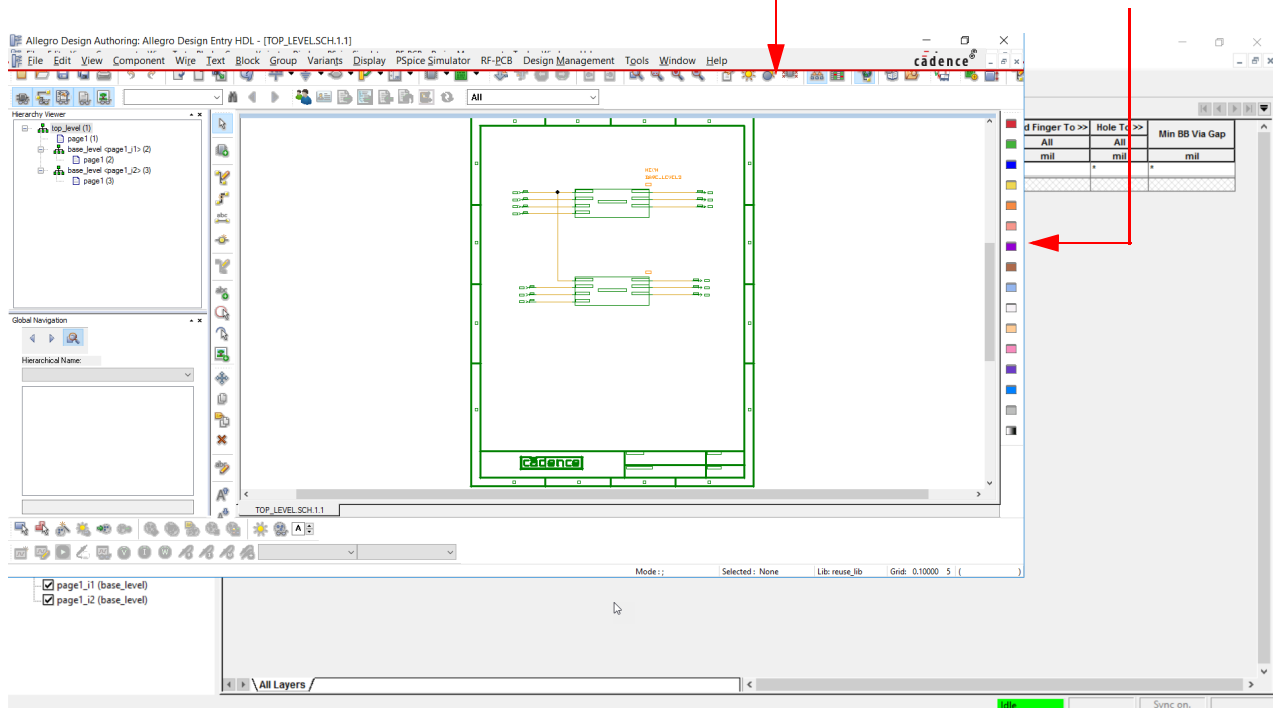
In the DE-HDL window

Description: When Constraint Manager is launched from DE-HDL on Windows 10 machines with Intel graphic cards, you may observe some display issues. In DE-HDL for example, the menu bar appears twice and the size of the menu bar and icons reduces. In Constraint Manager, the font size of the menu bar increases, a distorted menu bar might sometimes be displayed and some dialogs show text with a higher resolution.

The menu bar appears twice.

The size of the menu bar and icons reduces.

Solution: To fix this issue, do the following:

1. Close Constraint Manager and DE-HDL.
2. Click *Start* and choose *Cadence Release 17.2-2016*.
3. Right-click on *Design Entry HDL*.
4. Choose *More – Open file location*.
5. Right-click on *Design Entry HDL* and select *Properties*.
6. In the Design Entry HDL Properties dialog, click the *Compatibility* tab and select the *Disable display scaling on high DPI settings* check box.
7. Click *OK*.
8. Restart DE-HDL and launch Constraint Manager.

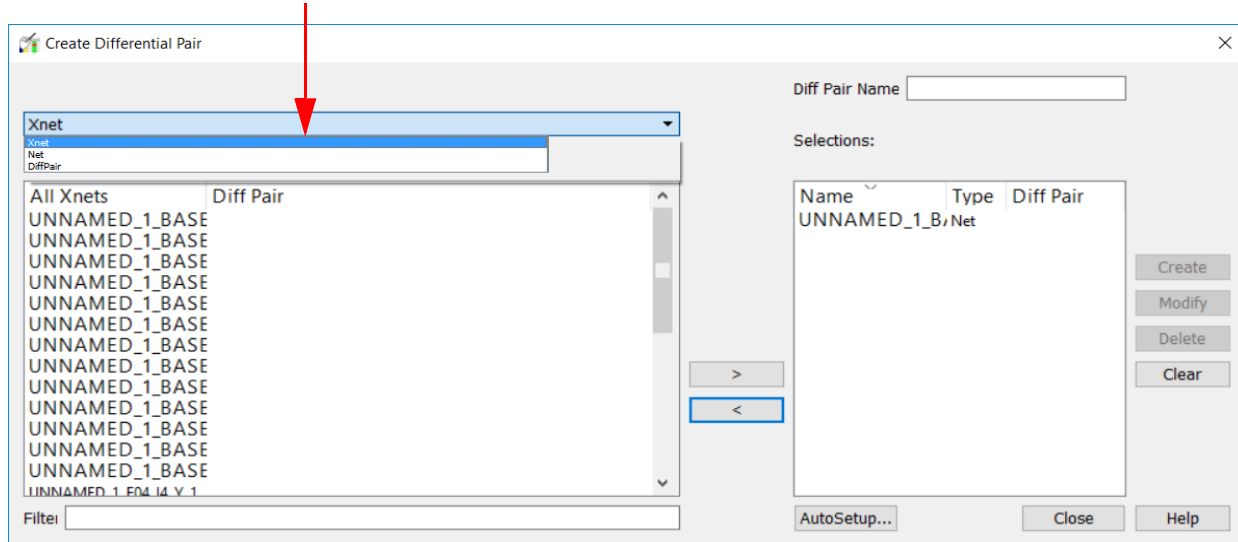
In the Constraint Manager window

The font size of the menu bar increases and a distorted menu bar might sometimes be displayed

Some dialogs show text with a higher resolution.
