Check amperage rating of FT sensor

Property of Vestas Wind Systems A/S. This drawing must not be passed on to any person, nor be copied or otherwise made use of without our approval.			Date	Initials	Function					RS485 comm. to +AT1 Top Panel			
			Designed	070628	FLT	Project title					Control Panel +AT2 V82-1.65MW Mk5 50Hz			
			Approved	070628	FLT	Comments					Customer		Vestas Wind Systems A/S	
			Revised	070628	(N)	Rev.	-	Drawing no.	934704	Cont. sheet	505	Sheet	50

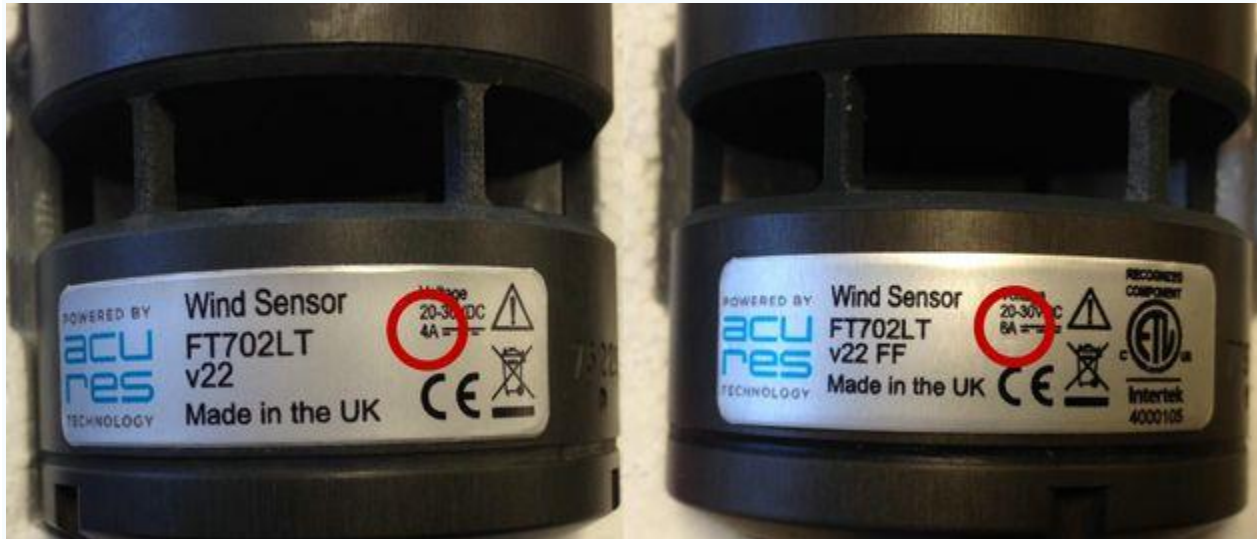
Check the amperage rating of the FT sensor. Typically the FT sensors supplied have been rated at 4 Amps, however in some sites have received sensors rated at 6 Amps.

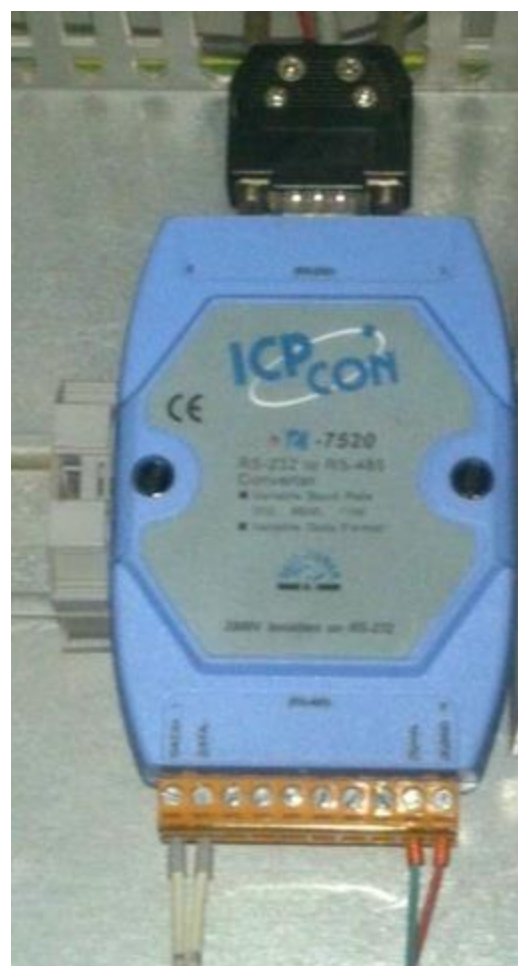
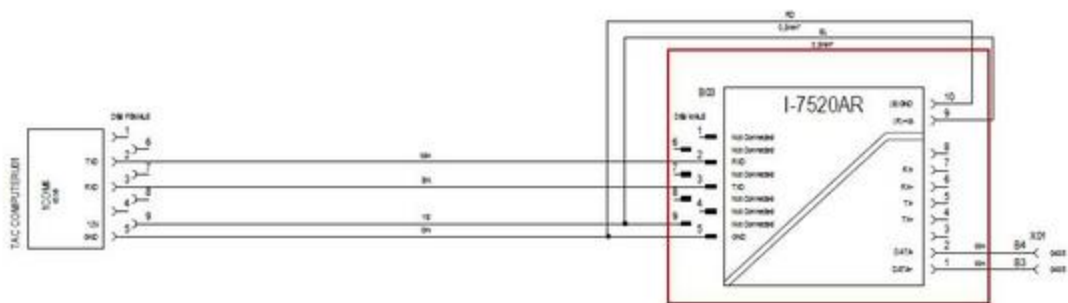
- Explanation**
+AT2 Panel:
 Check the connections at the ICP RS232/RS485 converter in the AT2 panel. Check for loose wires and plugs or corrosion at the converter.

Replace defective RS232/RS485 CONV I-7520 ICP
