Replace the yaw box

- **Explanation**
IN THE NACELLE:

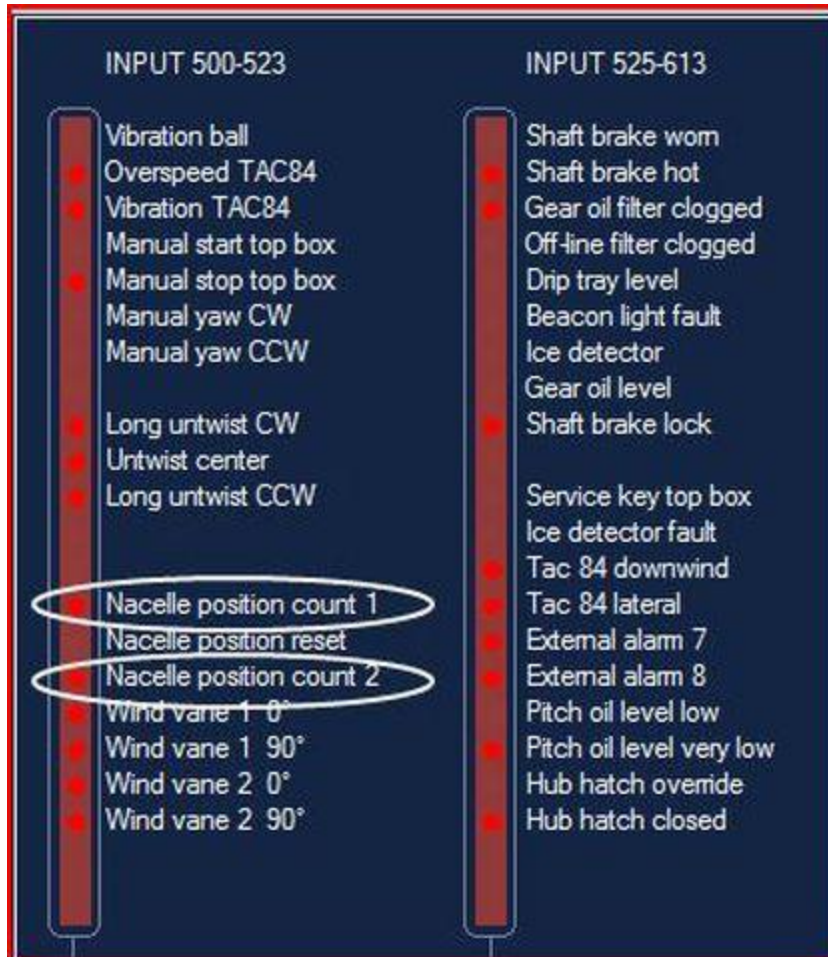
TOI Input:

—Power supply to the encoder may fail. In This case while yawing, Nacelle Position count & Yaw counter will remain the same as read even when the turbine is yawing.

—If any one of the signal (count 1 or count 2) is missing in the encoder, then the yaw position will indicate but the yaw counter will not change.

—Under normal conditions if turbines yaw CW, the yaw counter value should increase. If this doesn't happen then it may be a wiring problem or defective encoder or a mechanical defect within the yaw box.

—Before referring to the yaw counter values always remember that the count will be zero if the center cam is activated. Until the center cam is released, the count will remain at zero. At the time of yawing only the nacelle position value will change and this depends on the direction of yaw.

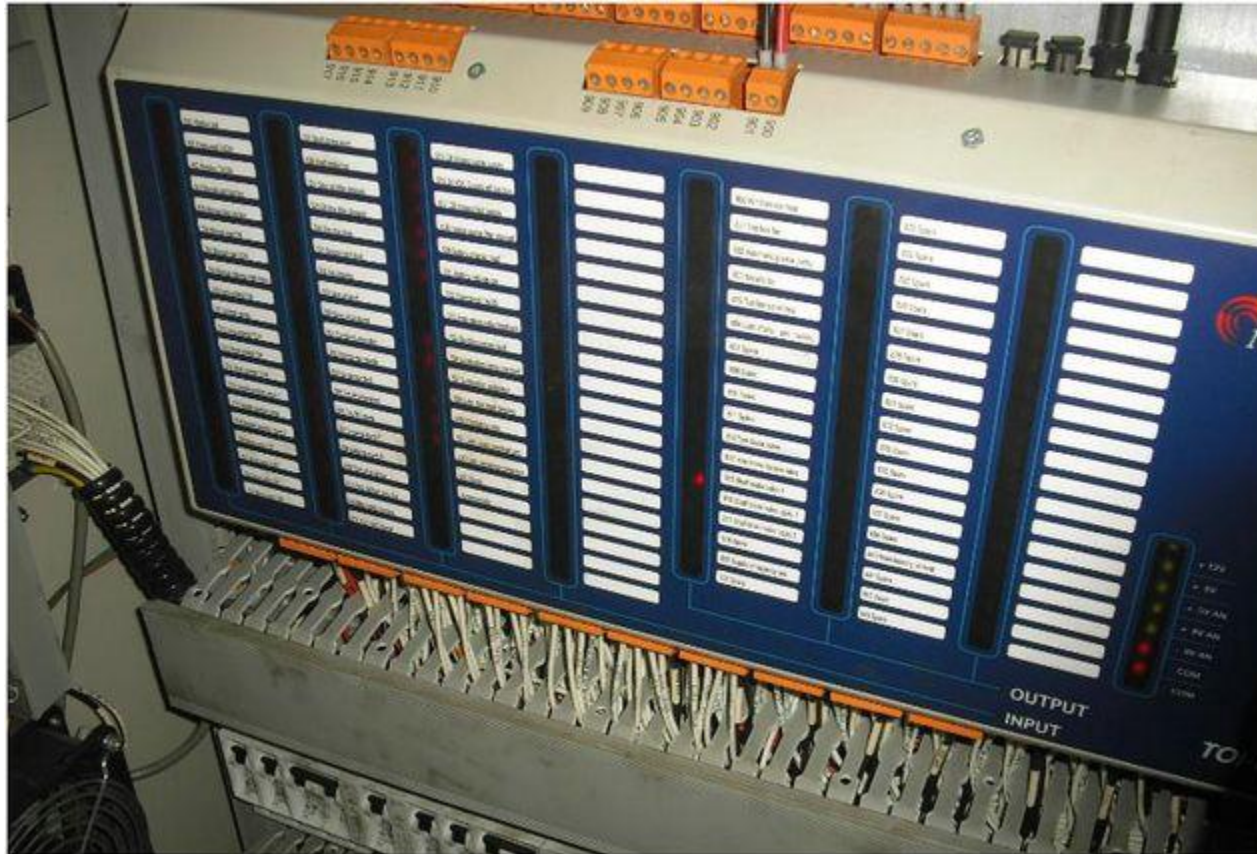
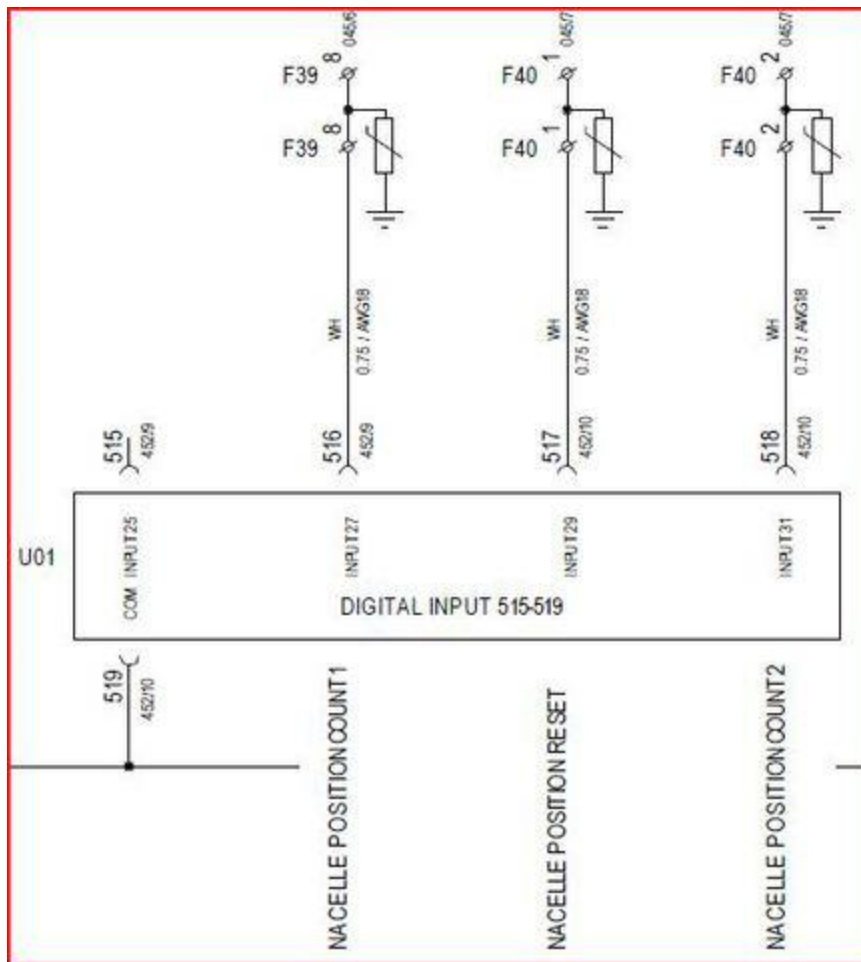
Nacelle TOI part Number:

Check the indication on the nacelle TOI during yawing, the LED should blink and TAC yaw counter value should change.

If the value does not change in TAC, then the cause is likely a faulty Nacelle TOI .

Replace the defect nacelle TOI

51701601- TOI-II INTERF EXT POC

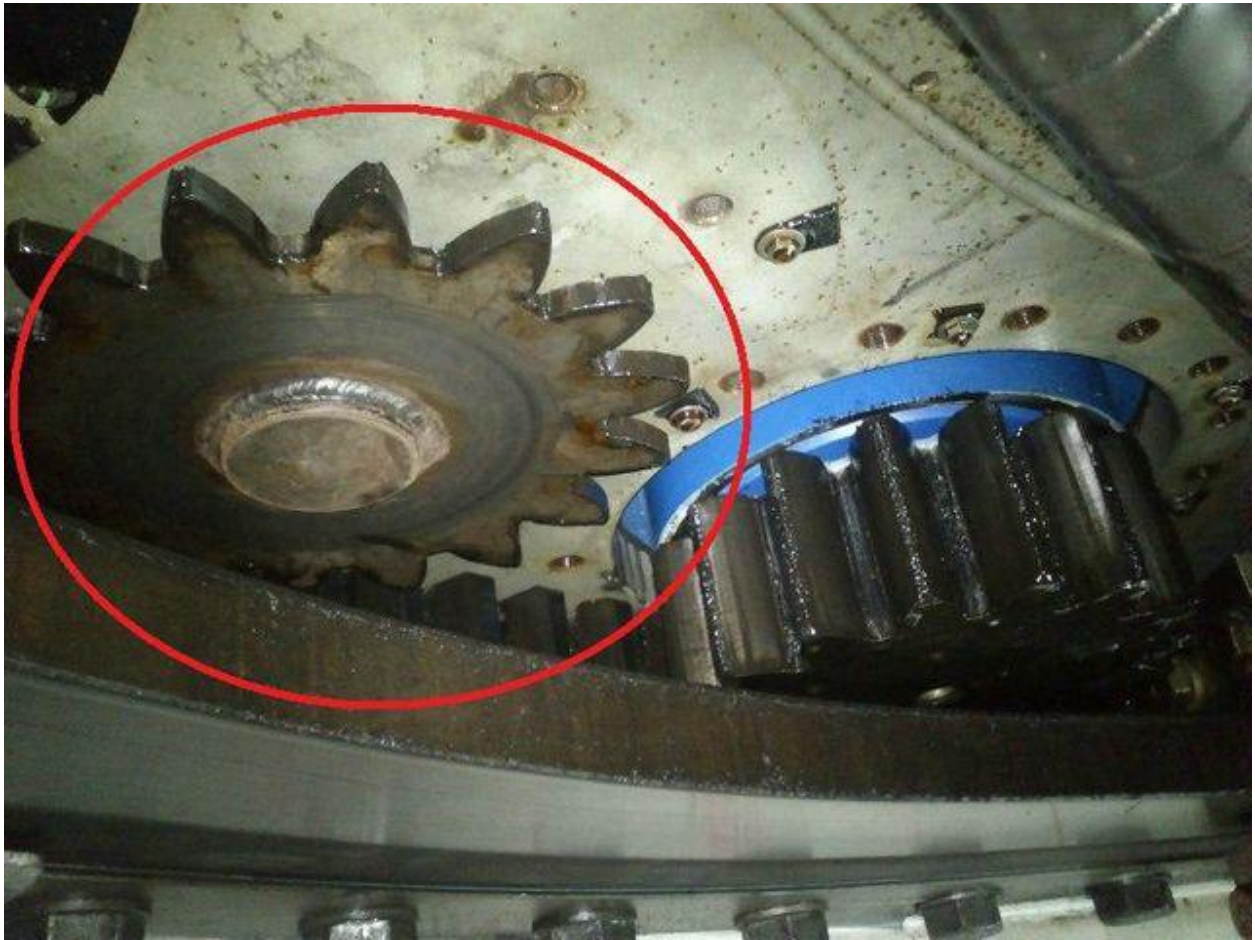
Check the yaw reader wheel which is connected to the yaw box

Check the teeth on the remaining yaw gear pinion wheels for any damage.

Replace the yaw reader wheel
