Replace the defect PT100 Sensor

882 - Pt100 fault gear oil exchanger NM72 NM82 V82 Mk1-5\_

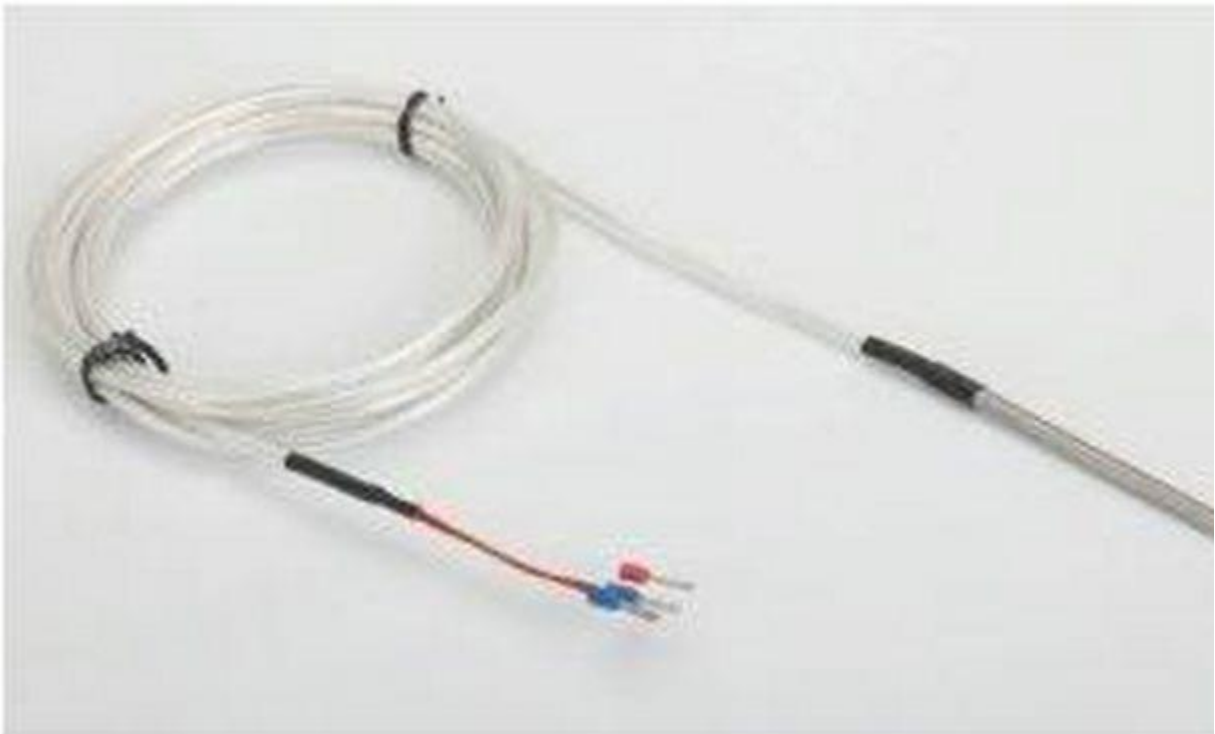
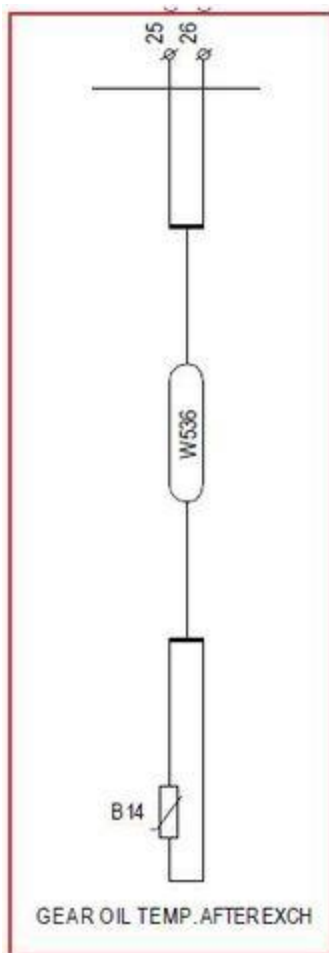
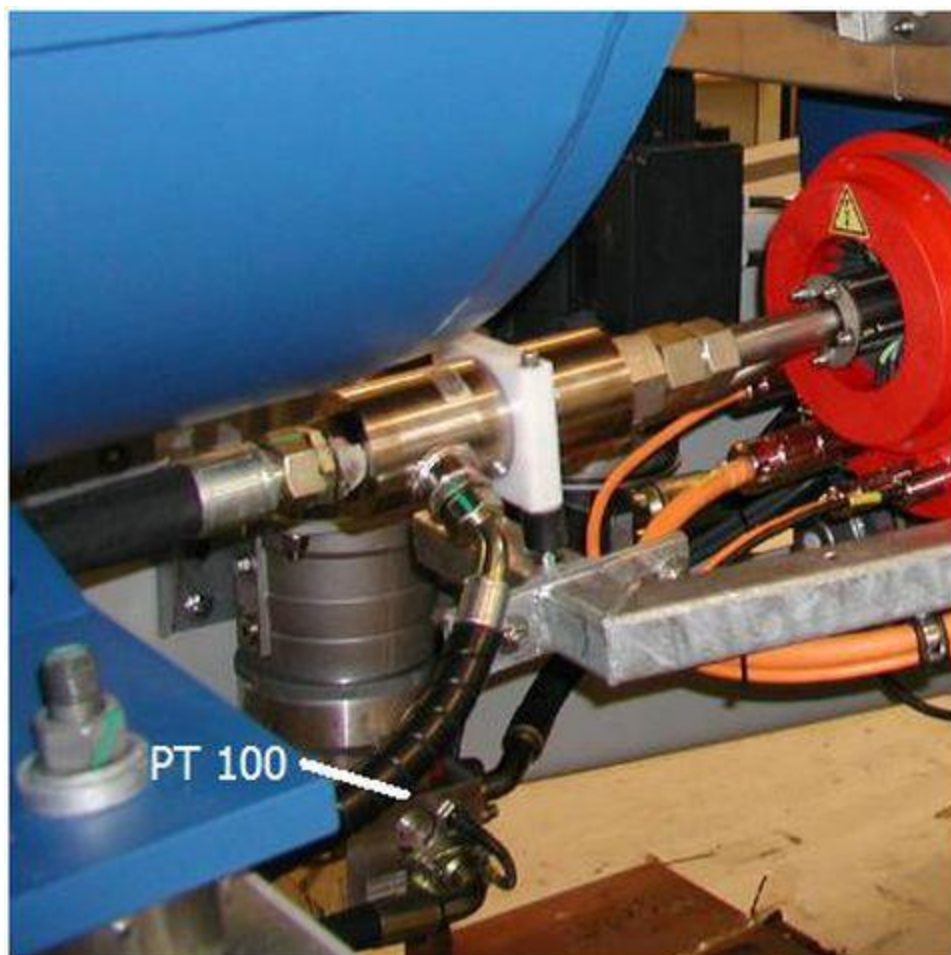
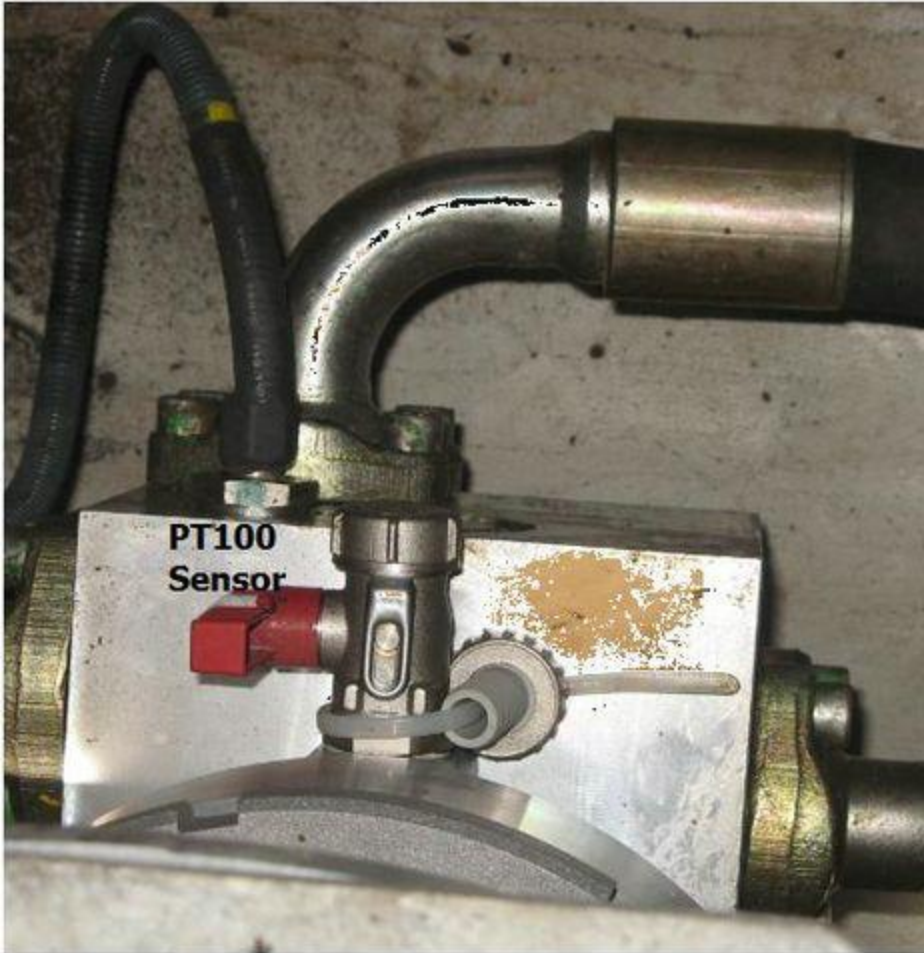
[60009281](#)      **PT100 180-4-7M Ø6x60mm**

If the value is unreal (-40 to 200 °C), then the PT100 is faulty and must be replaced.

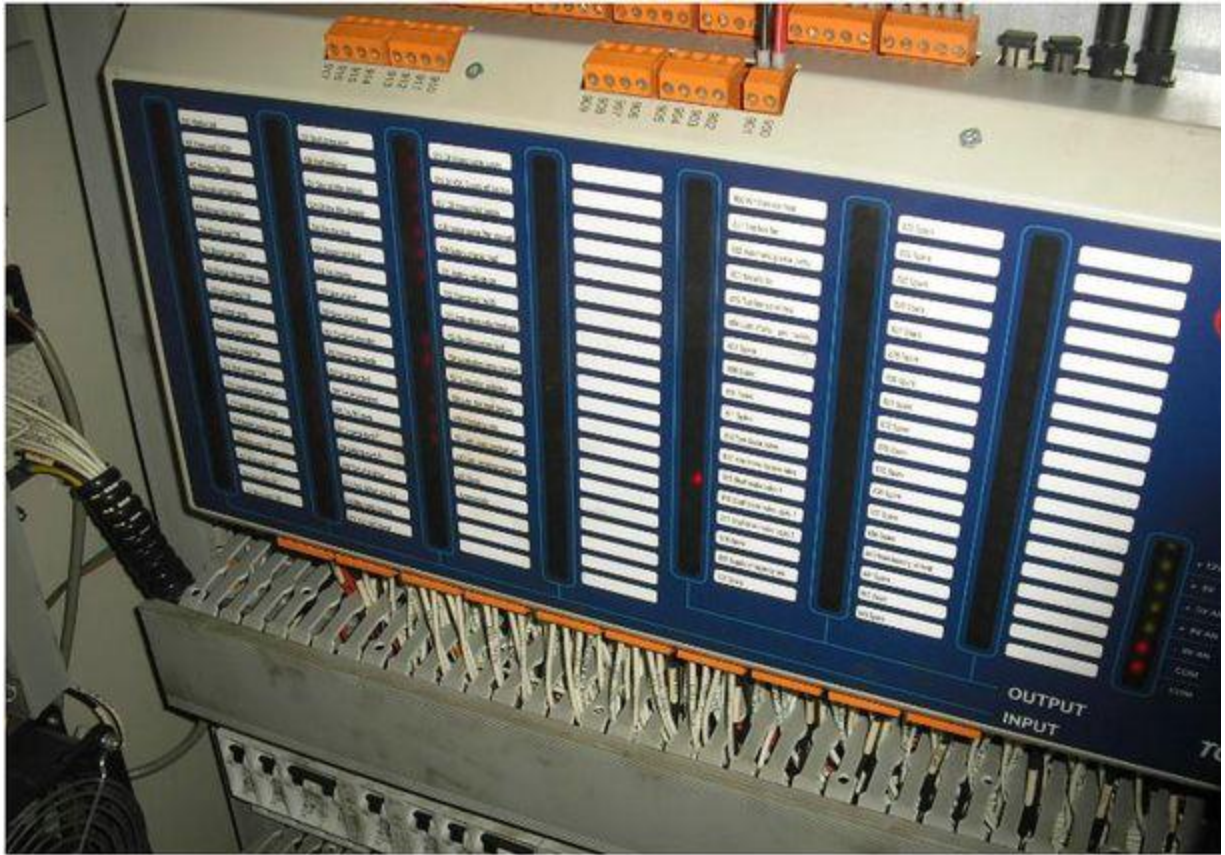
Item Number: [51701601](#) - TOI-II INTERF EXT POC

If the value does not match that taken from the TAC Temperature menu, then the cause is likely a faulty nacelle TOI (check other panel temperature alarms, as these will likely be affected as well).

Replace the defective TOI
