## Replace the breather

**Replace the defective level switch**

**Check the electrical connection**

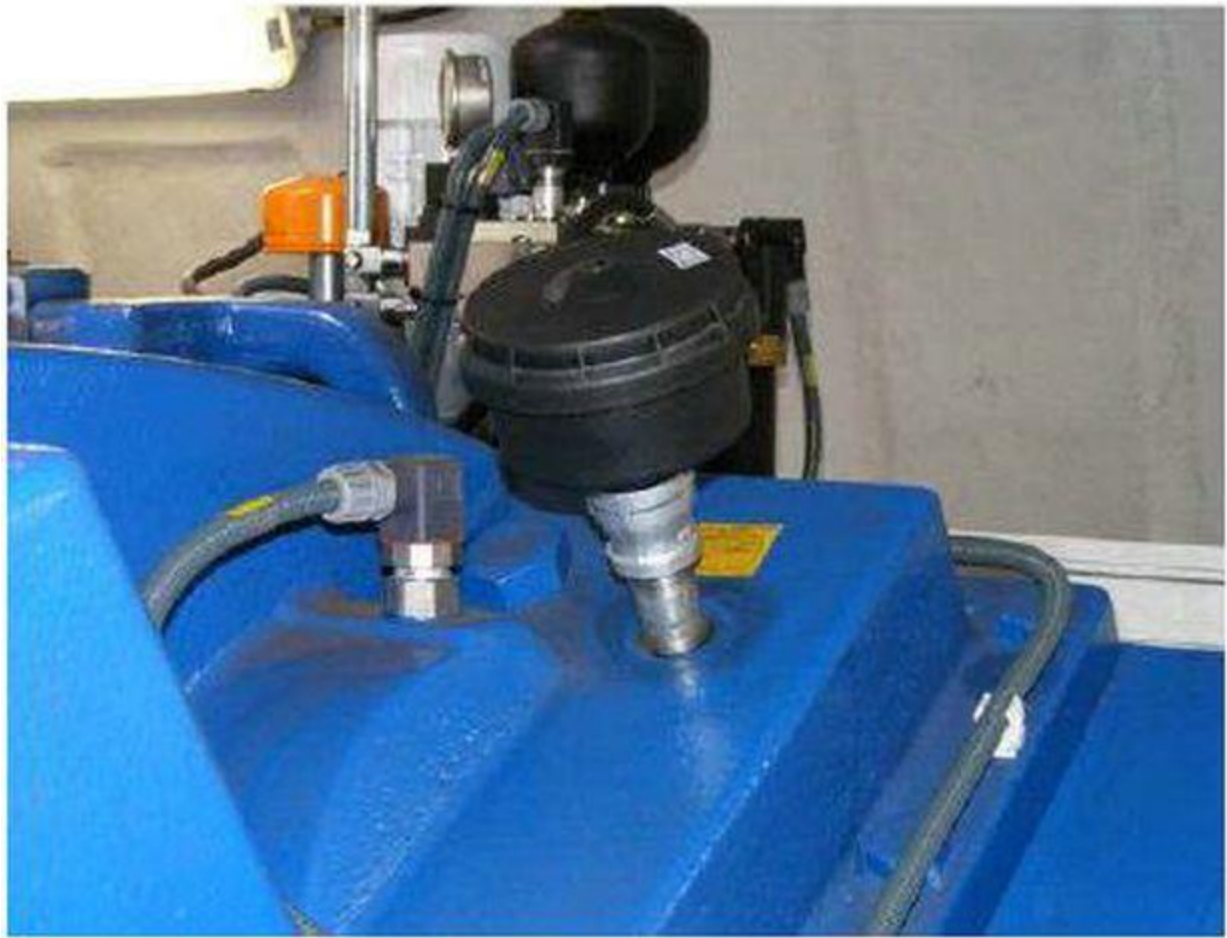
CIM [1855](#)

Ensure that the breather for the gearbox is not saturated with oil. A clogged gear breather will cause the pressure inside the gearbox to deviate from atmospheric; when this happens the sight glass sensor is affected as well as the seals.

Replace the breather if necessary.

A new type breather is available that is much less susceptible to oil saturation and clogging.

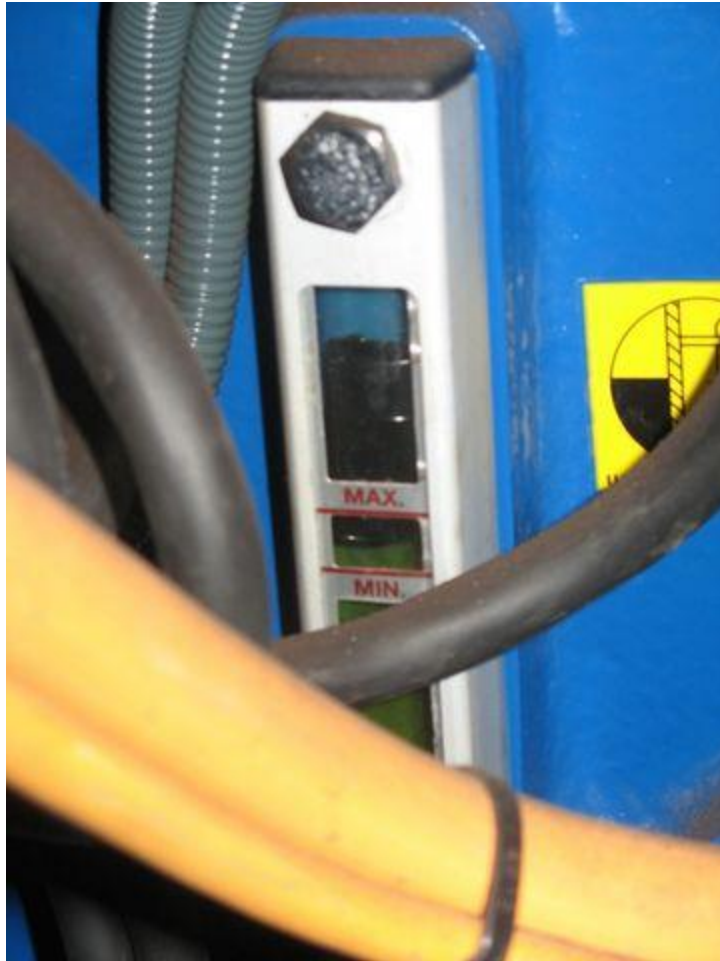
Here the indicator shows low oil in the gearbox.

Here we need to add approx. 30 liters of gear oil in the gearbox to maintain the correct level.

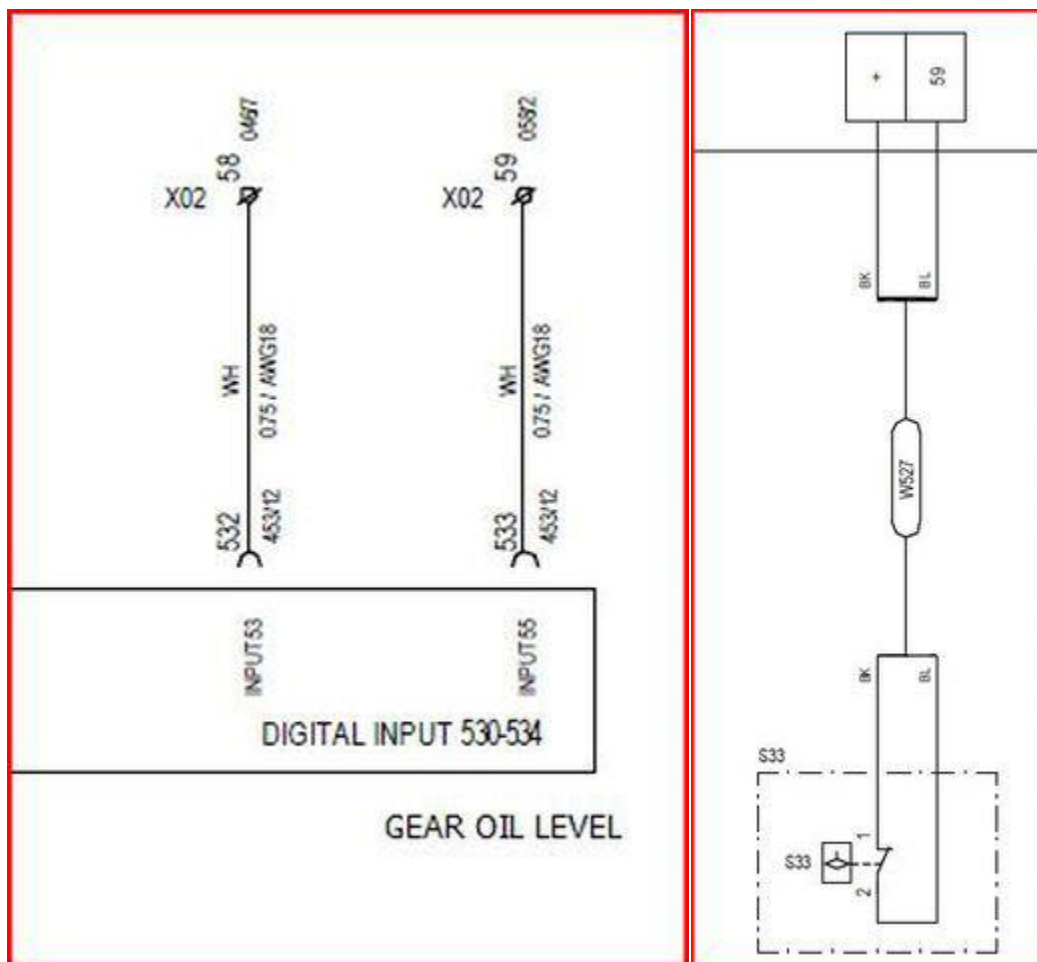
Check the electrical connections in the gear oil level switch.

Check the W527 cables for damage or abrasions.

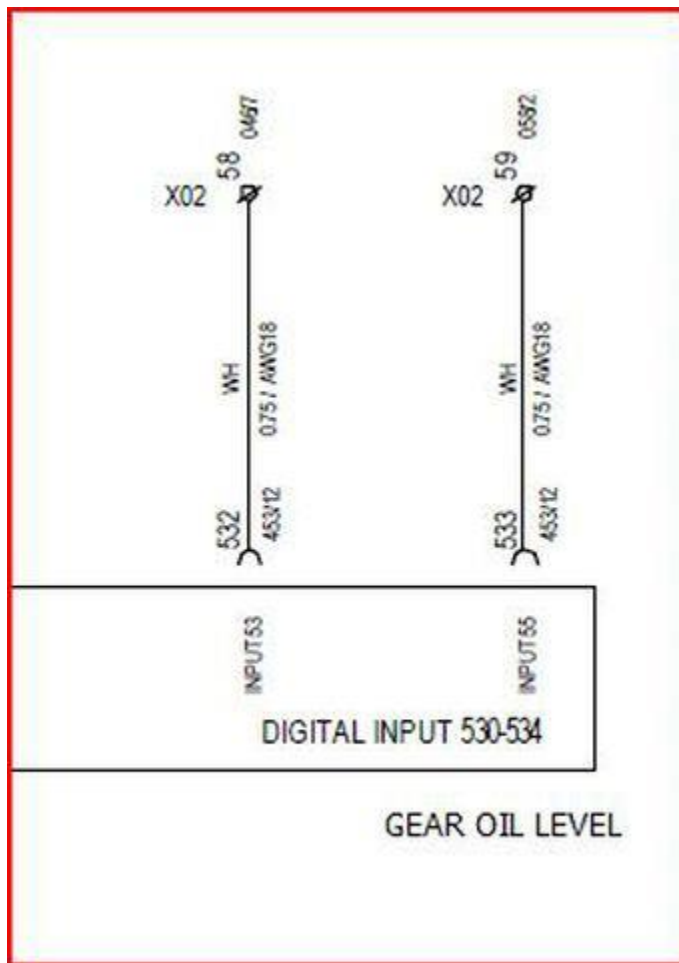
Check the Nacelle TOI input for gear oil level switch.

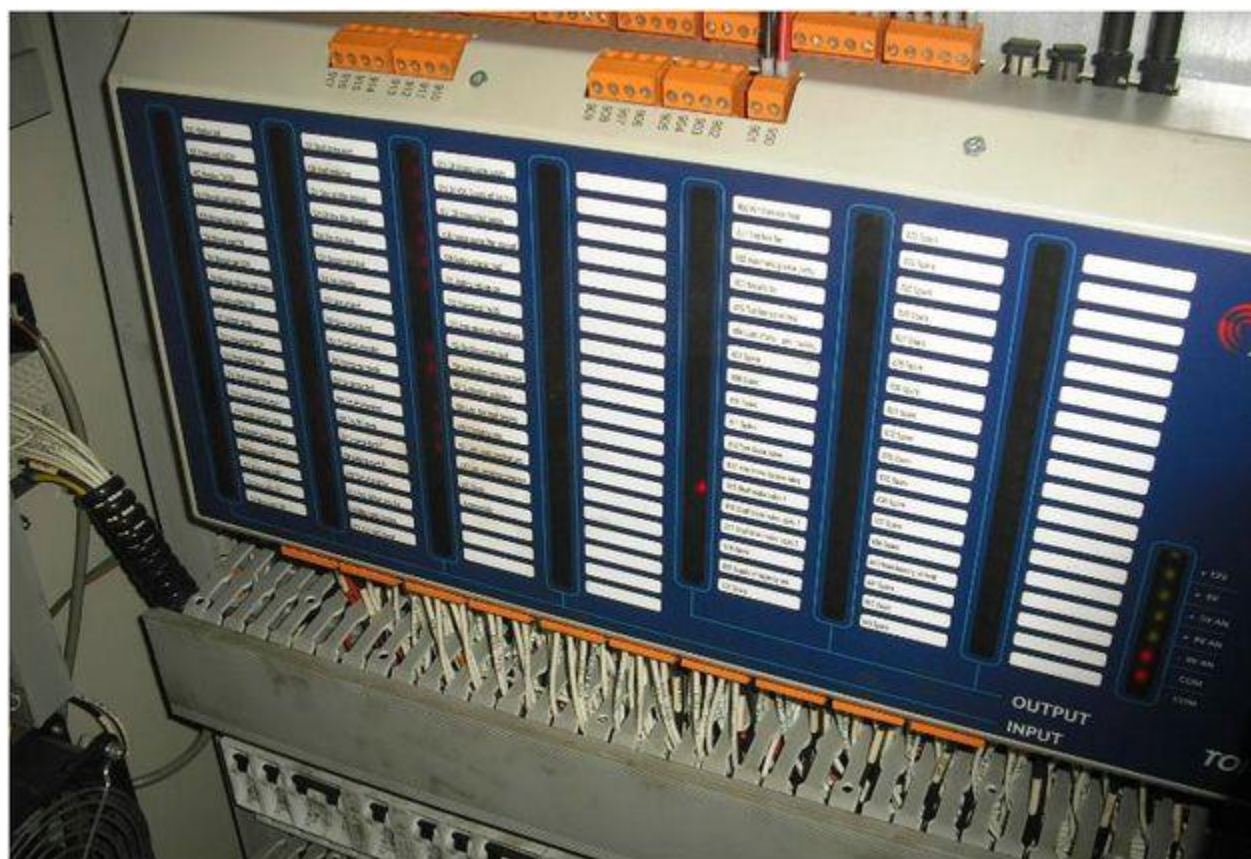
#### Part Number for TOI unit:

If all connections and switch are ok , then the cause is likely a faulty nacelle TOI.
