Replace the defect TAC84 module

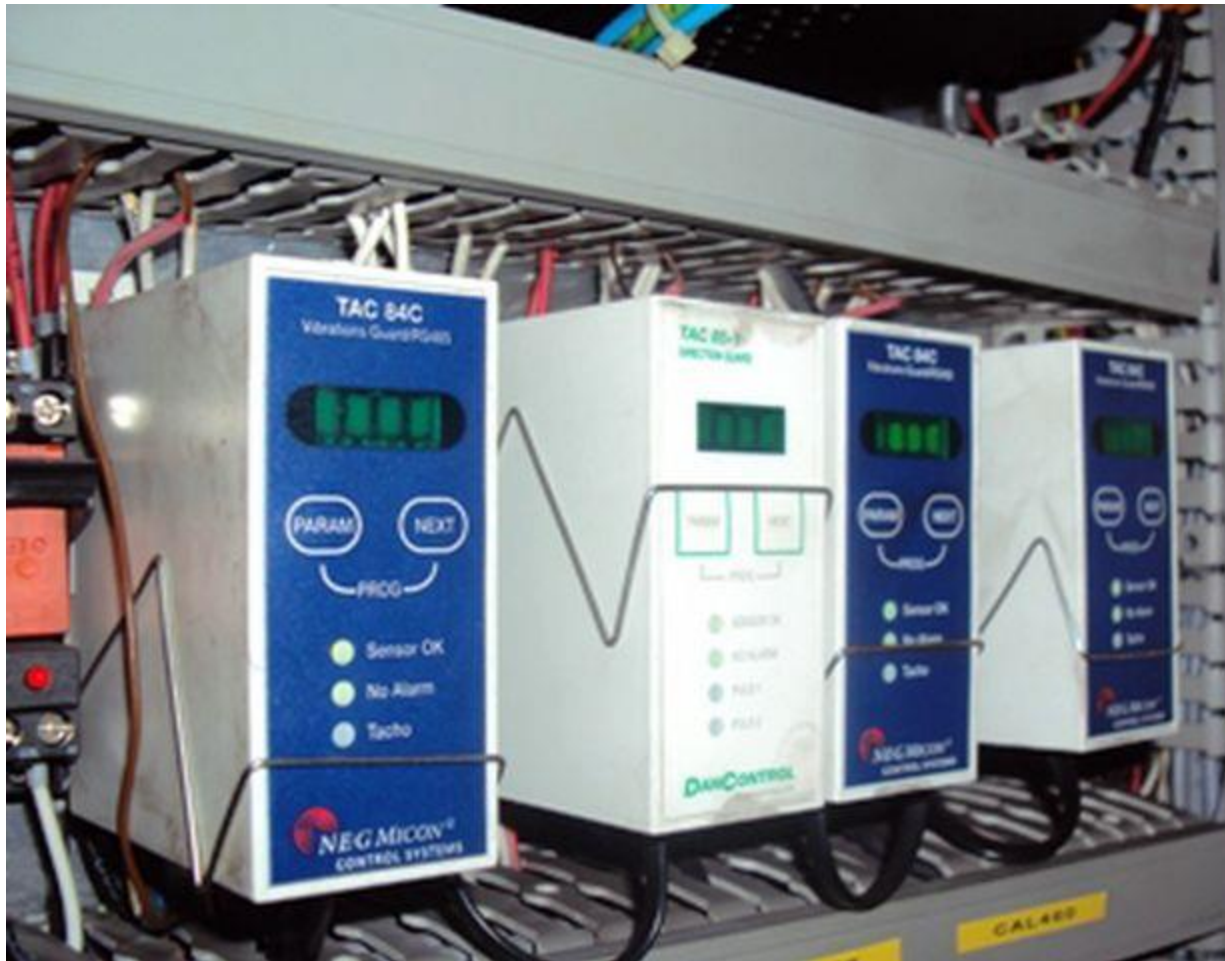
Settings for TAC 84 Edgewise blade vibrations

Check the TAC84 module parameters as per instruction

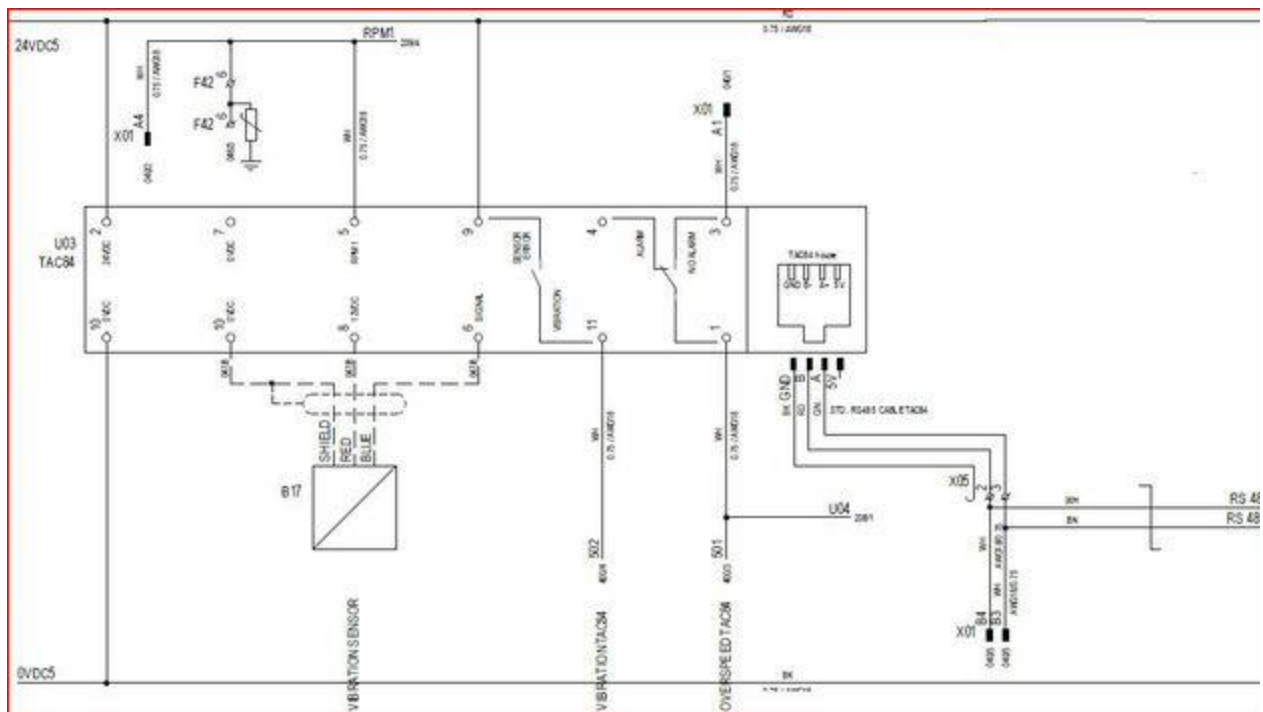
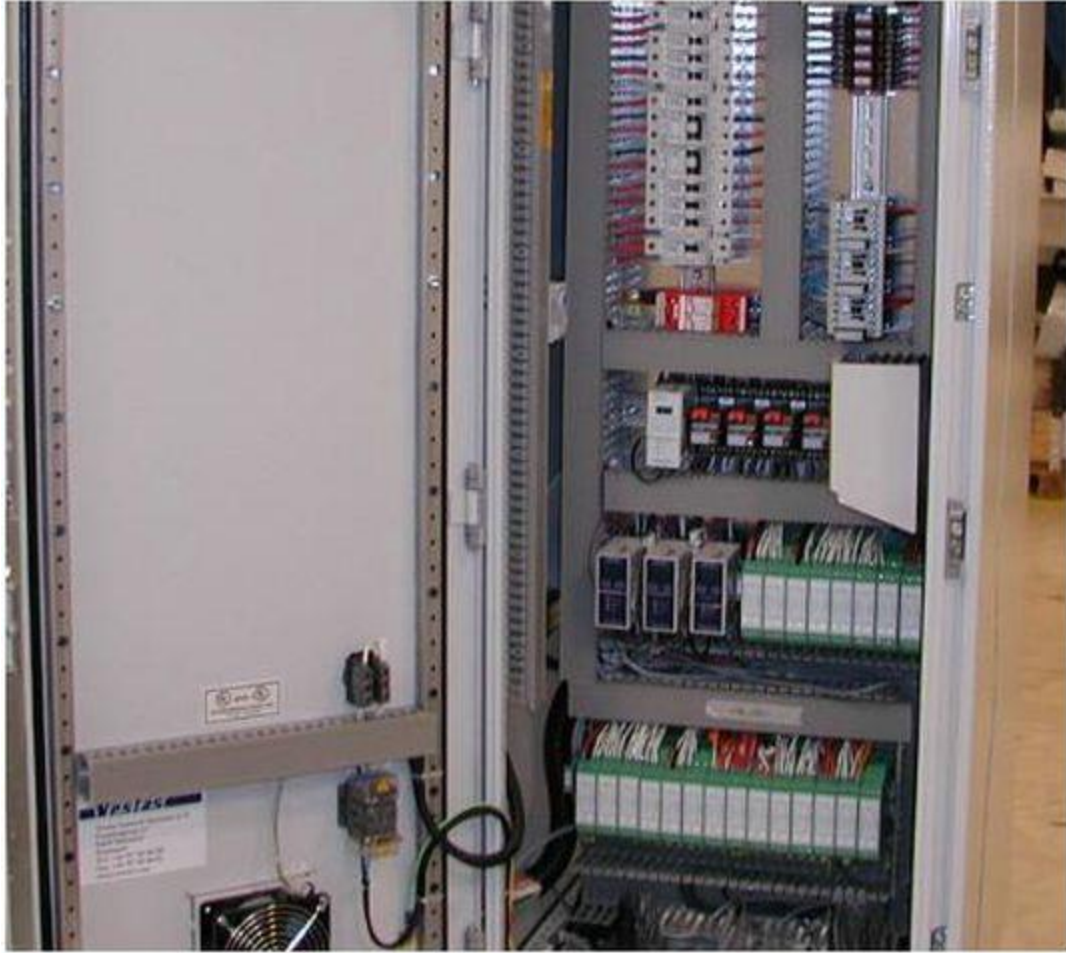
Check the TAC84 module for any loose connections:

Part Number for TAC84 module (2 Filter)

51701001 -TAC 84C VIB GUARD 2 FILTERS

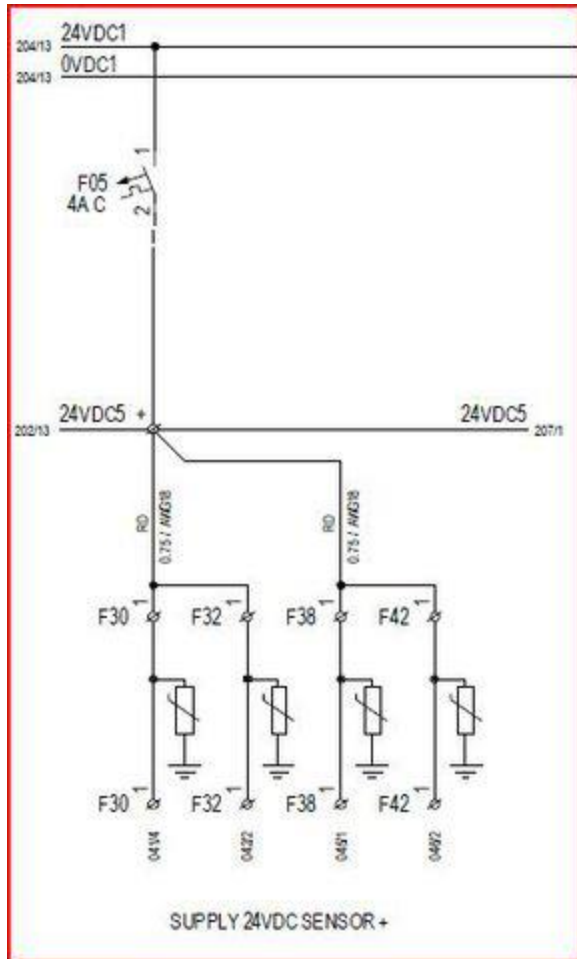
Check the 24VDC5 circuit including power supplies G05 & G06 and F05 circuit breaker in the AN1.

Part Number for Powernet:

188453 - PS ADC 5483R-3 10A-27,4 NM PIN

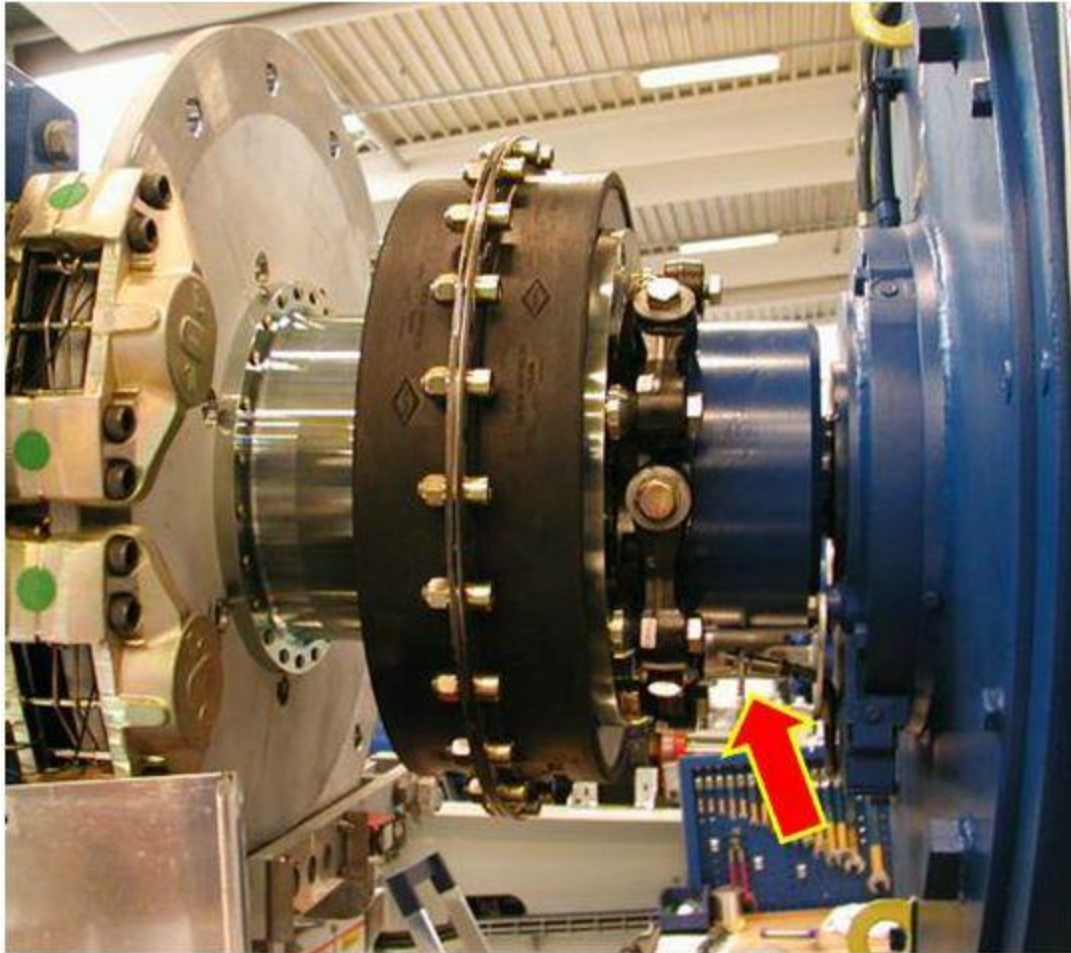
Check the generator speed sensor for any physical damage or dirt.

Check the speed measuring value through TAC84 Module

If found to be defective replace the sensor.

Sensor part number:

60009270 - PROXI SWITCH I1808PPOS1531 Ø18

Adjust the distance between the Inductive sensor and the scanning points as per Instalation and service data DMS : [5003033](#)

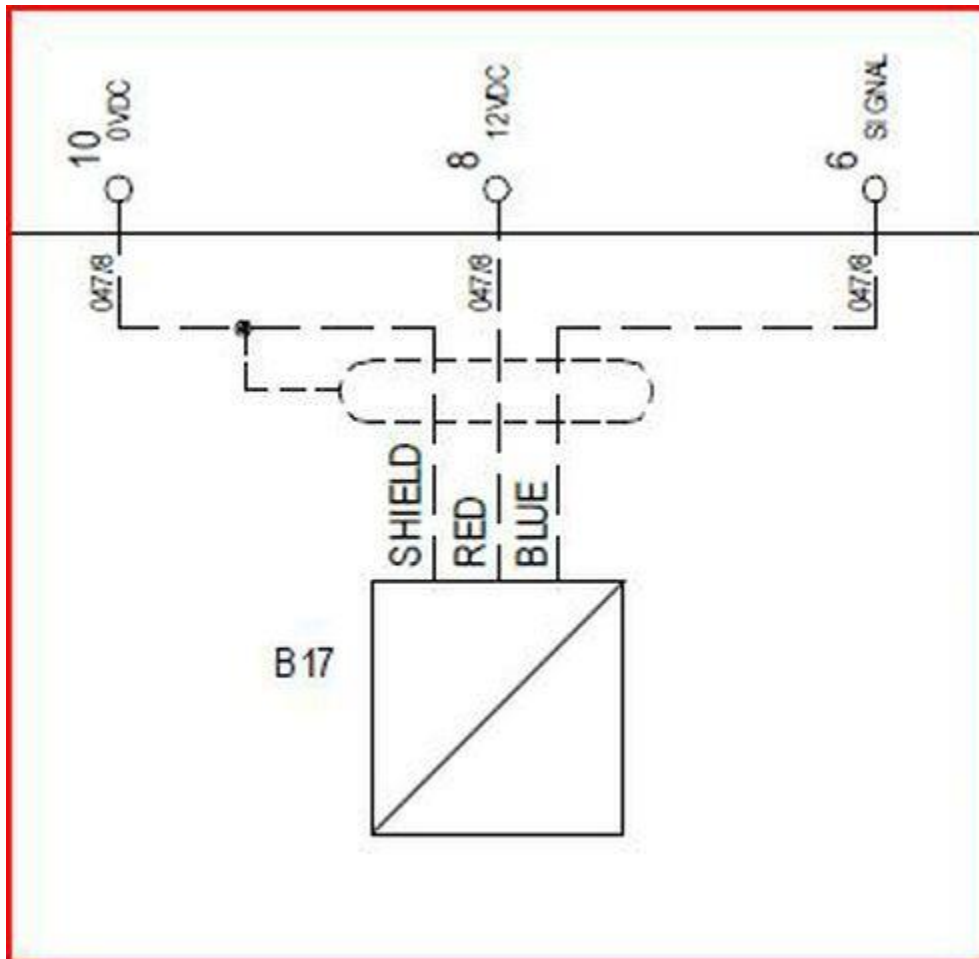
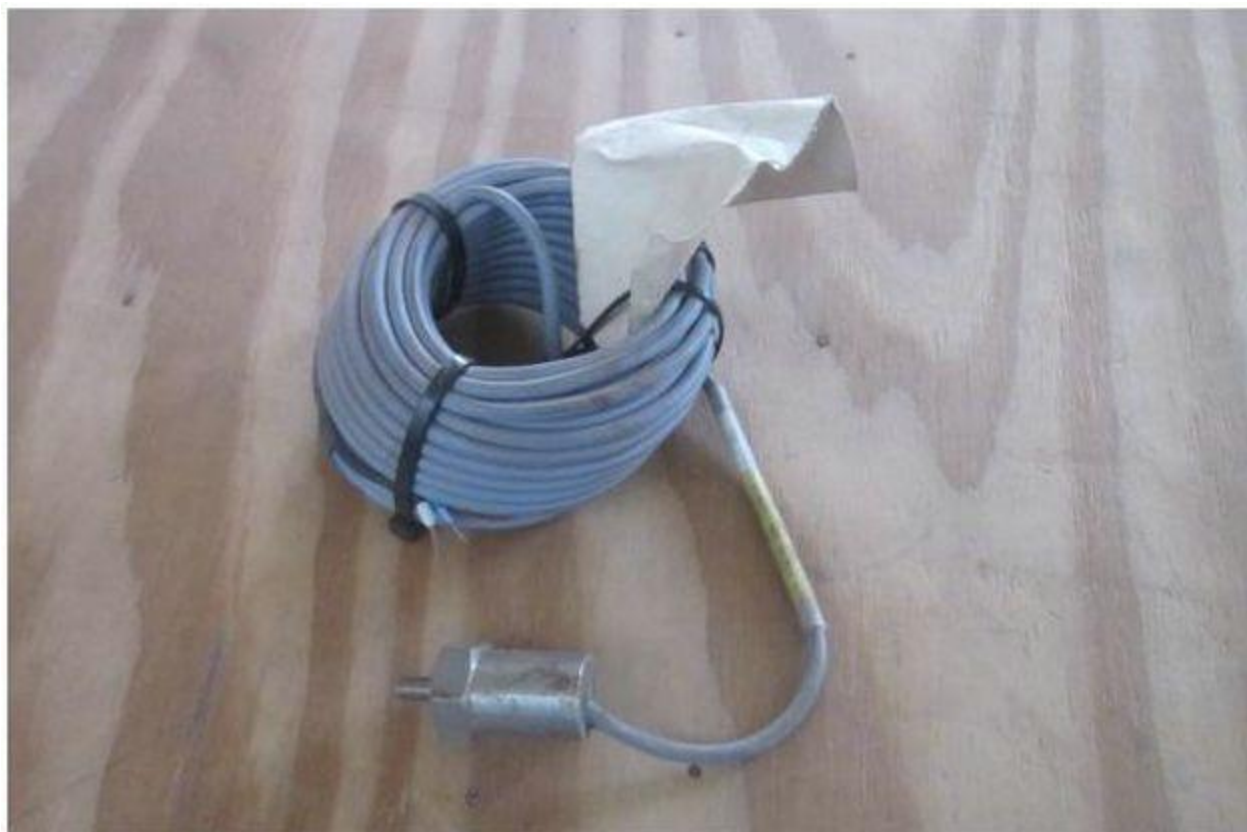
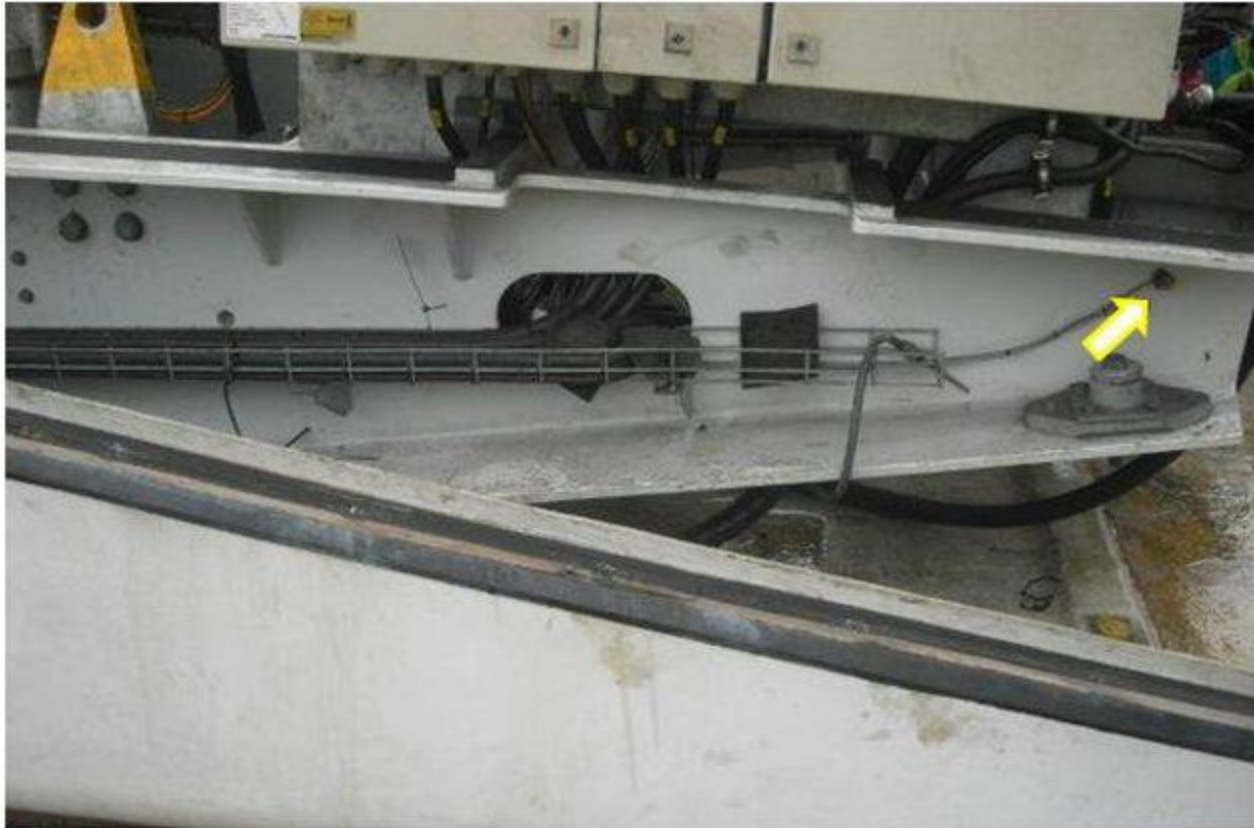
Check that the vibration is being measured properly through the TAC84 module.

Replace the vibration sensor if found to be defective.

Part Number for Vibration sensor:

51712401 VS05E ACCELEROMETER 6.5M

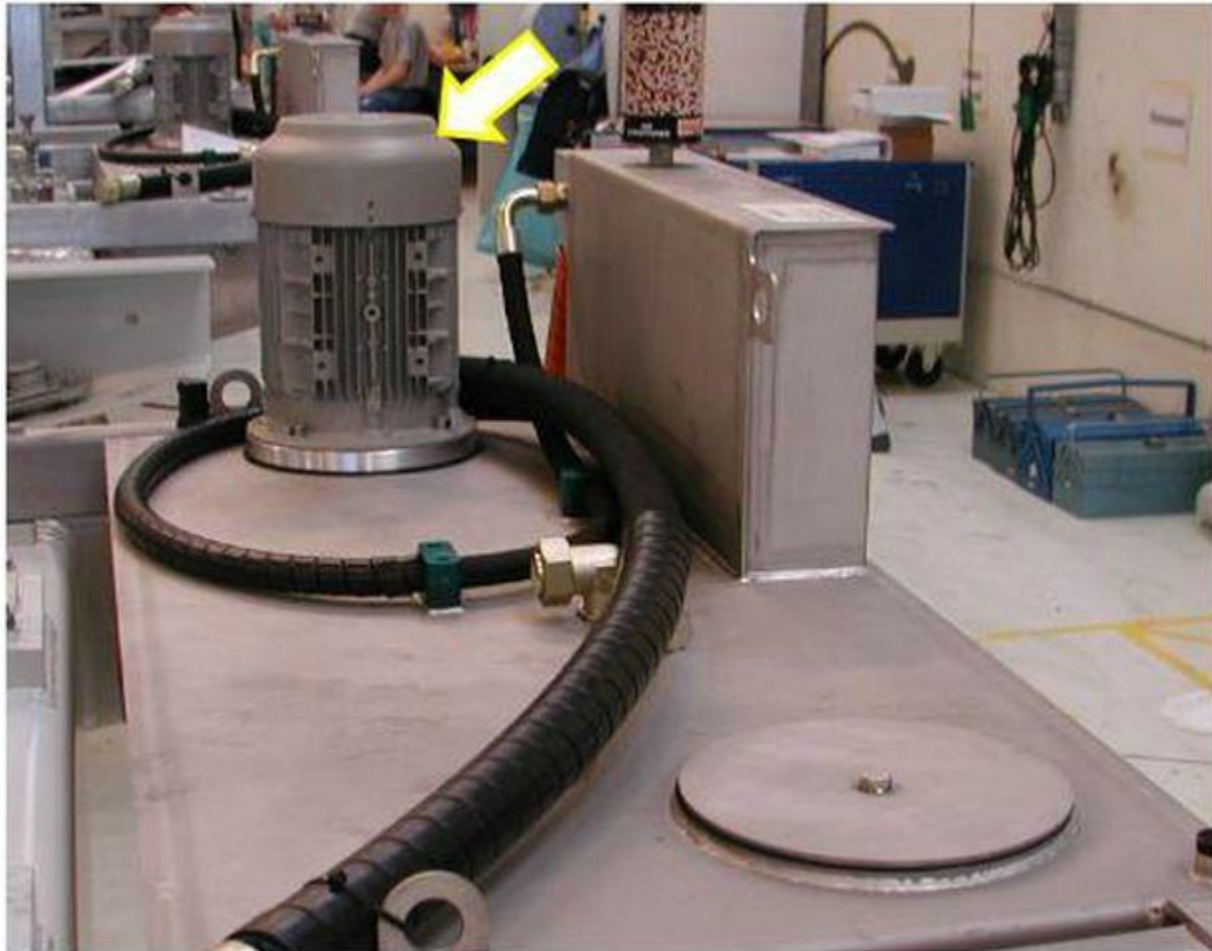
Check the feeder pump and motor if any vibration due to bearing failure,
If found defect, replace the motor or pump.

Part number for Motor & Pump

60073425 MOTOR EI. 4AP112M-6S-B5-4/6 2.

60073428 GEAR WHEEL PUMP 52CCM 3SPA-52D

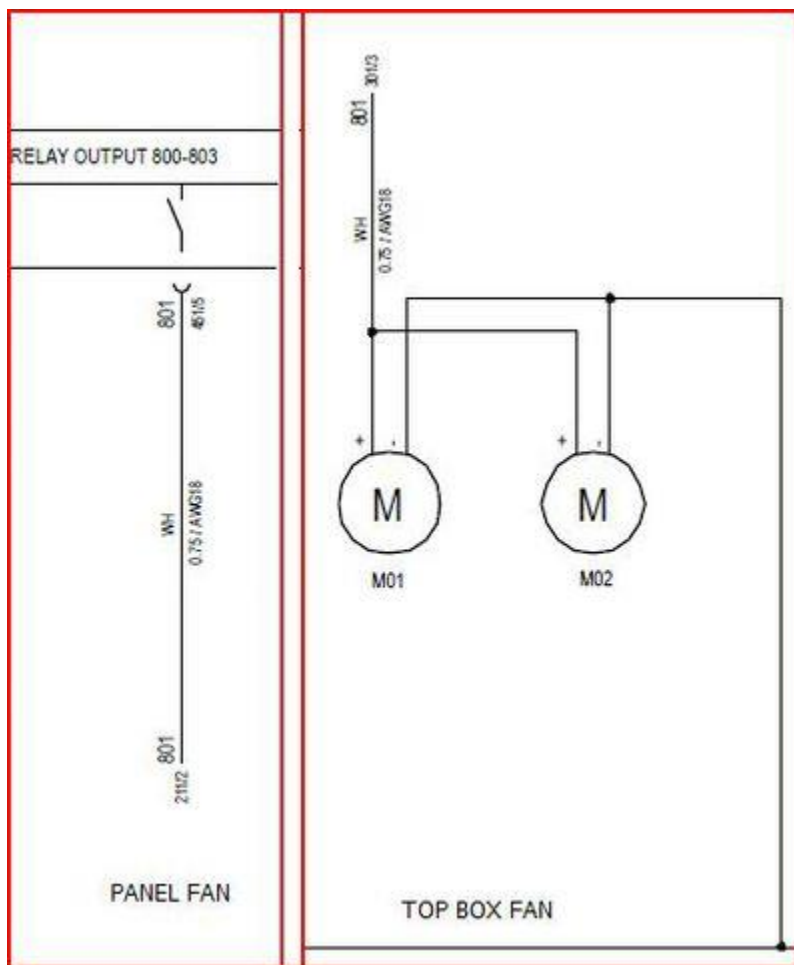
MK1 and MK2: (24V DC)

Check that both cooling fans in the AN1 Top Box are operational. High cabinet temperatures may cause a malfunction in the relay inside the TAC84 module.

Check the Heater setting and ensures the set value @30 deg C (Mk3 and above)
