Replace the PT100 sensor

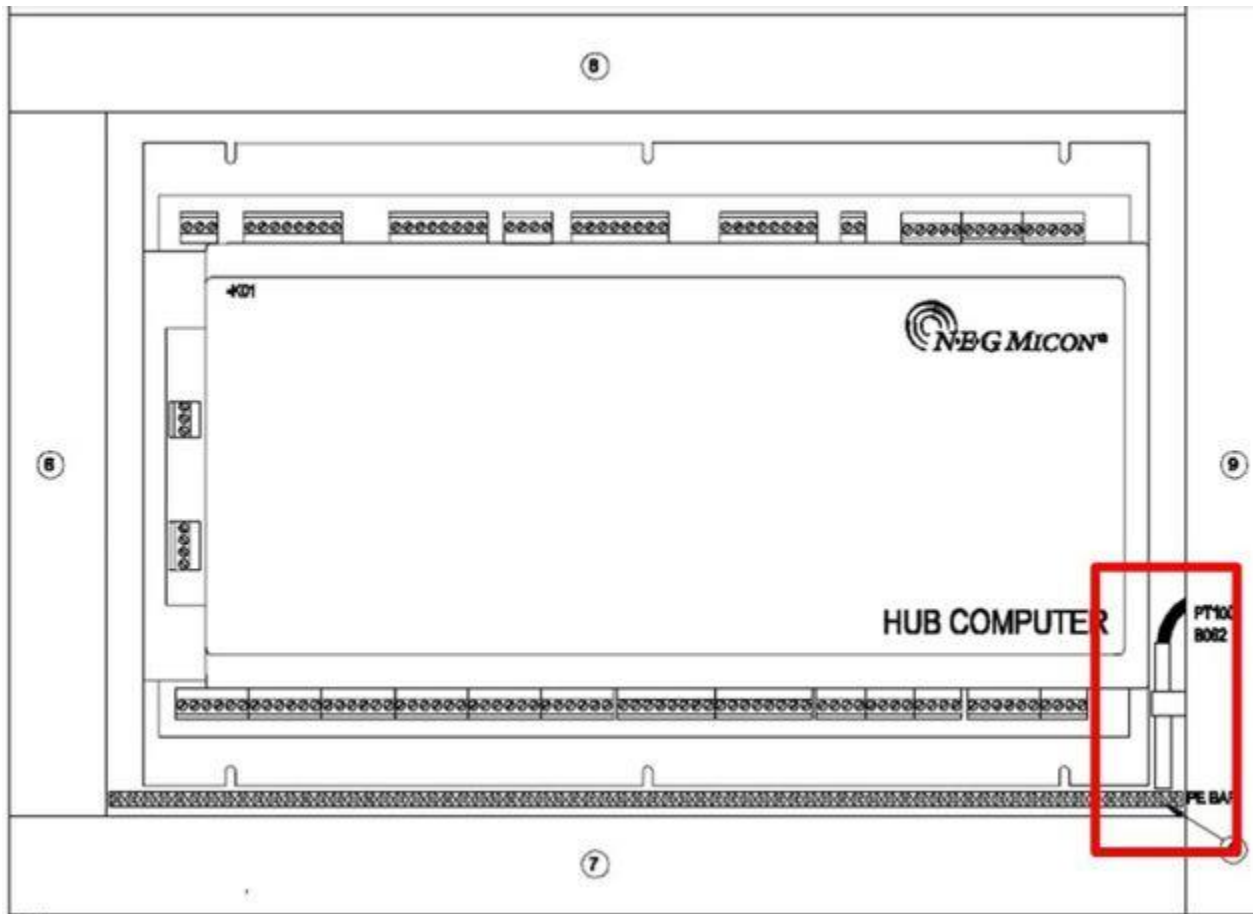
Check that the PT100 for the AK4 panel is secure in its original position:

Check the PT100 cable (W929) for damage.

Check that the W929 terminations are tightened (Terminal X20 71 & 72).
