## Locate and repair leak

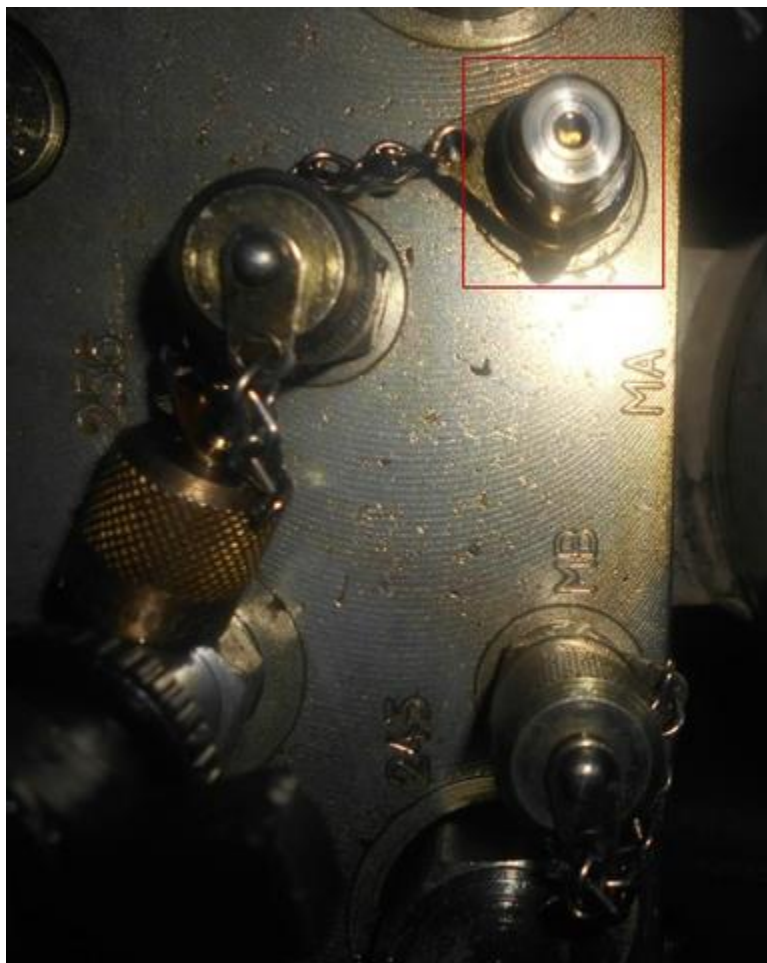
8. Hoses and fittings.
9. Test nipple in blade manifold- MA position

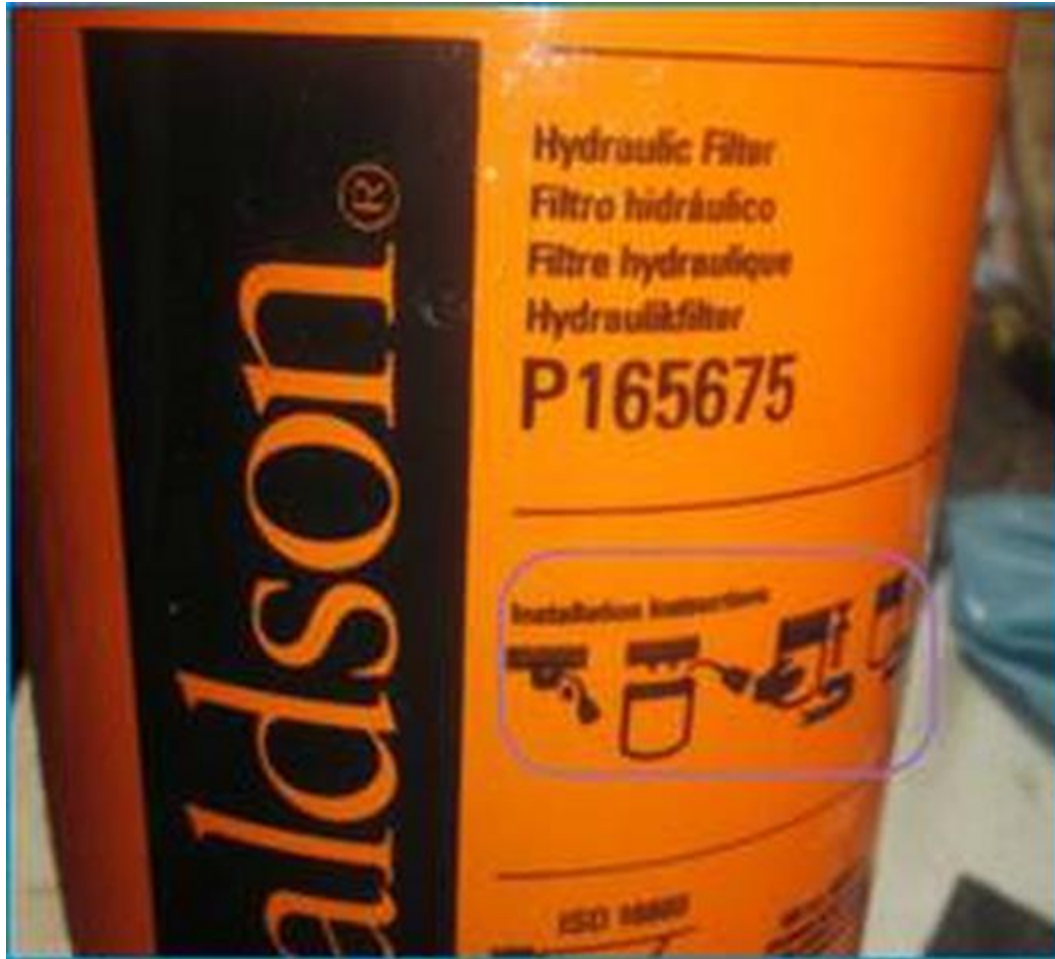
- As per OEM as well as Vestas recommendation, these filters to be tighten with hand. Hence do not use ratchet or any type of tools for tightening which might cause over tightening issue which will damage the seal (O ring).

- few important installation instructions which mentioned in the filter housing as shown below;

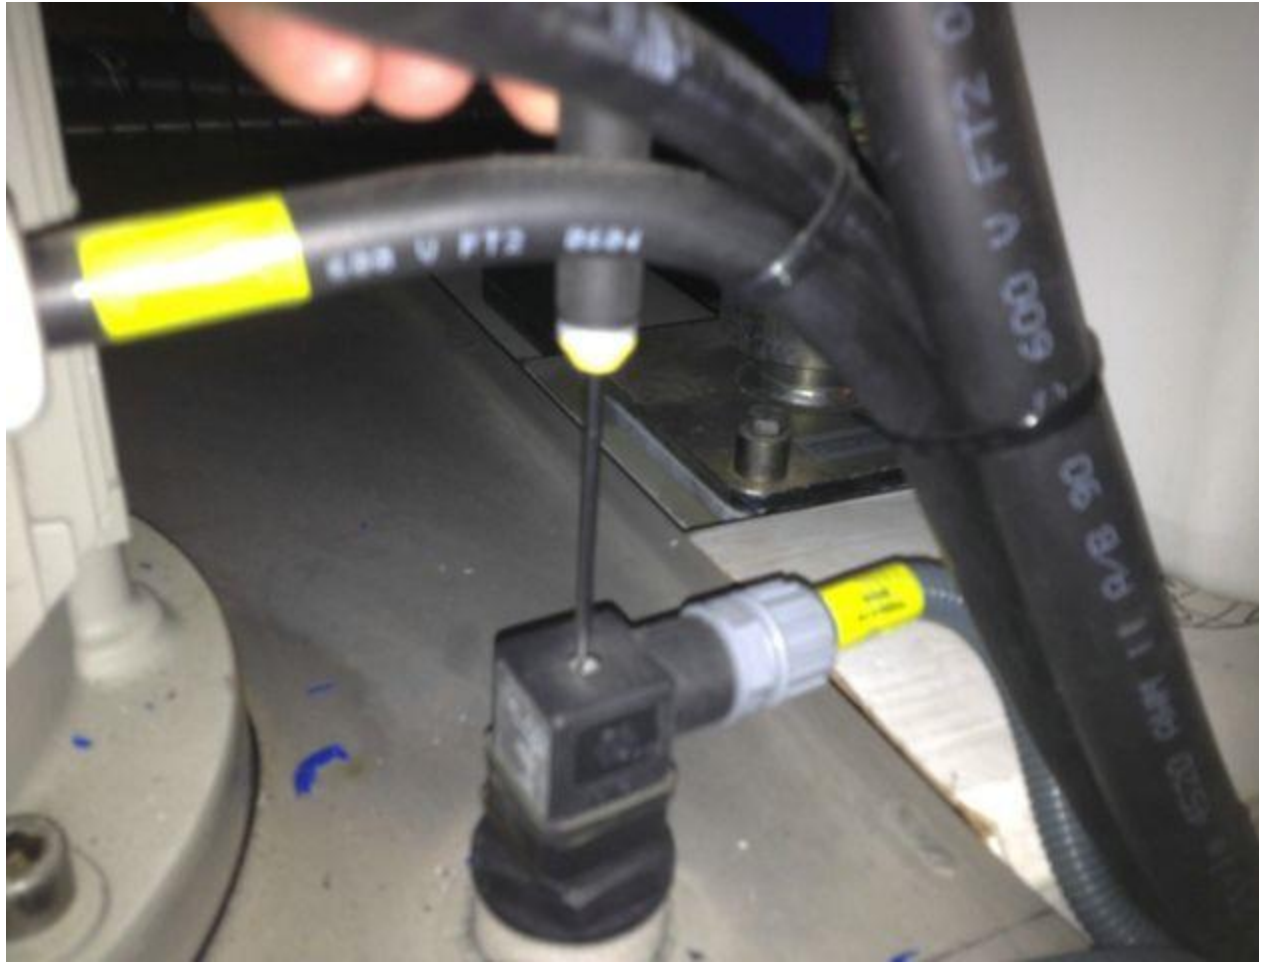
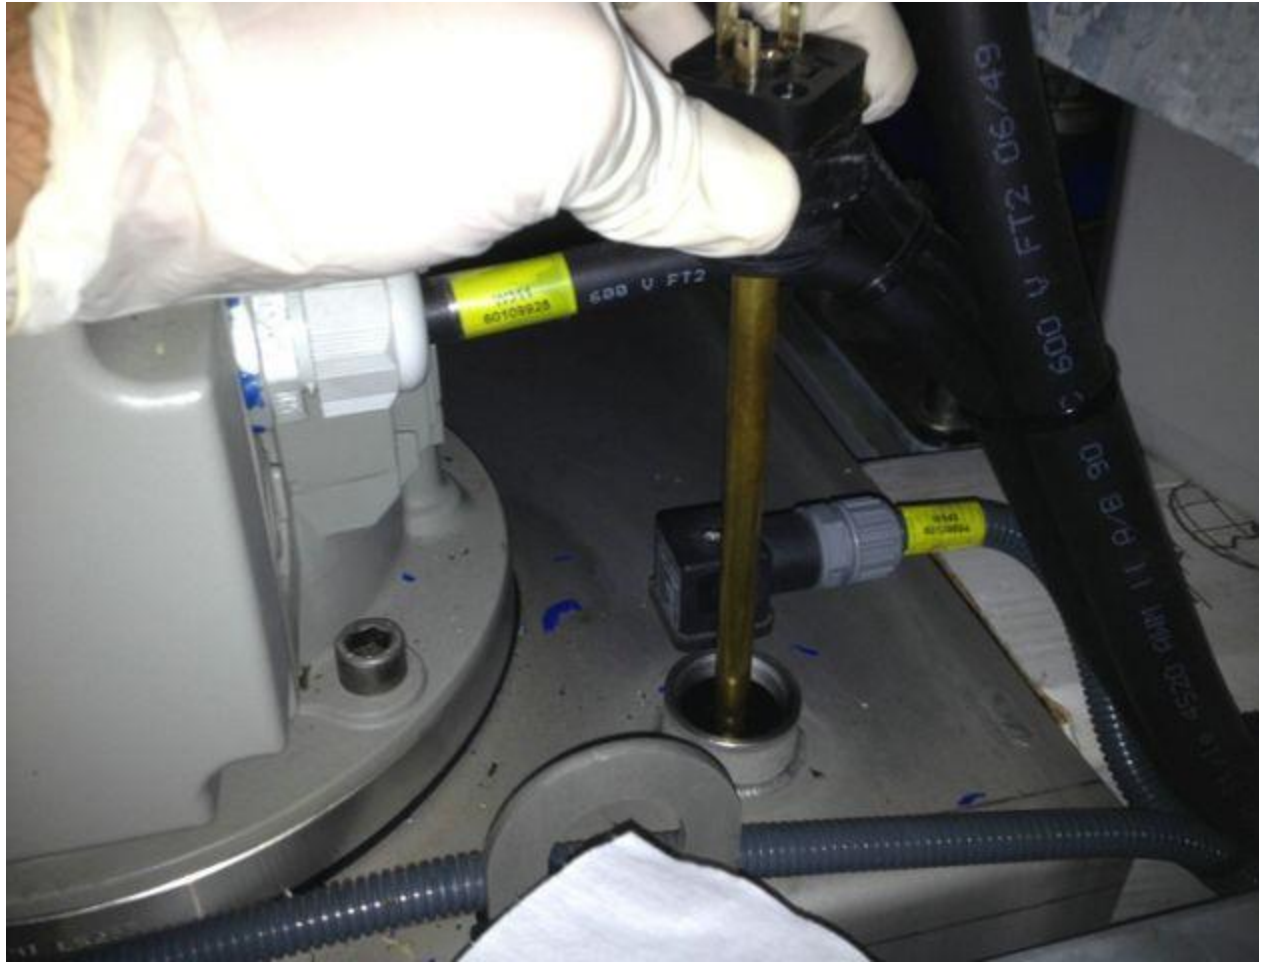
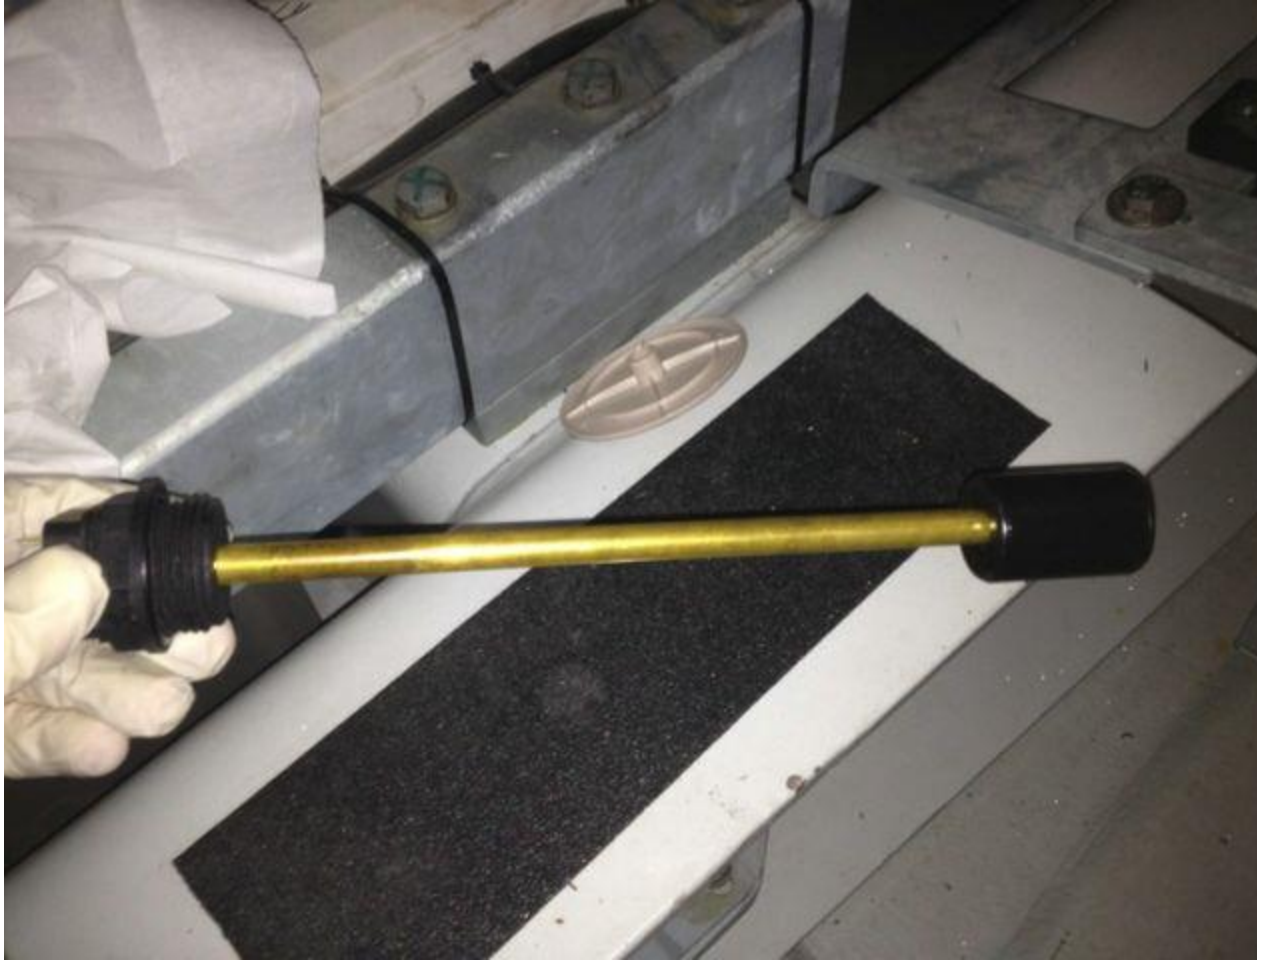
OLD STYLE FLOAT SENSOR:

**NOTE:** Older plastic versions of the sensor should be replaced with the new version whenever removed from the tank as the old sensor floats are susceptible to deterioration and can come off into the tank when attempting to remove.

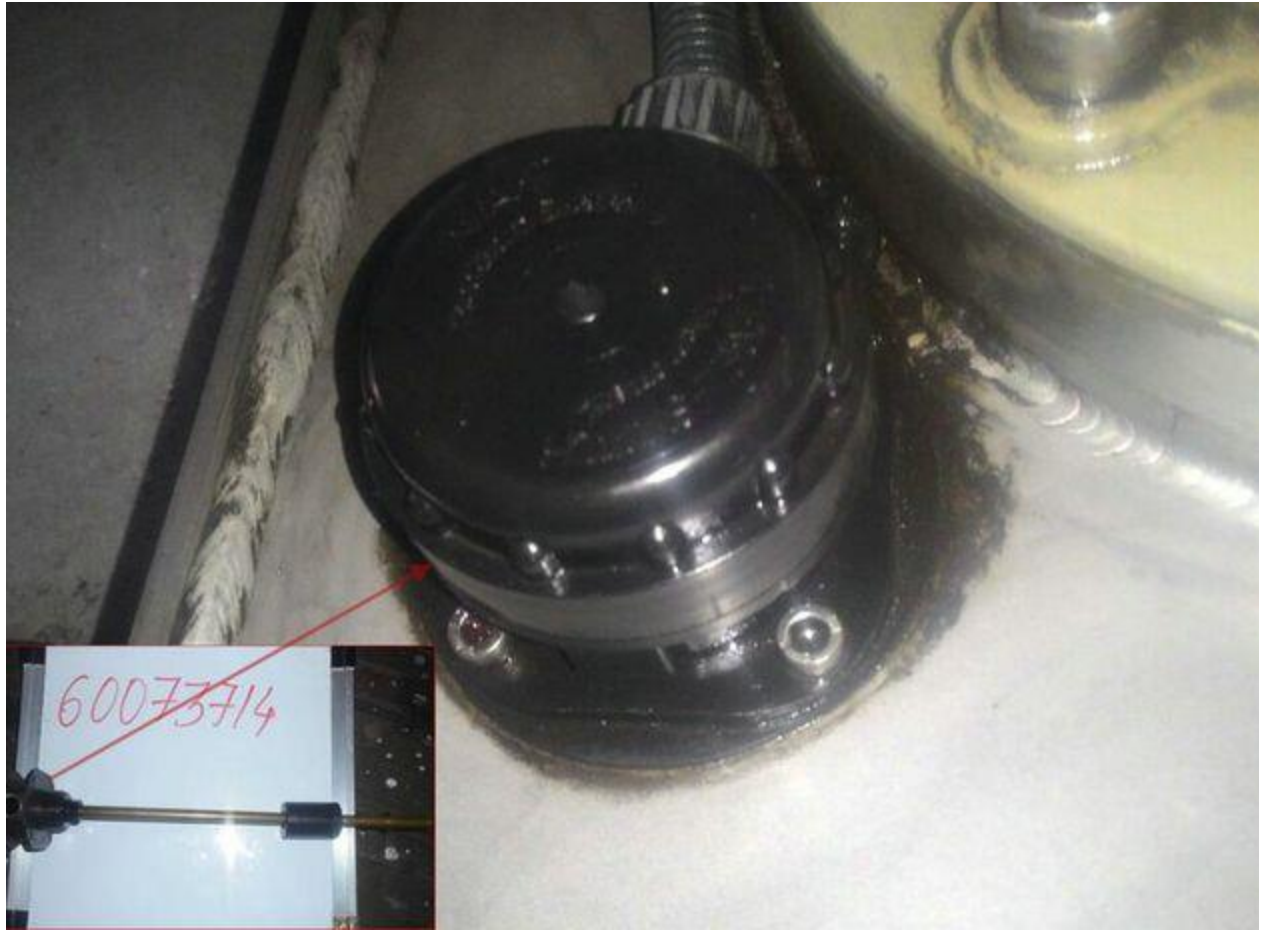
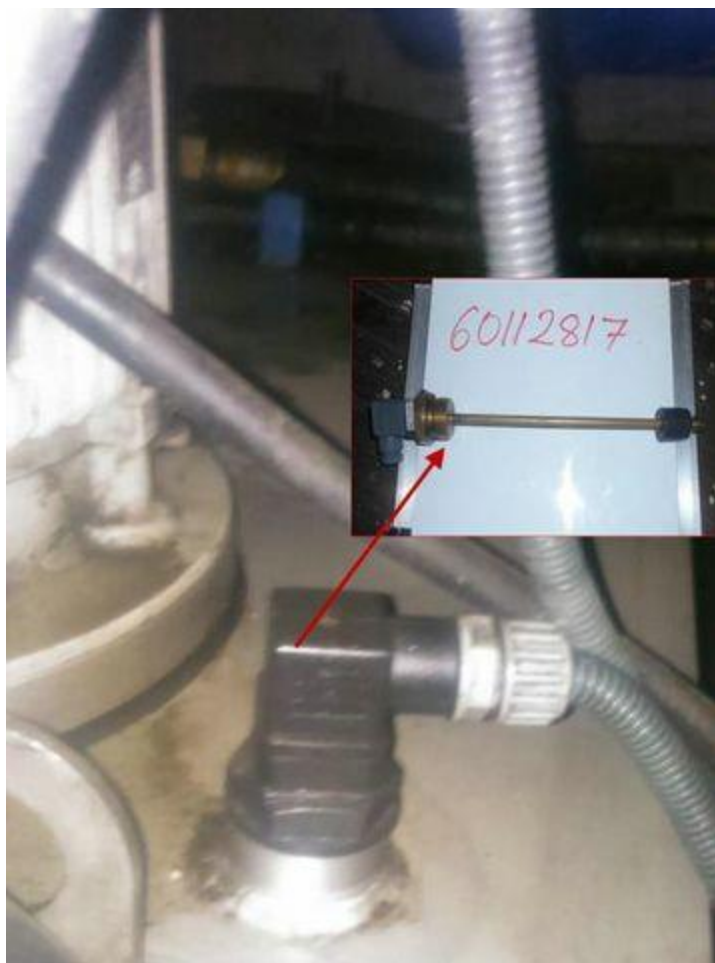
If the value does not change or is unrealistic, replace the float sensor.

Relevant spare parts	
Description	Item No.
NIVEAUCONTROL HMFB-VT = 250 MM	<a href="#">60073714</a> (Screw Type)
LEVEL CONTROL LM1CTPA260 NA	<a href="#">60112817</a> (Thread Type)

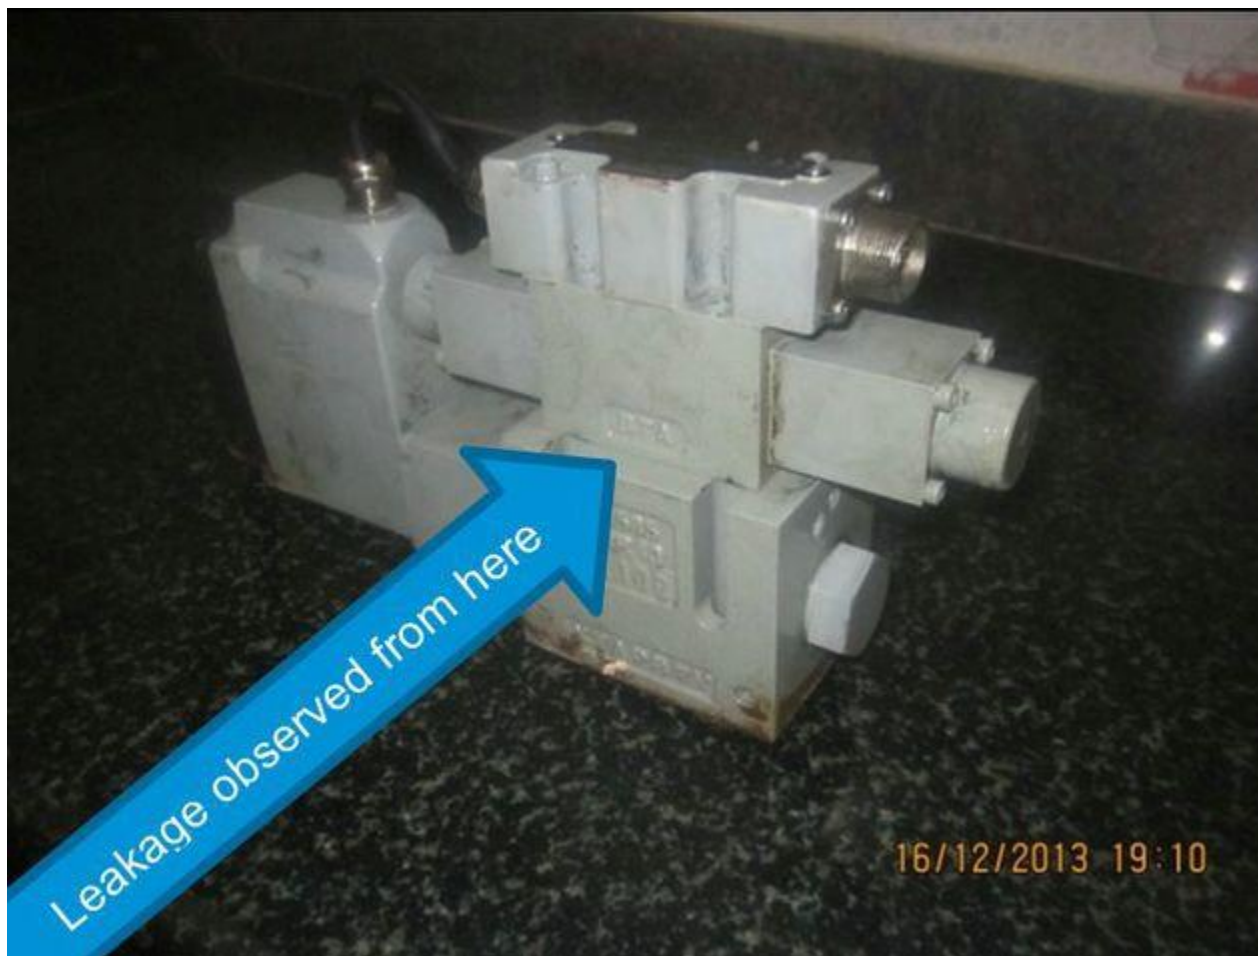
Proportional Valve leakage observed not from the port but at the joints.

Replace the Proportional valve this is the case.

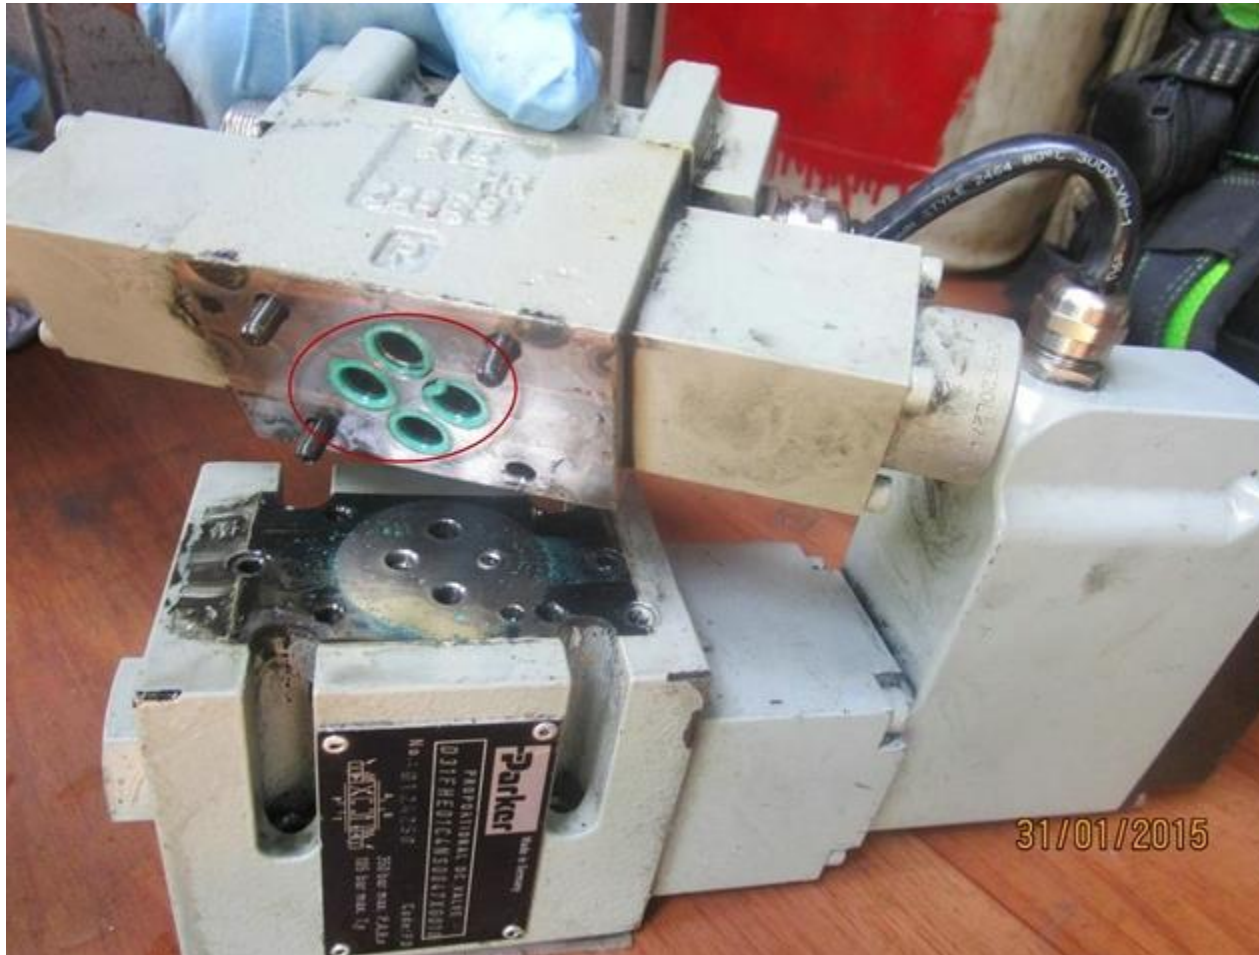
Below picture shows damaged O-ring.

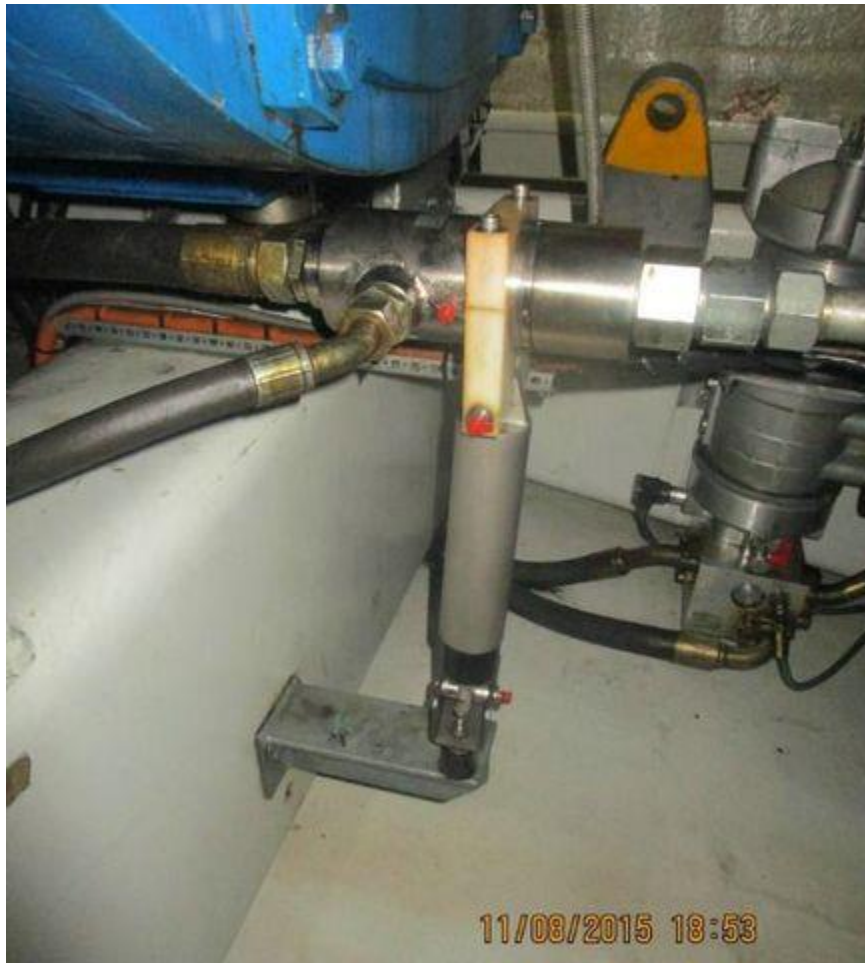
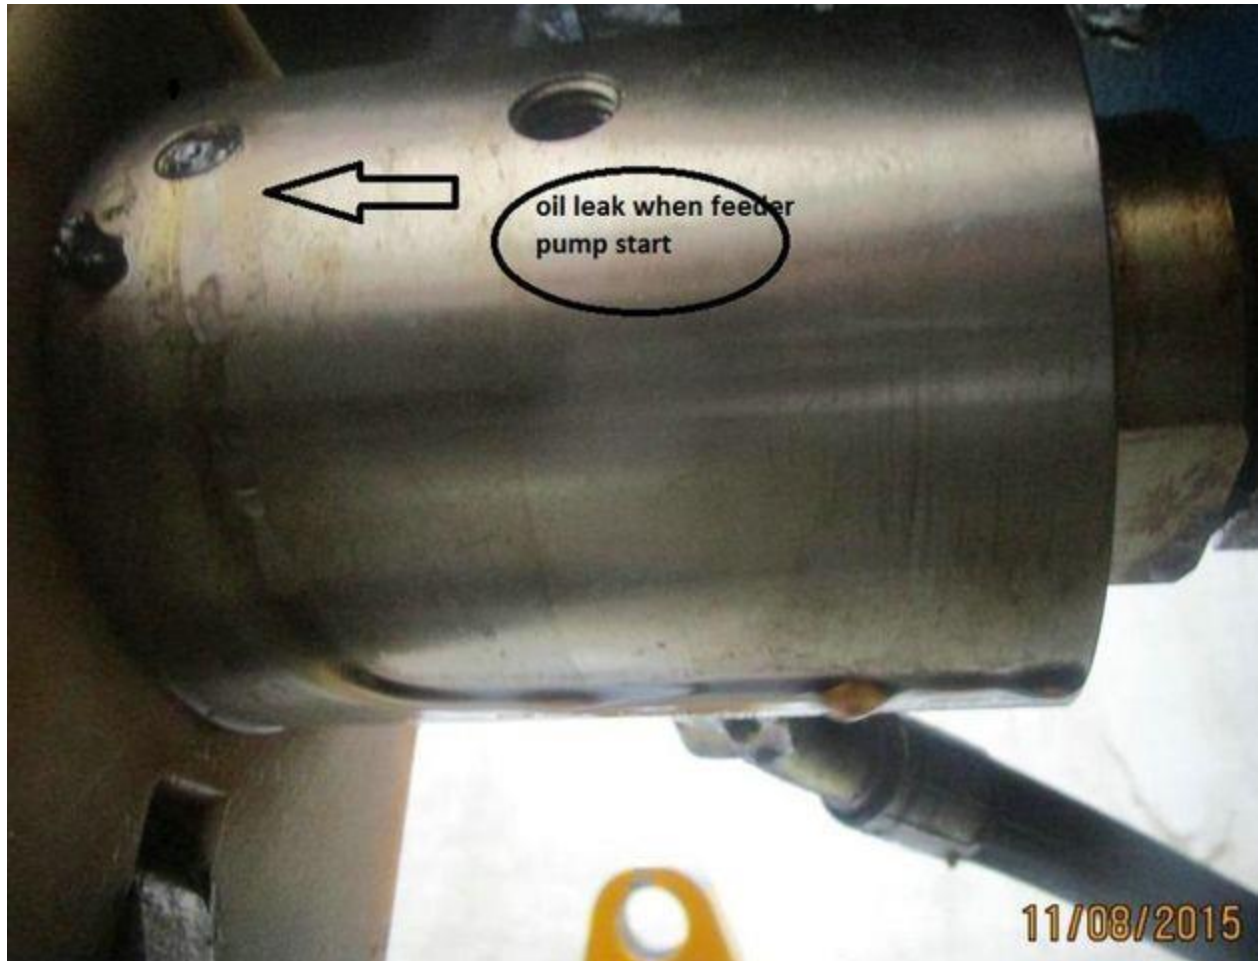
Check and repair/ replace Rotating Union, if found oil leakage.
