Troubleshoot alarm 97

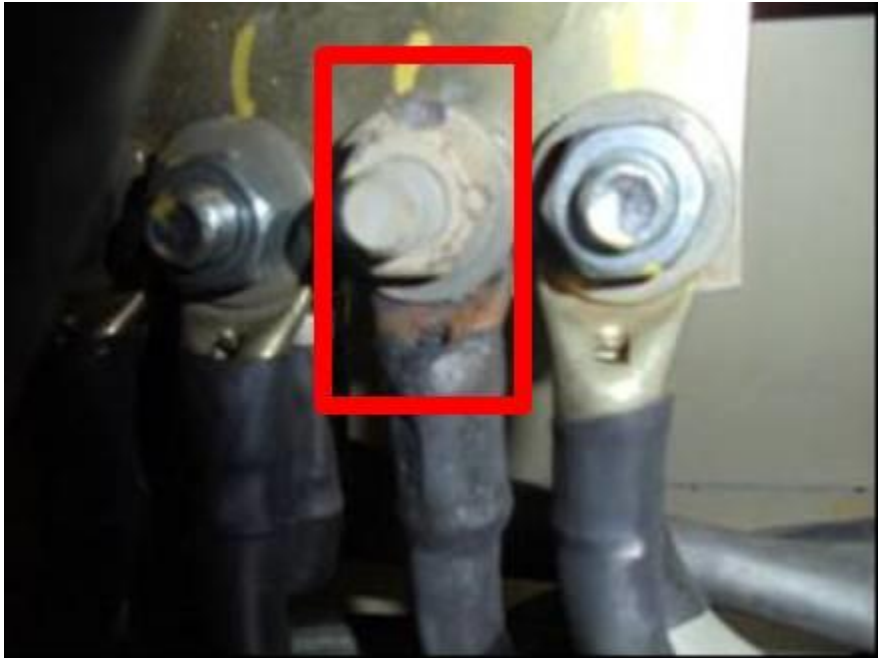
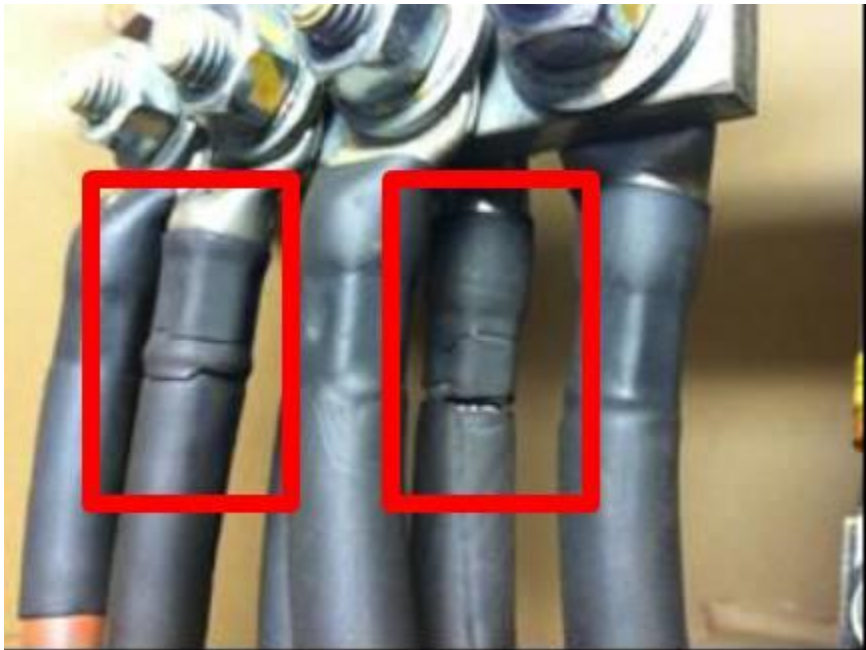
Follow directions outlined in DMS [0041-0719](#). A video instruction also exists explaining the correct method for crimping cables: <http://dkrdsdezide01/internal/index.jsp>. Remove cover of generator junction box. Inspect for signs of loose connection such as damaged heat shrink or cable lug.

Check connections and replace damaged components as necessary. Ensure proper torque

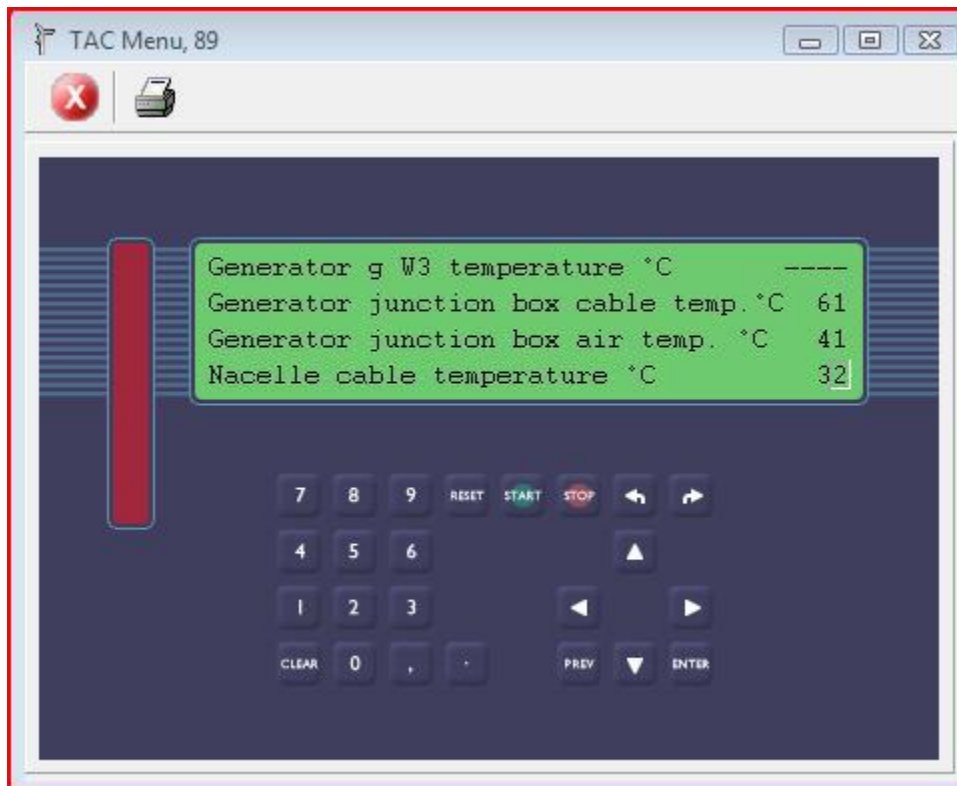
Check the TAC computer for the generator junction box temperature. If temperature is unrealistically high (e.g. >205C) then PT100 is defective.

Replace PT100
