## Troubleshoot generator speed sensor

## Generator speed sensor

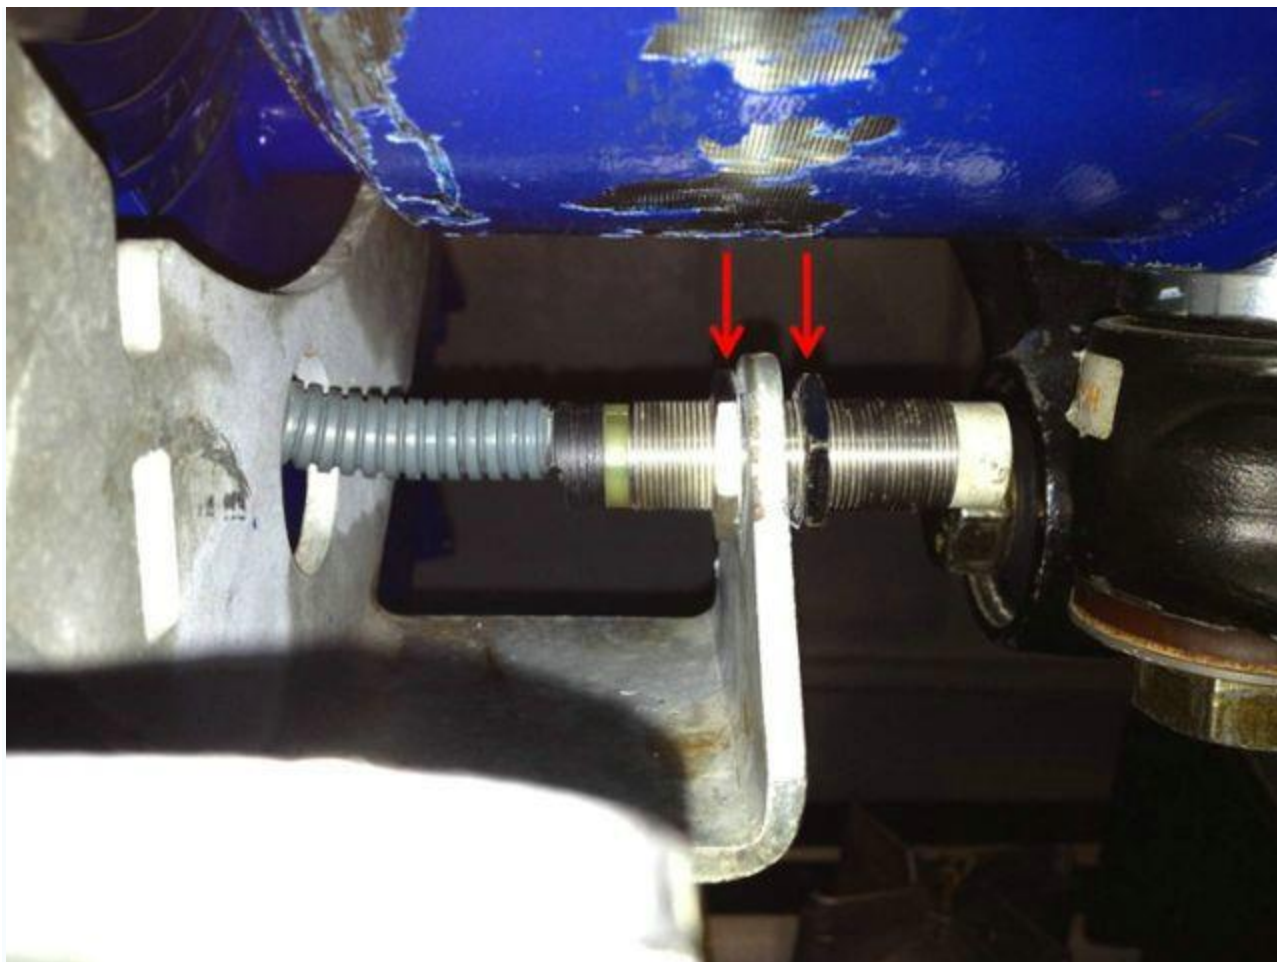
Sensor adjustment nuts:

If the sensor does not emit a light each time a link element bolt passes over it, lock the shaft and check for correct sensor adjustment. Check the bolts on the speed sensor bracket and ensure that they are properly tightened. The end of the sensor should be within 1,5-5 mm from the pickup point. Adjust the sensor by loosening the nuts that clamp it to the mounting bracket and move it forward or back to achieve the required distance from the pickup point.

If after adjustment the sensor still does not light up, or lights up intermittently when passing the pickup point- replace the sensor (sensor and cable are combined-W509)

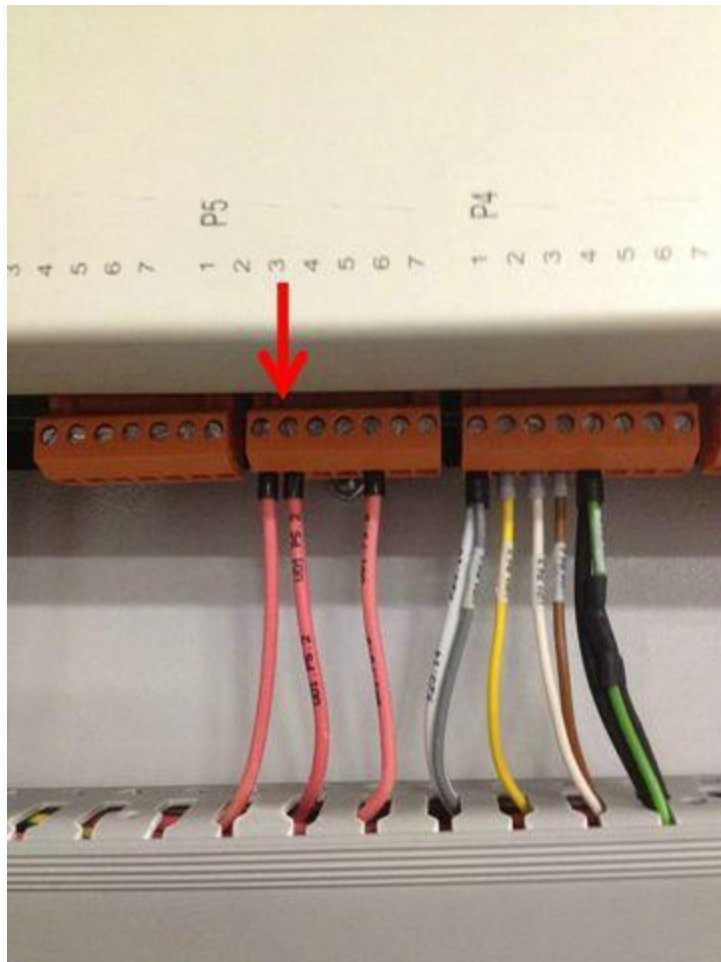
Finally check the signal termination at the TAC controller (P5 terminal 2):

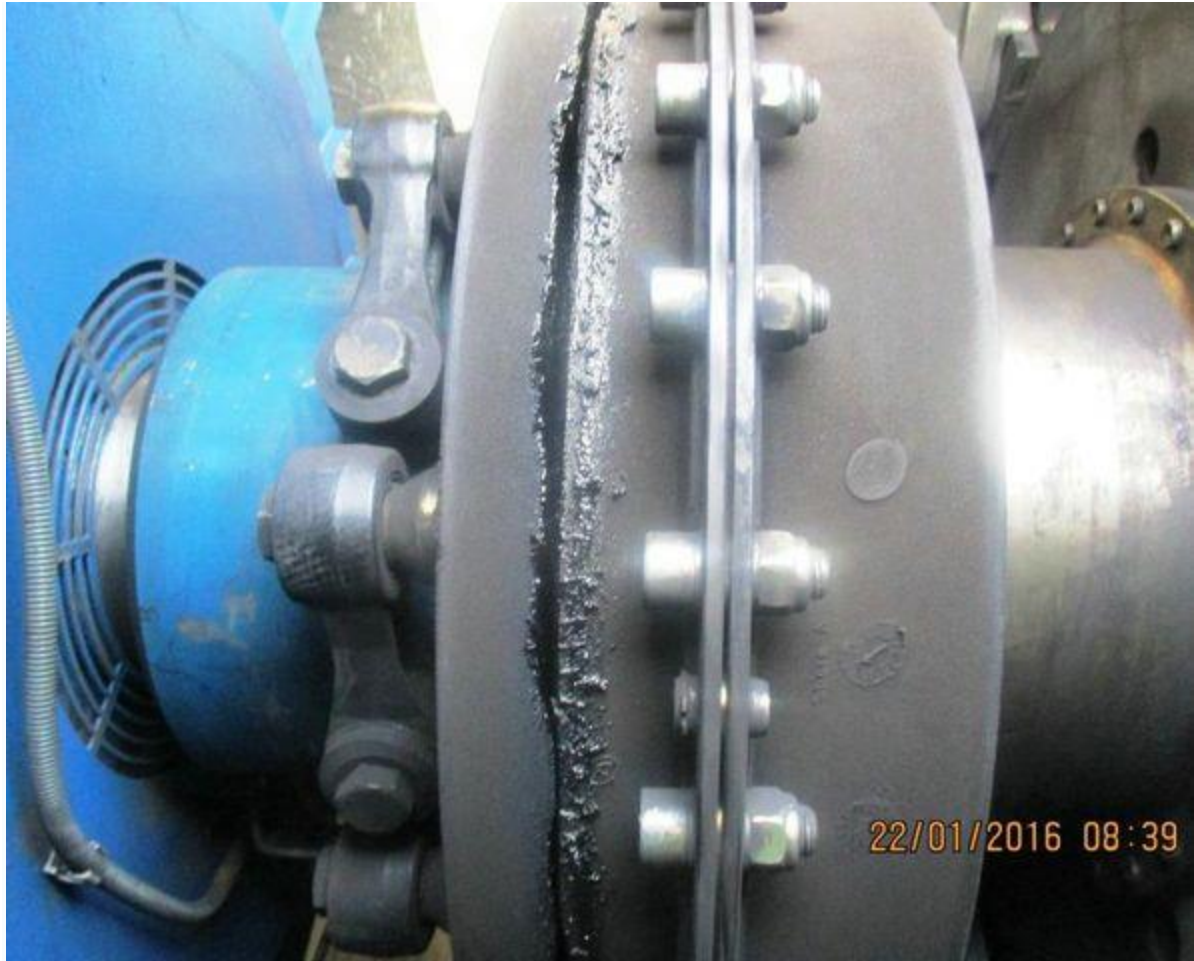
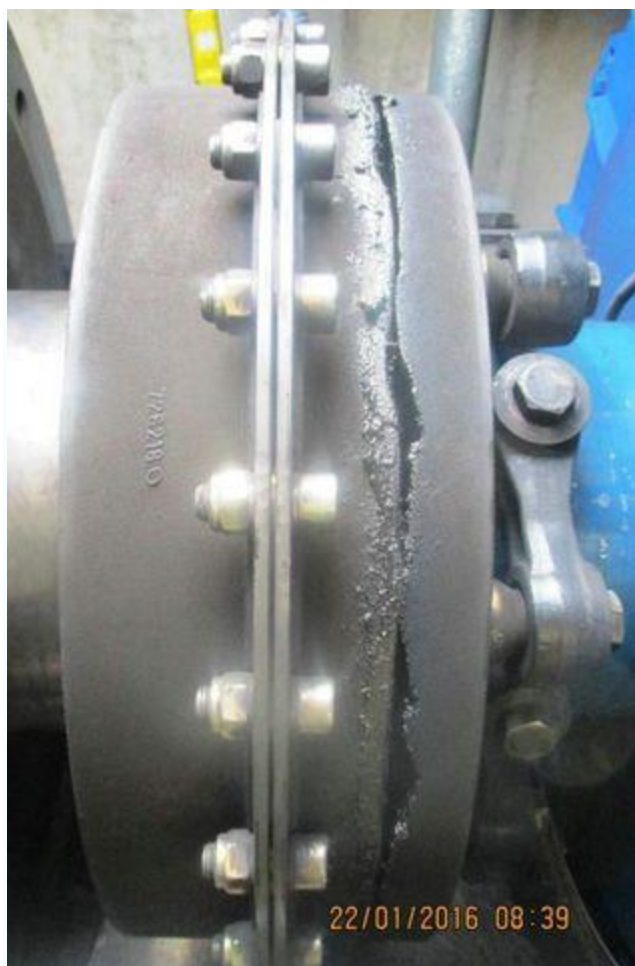
Failure view of coupling:

Check and replace the Generator coupling which might be detached from drive train which causes this alarm.

Check generator – gearbox alignment before replace the defective coupling.
