870 -Pt100 fault gear bear. rear - NM72,NM82,V82 Mk1-5

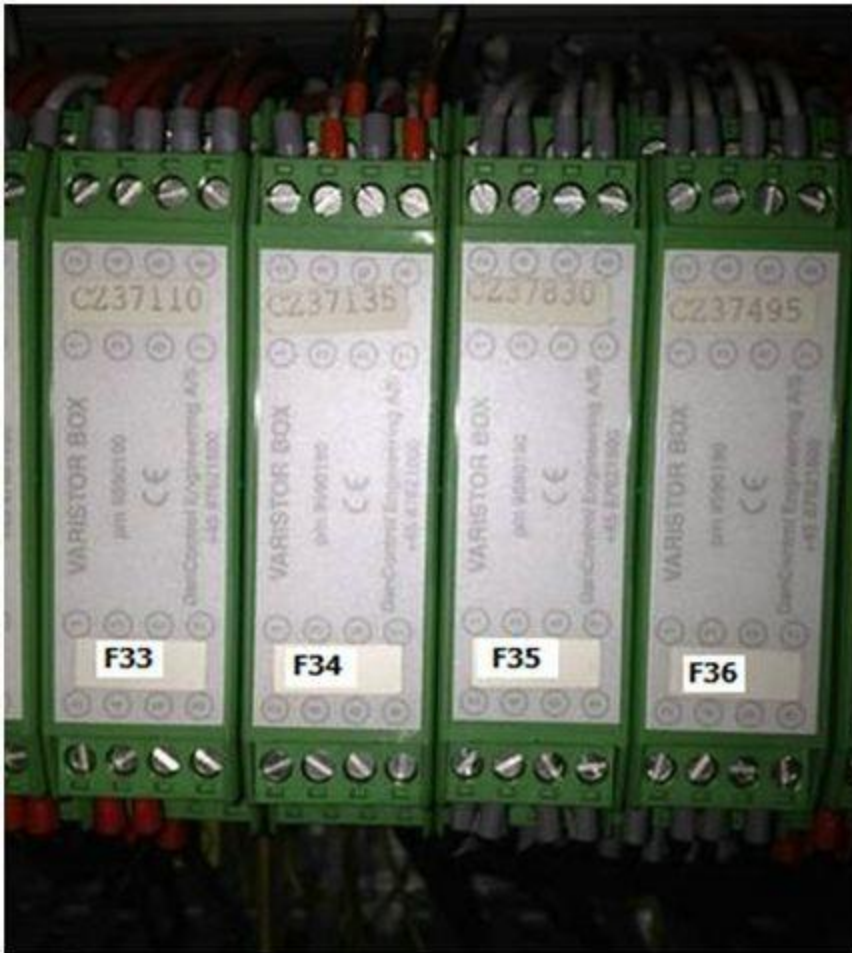
Varistor box F34/F10:

Varistor box (MkIII and above = F34/MkII and below = F10) can be tested individually by placing a multimeter (set to measure Ω) lead on the common (earth) side of the varistors and the other on the individual varistor terminals. The resistance value over the varistor should be ∞ or in the high M Ω range. If the resistance is lower, the varistor has been damaged by an over voltage in the circuit and must be replaced.

Replace the defective varistor
Does this solve the problem?

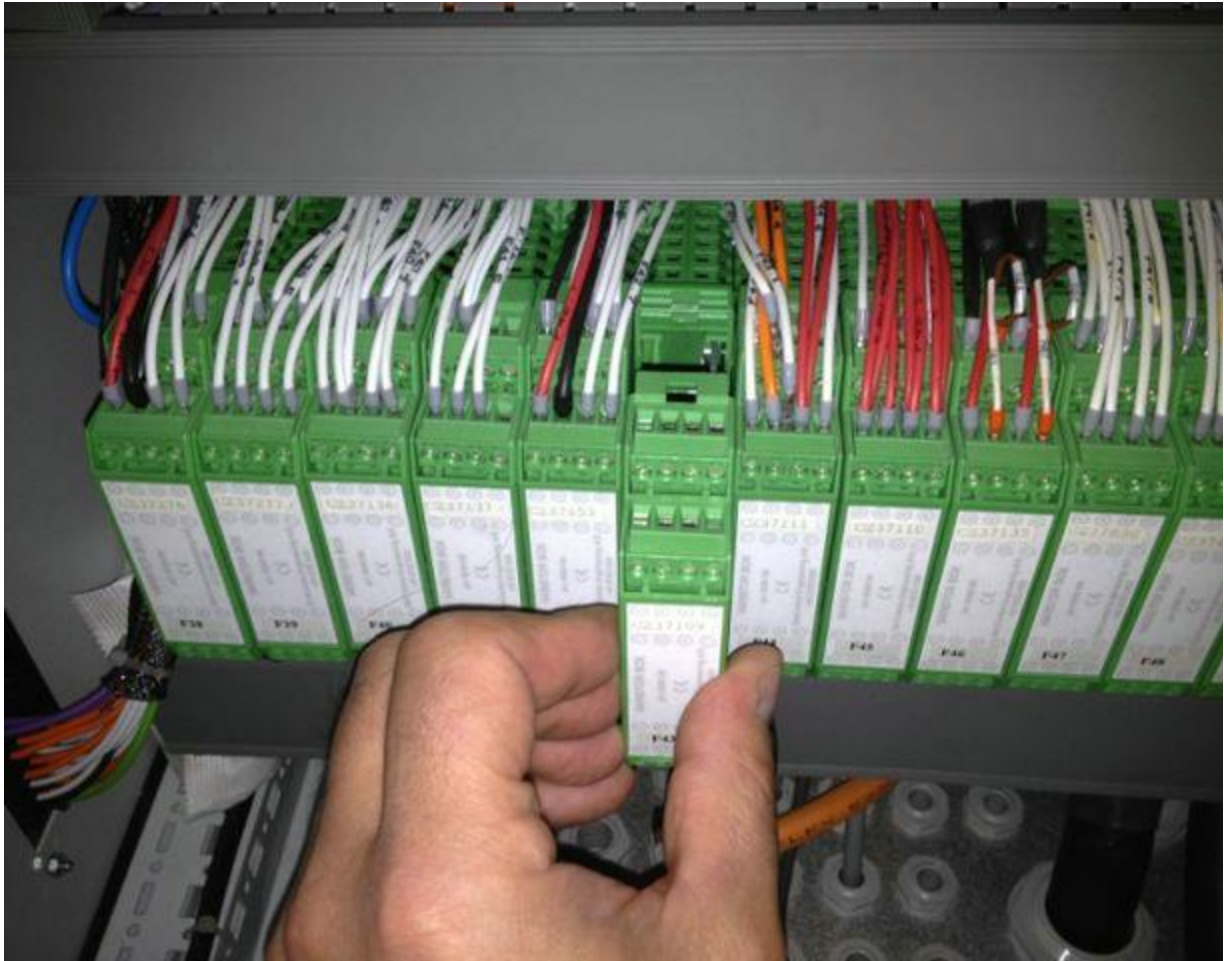
Press clip on top and bottom of varistor box and remove the varistor assembly from the housing:

The varistor box is made up of eight varistors and has provisions for 16 wire connections (protection for 8 signals)

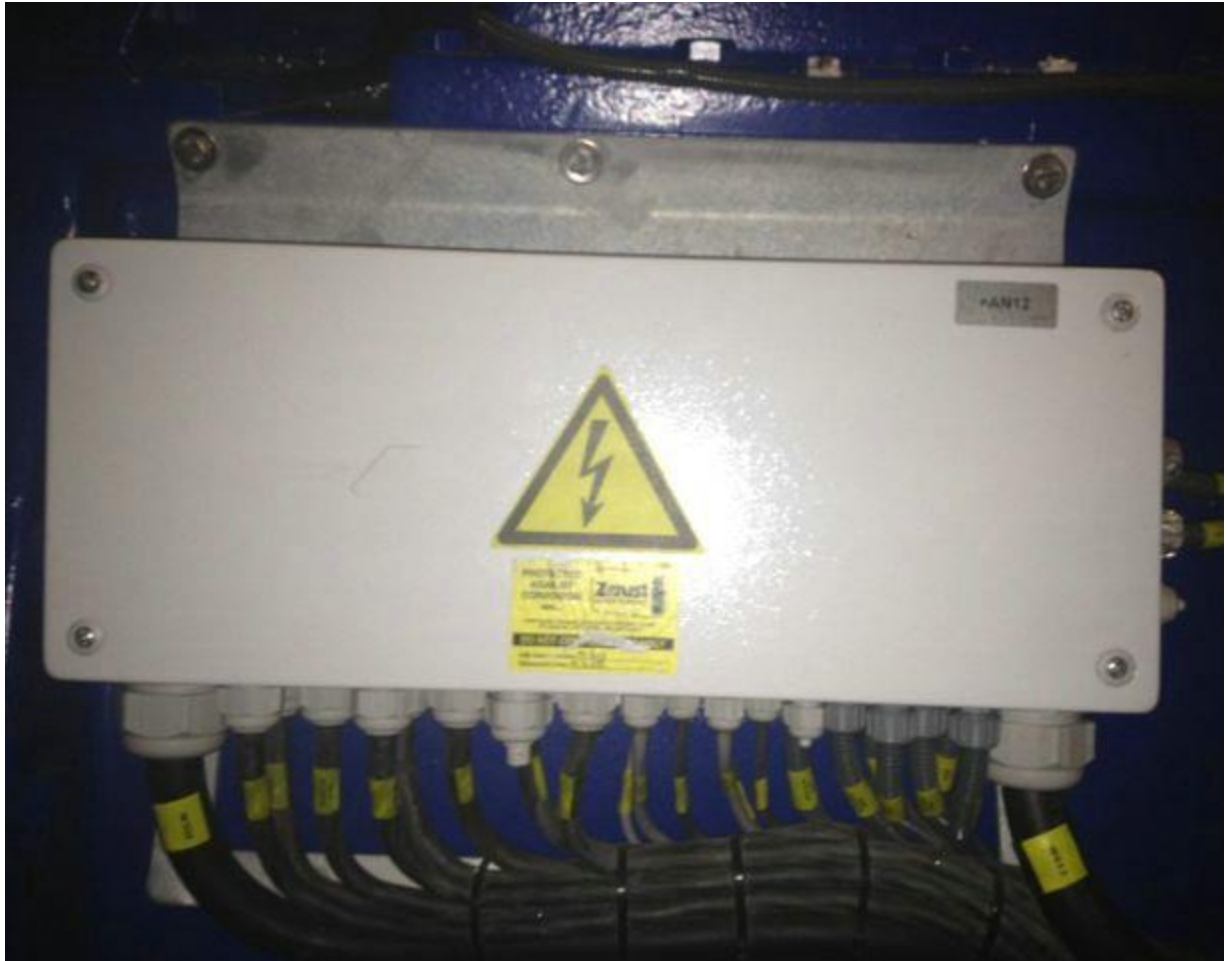
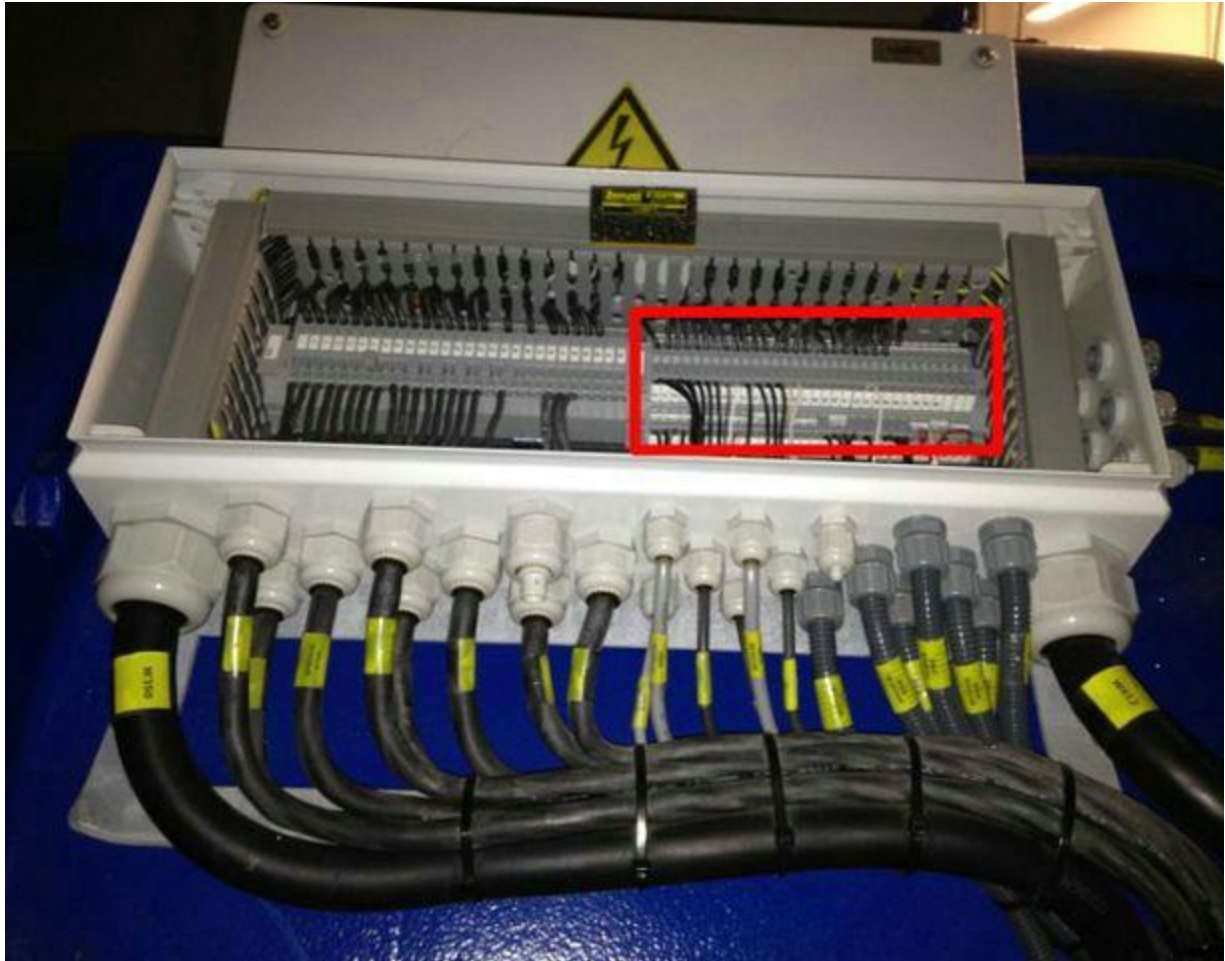
Check PT100 connections and tightness in +AN12 panel X02 connection 23 and 24.

Replace the defective PT100 Sensor

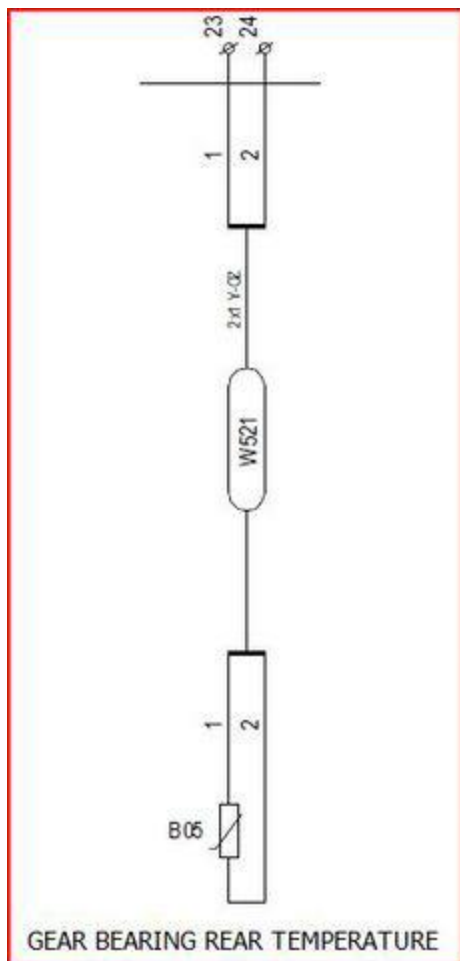
Check the sensor cable if any cracks or damage.
If defect replace the new cable

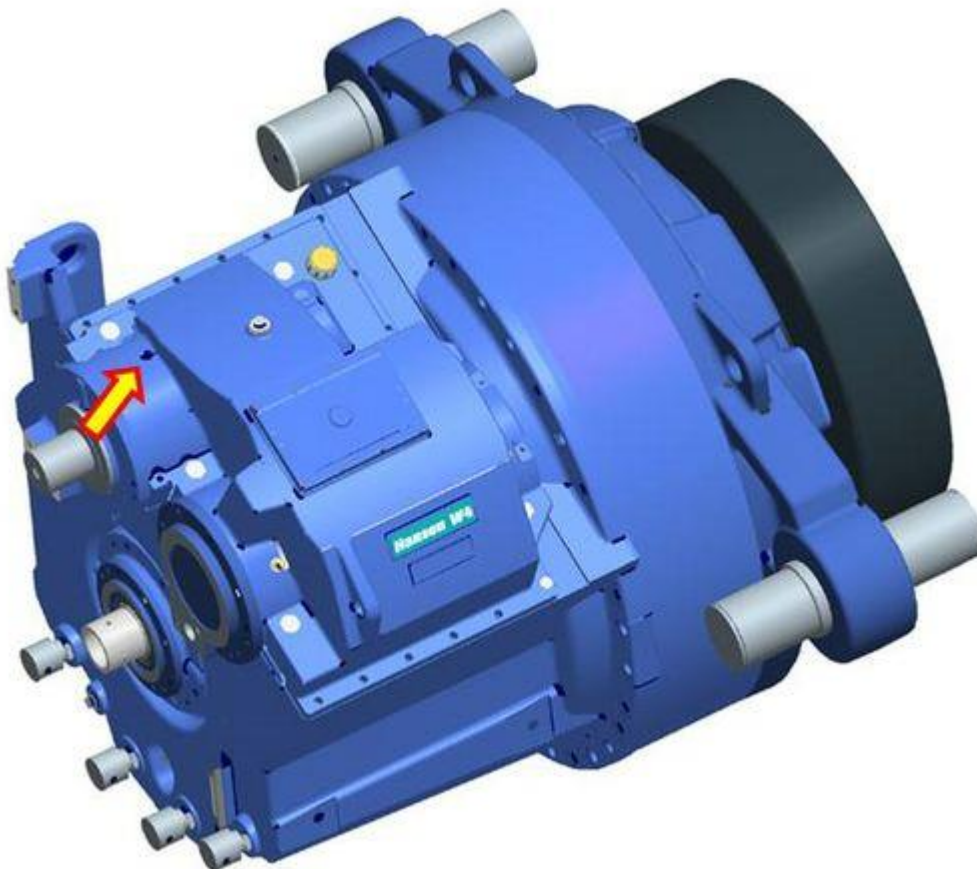
Position of the Sensor:

If the alarm "116 –Gear bear rear temp high", is active or recent in the alarm log, and the turbine is equipped with a HANSEN gearbox- it is most likely a spinning bearing race that has damaged the sensor and caused the fault.

Replace the PT100 sensor and repair the bearing housing

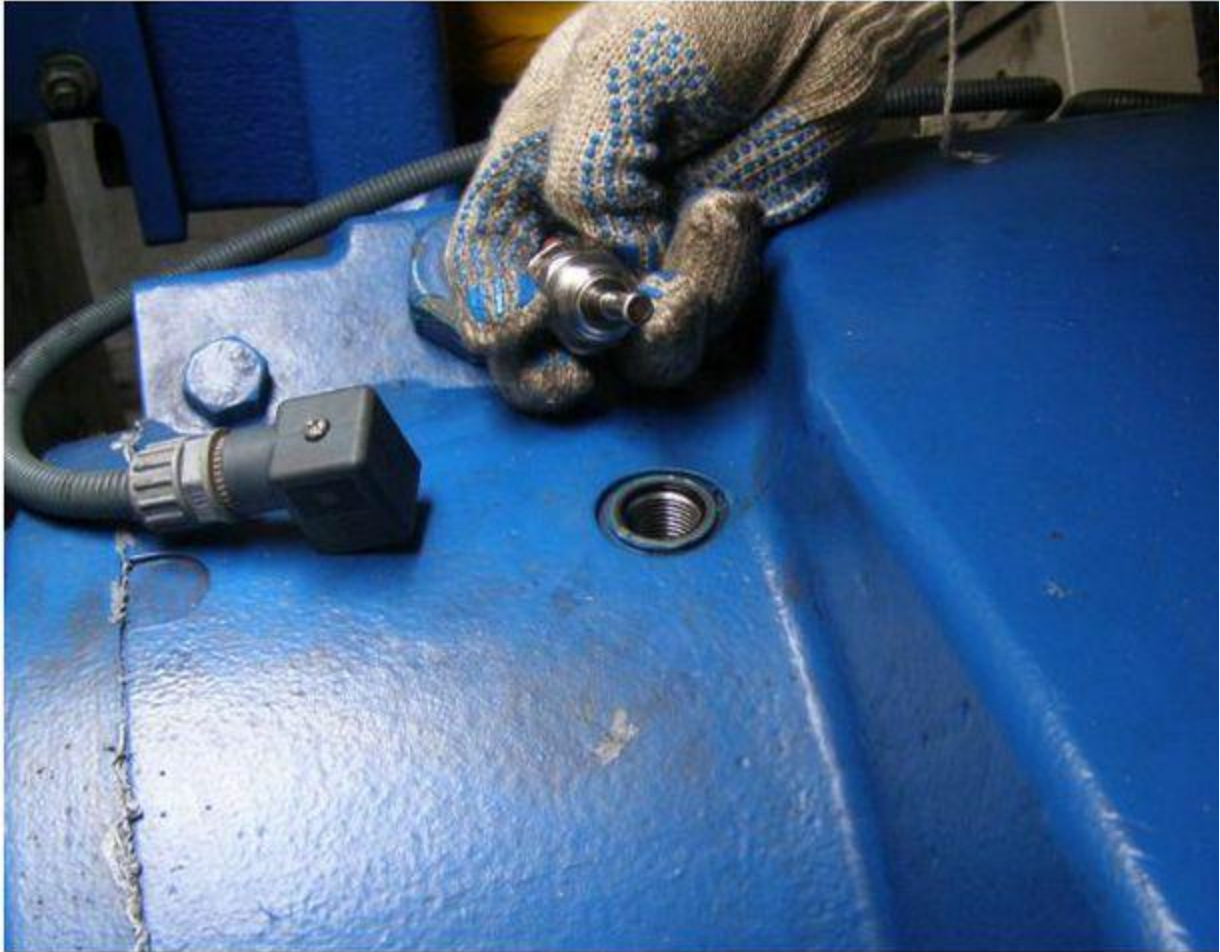
Remove and inspect the gearbox rear PT100 sensor tip for signs of wear.

If there is wear on the tip, the outer race of the bearing has been spinning in the housing. Then proceed with repair solution.

Remove the PT100 sensor and check the sensor tip surface for wear.
