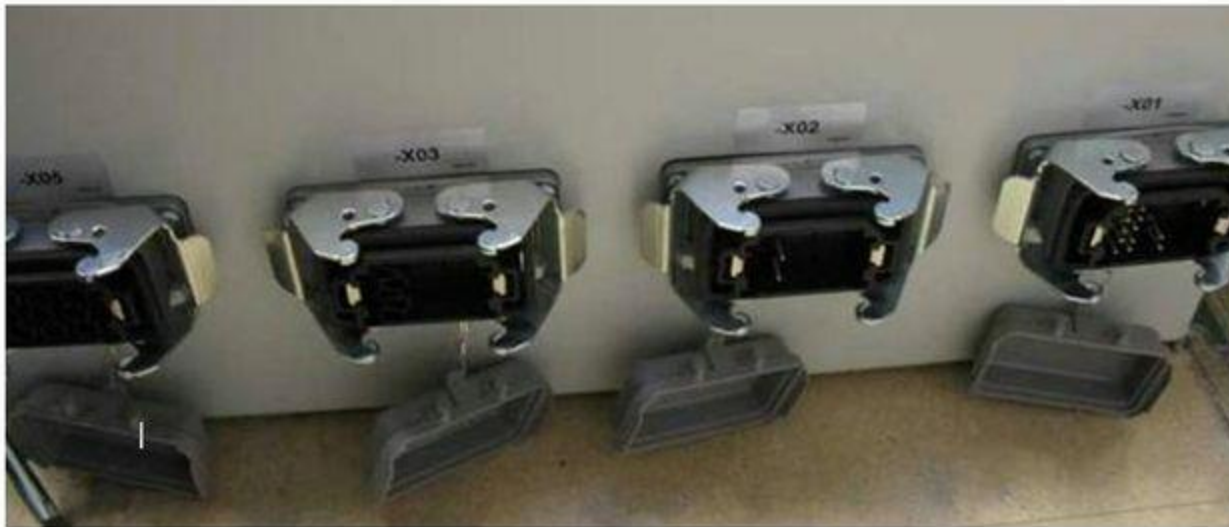
Check the control voltage port and plug for loose connections.

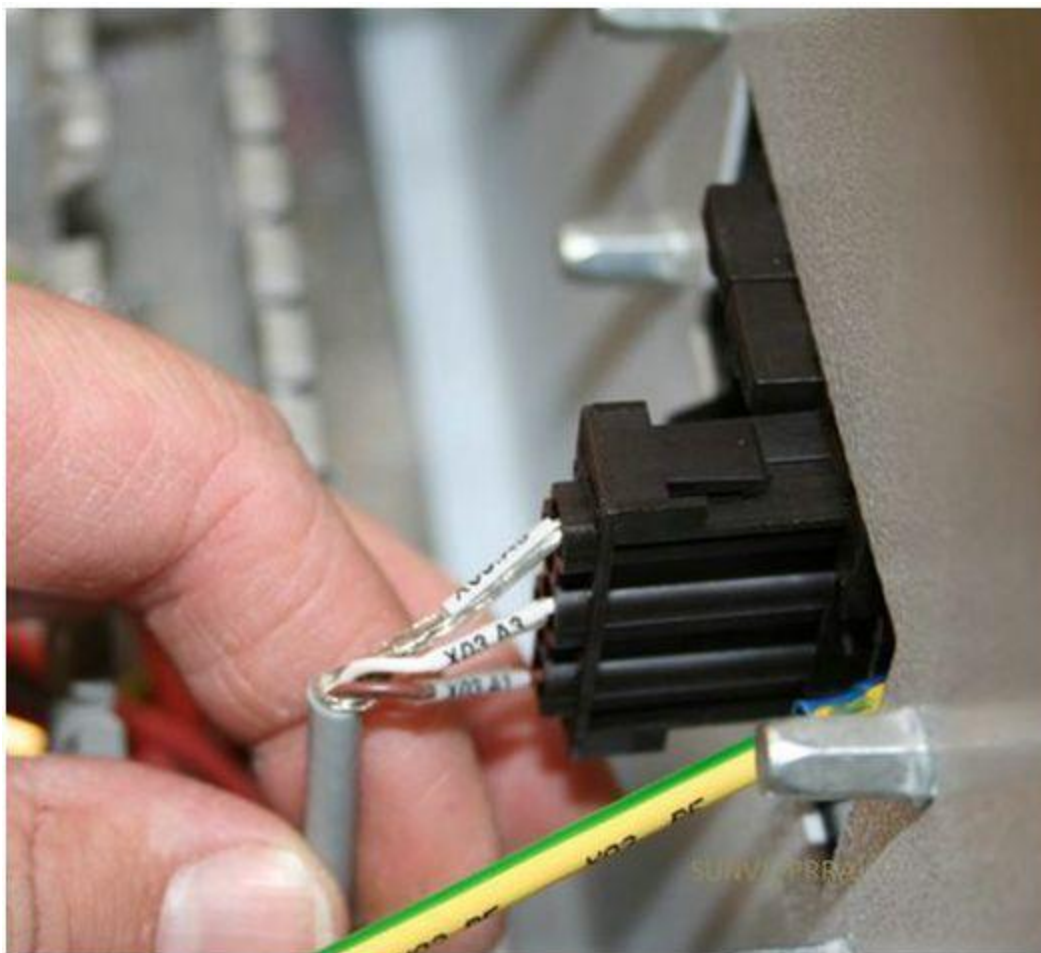
Check the communication cable for poor or loose connection.

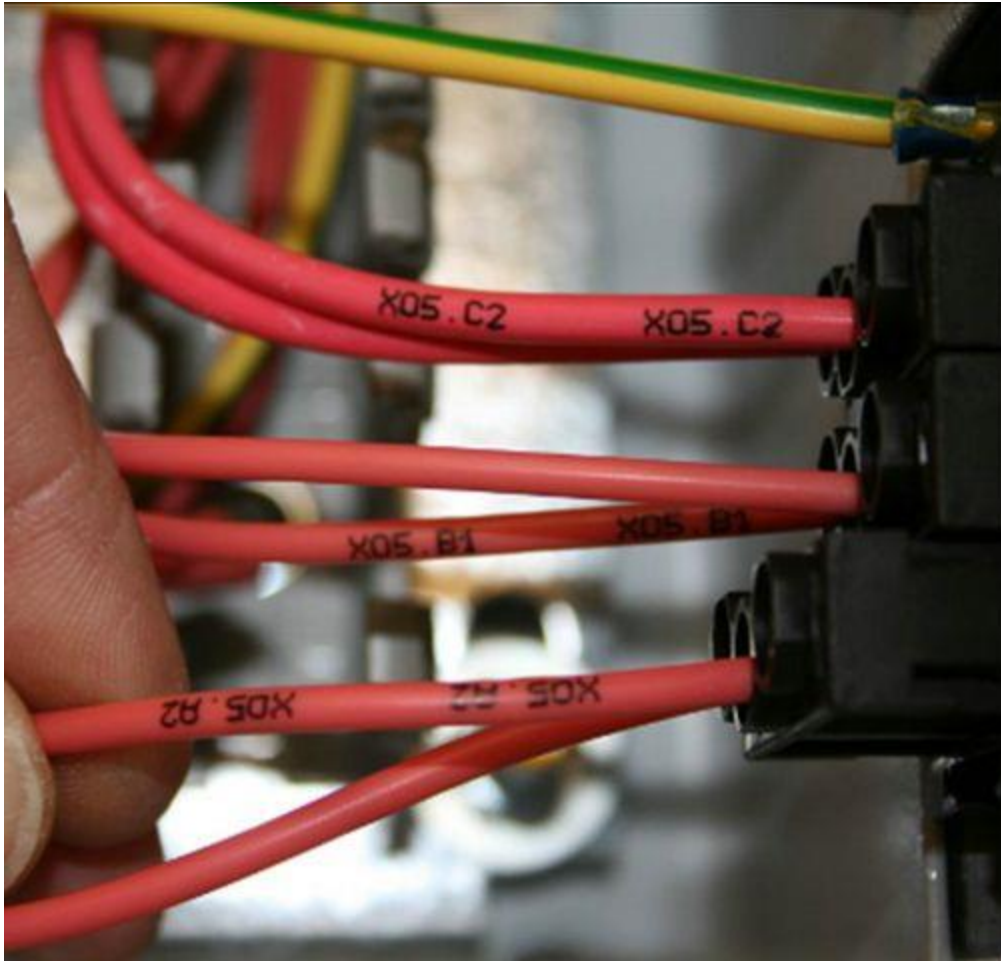
Check the control voltage cable for poor or loose connections.

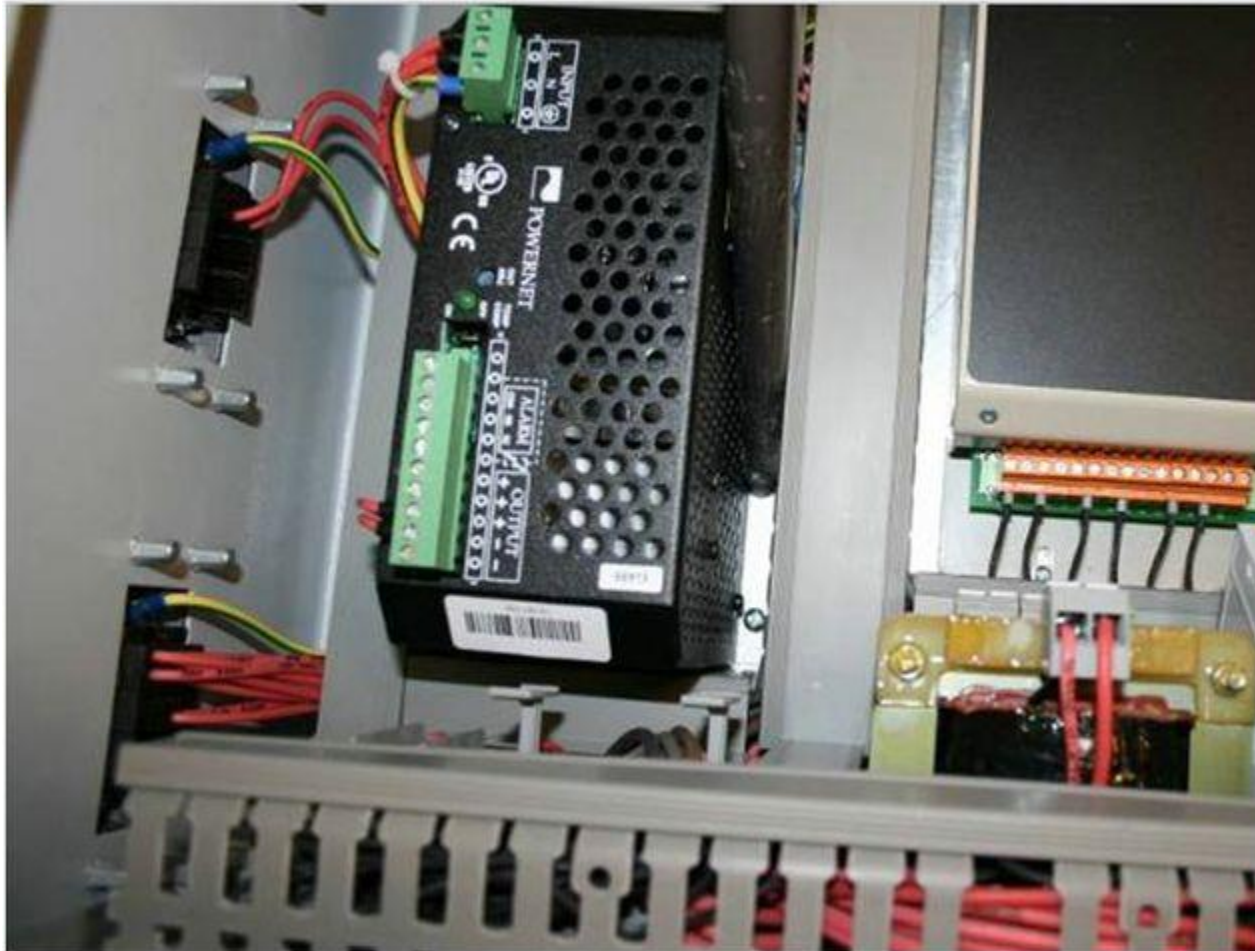
Check for any loose connections at the power net (Pos: G401)

Check the input and output voltage 230/115VAC => 24VDC

Replace the power net if it is defective.

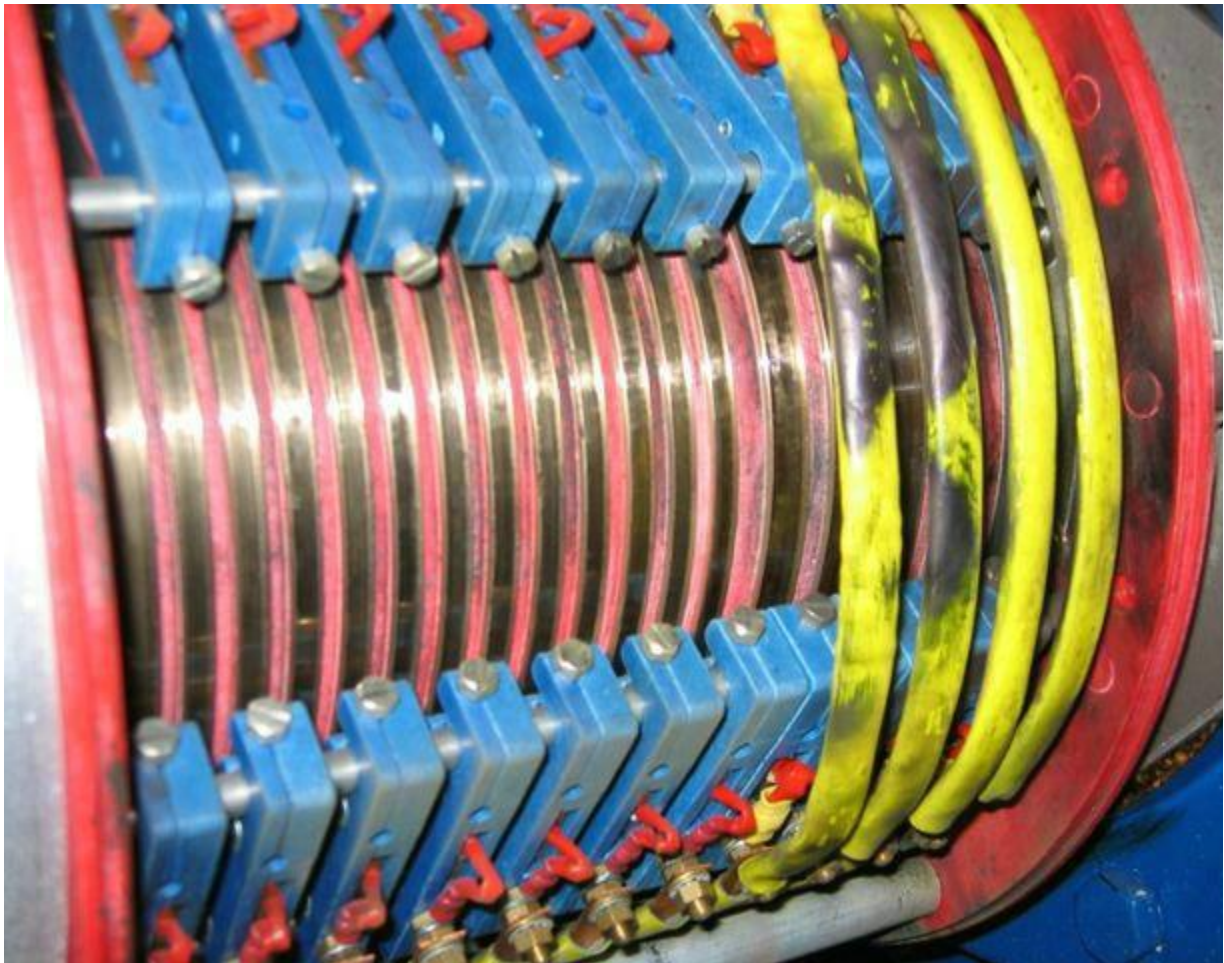
In most instances, a bad connection at the slip ring causes this alarm.

Dust and oil accumulation on the slip ring short circuiting between the tracks which can cause this alarm.

Use the document- DMS: [0001-4933](#) Cleaning Procedure for slip ring unit as a guideline.

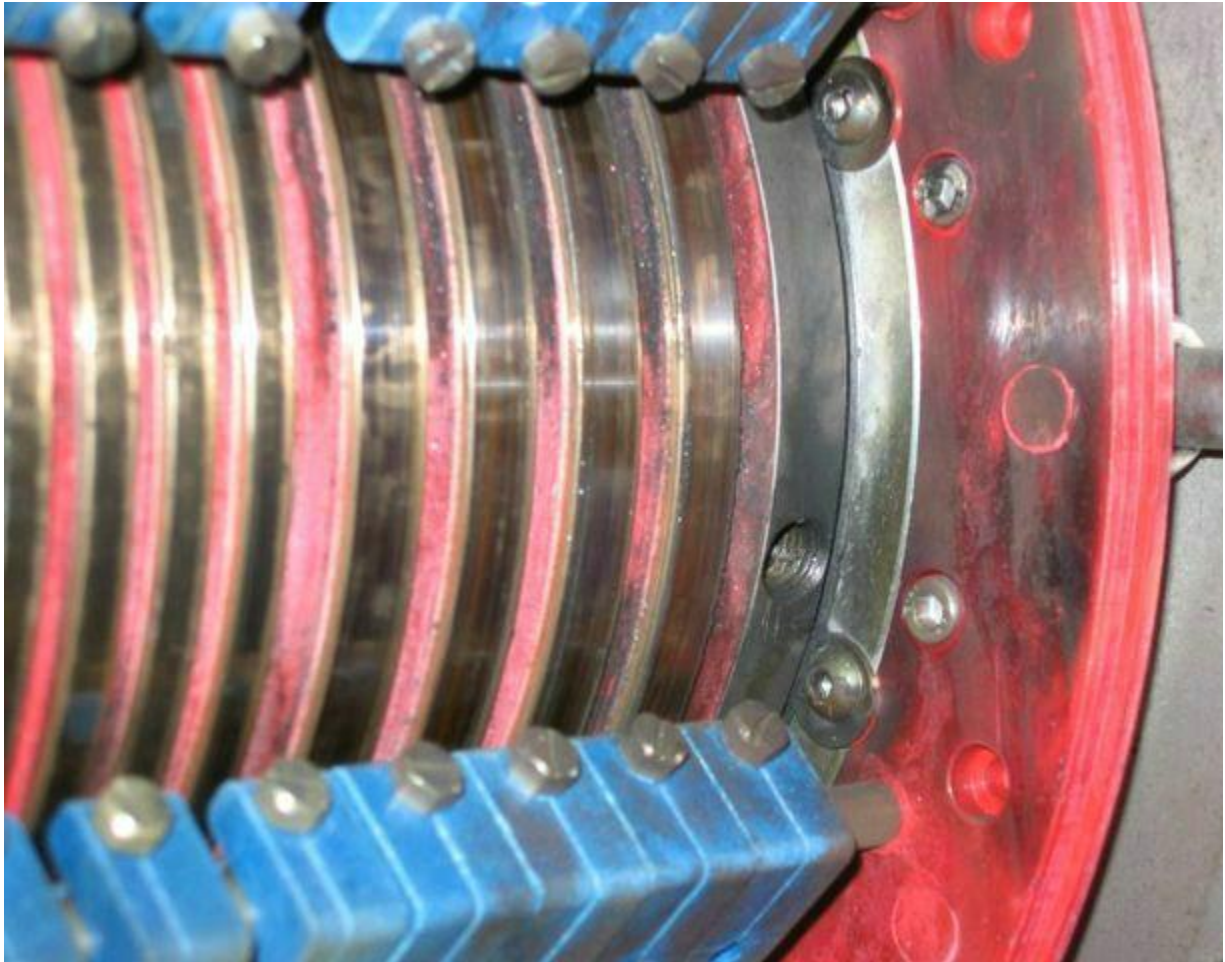
Check the condition of the brushes on the slip ring. Check for 230VAC supply to the hub and hub communications:

Replace the brushes if worn, damaged or contaminated beyond repair.

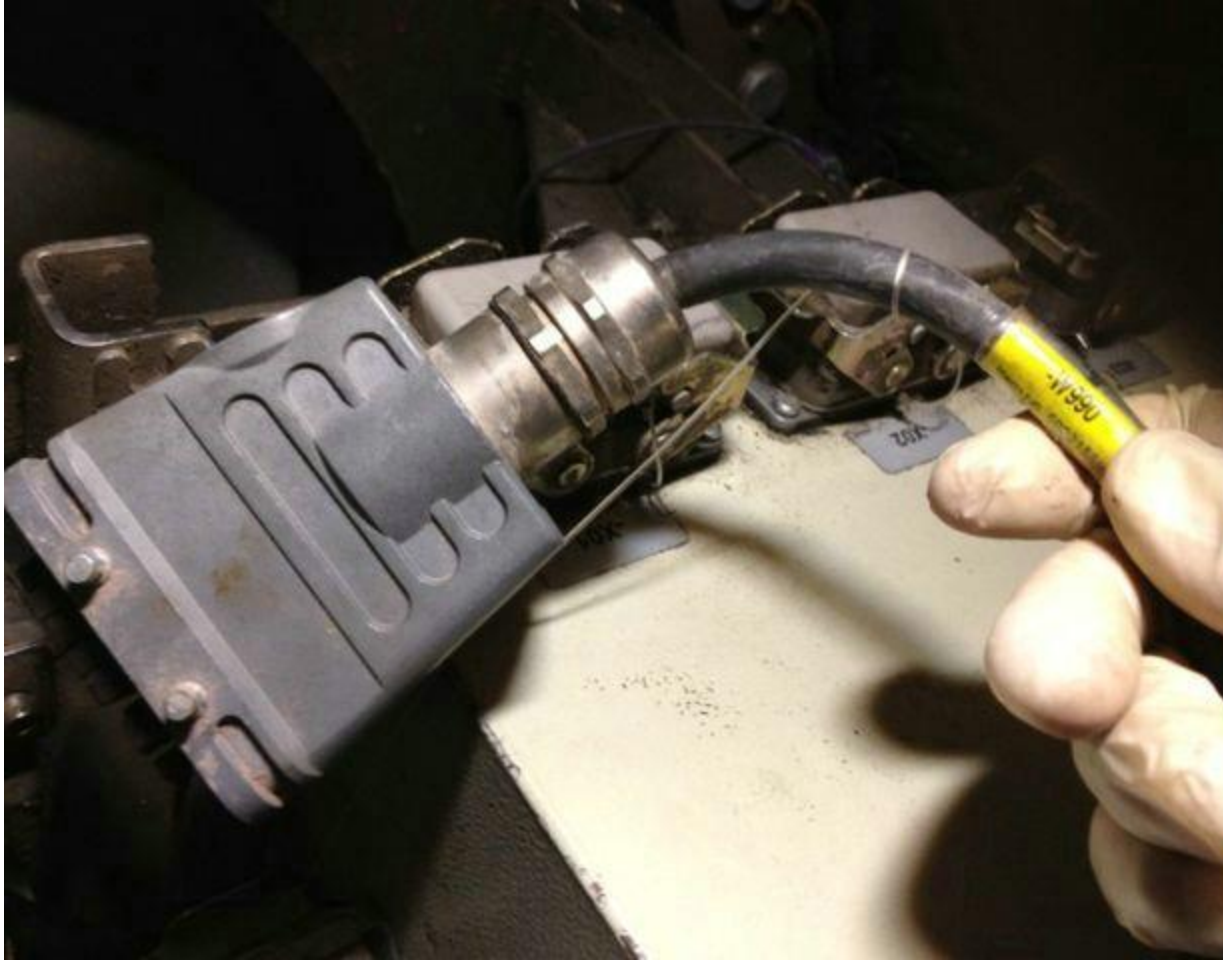
Check the condition of the Communication cable -W990

Check for any cracks or wear on the cable.

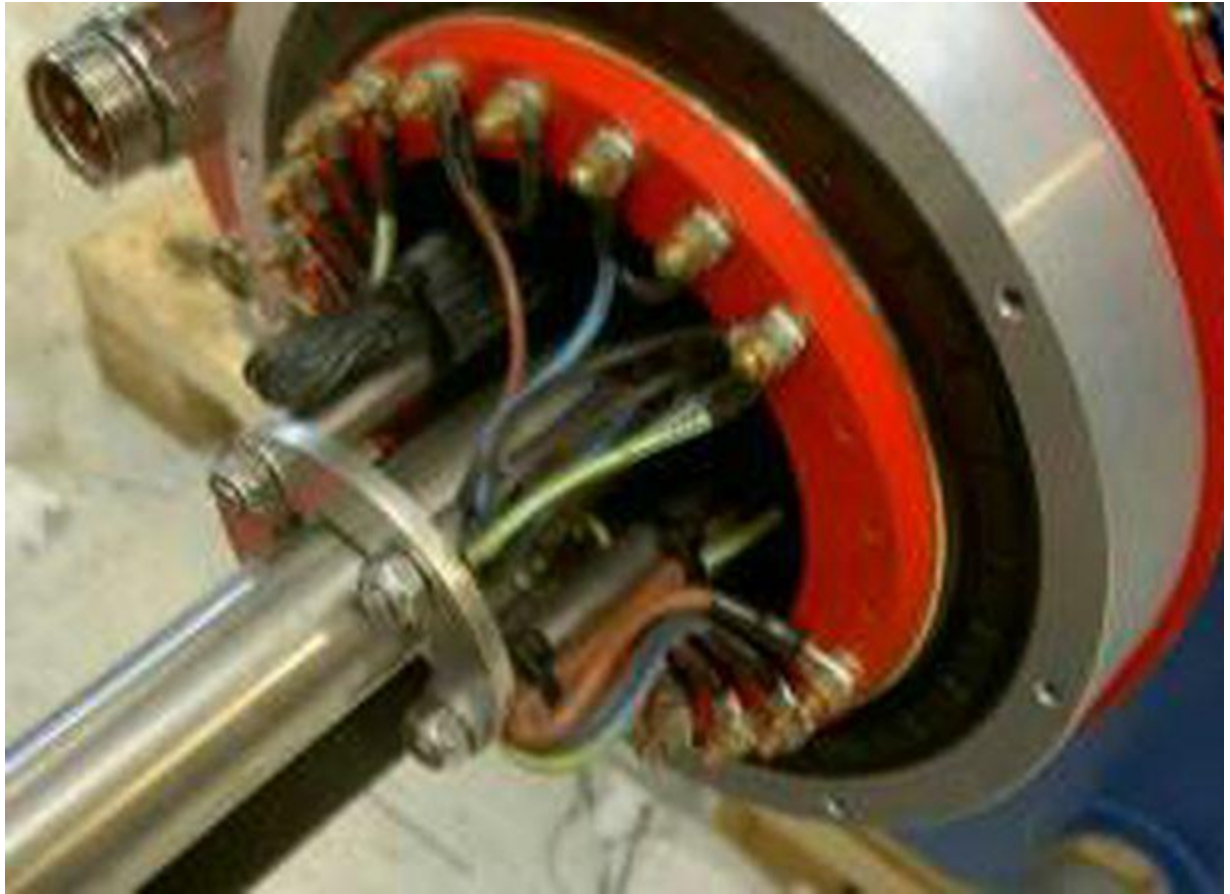
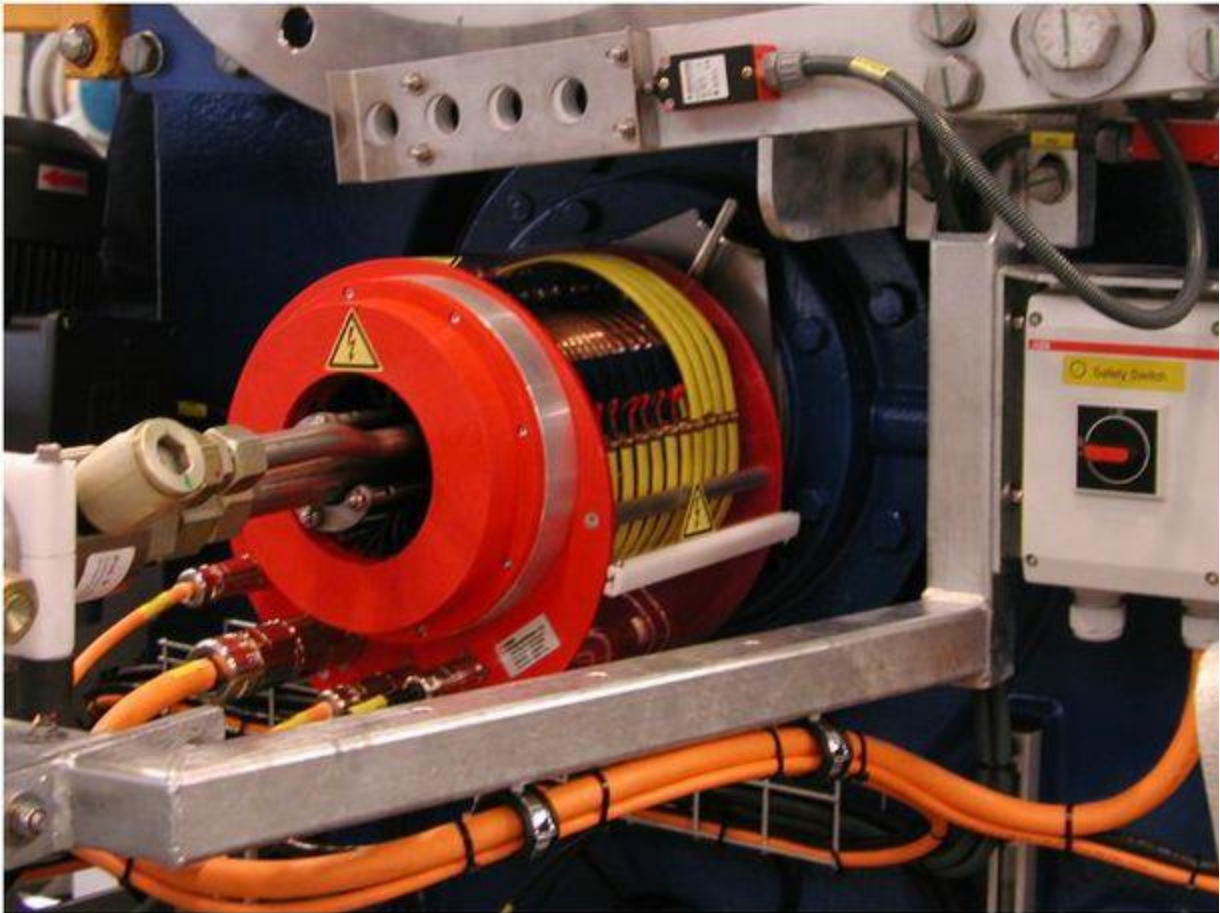
Check the cable terminations for any arc flash or loose connections.

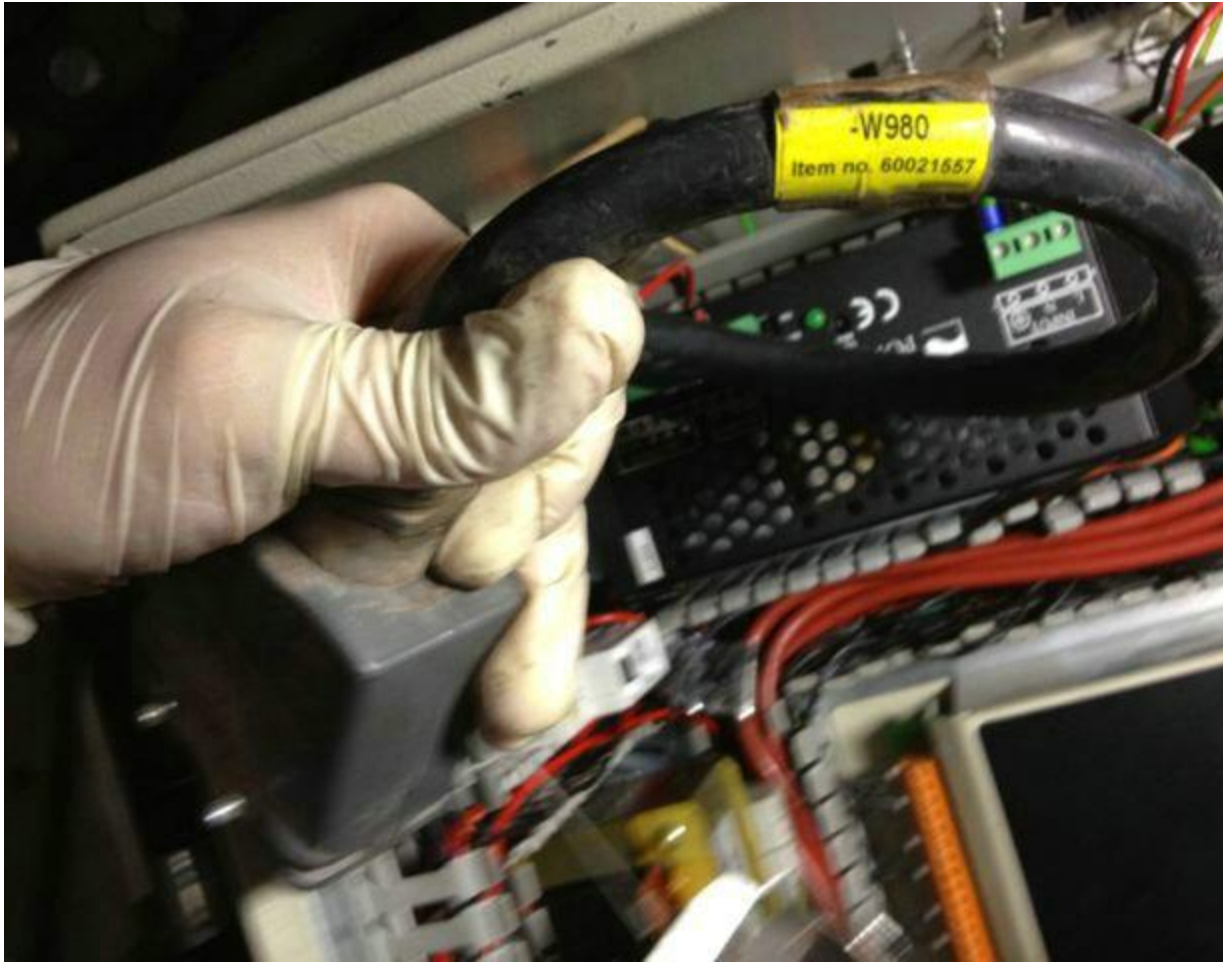
Check the condition of the –W980 cable in the hub.

Check for any cracks or wear on the cable.

Replace the cable if it is defective.
