Replace the defect pitch position sensor

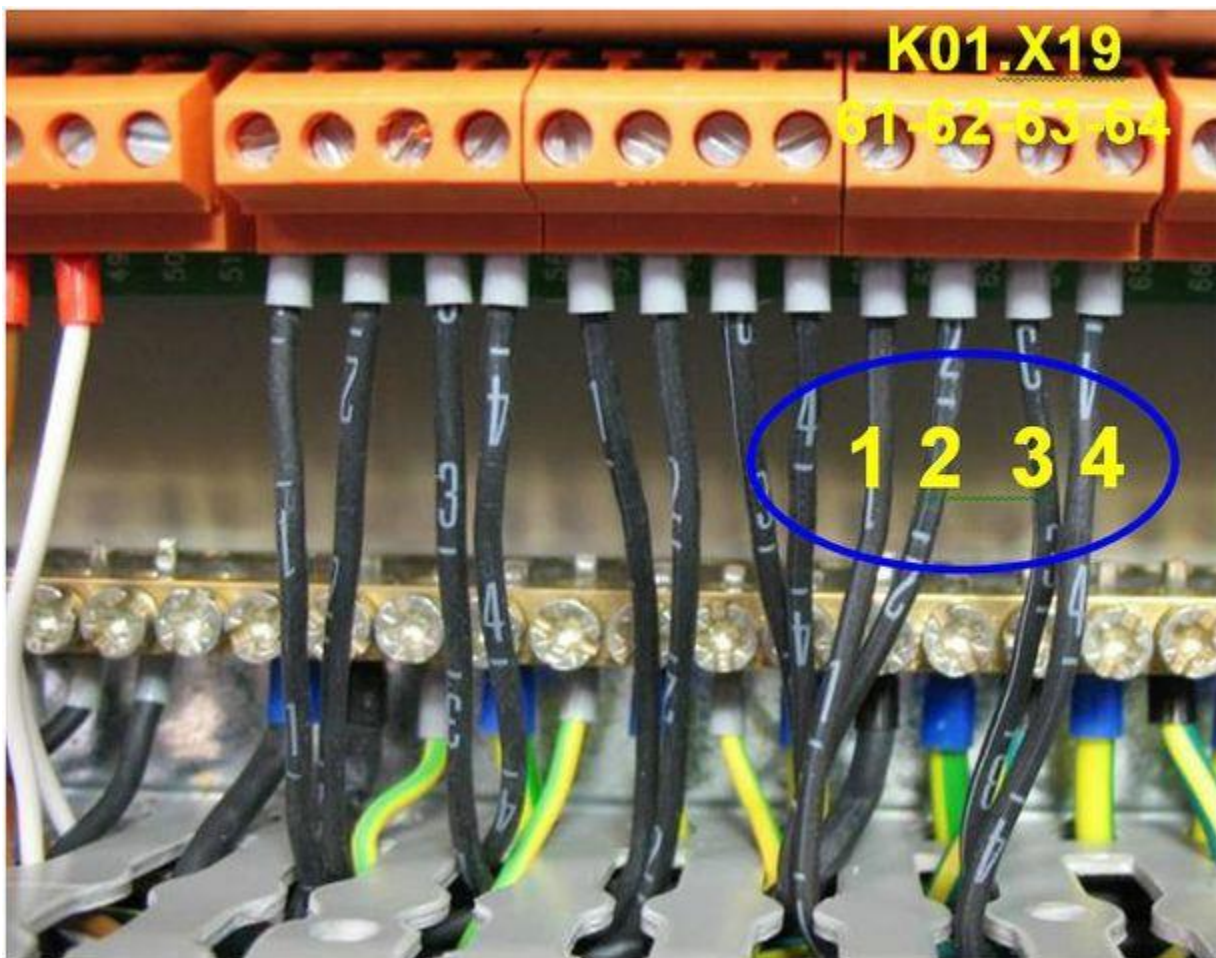
Check if any loose connection in the hub computer terminal X19

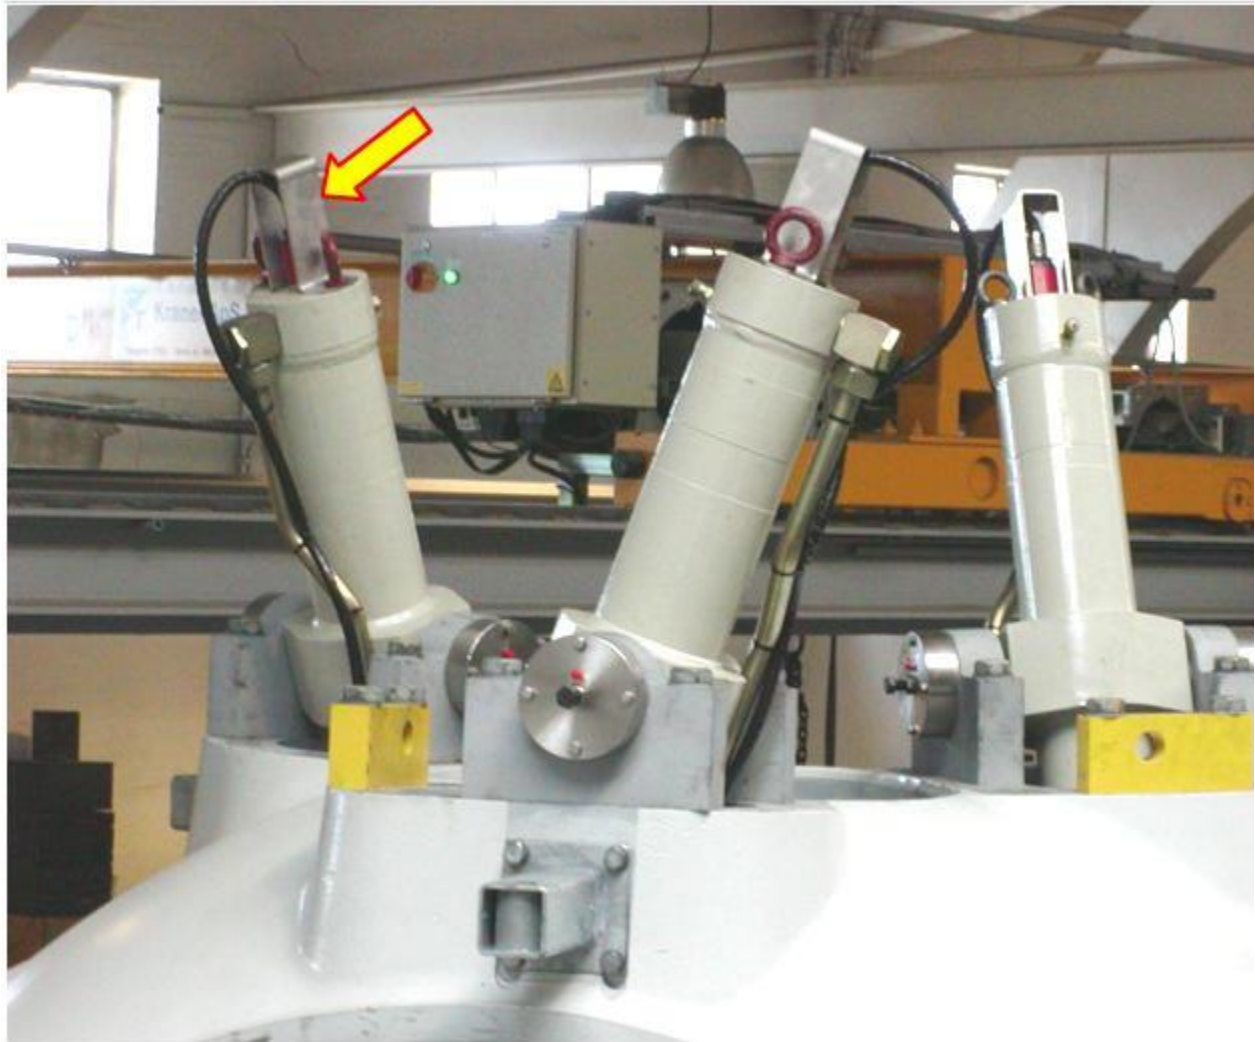
Check if any loose connection for Blade C position sensor.

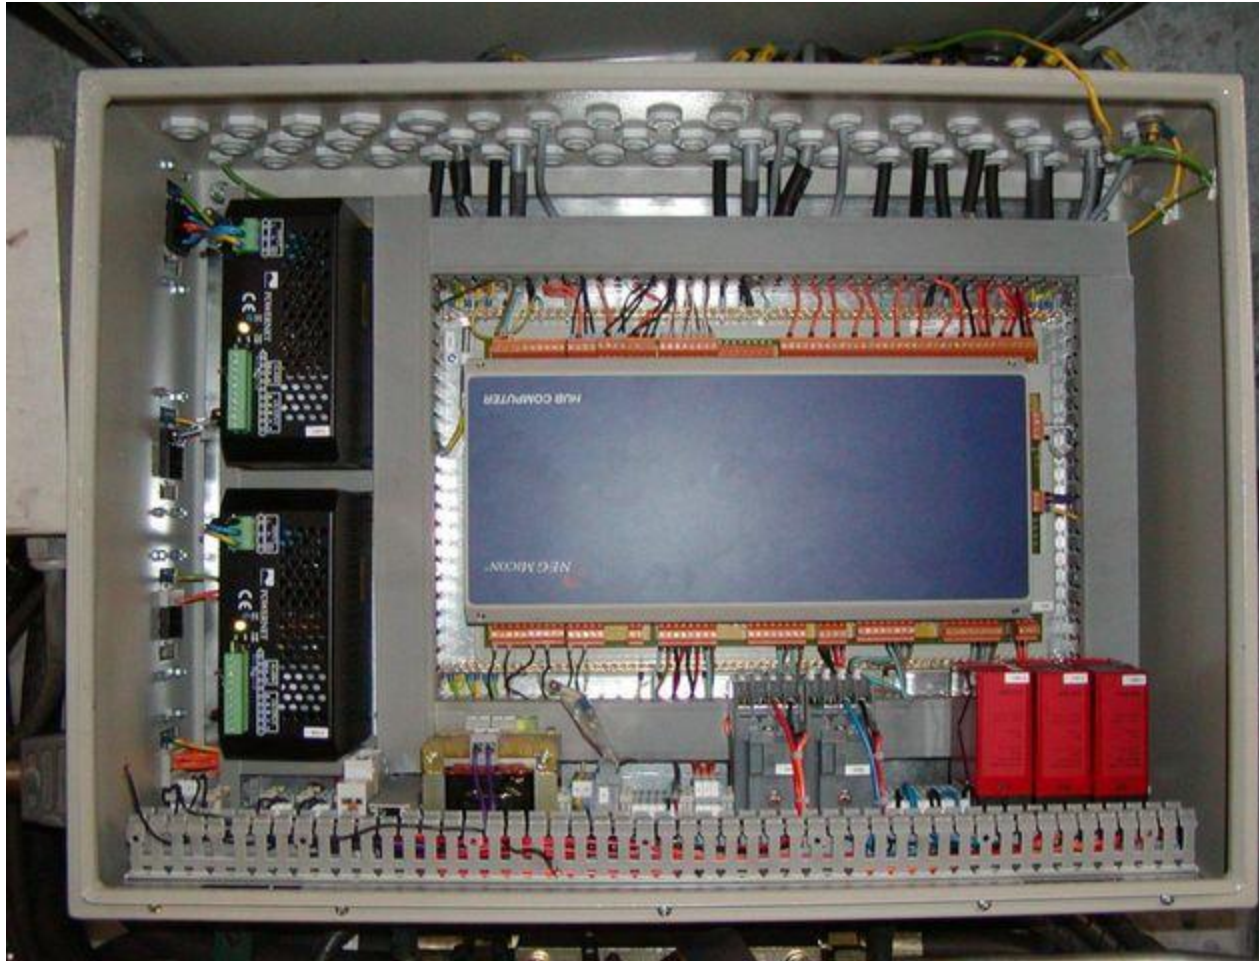
Swap the signal wire to the position transducer (Balluff) on the hub computer. If the fault follows to the new blade then the fault is either in the position transducer or one of the cables.

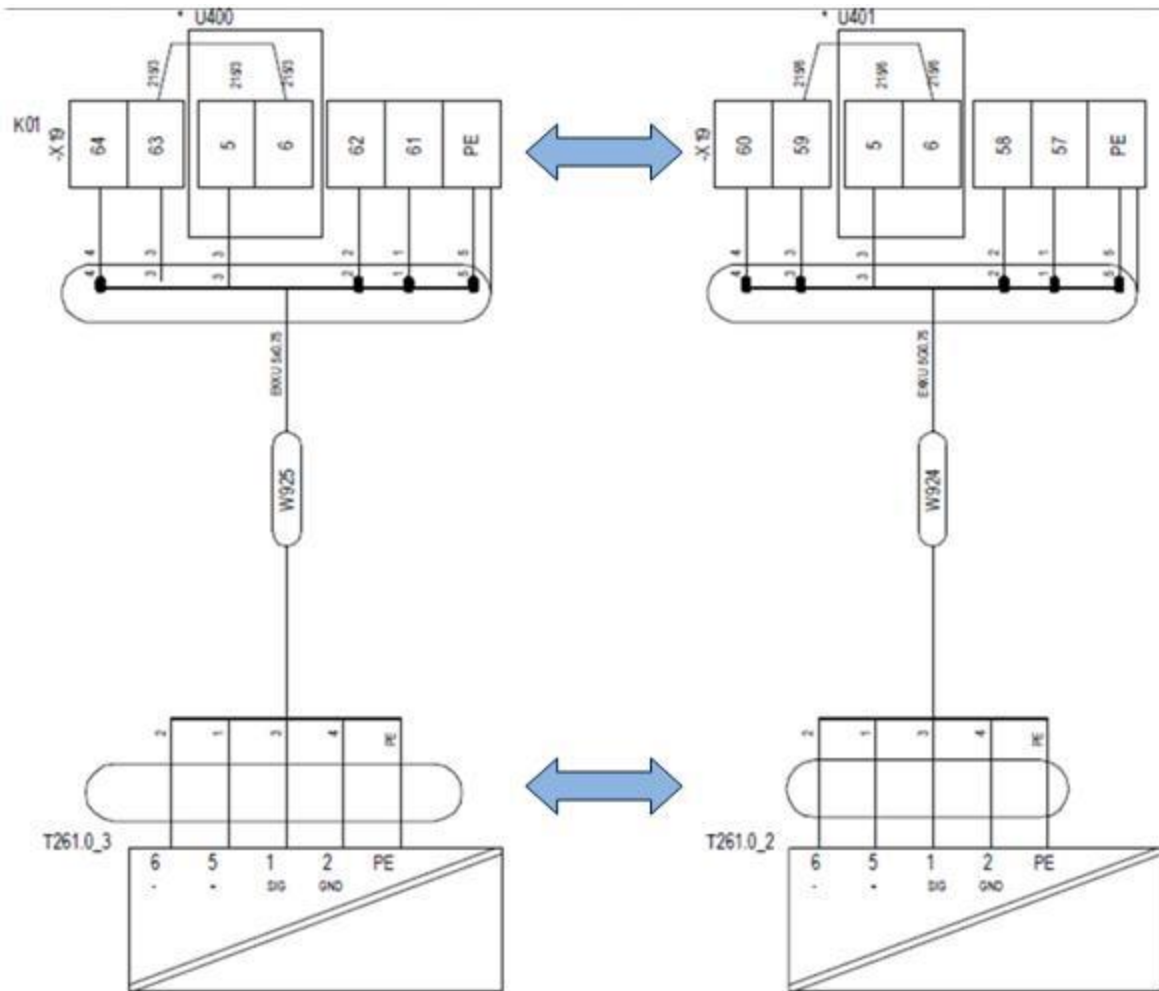
In the example below, we are swapping the plugs between blades B and C.

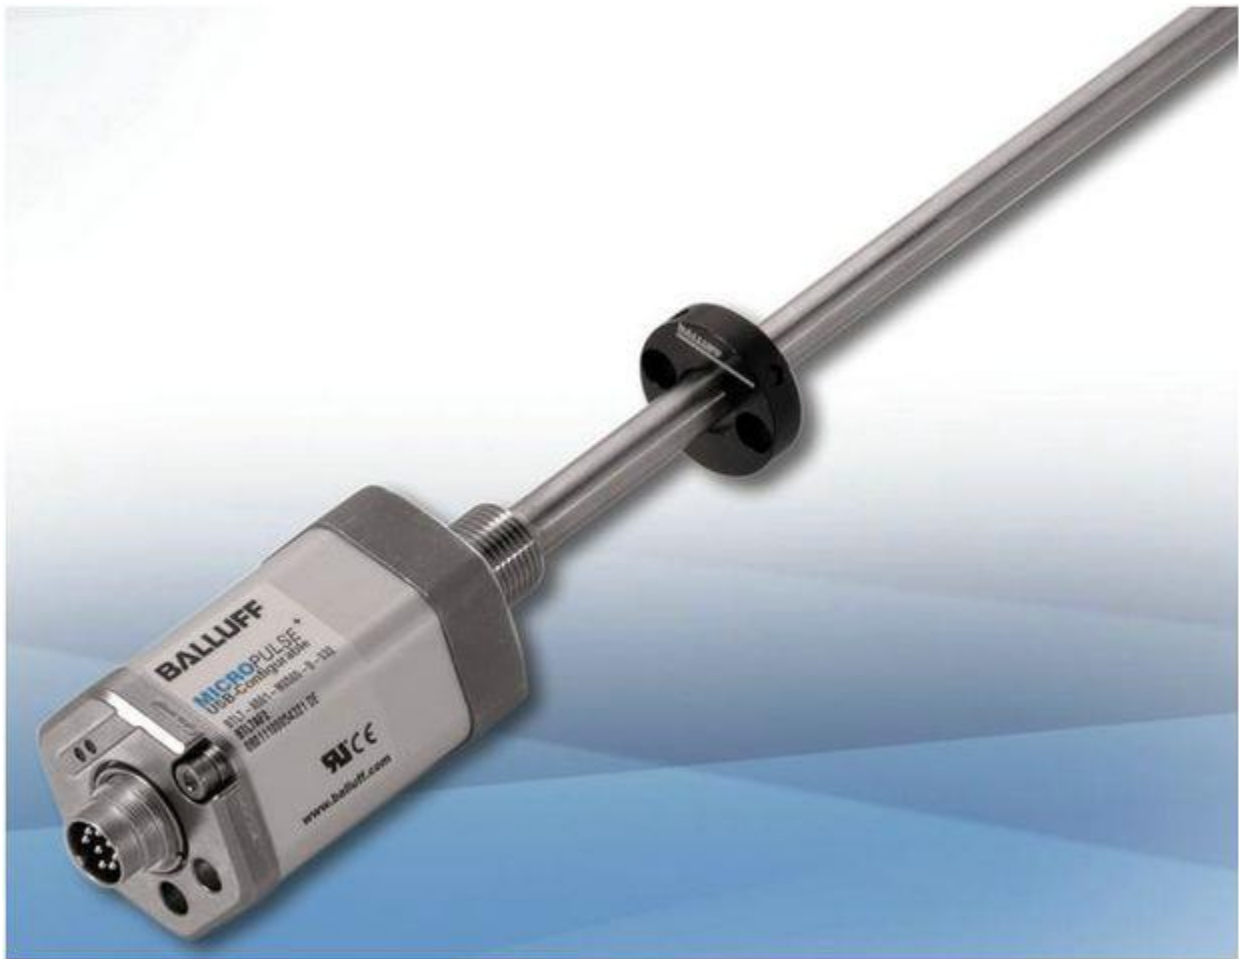
Pitch position sensor Item number :

If the alarm follows the component to the other blade, the pitch position sensor is defective.

If it does not, the pitch position sensor is likely not the cause.

Place the cables back to their original position and then swap pitch position sensor from affected blade to another working blade.

60098816 - TRANSDUCER BTL5-E10-M0950-A-S

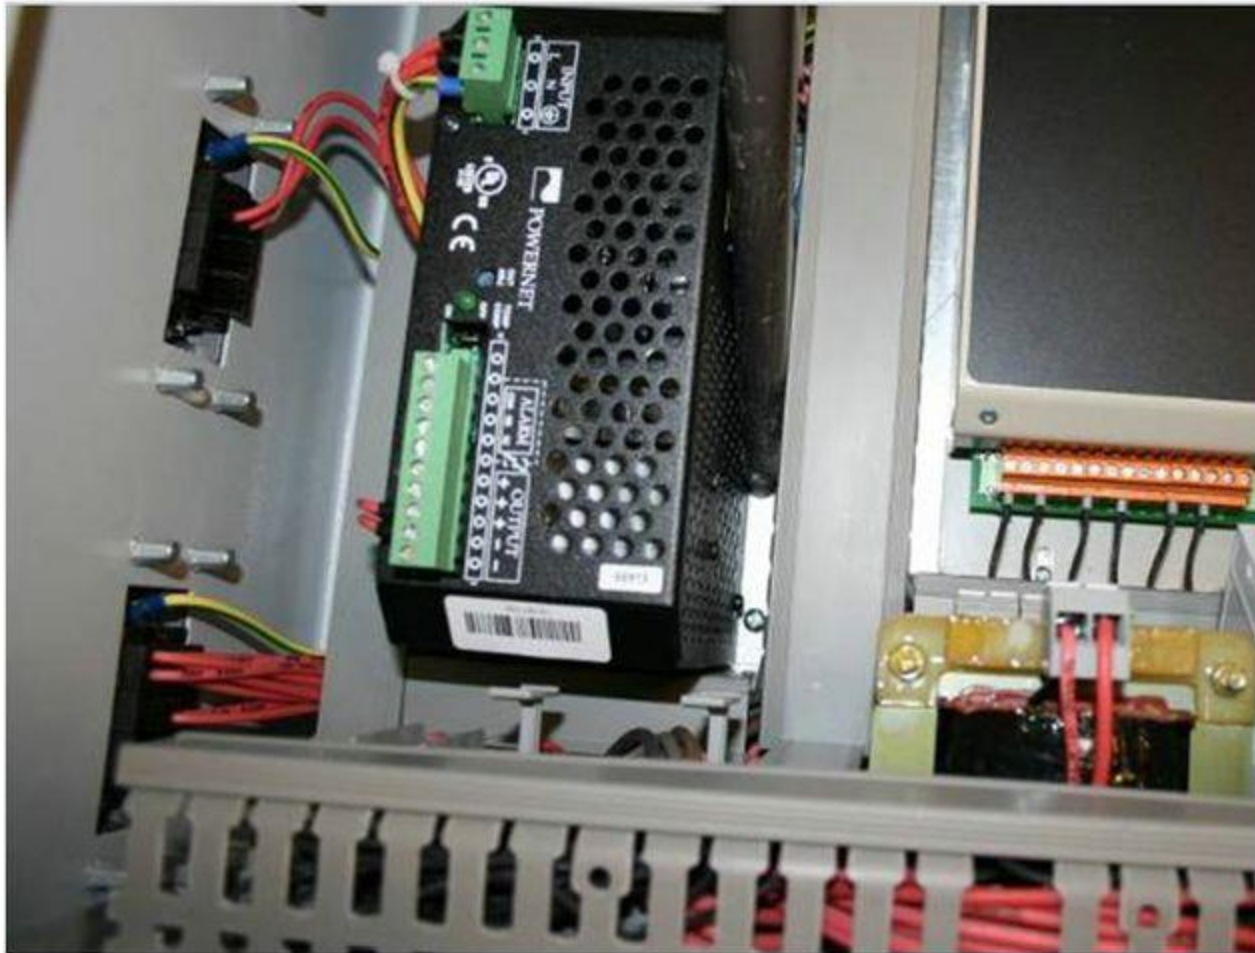
Check for loose connections in the powernet (Pos: G401)

Check input and output voltage 230VAC/24VDC

If defective, replace the power net.

188453 PS ADC 5483R-3 10A-27,4 NM PIN

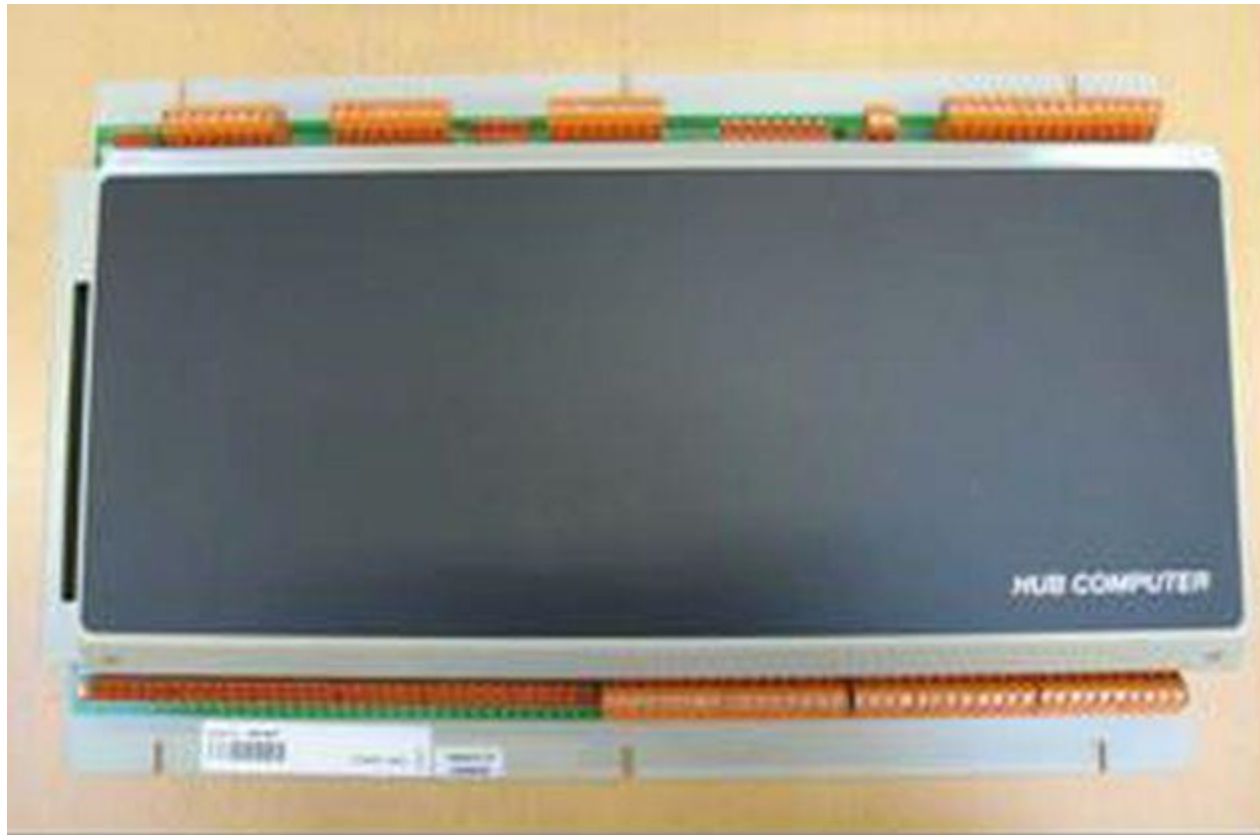
Hub Computer Part Number: 51701801

If after the blade calibration, there continue to be any pitch angle deviations, or the angle values show constant when pitching the blades, the hub computer may be defective.

Replace the defect Hub Computer
