880 - Pt100 fault water before cooler - NM72,NM82,V82 Mk1-5

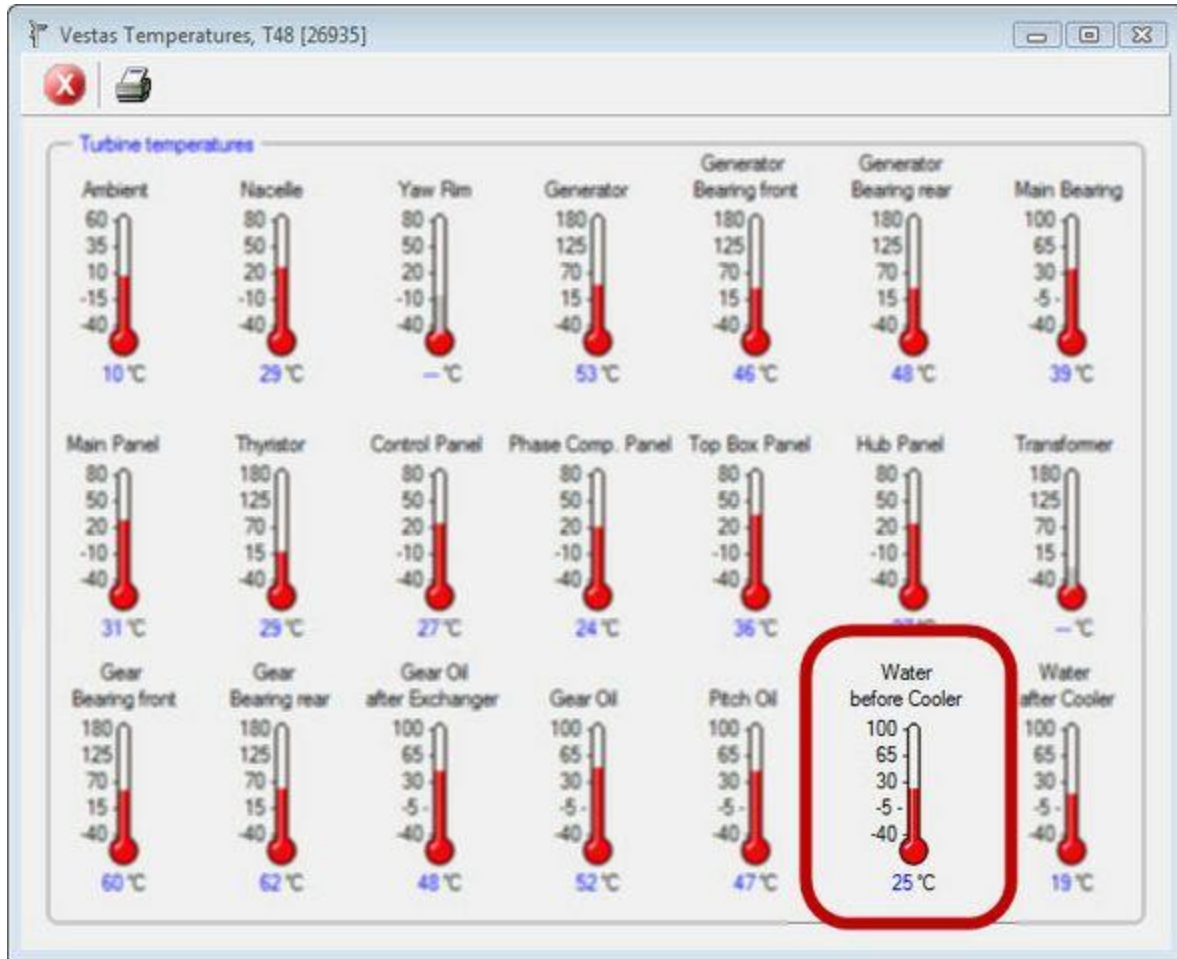
Check the water temperature before cooler.

If the temp is -40°C, you should troubleshoot a line to line short. Disconnect the Pt100 and test the circuit for continuity. If the circuit passes the test, replace the Pt100.

If the temp is at the upper limit (200°C to 245°C), you should troubleshoot an open in the circuit. Perform a pull test on the wires to ensure any opens are not due to loose connections. Disconnect the Pt100 leads in the AN14 and test for continuity through them. If they are open, then the sensor is defective and needs to be replaced.

Replace the Pt100
