Troubleshoot circuit and fix fault

Identify cause of vibration in nacelle, fix and replace vibration ball in holder

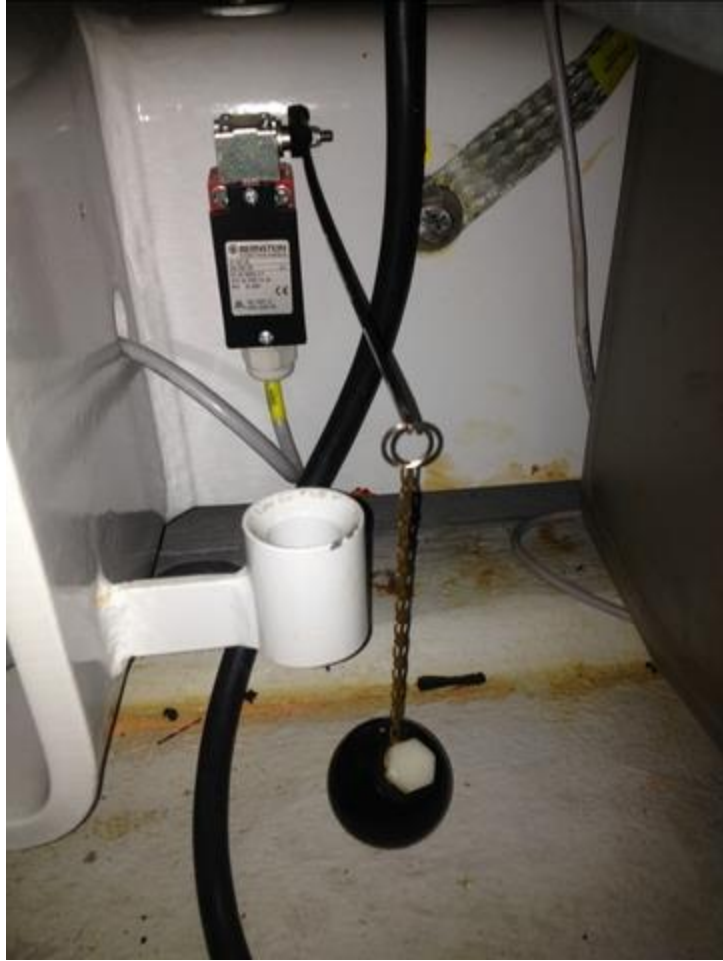
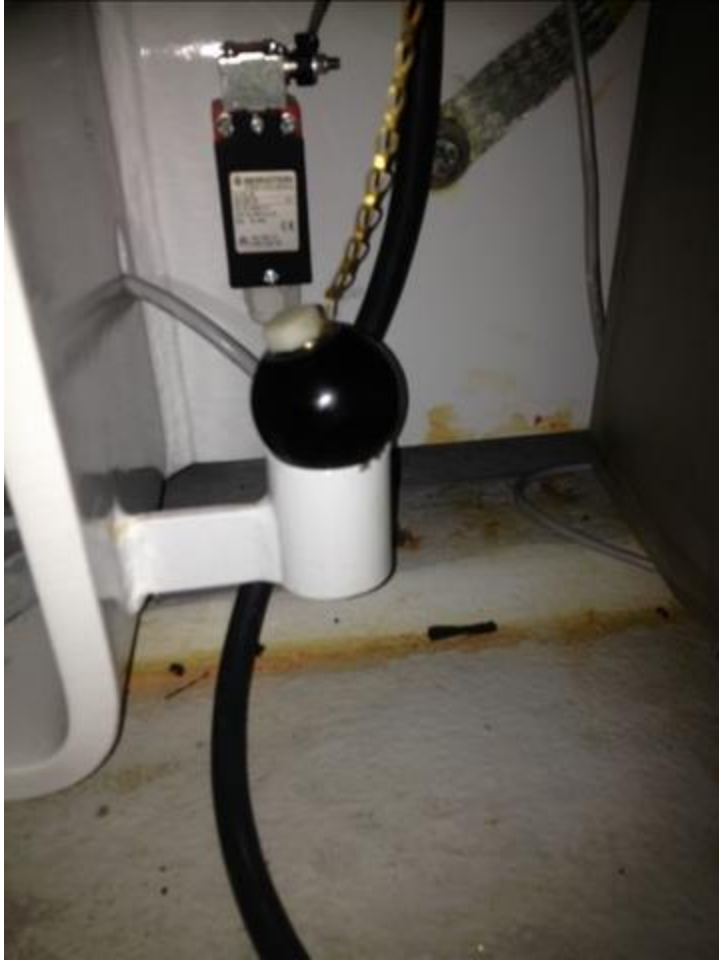
Finally, inspect the vibration ball. If the ball is not in its holder, continue to investigate the drivetrain.

If nothing can be found, replace the vibration ball into its holder. If the HSS shaft brake has been applied, release the brake momentarily to allow the rotor to slowly freewheel. Listen for any abnormal noise from the drivetrain, rotor/main shaft connection or any other part of the nacelle. Closely inspect any area emitting any abnormal noise. With all safety precautions in place and the HSS lock engaged, an internal visual inspection should be performed on the gearbox to rule out any gearbox damage.
