Replace defective RS232/RS485 CONV I-7520 ICP

Property of Vestas Wind Systems A/S. This drawing must not be passed on to any person, nor be copied or otherwise made use of without our approval.			Date	Initials	Function RS485 comm. to +AT1 Top Panel							
			Designed	070628	FLT	Project title Control Panel +AT2 V82-1.65MW Mk5 50Hz							
			Approved	070628	FLT	Comments							
			Revised	070628	IN	Rev.	-	Drawing no.	934704	Cont. sheet	505	Sheet	50
			VESTAS PROPRIETARY NOTICE

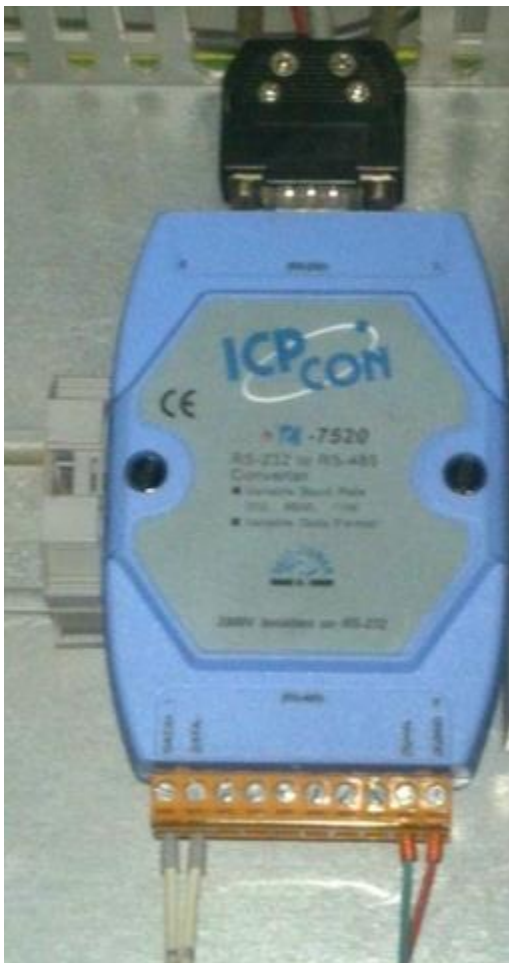
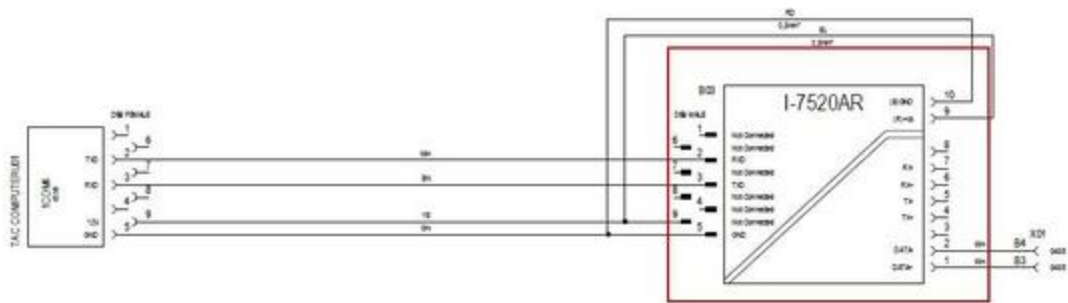
Check the connections at the ICP RS232/RS485 converter in the AT2 panel. Check for loose wires and plugs or corrosion at the converter.

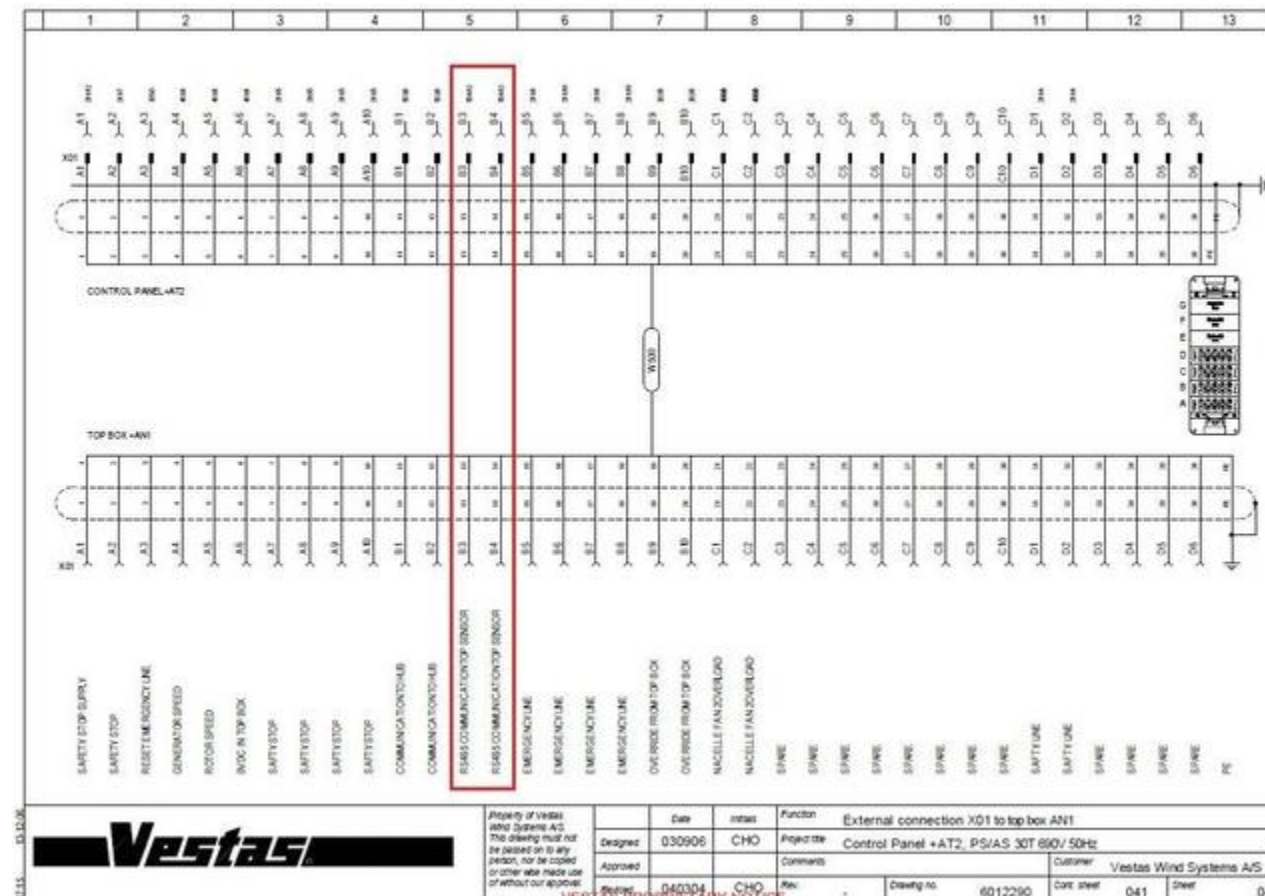
The below errors also may occur due to this defective cable core;

Check the continuity of B3 & B4 cores in cable W500 and replace with spare core, if no continuity.

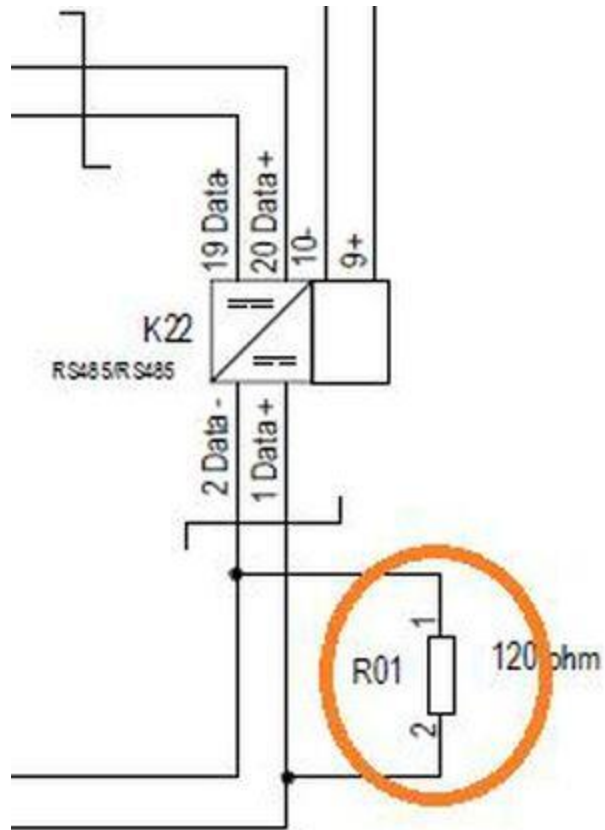
Check the connections at the ICP RS485 repeaters (K21 & K22) in the AN1. Check for loose wires and plugs or corrosion at the repeater.

Check the resistor loose connection and value and replace if any deviation

If there is still no communication, switch the ICP RS485 repeaters to see if the communication returns. If communication returns when the repeaters are switched, replace the faulty repeater.

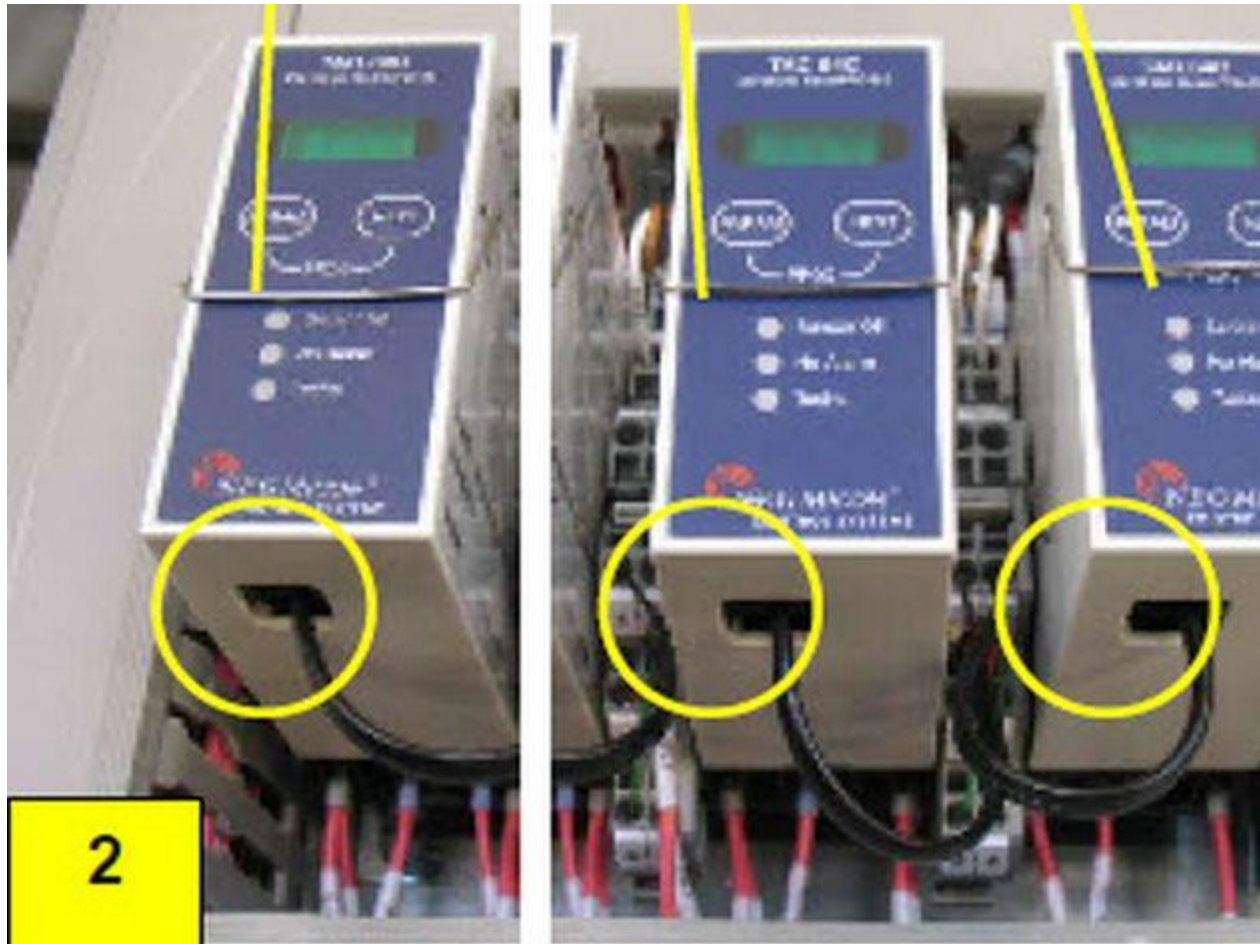
Wiggling the wires may cause intermittent communication caused by damage with in the wire. After replacing the wire cut the old one apart to see if there are any broken wires.

Broken internal wires on RS485 cable

Check and replace RS485 Cable

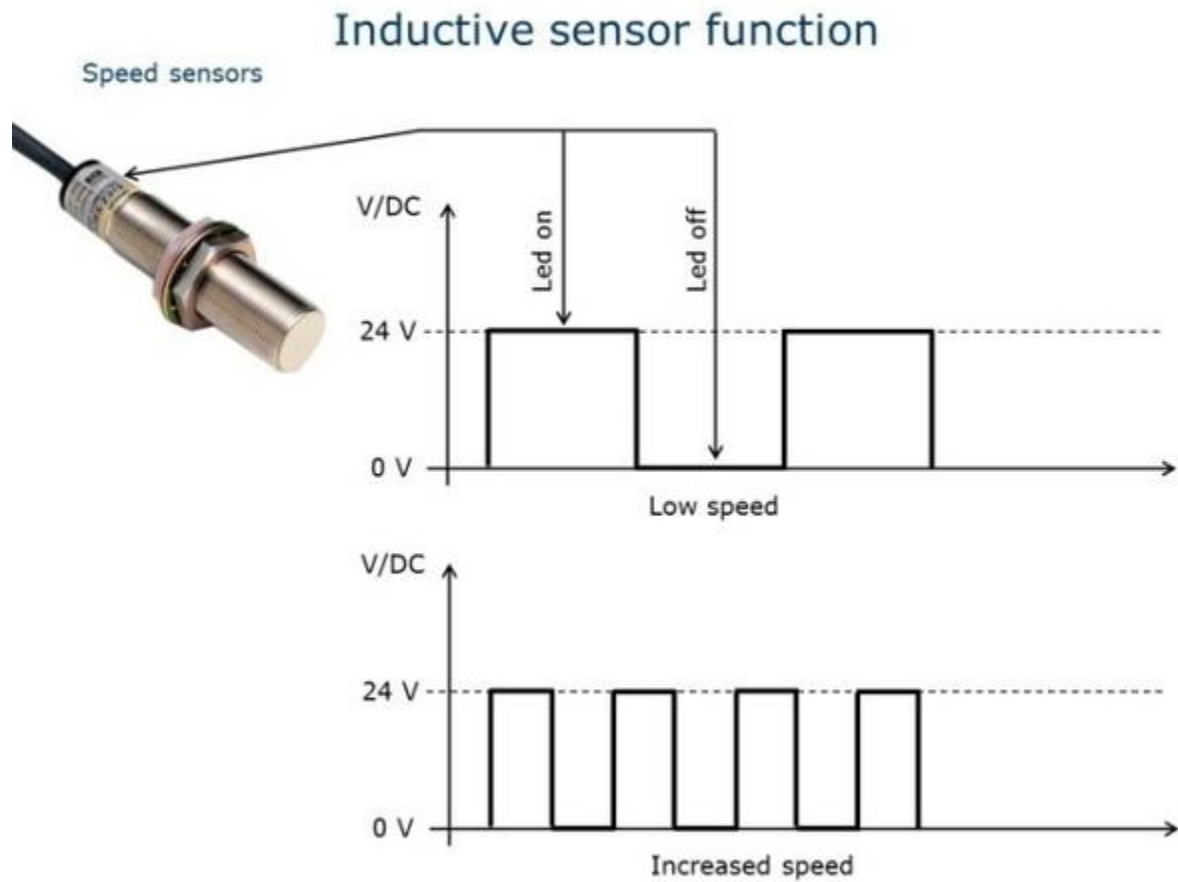
Generator speed sensor

The generator speed is measured by an inductive proximity sensor which creates a pulse signal as a pickup point passes over it.

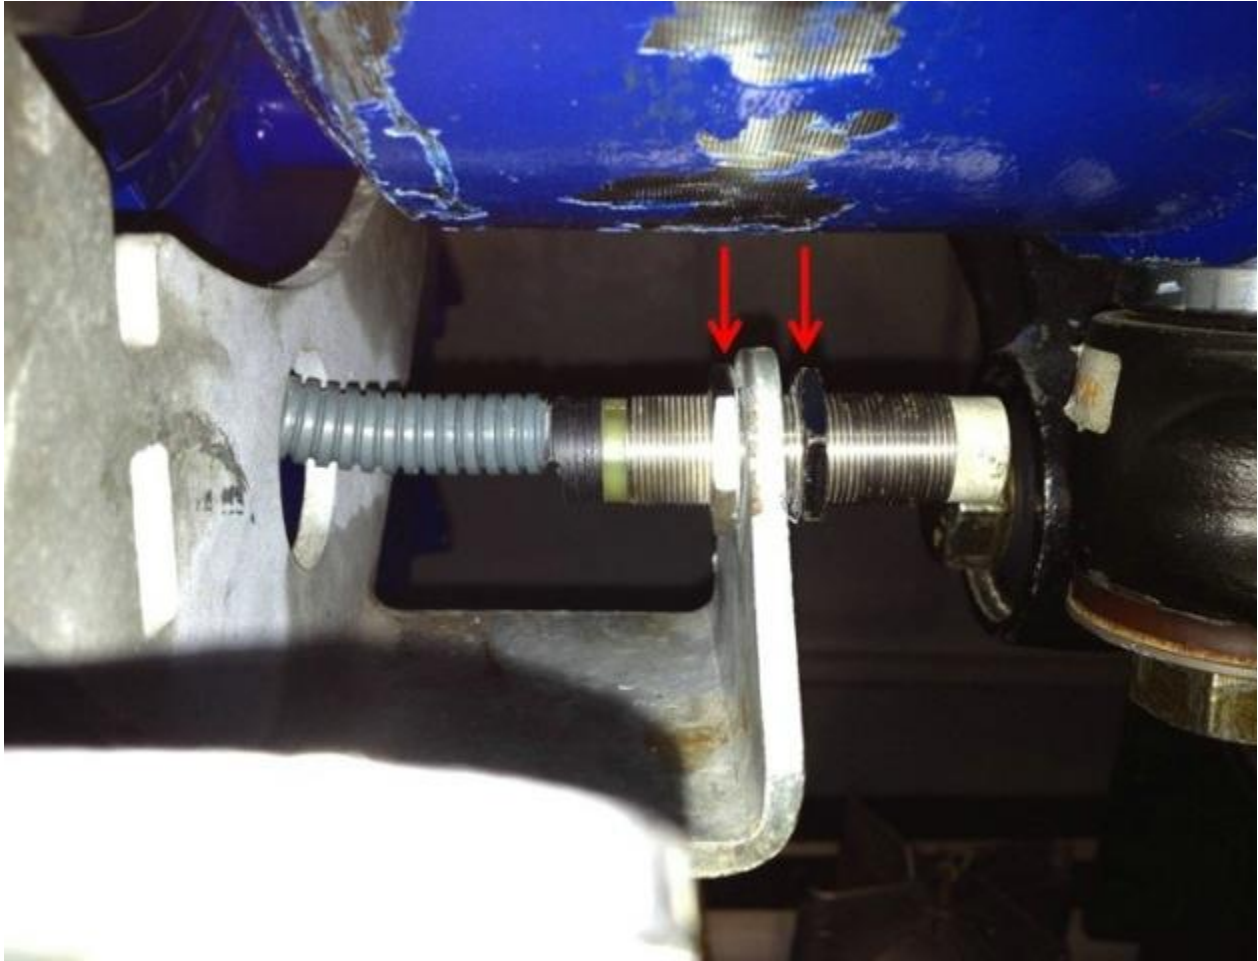
Sensor adjustment nuts:

If the sensor does not emit a light each time a link element bolt passes over it, lock the shaft and check for correct sensor adjustment. Check the bolts on the speed sensor bracket and ensure that they are properly tightened. The end of the sensor should be within 1,5-5 mm from the pickup point. Adjust the sensor by loosening the nuts that clamp it to the mounting bracket and move it forward or back to achieve the required distance from the pickup point.

If after adjustment the sensor still does not light up, or lights up intermittently when passing the pickup point- replace the sensor (sensor and cable are combined-W509)

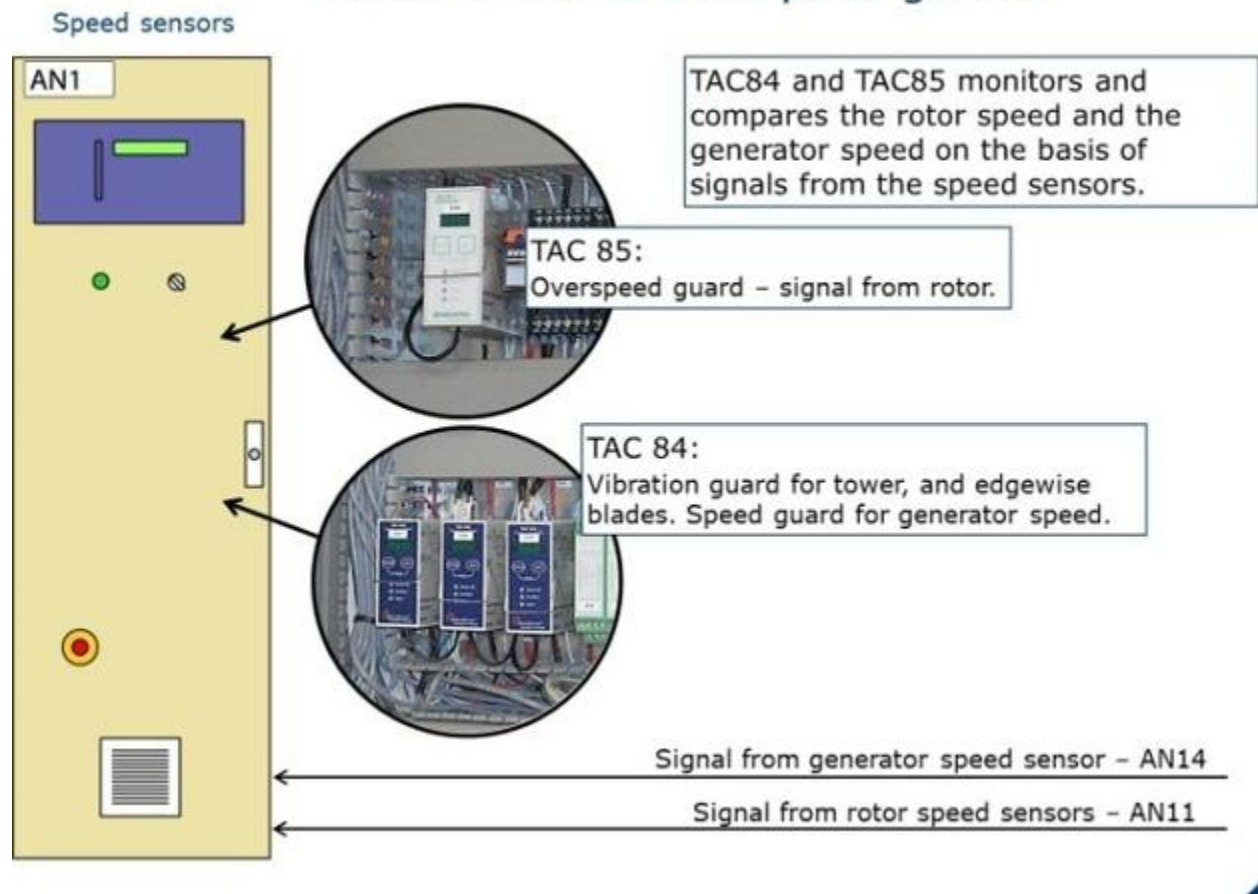
TAC84 & TAC85 overspeed guards

The signal is transmitted to the TACII controller and the three Vibration/overspeed guard modules.

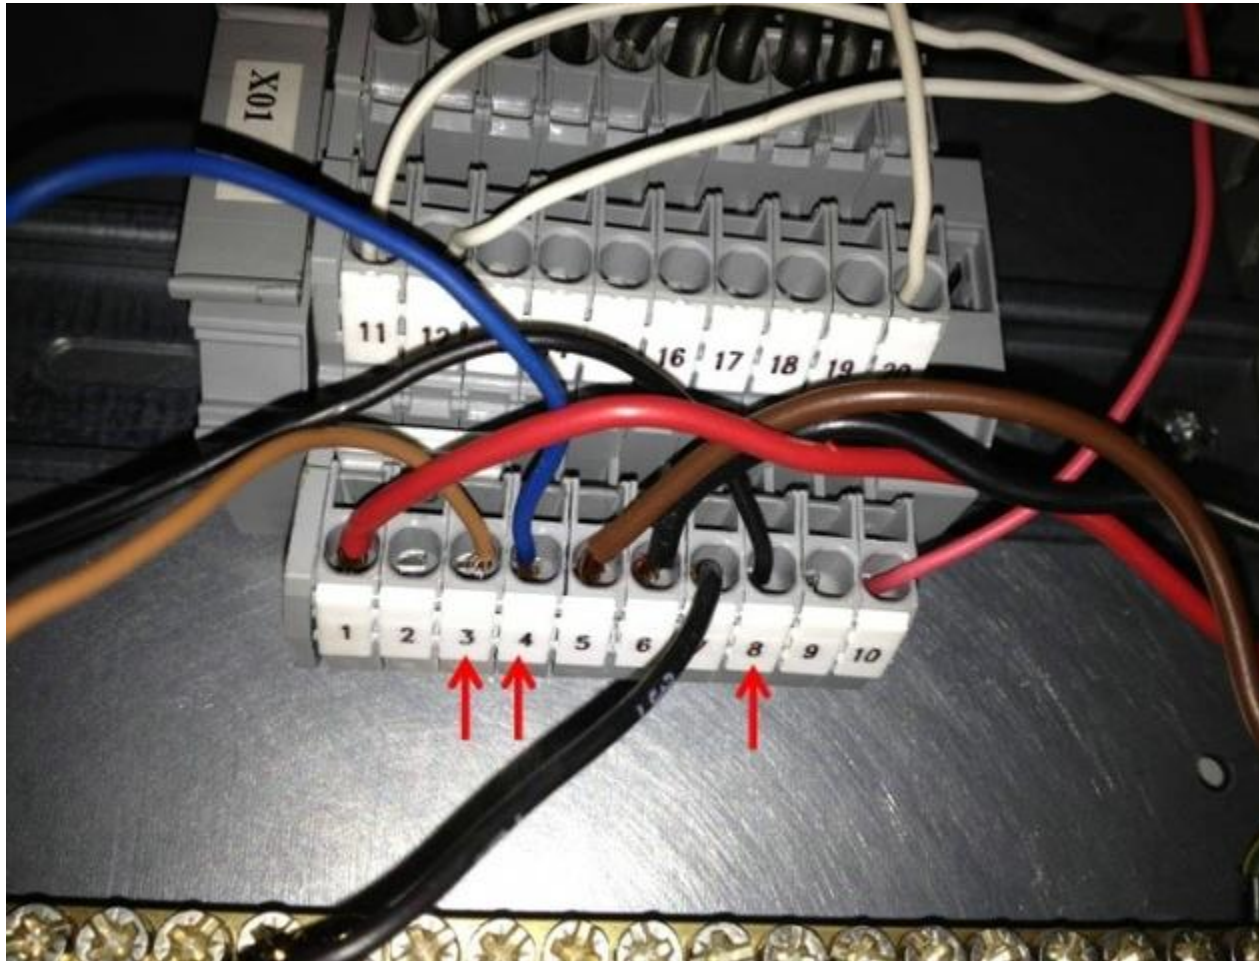
Terminal block –X01 terminals 3, 4 & 8:

Check for loose sensor terminations in the AN14 panel. (The AN14 terminal panel exists only in V82 1.65 Mw. NM72/82 1650Kw generator speed sensor cables terminate directly at the AN1 Top Box).

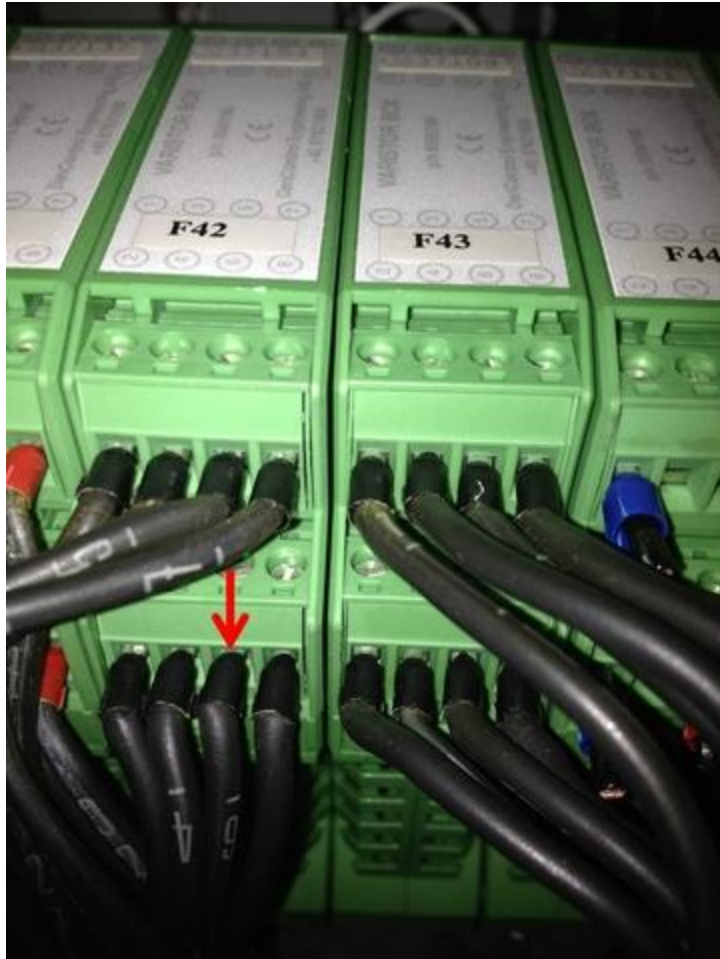
Check for loose wire terminations in the AN1 Top Box (sensor wire from the AN14 terminates into F42 Varistor Box terminal 6:

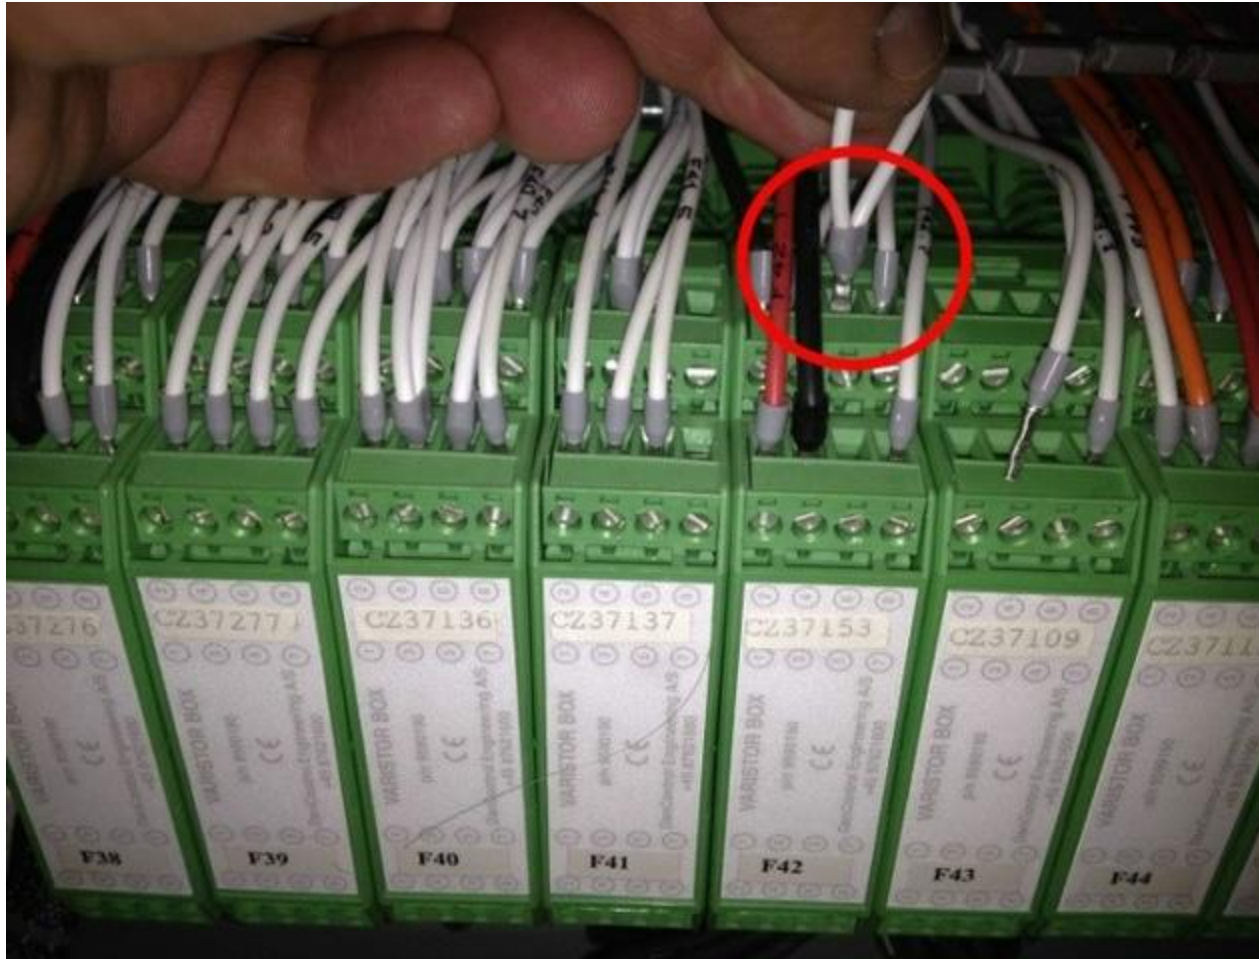
The signal wires from the F42 varistor box are double stacked, pay close attention to this crimped connection as the wires may be loose:

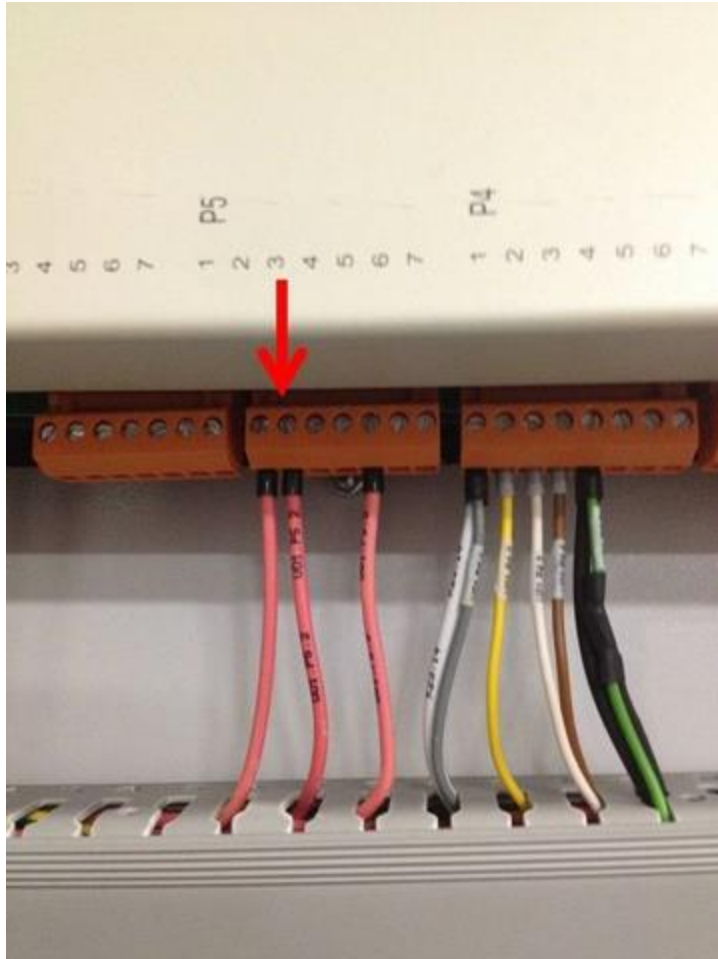
Finally check the signal termination at the TAC controller (P5 terminal 2):

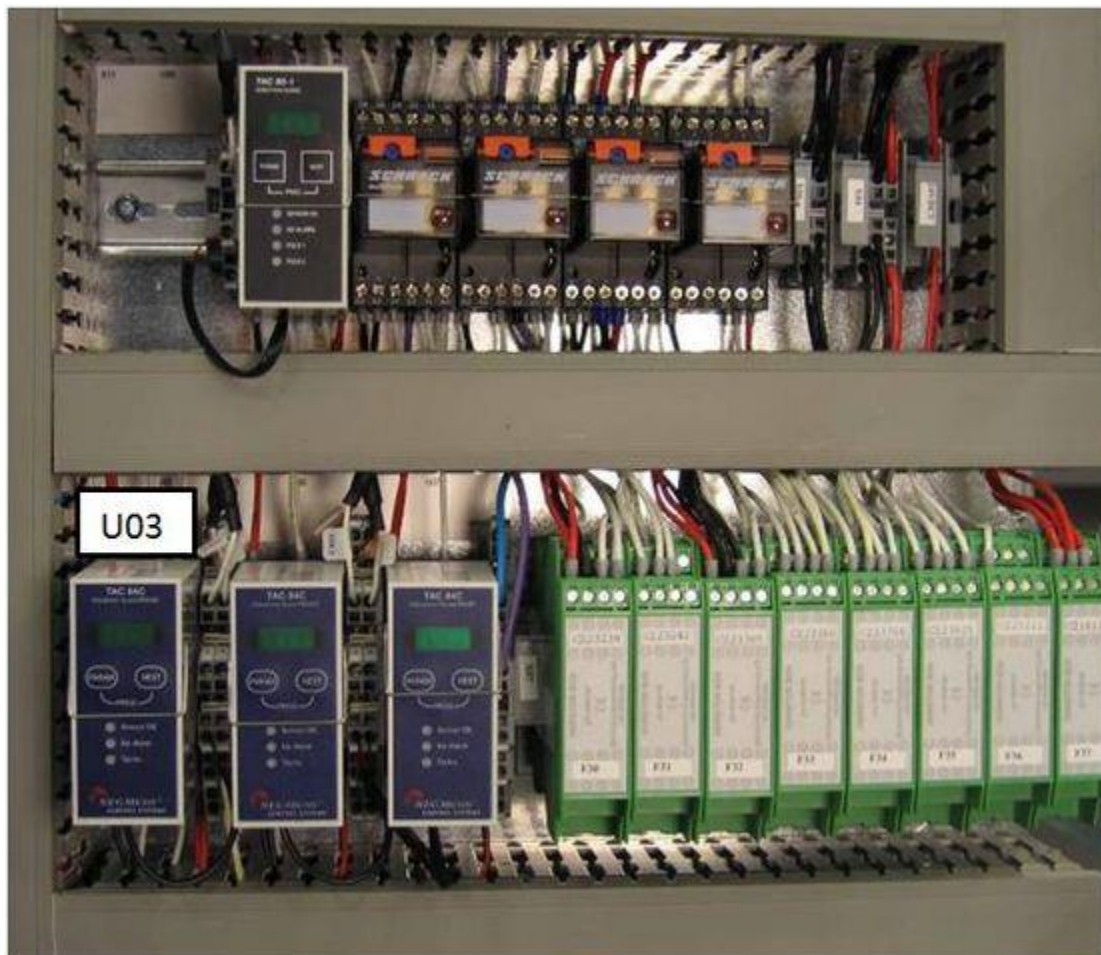
Check the TAC84 module following parameters as per instruction at the hidden menu:

If the module (U03) is found to be defective, replace with new.
