## Troubleshoot/repair ROS sensors

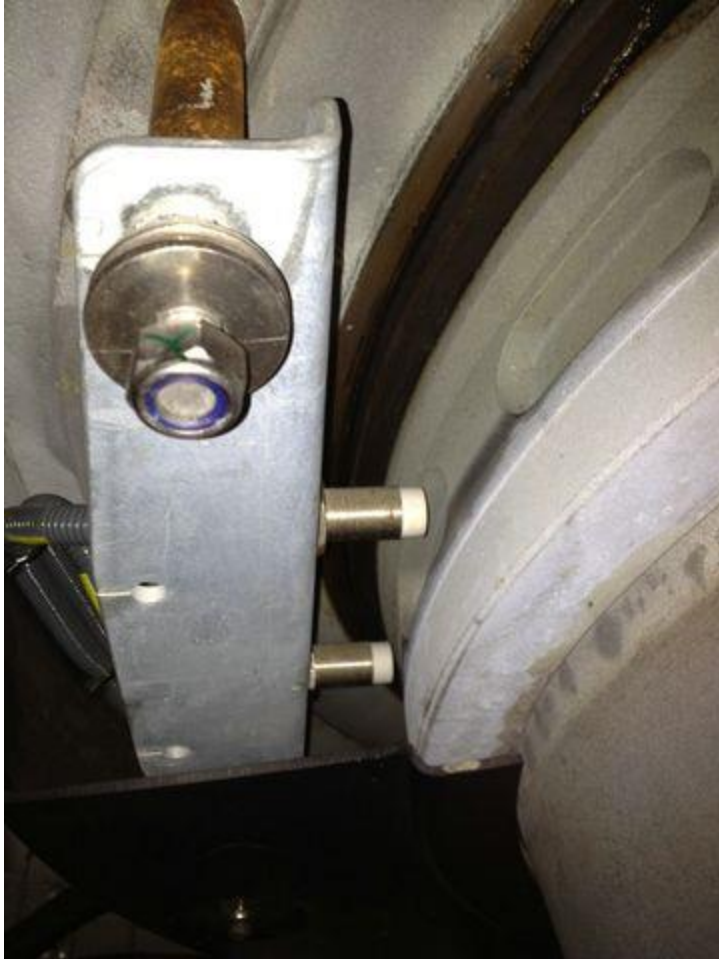
Rotor speed sensor mounting bracket:

Check that the sensors are secure in the mounting bracket and are adjusted correctly:

Adjust the distance between the sensors and the scanning points to 1-2 mm

Using a screwdriver, pass the metal portion past the inductive sensors. The sensors should light up at the moment the screwdriver is passed over them.

If they do not, ensure that the sensors are free of dirt and oil/grease. Retry passing the screwdriver over the sensors at varying distances.

If only one of the sensors emits a light, the other is likely faulty or has a faulty cable.

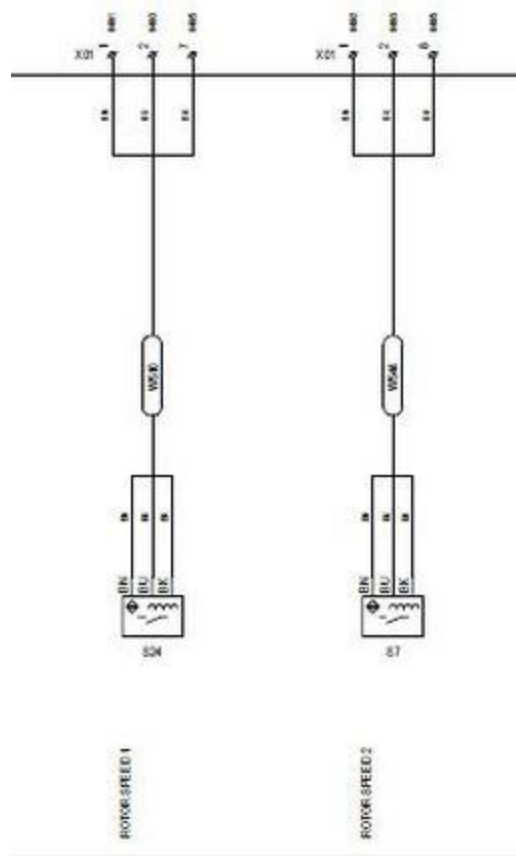
Check connections from the rotor overspeed sensors:

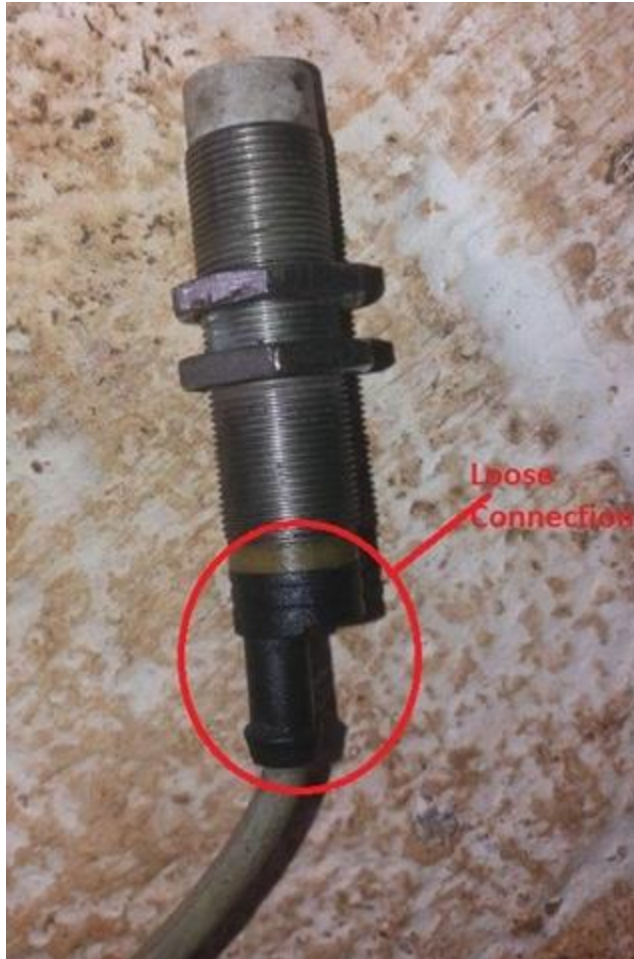
Check the sensor cable entry portion for any damage/ loose connection:

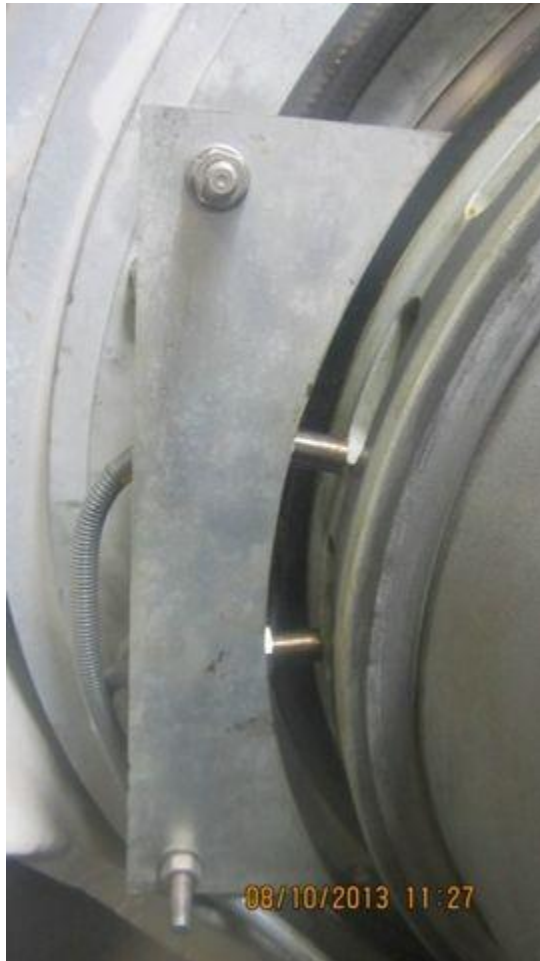
New Upgraded bracket

Incorrect sensing due to old bracket design.

Upgrade the existing rotor sensing bracket along with unshielded proximity sensor which will resolve the sensing inaccuracy as per the SWI.

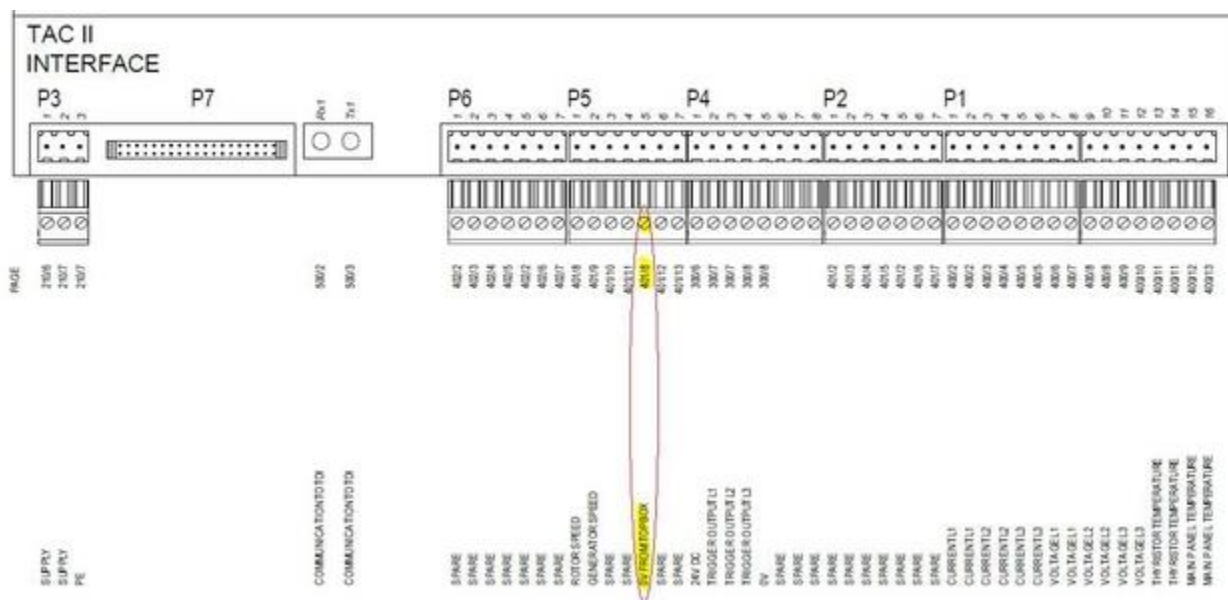
- Explanation**  
 Check the continuity of 0V DC IN TOP BOX (A6 core) in cable W500 and replace with spare core, if no continuity.

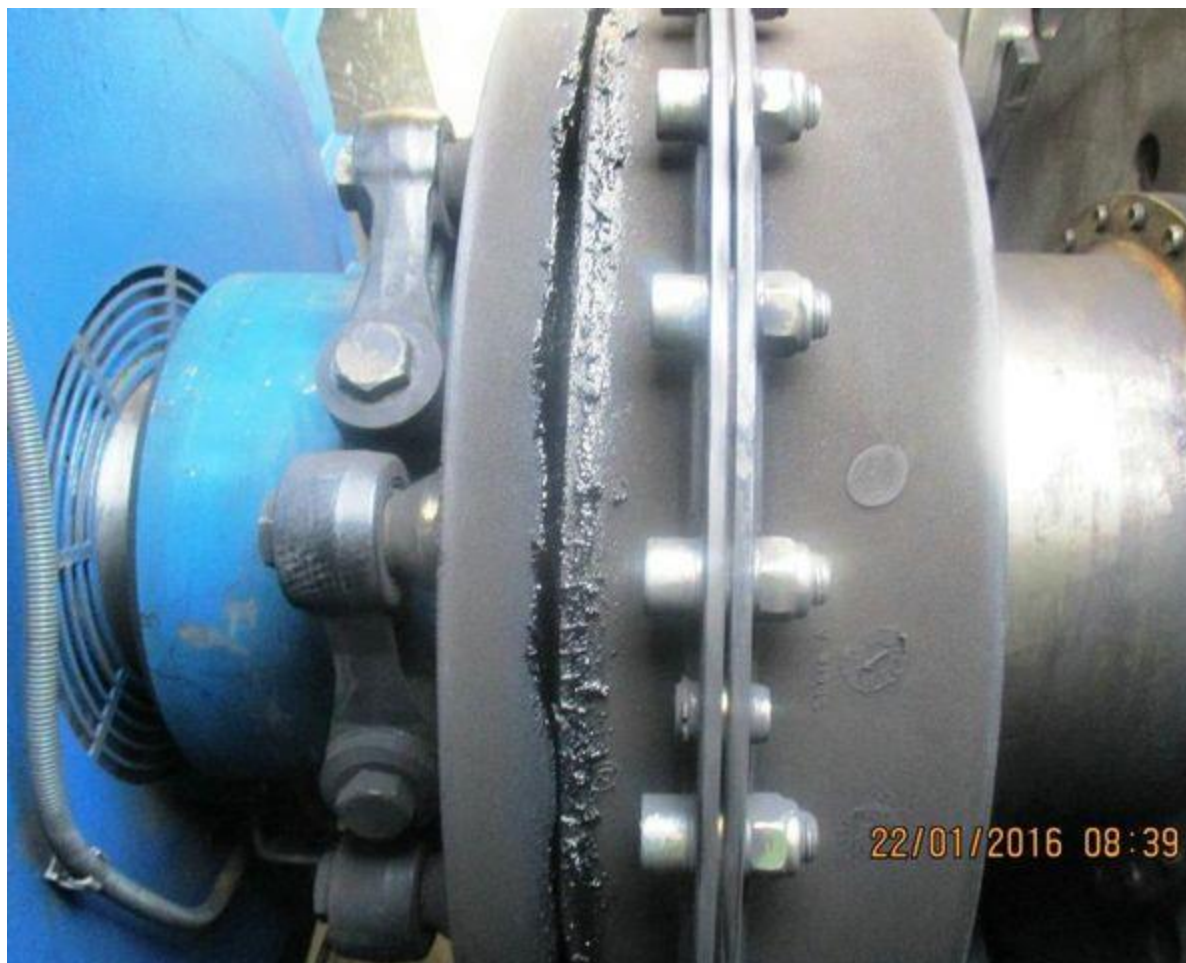
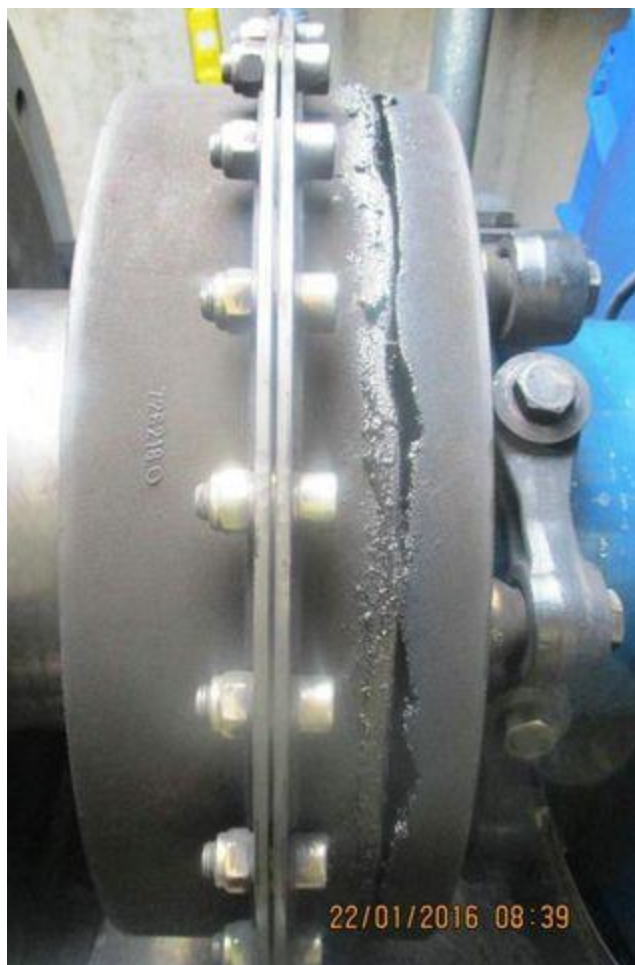
Failure view of coupling:

Check and replace the Generator coupling which might be detached from drive train which causes this alarm.

Check generator – gearbox alignment before replace the defective coupling.
