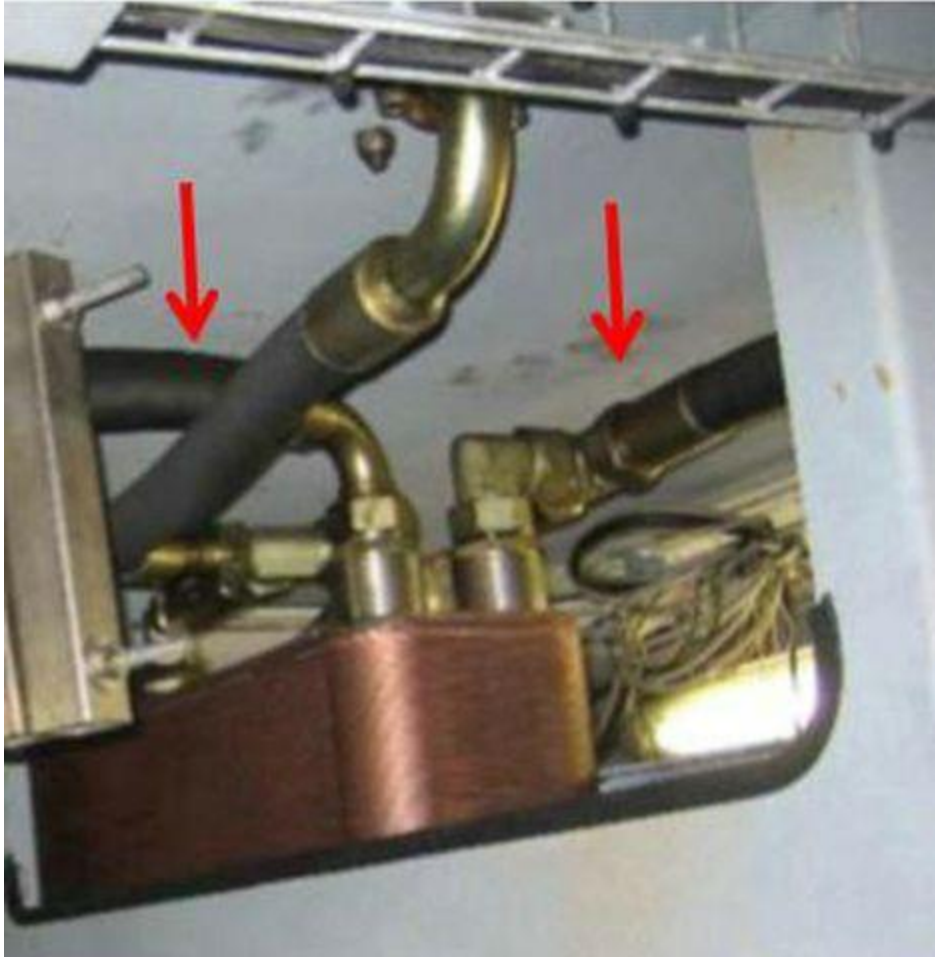
Measure the temperature on gear oil hoses with gear oil pump running, check if temperature increases near heat exchanger or is same temp as by-pass hose.

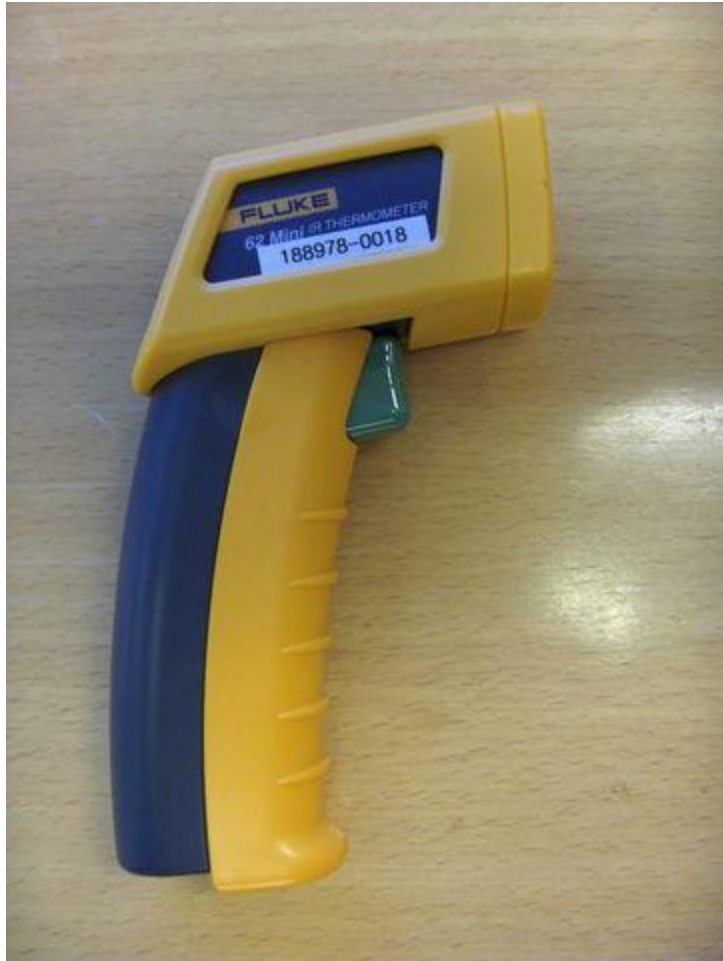
If temperature is low near heat exchanger then the by-pass valve is likely defective in the pump manifold. (VT 188978 "IR- Thermometer Fluke 62)

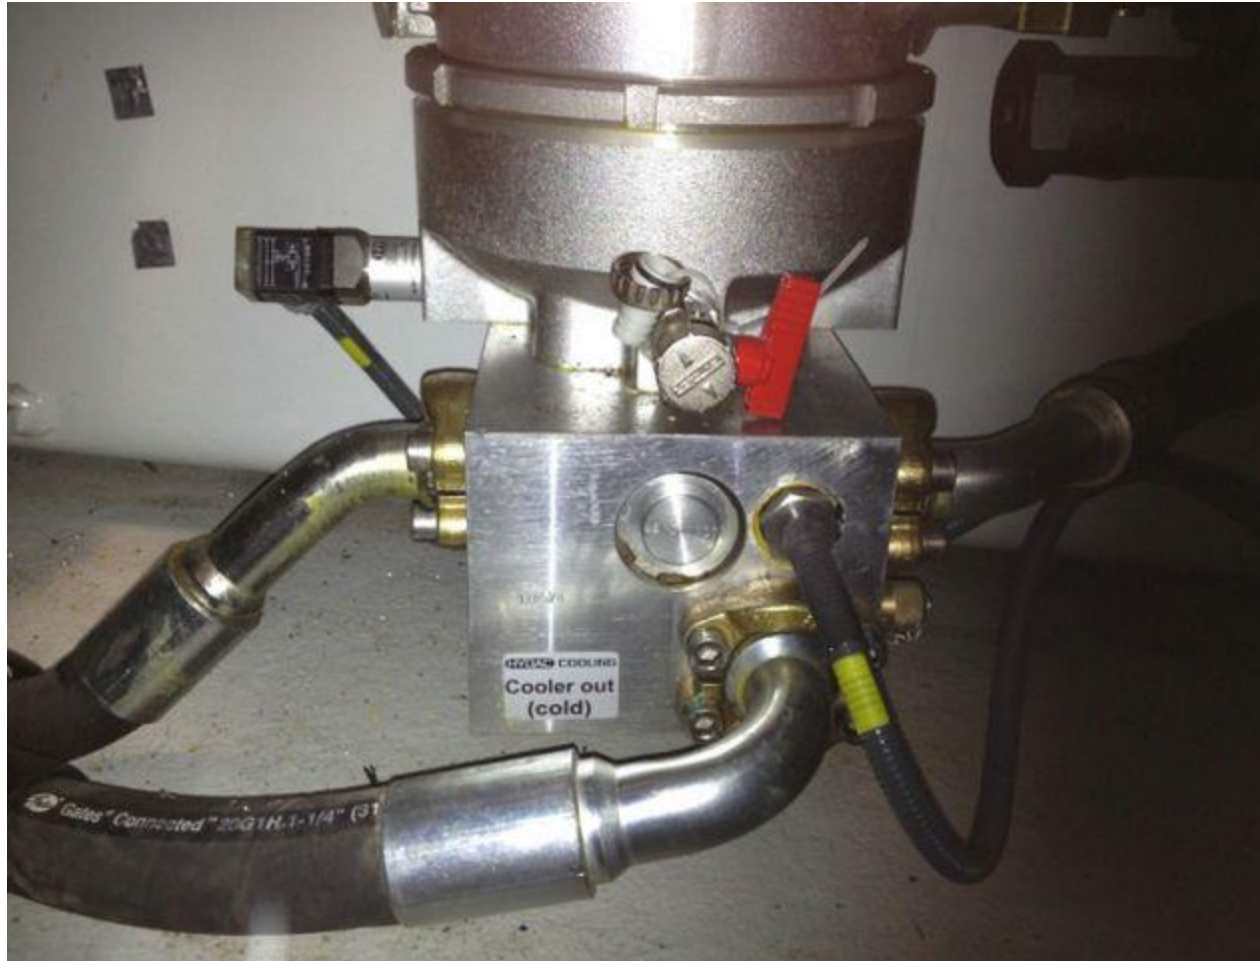
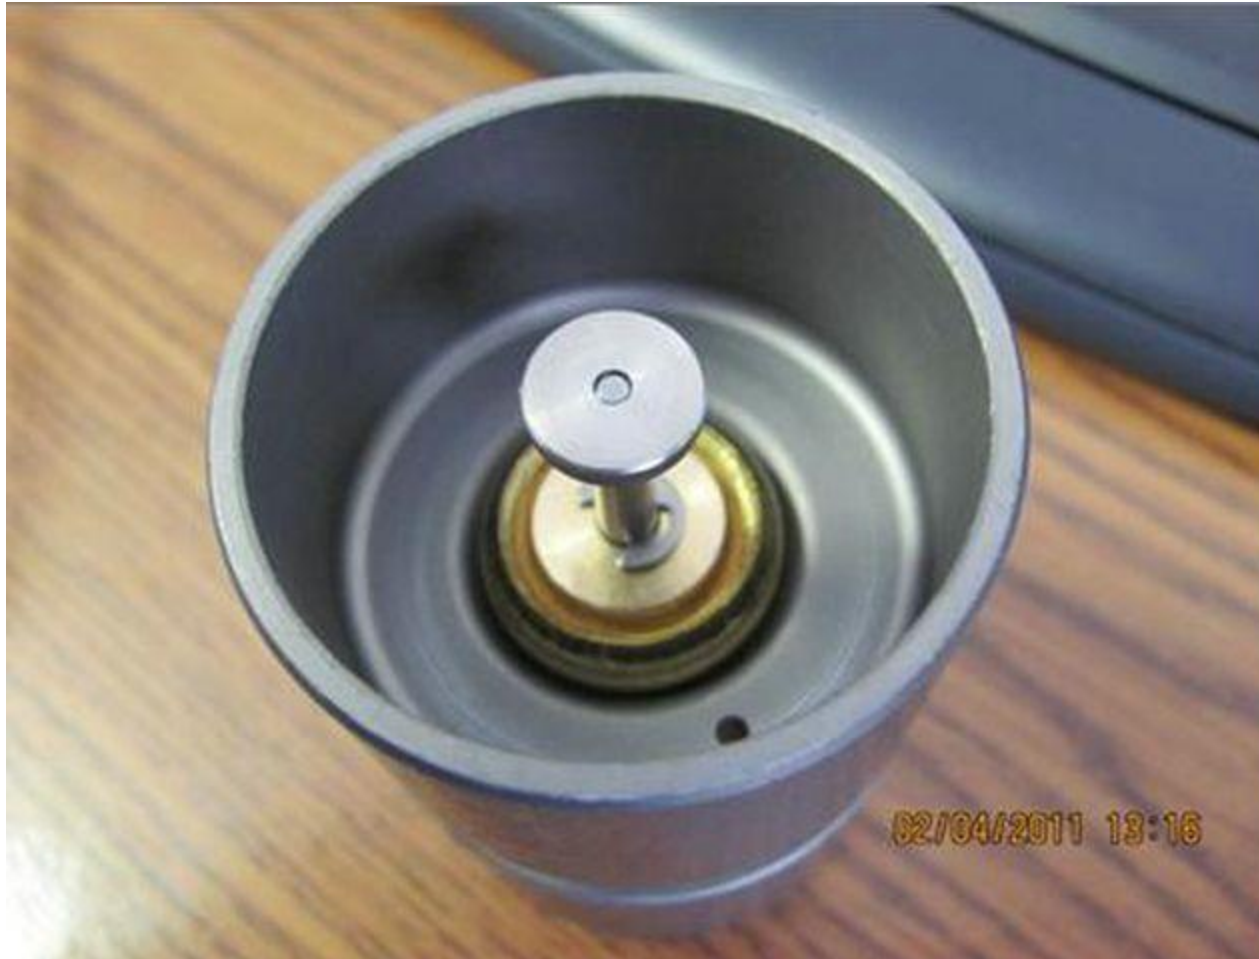
If replacing the 45 degree thermal bypass valve, the valve must have the center pin in valve body. Do not pull the center pin out of the temperature sensing bulb. If pin fell out during shipping, do not install valve in turbine. (Some valves have been received at sites with dented valve bodies, inspect the valve prior to instillation and do not install a damaged valve into the pump manifold).

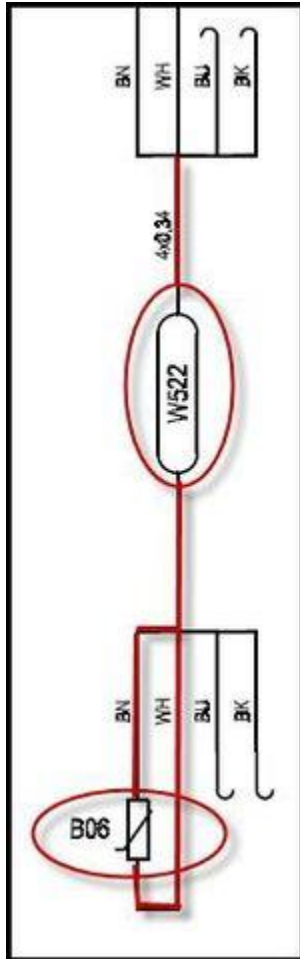
Mrk2-5 Circuit

Check the connections at terminals 19 and 20 at AN12 (Mark2-5) Check the PT100 and cable for any damage and check resistance value

Replace the defective PT100

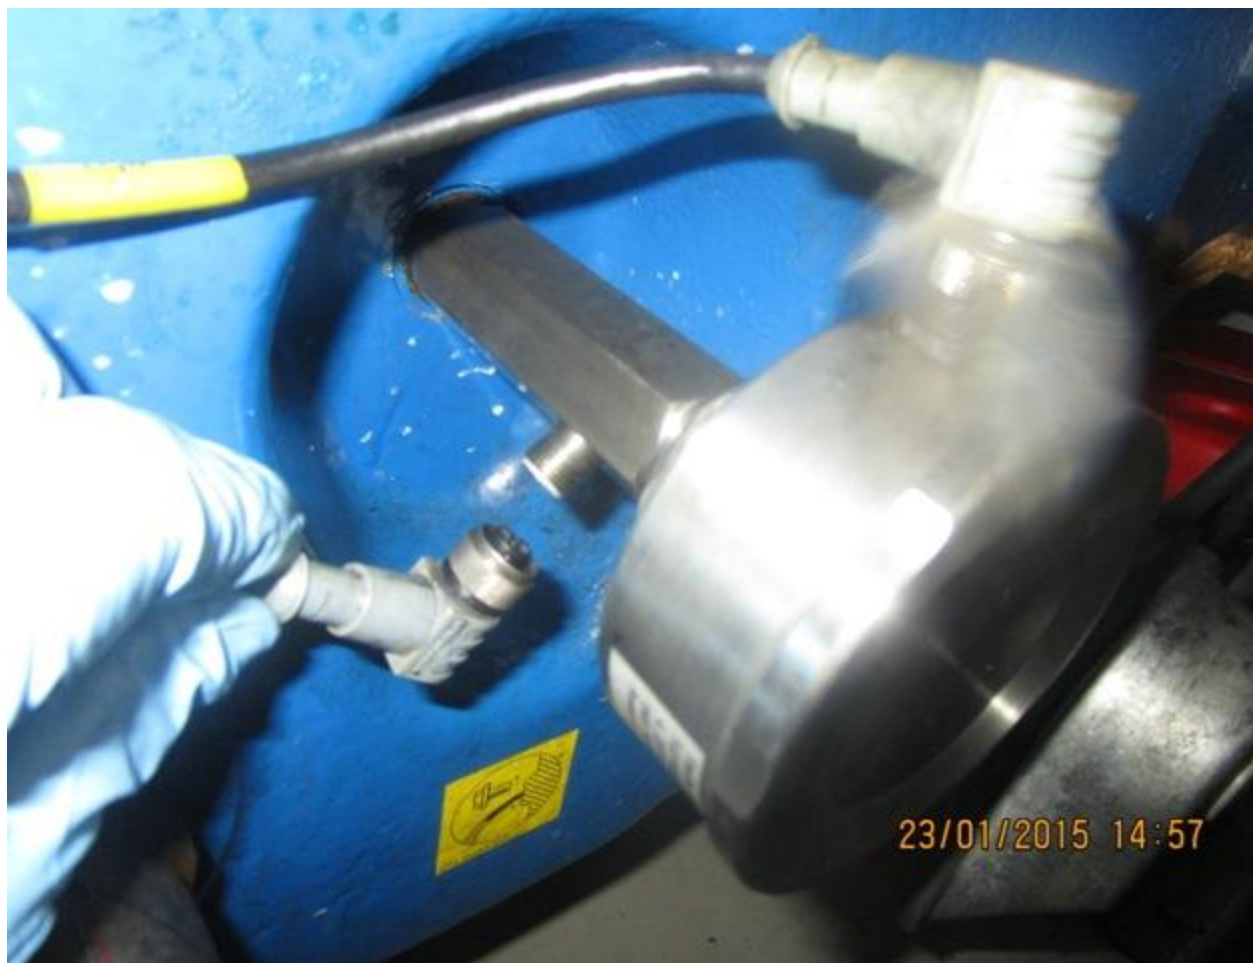
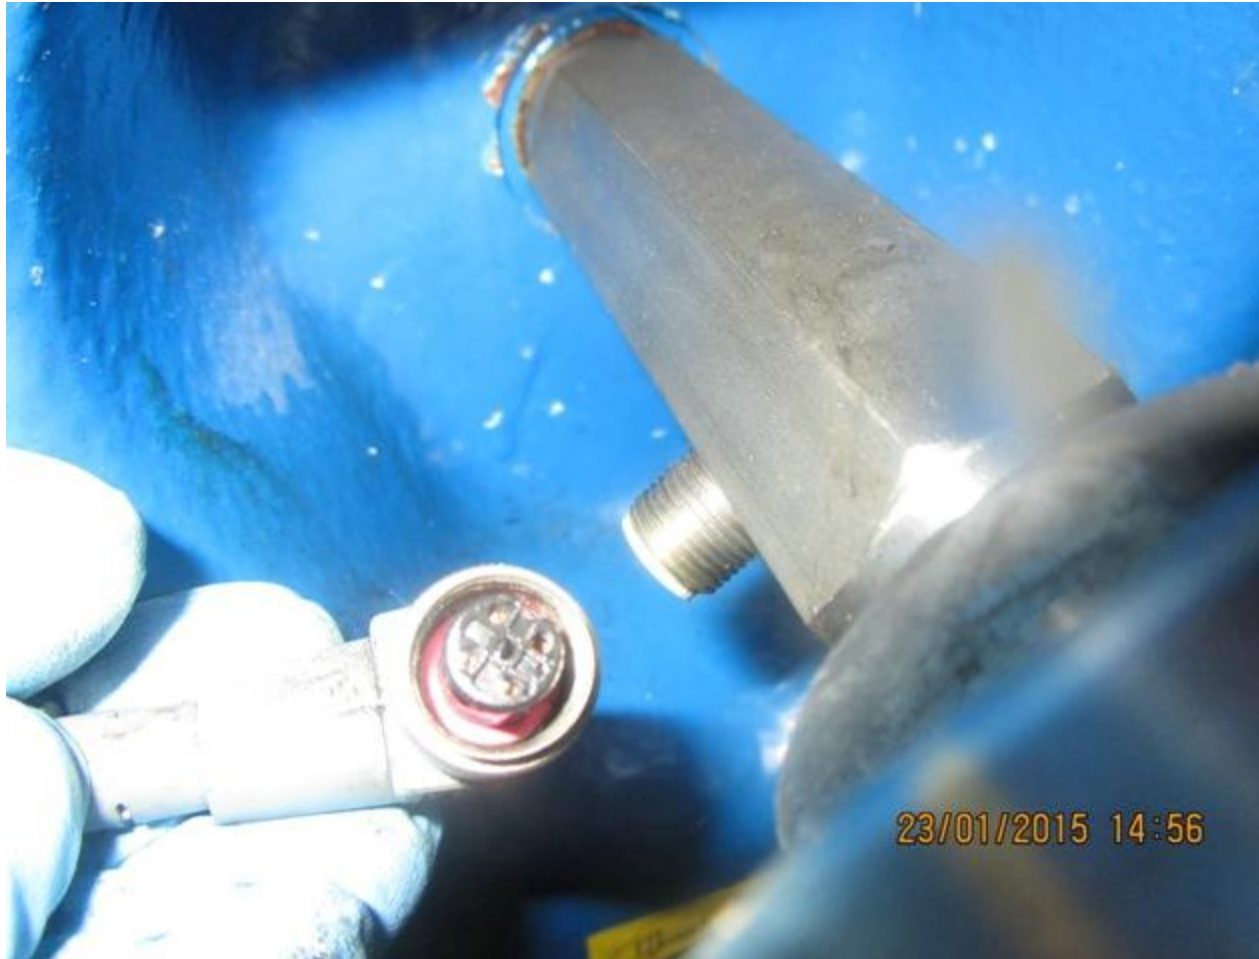
Check cable connector terminal for any loose connection /oil contamination as shown below. If so, clean the oil or replace the cable W522.

Relevant spare parts	
Description	Item No.
CABLE -W522 NM30t. MRK III 4x0	60110452

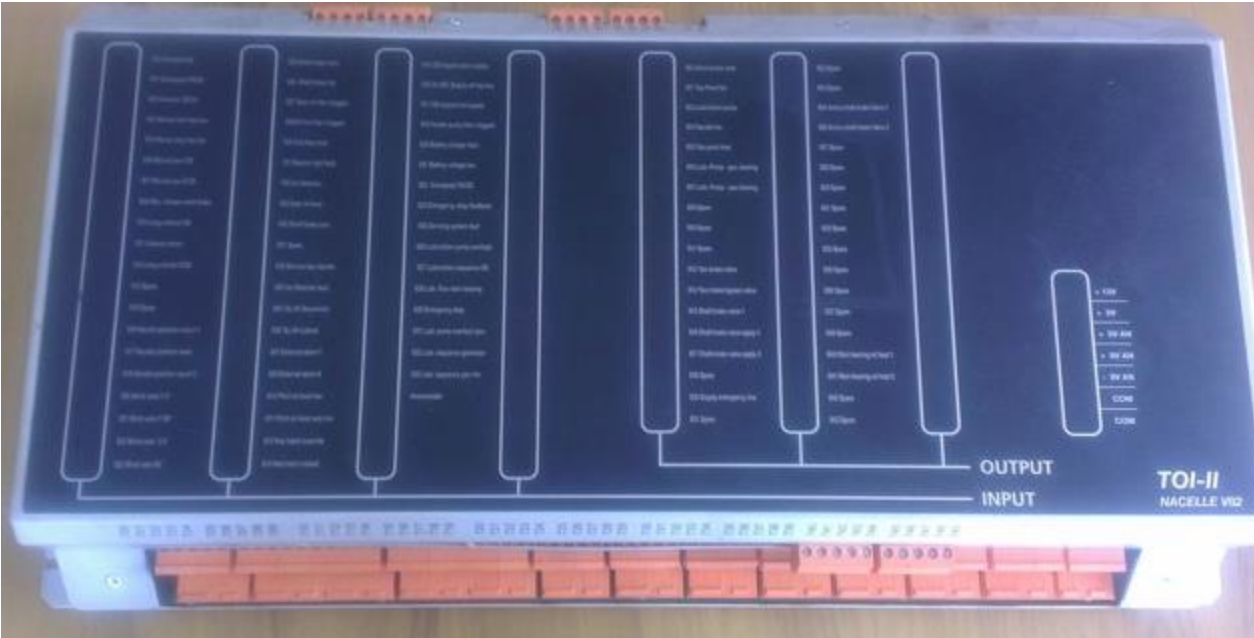
TOI-II
NACELLE V62

This alarm will occur, if the Particular temperature channel circuit malfunction. Replace the defective TOI II (TOP)

Relevant spare parts	
Description	Item No.
TOI-II INTERF EXT V82 TOP	51713101
