930 - Internal battery low - NM72,NM82,V82 Mk1-5

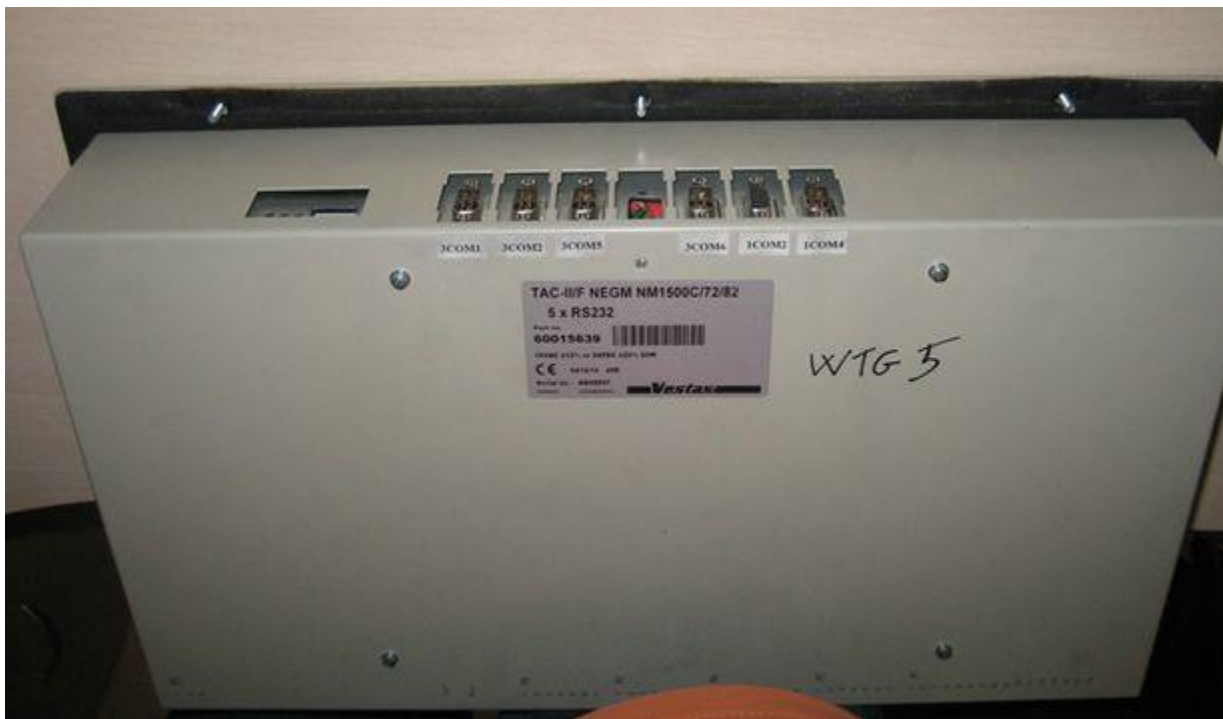
Remove **only** all connectors in the top of the controller:

This procedure must be performed with the TACII controller powered up. If the battery is removed when the TACII is powered down, stored data in the controller will be lost.

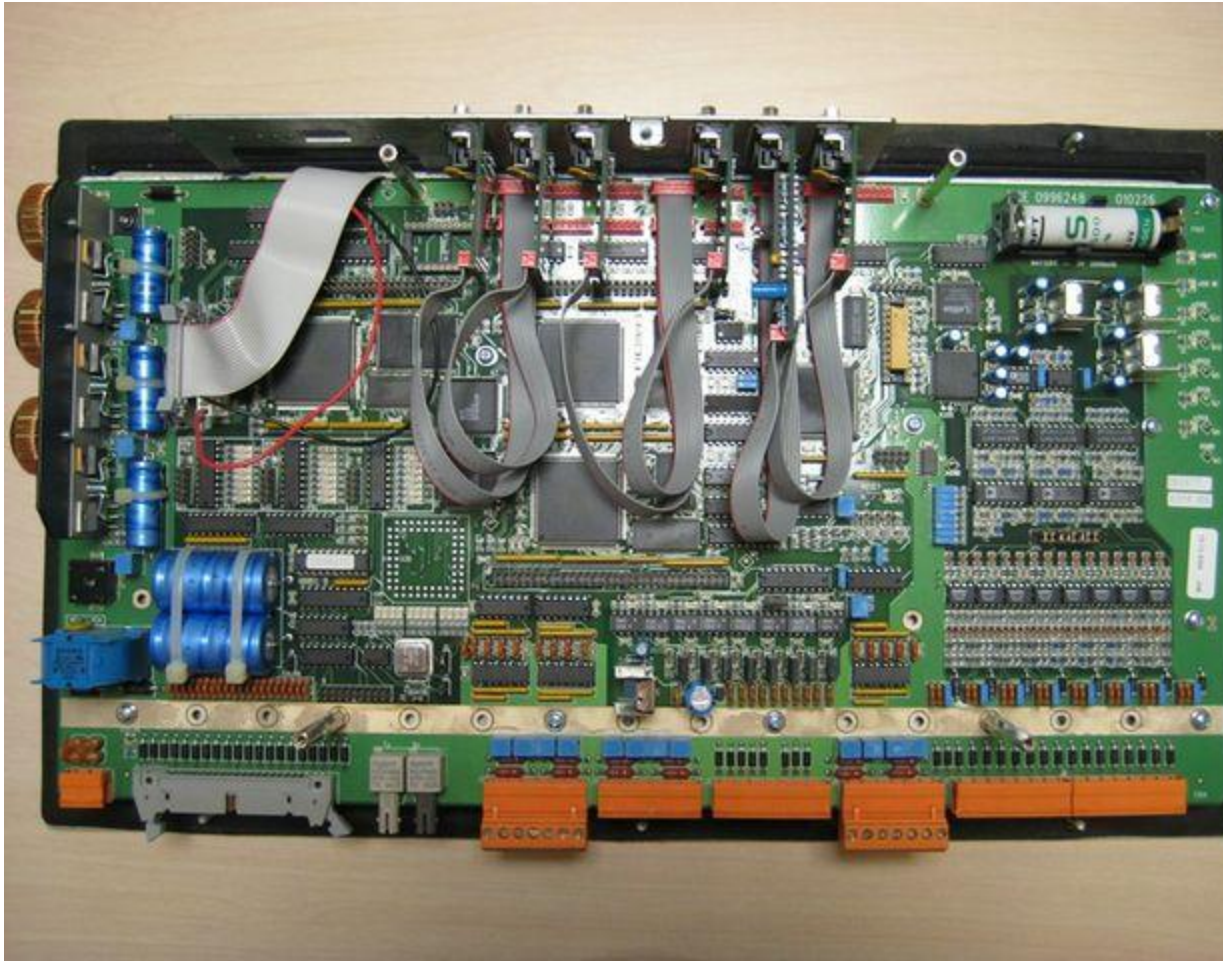
Unscrew the back panel of the TAC (pay close attention not to touch anything else other than the battery, even it's only 18 Vac):

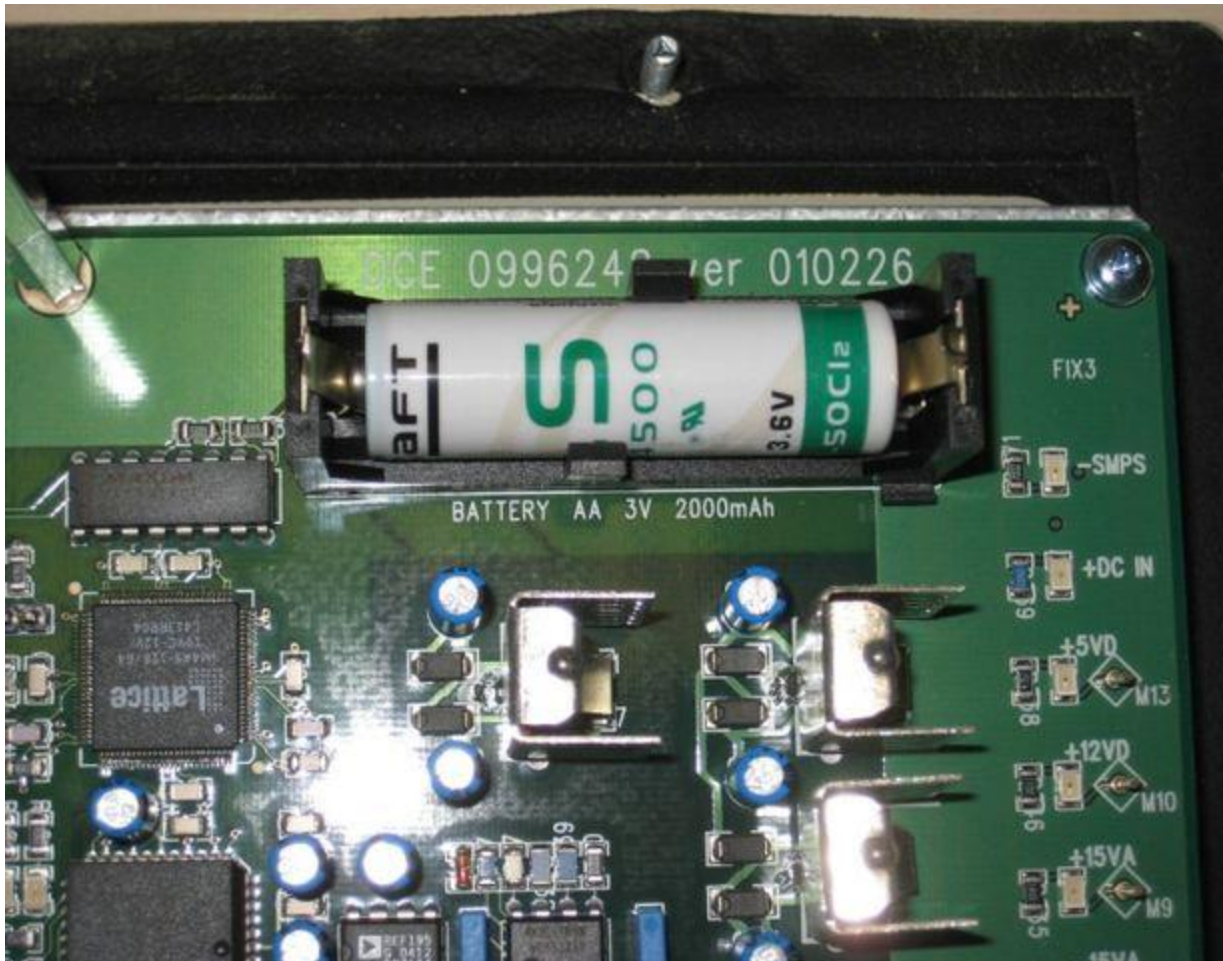
The backup battery is located in the top right corner as seen from the back of the controller:

Replace the existing battery in the TAC Controller with a new battery from inventory.

[60000698](#) BAT LS14500 3.6V 2.25Ah SAFT
