Replace the defective TAC84 module

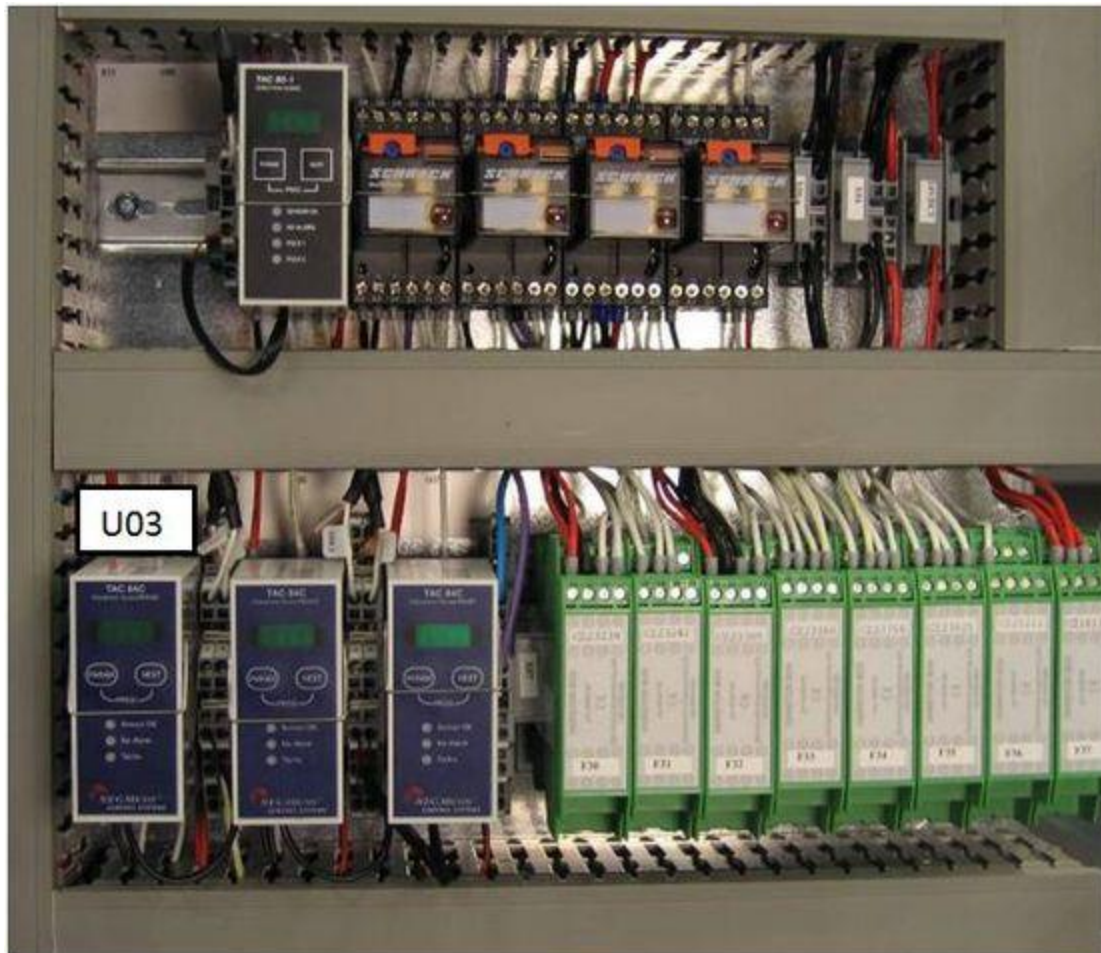
Check the TAC84 module parameters as per instruction:

Perform the test as per commissioning manual :

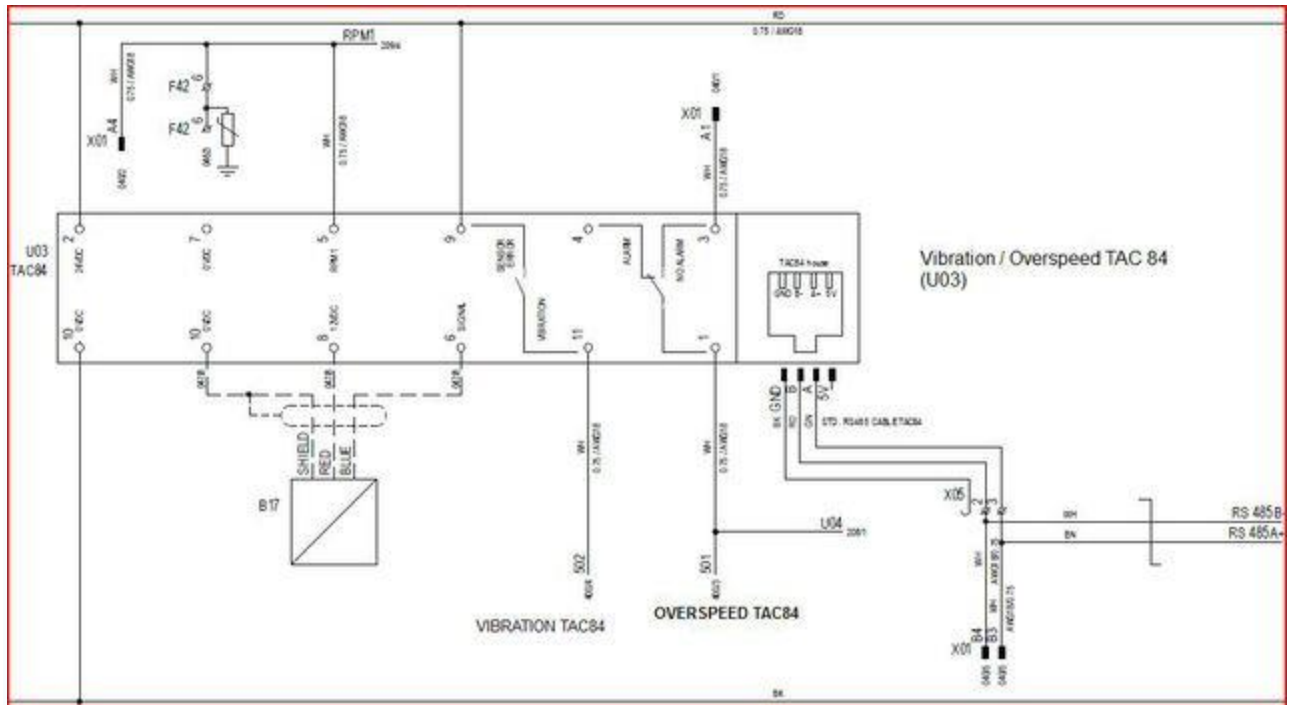
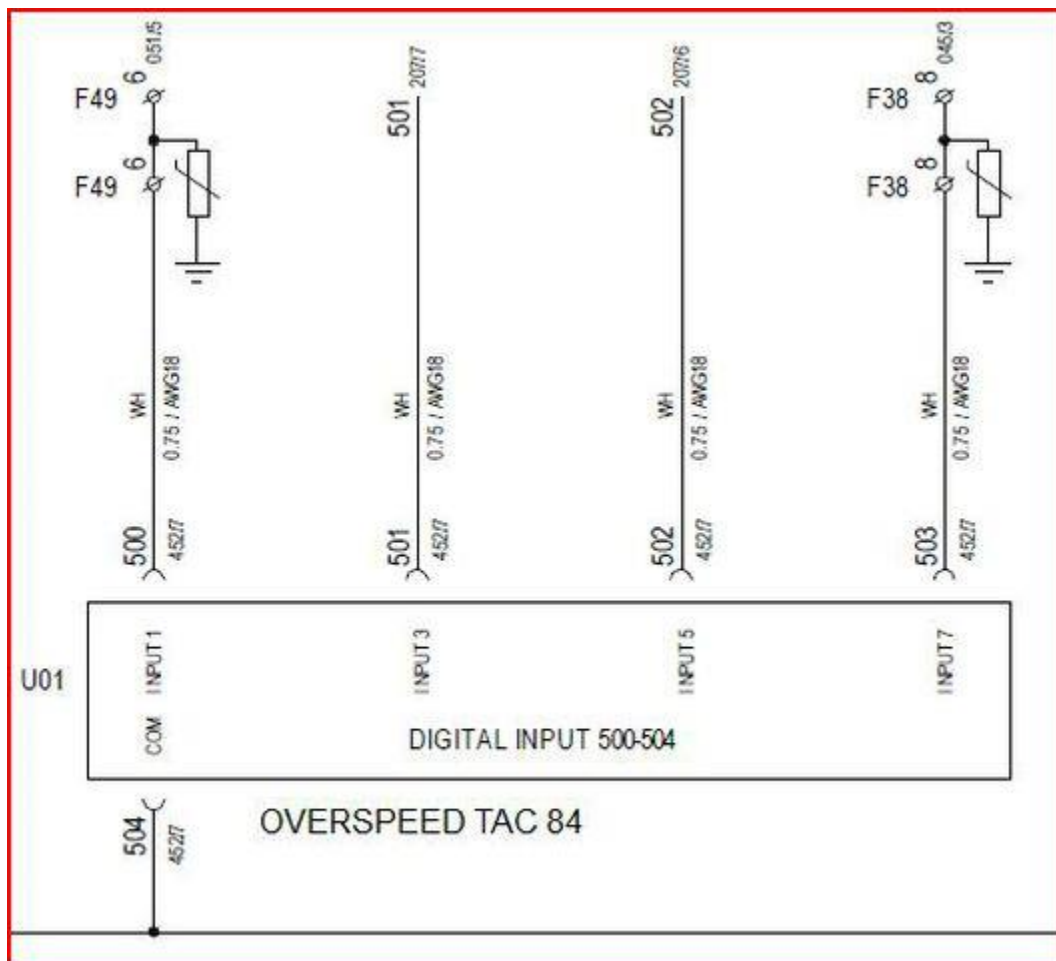
Vibration / Overspeed TAC 84 connections:

Check the TAC84 module for any loose connections.
If the module is found to be defective, replace with new.

Part Number for TAC84 module 2 Filter (U03)

[51701001](#) - TAC 84C VIB GUARD 2 FILTERS
