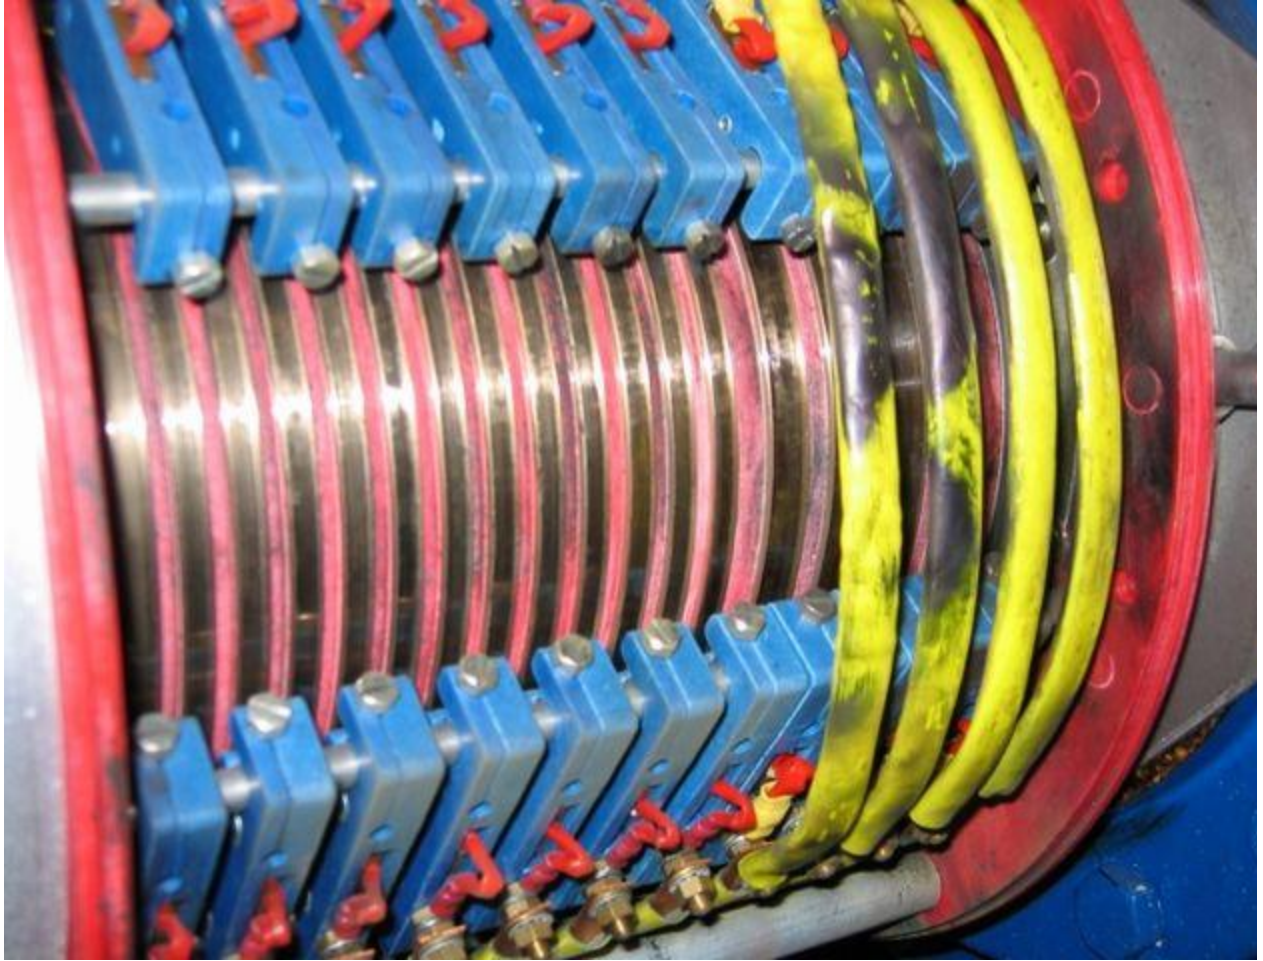
Contaminated Slipring:

Use above document as a guideline.

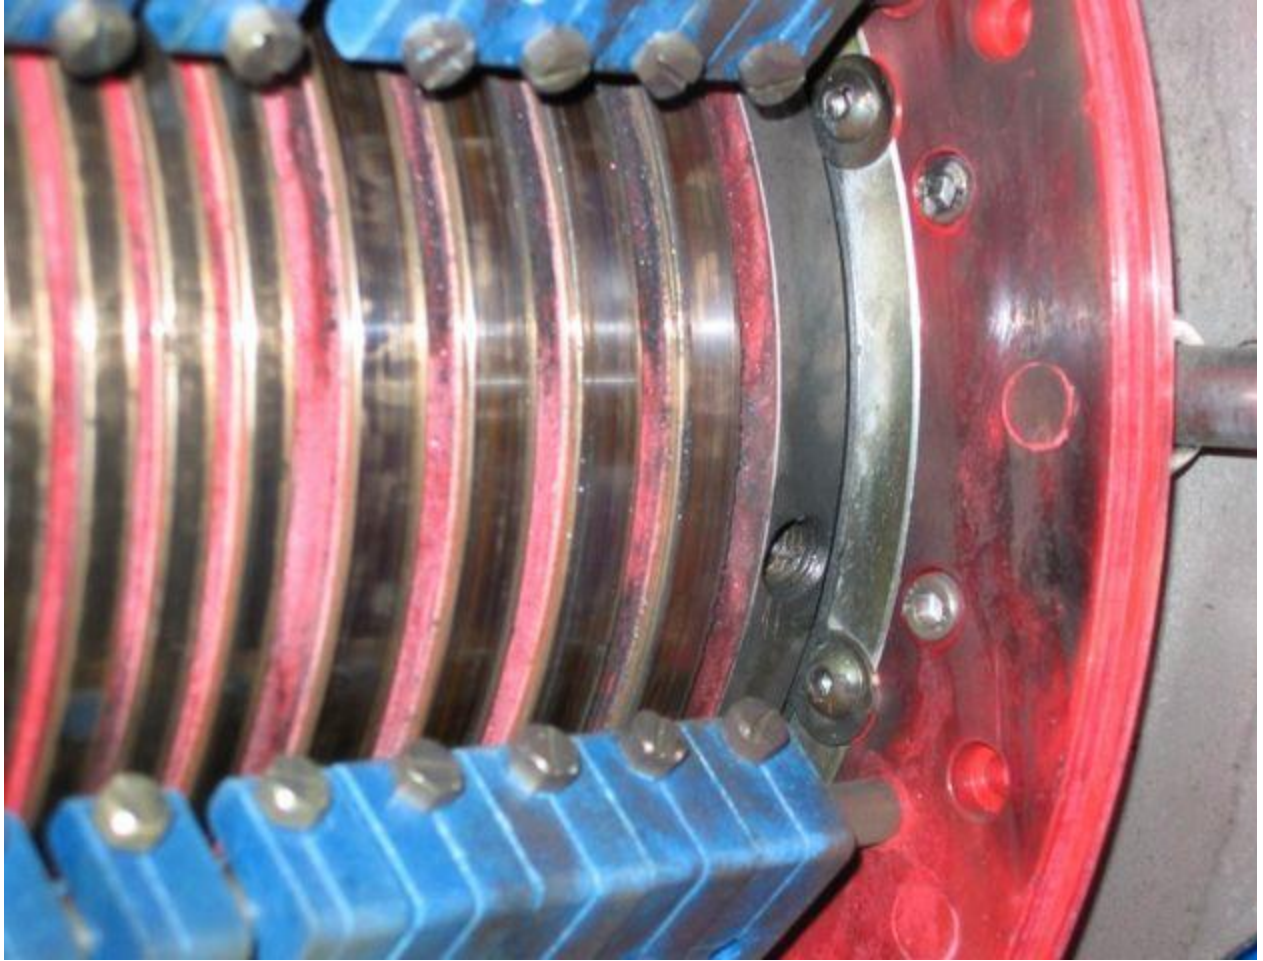
Dust buildup and contamination on spring:

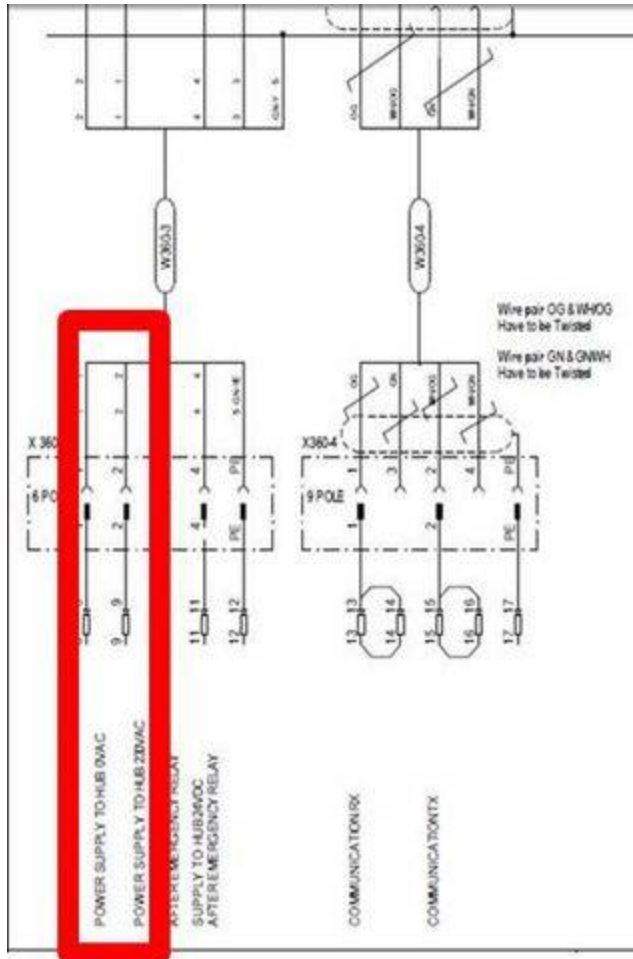
Pay particularly close attention to brushes on rings for 230VAC supply to hub:

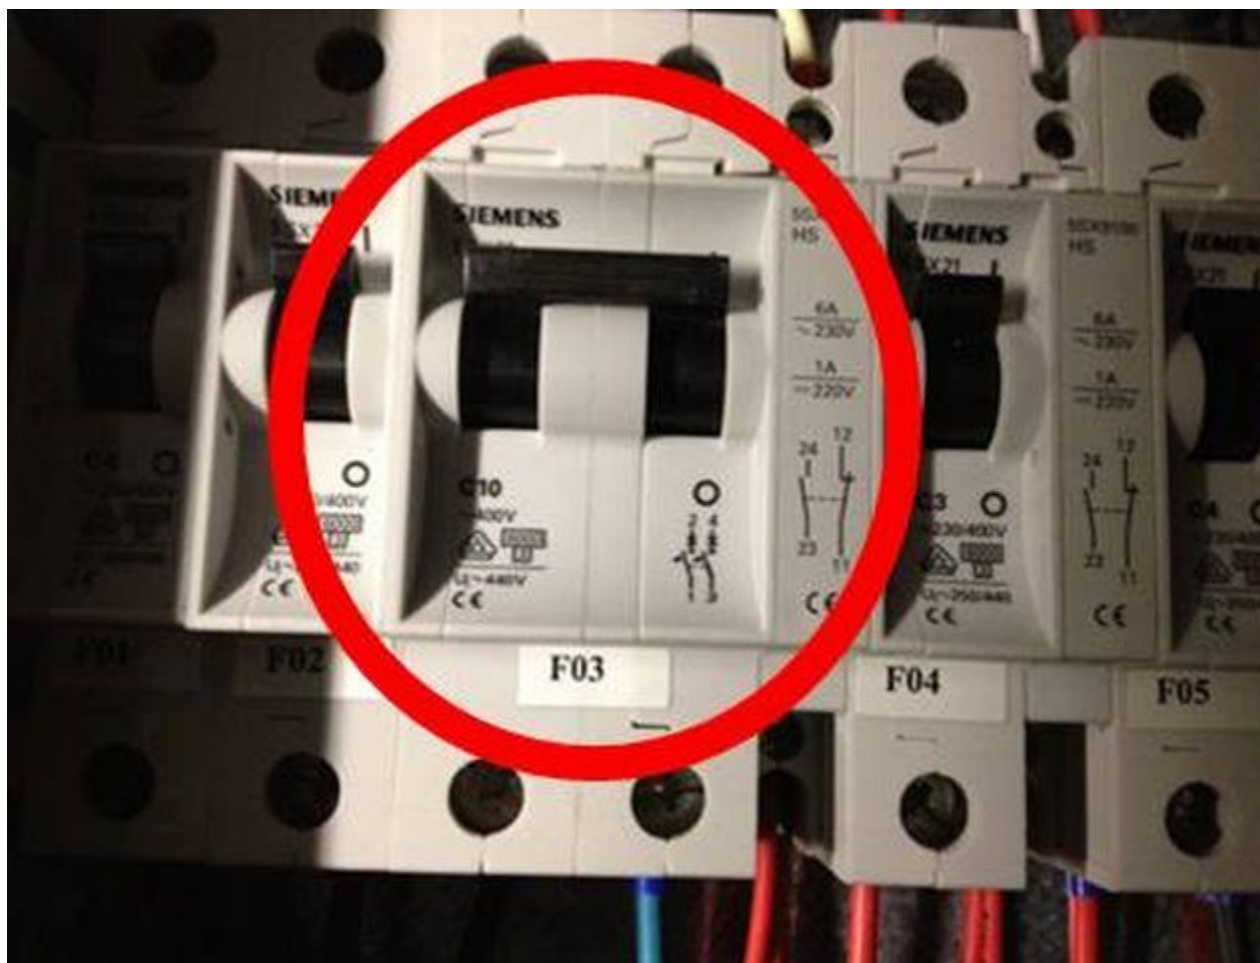
F03 Breaker in AN1:

In the AN1, check the aux contact at the F03 breaker. The F03 breaker interrupts the 230VAC hub supply circuit and is equipped with an auxiliary contact for signalling breaker position to the TOI.

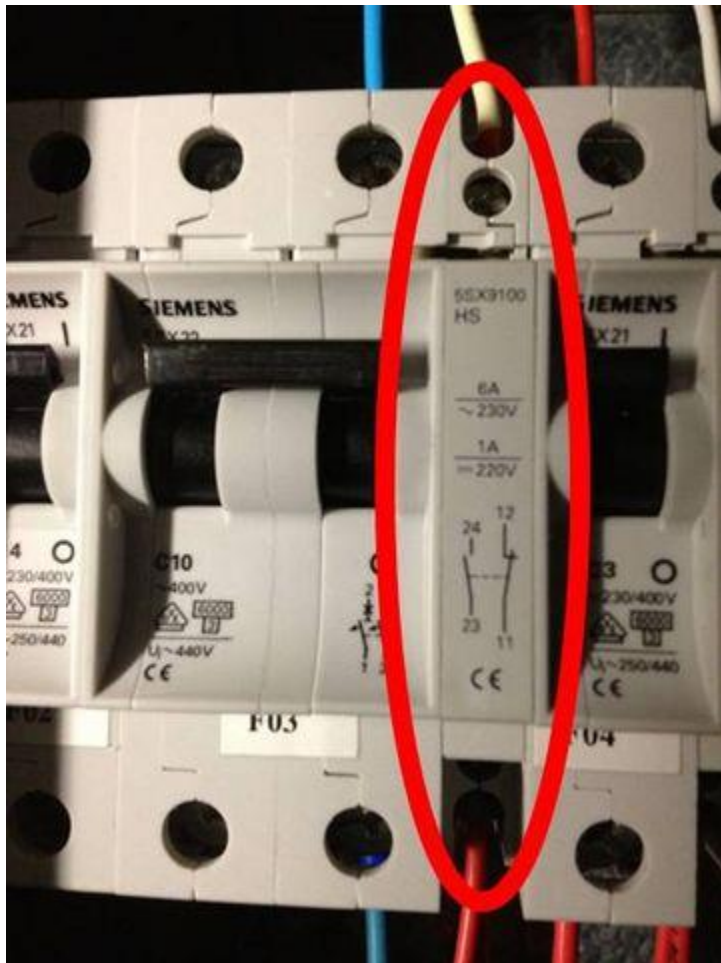
Auxiliary contact for CB Tripped signal to TOI:

With the breaker open, measure for 24VDC between terminals 23 & 24 on the Auxiliary contact. If there is no supply or the supply is intermittent, follow the 24VDC back to the power supply. However, if the 24VDC supply is off or intermittent at this auxiliary contact- there will be other alarms associated as 24vdc5 supplies many other signals e.g. CB TRIPPED VALVE SUPPLY, 24V SUPPLY OFF TOPBOX, FEEDER PUMP FILTER CLOGGED etc. If these alarms are not present, the 24vdc5 supply is likely stable and not the cause of the alarm.

Check that the wires in terminals 24 & 25 are tight and the crimped ends are in good condition.

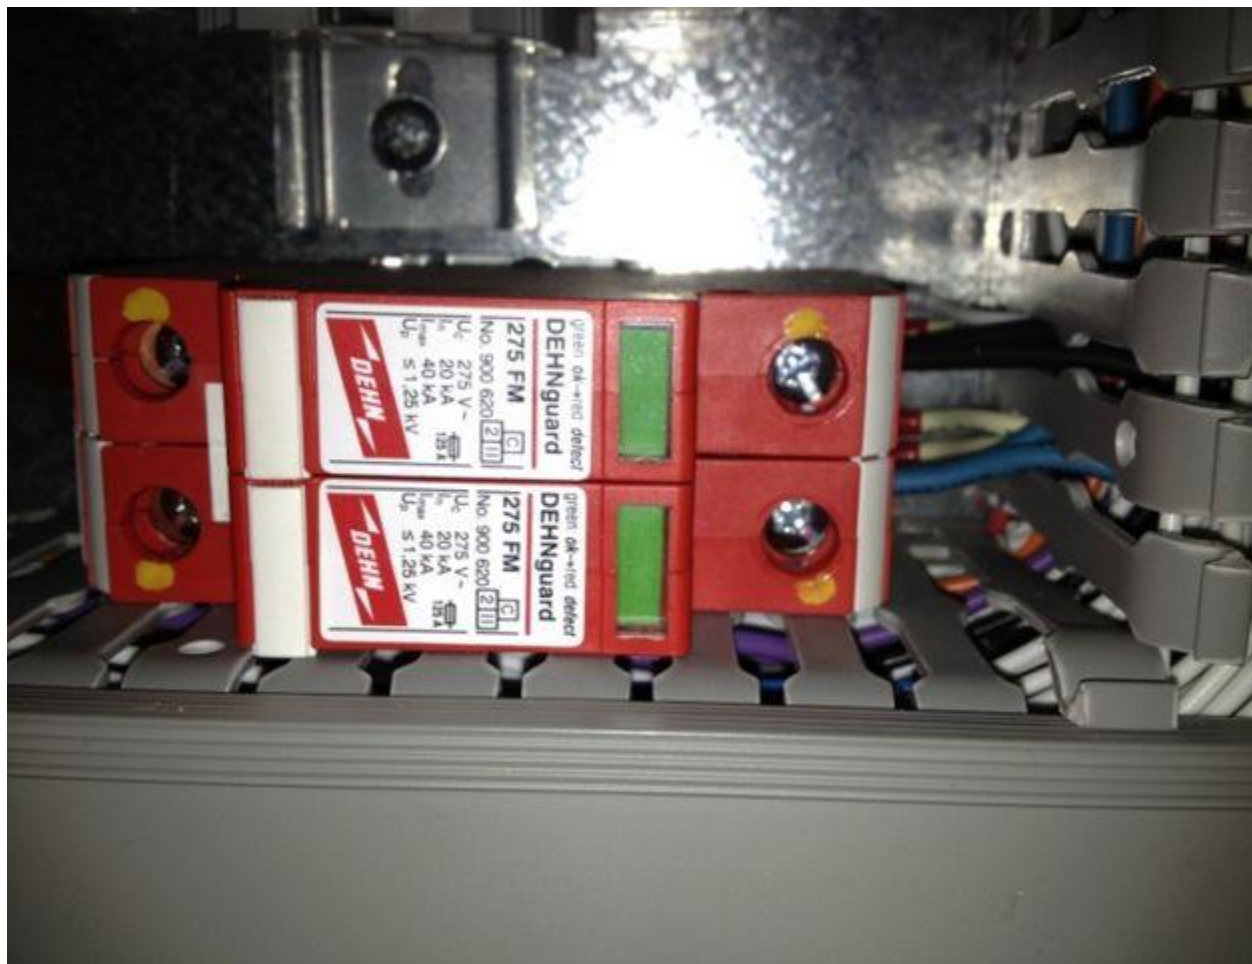
Check the DEHNguard (F16)

If the window is red, the device has detected an over voltage event and should be replaced when the cause is remedied.

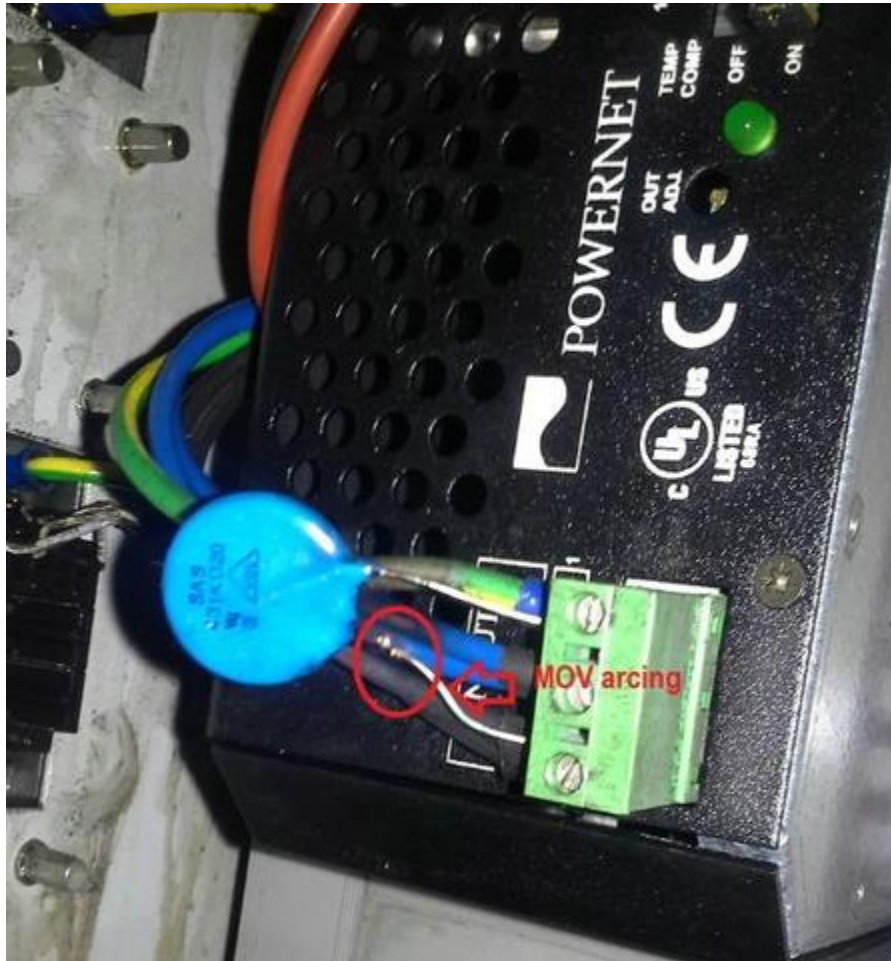
Check any loose connection and damage in the varistor fixed on G401 and replace if required

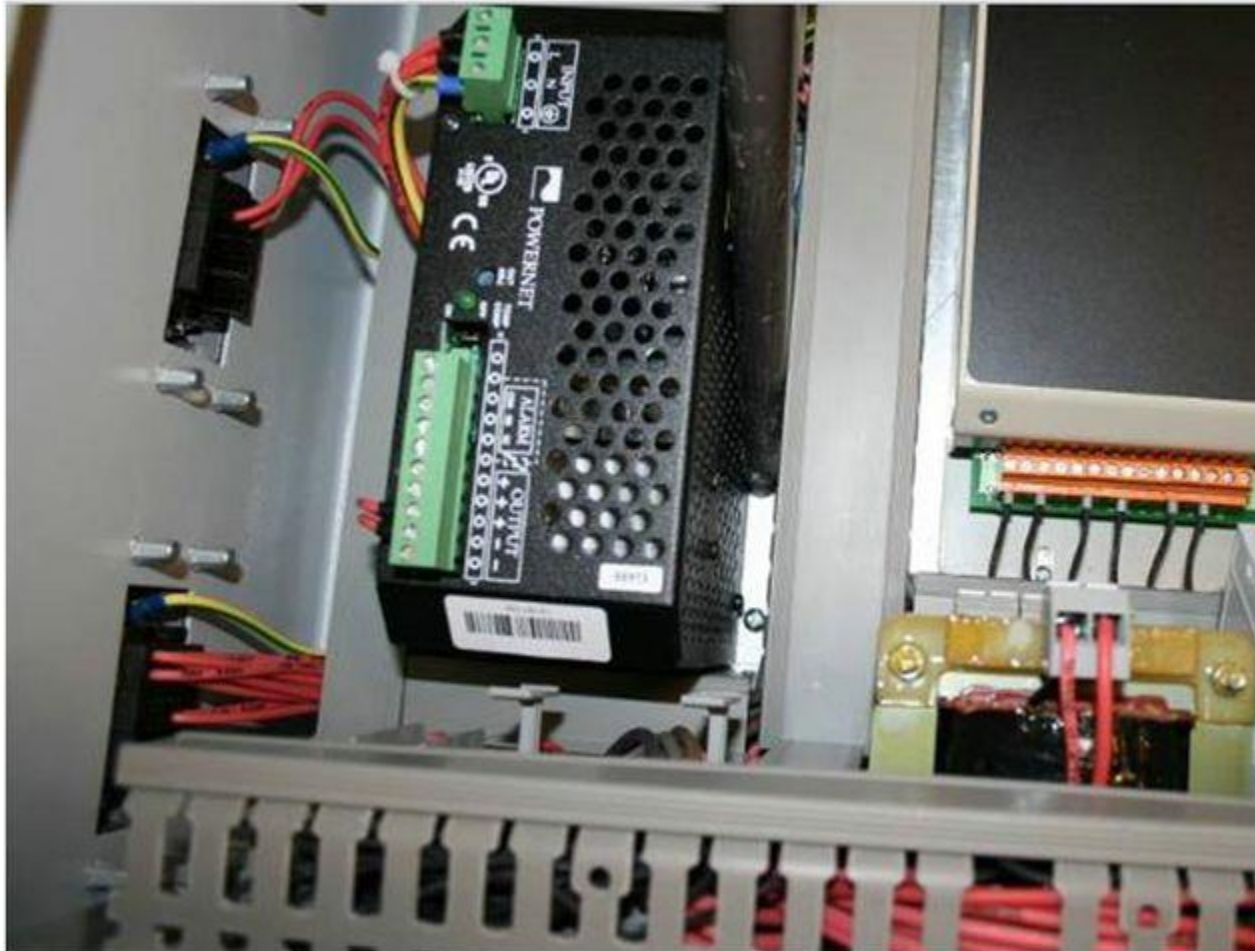
Check for any loose connections at the power net (Pos: G401/ G402).

Check input and output voltage 230/115VAC /24VDC

If defective replace the power net.

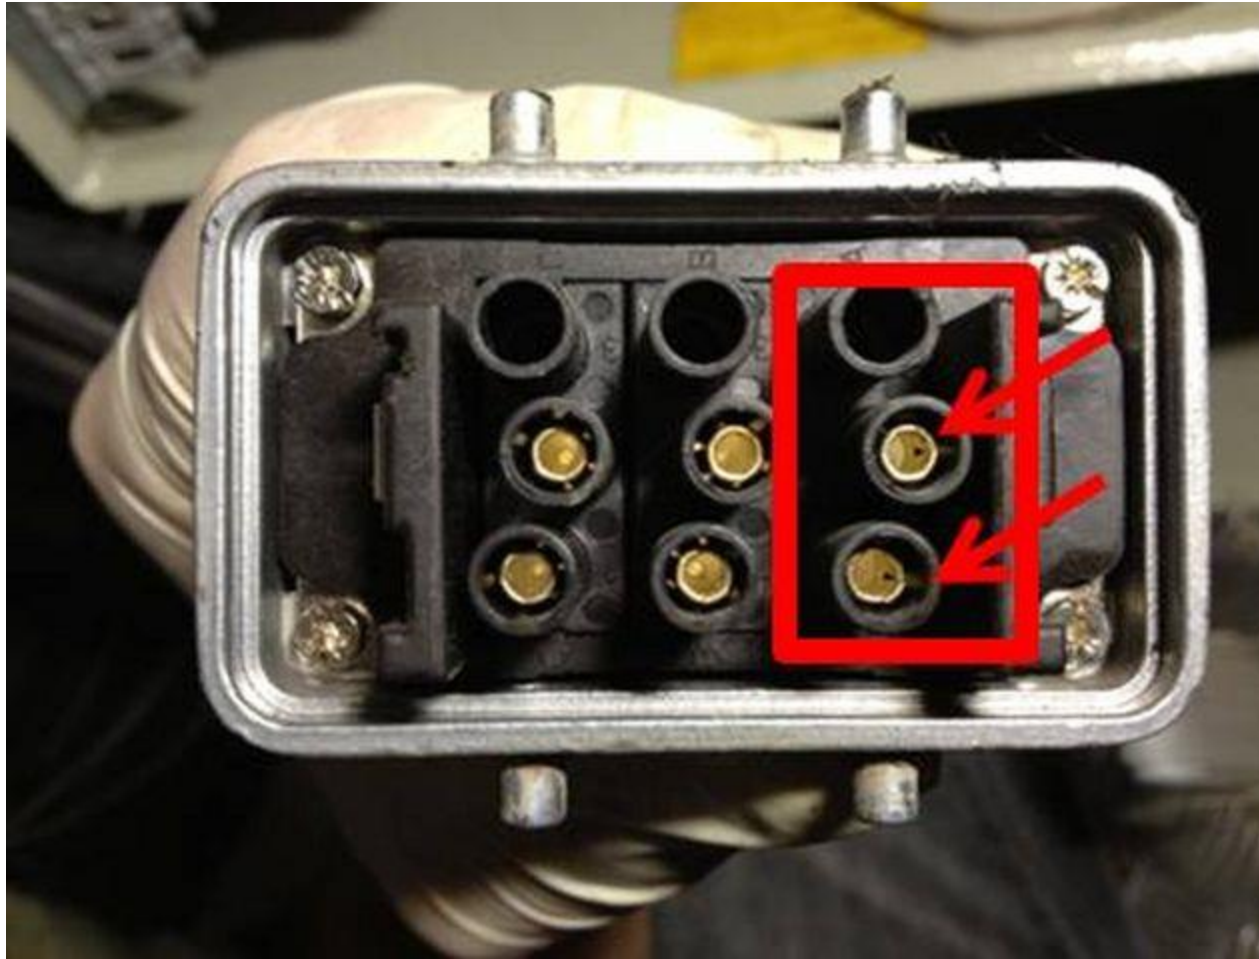
-X05 plug female pins:

Look for corrosion or broken pins on module A pins 1&2.

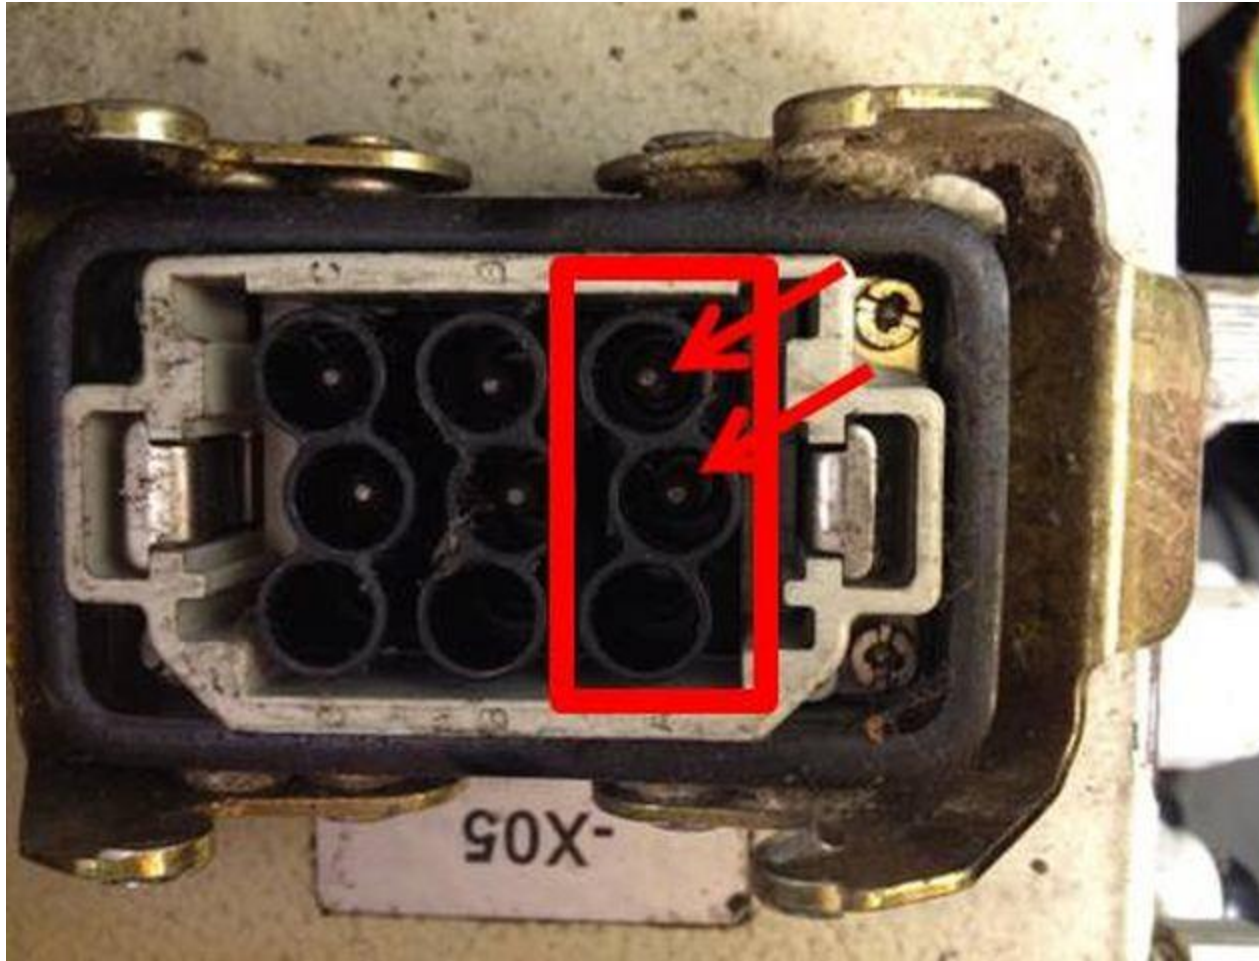
-X05 Male pins:

Look for corrosion or broken pins on module A pins 1&2.

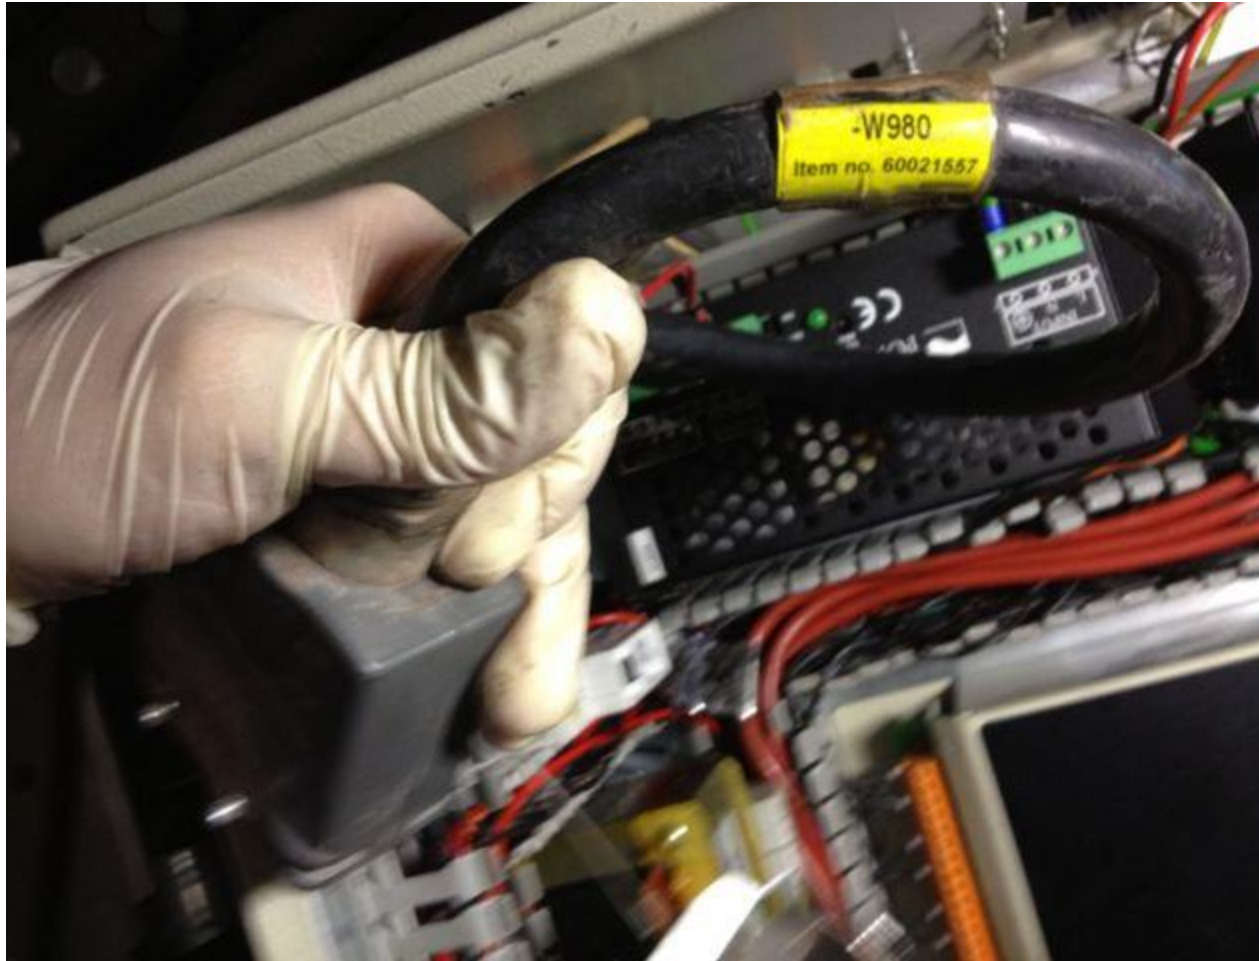
230VAC supply cable from slip ring –W980:

Check the condition of the –W980 cable in the hub. Look for cracks or wear on the cable.

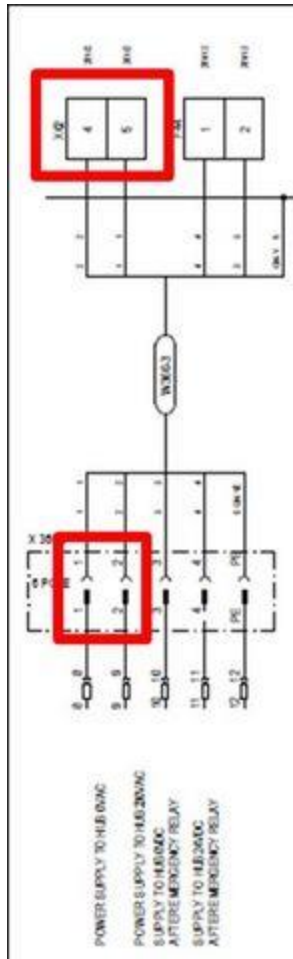
-W360-3:

Perform a continuity check on the -W360-3 cable between the slip ring and AN1 cabinet. Place a jumper between pins 1 & 2 on the -W360-3 Amphenol plug on the slipring. With the multi-meter set to read Ohms, measure between terminals 3 & 4 on the X02 terminal block in the AN1 cabinet.

Only a very low resistance should be detected. Replace the cable if it is found to be defective.

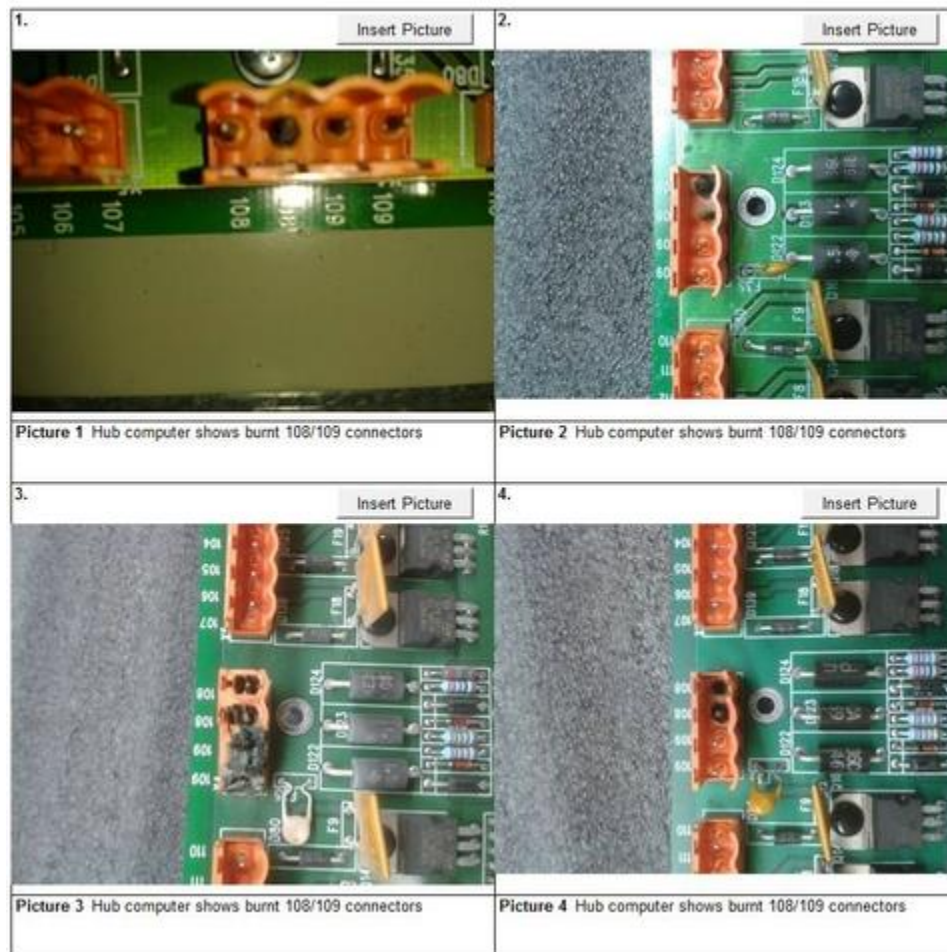
The problem is relating to the X4 plug connection where the 24VDC is supplied to the HUB Controller.

It has in many cases been seen that the plug connection have been overheated and burned as indicated on the below pictures.

The Minor Component Repair Team, has been requested to implement an improved interface on the PCB, so that the overheated connections could avoided.
