**Check the B57 Pt100, replace as needed**

OPTION  
PITCH ACCUMULATOR  
TEMPERATURE B57

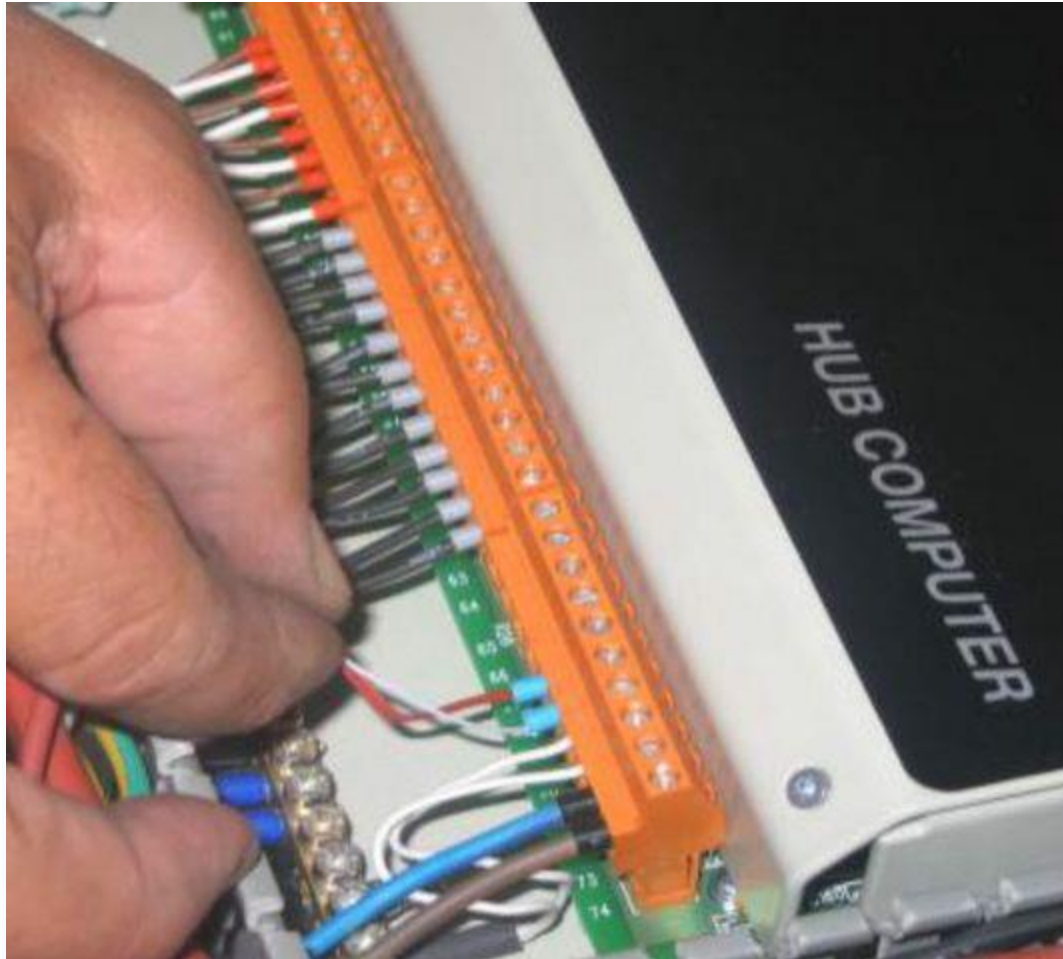
This Alarm is referring to the *optional* Pt100 that is between the heat blankets and the outside surface of one of the accumulators on LT turbines. This alarm is only for a bad Pt100 signal, alarms 182 and 183 cover low and high temperature errors respectively.

If you measure almost no resistance, check the circuit for a line to line short. A good Pt100 will measure about  $92\Omega$  at  $-20^{\circ}\text{C}$  and  $115\Omega$  at  $40^{\circ}\text{C}$ . If the resistance is outside the span of 90 to 120 ohms, then that is probably a bad Pt100. Refer to Pt100 temp/resistance conversion table in Doc# [0039-6203](#).

If you measure OL or 'infinite' resistance, then you probably have break in the cable, in which case, you need to replace the cable.

If you measure the correct resistance for the current temperature, try shaking the cable to make sure you do not have an intermittent short or open. If you are certain that the Pt100 is functioning correctly replace the hub computer.

Disconnect the Pt100 from the terminal X20 on the Hub Computer and use your digital multimeter to check resistance. Use alligator clips to hold the wires so you don't inadvertently complete the circuit with your body.

You can test the hub computer by replacing the B57 with a 100 Ohm resistor and check the accumulator temp on the service panel. It should read 0°C.
