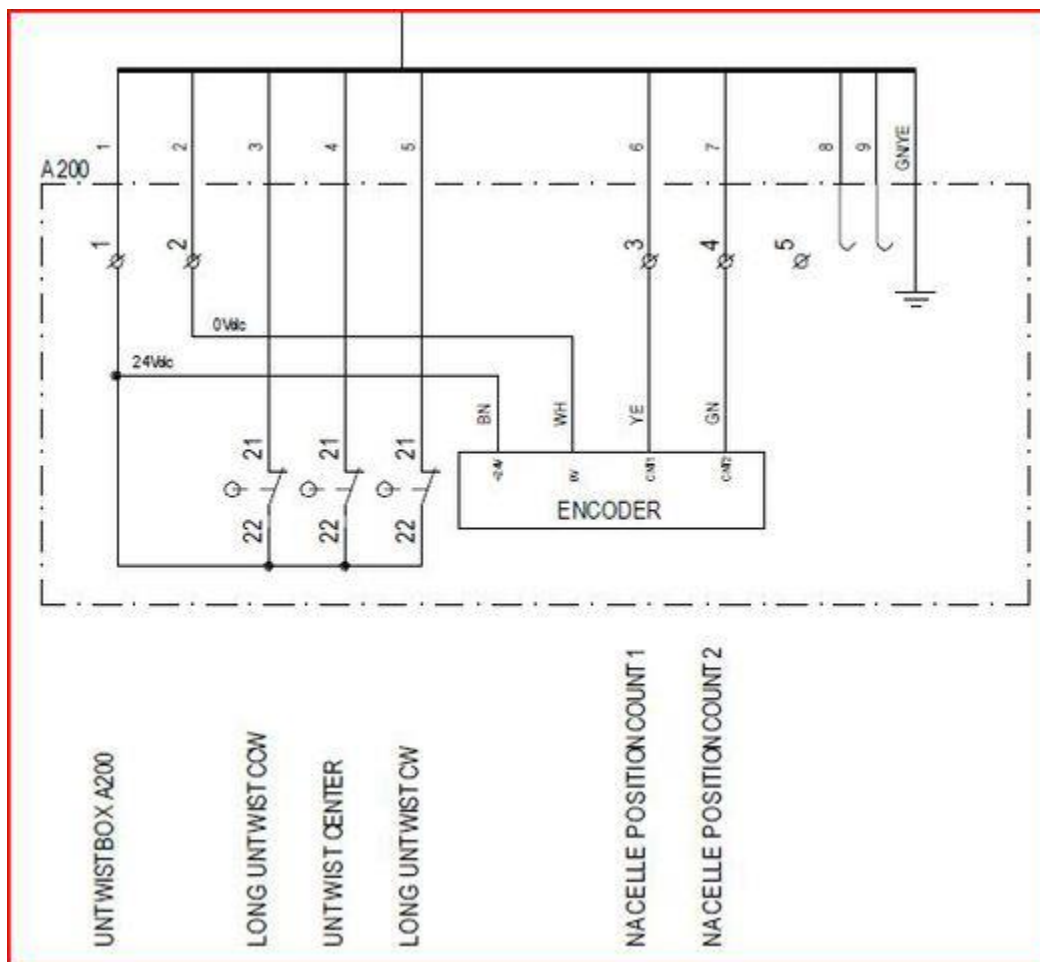
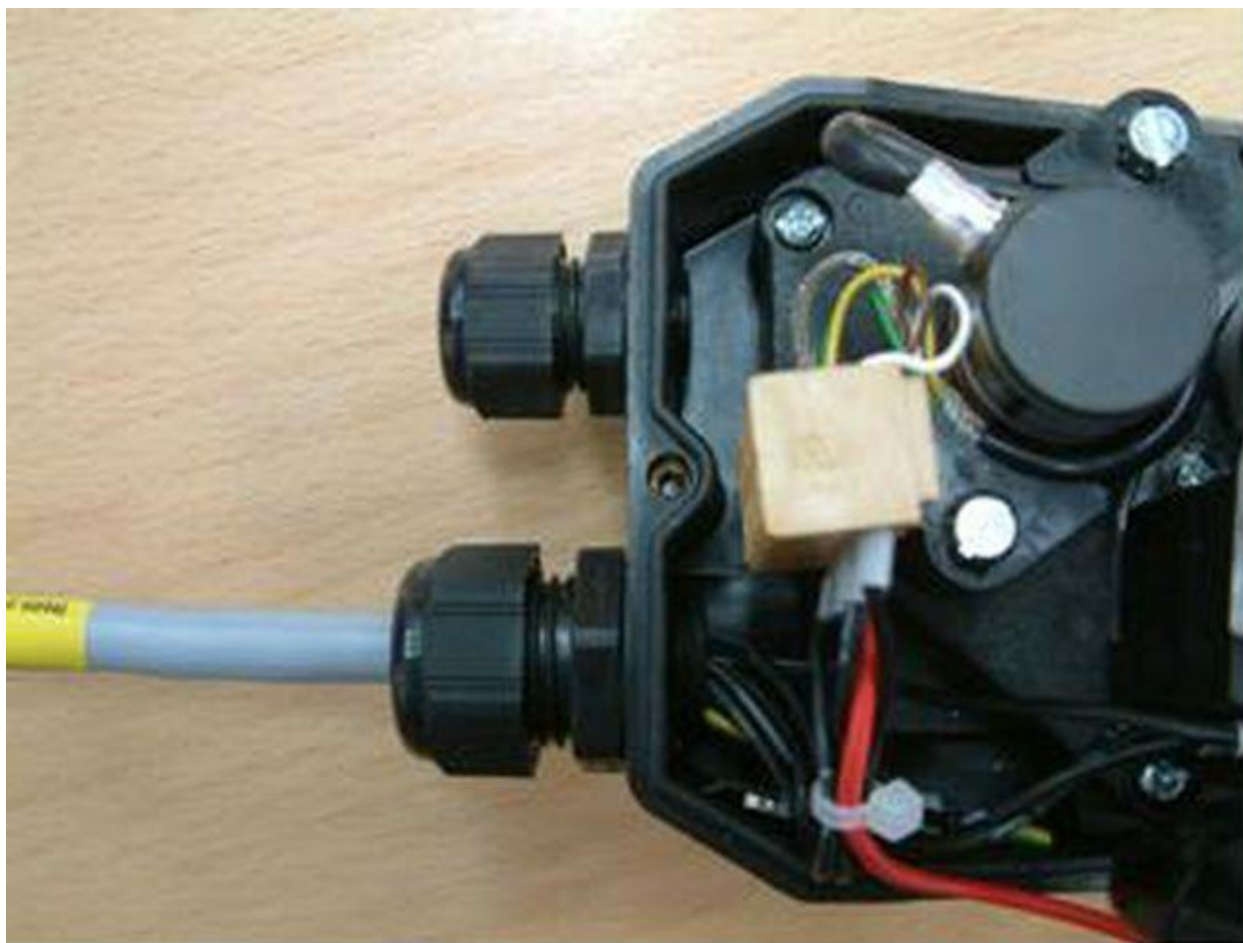
**IN THE NACELLE +AN13 box**

Check the wiring connections in the yaw box and +AN13 box.

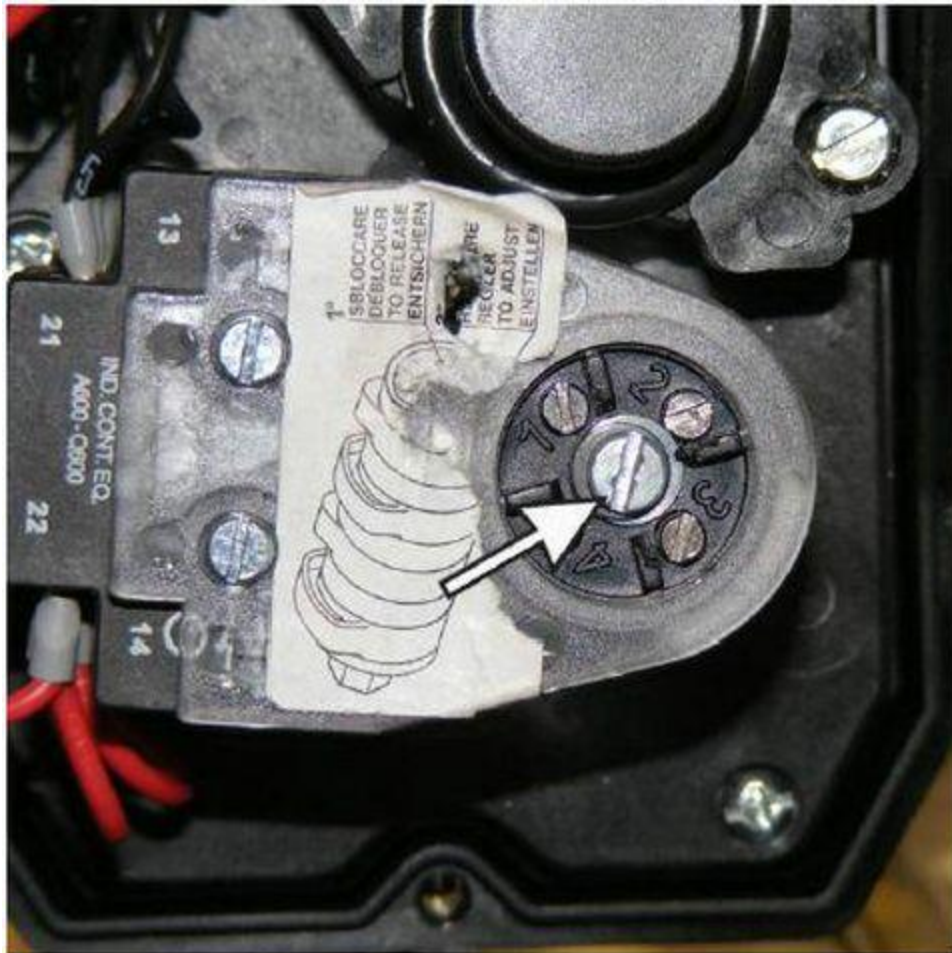
Under normal conditions both cam limit switches (CW & CCW) have been activated it may be a defect cam switch or mechanical defect.

Check the tightness of the cam screws.

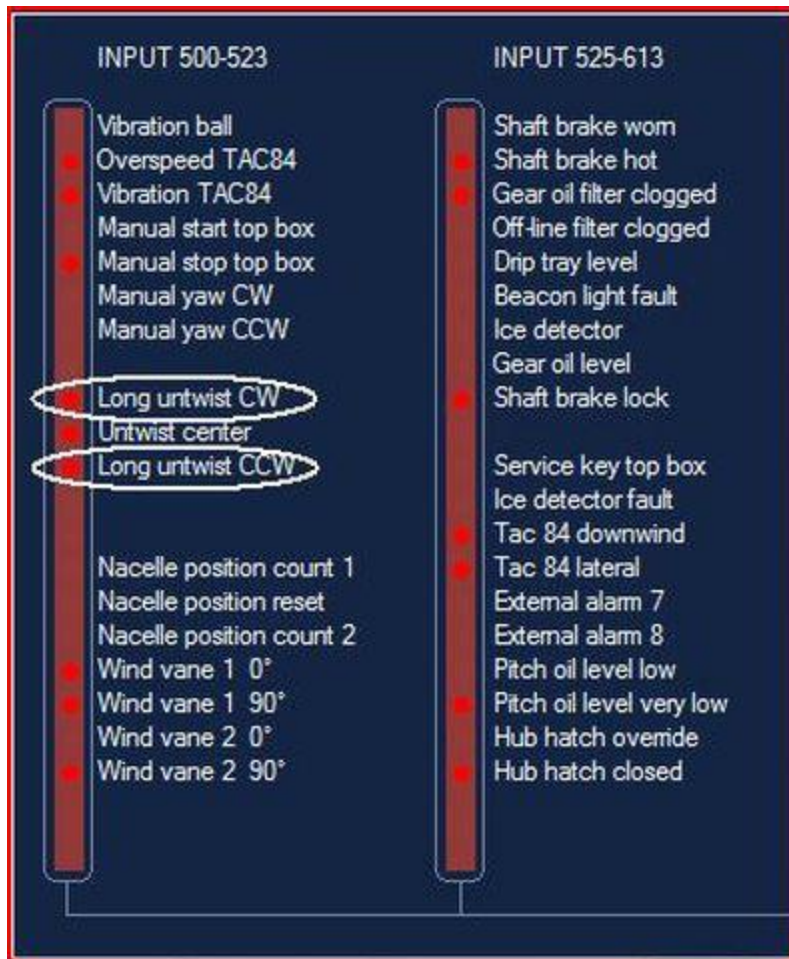
Check the limit switch signal in the Nacelle TOI.

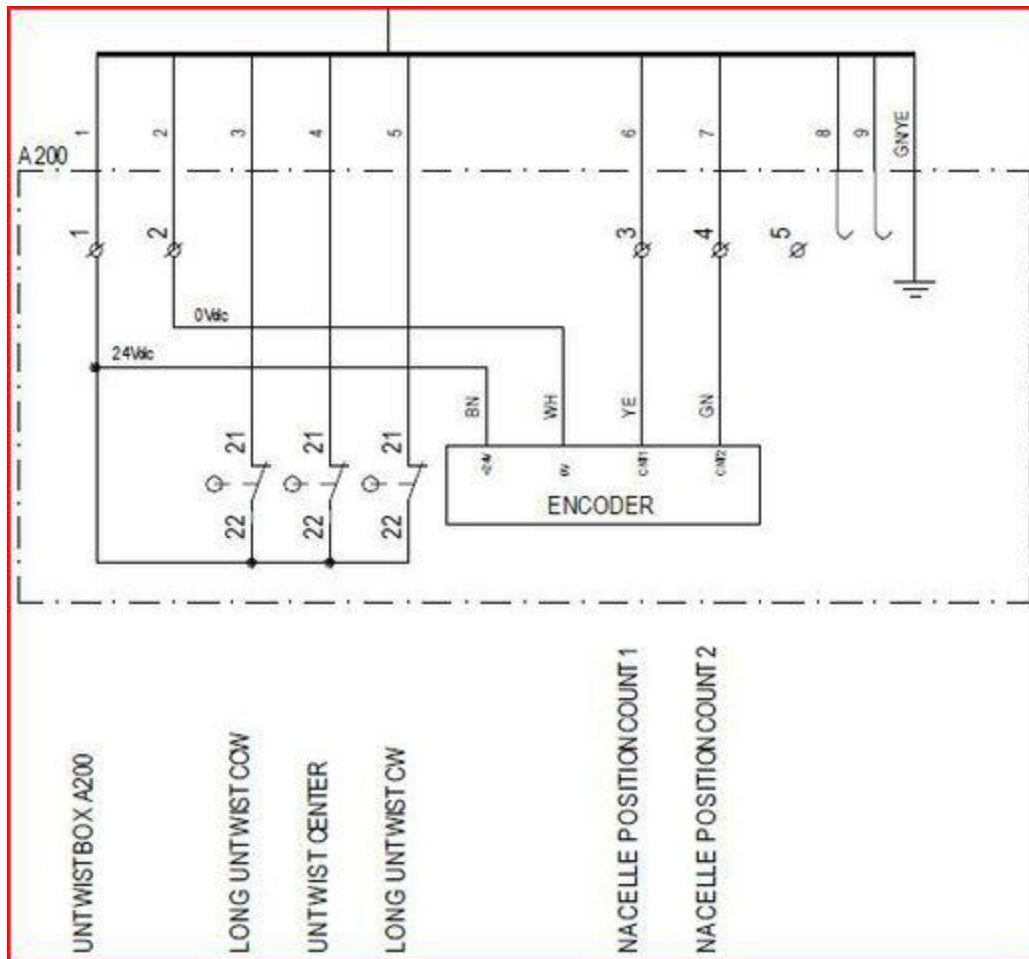
Check for any loose wiring connections in the yaw box and +AN13 box.

Adjust the cams according to the work instruction.

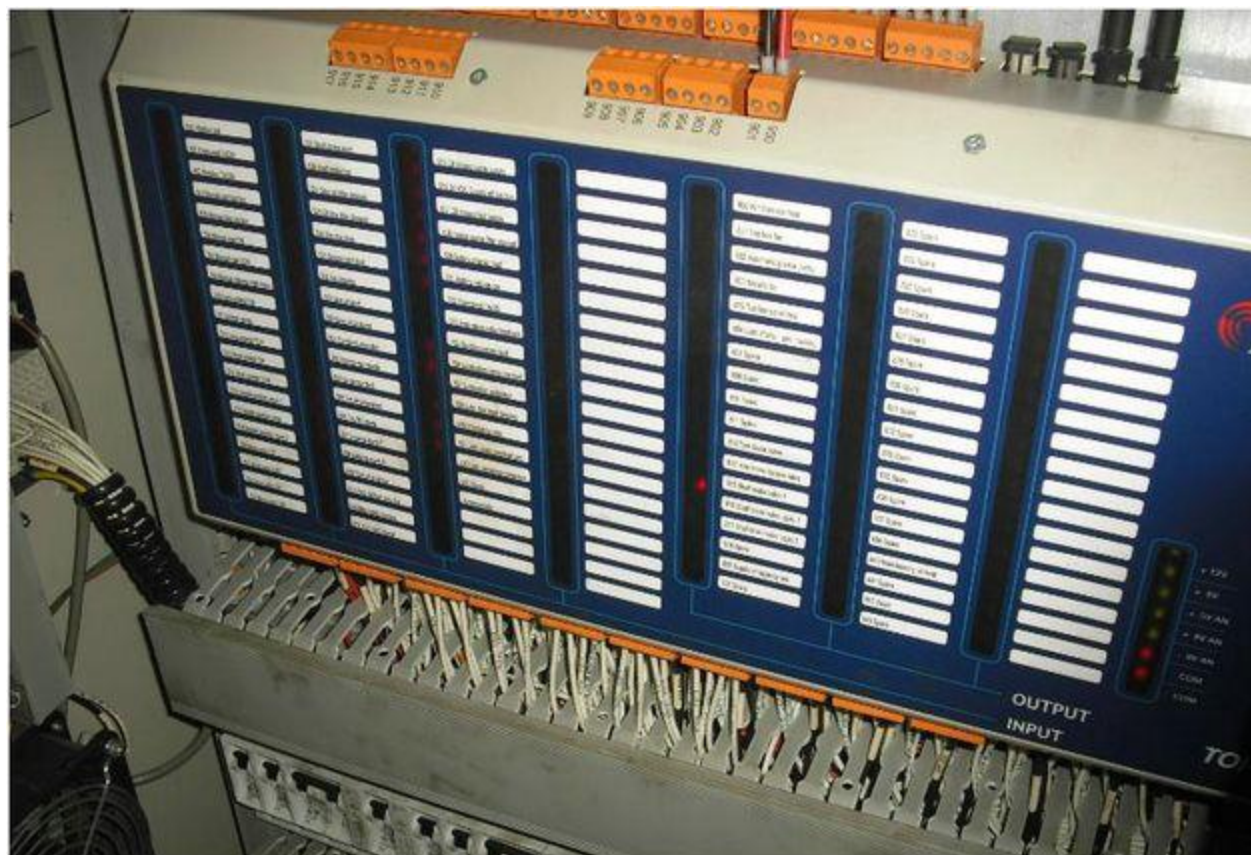
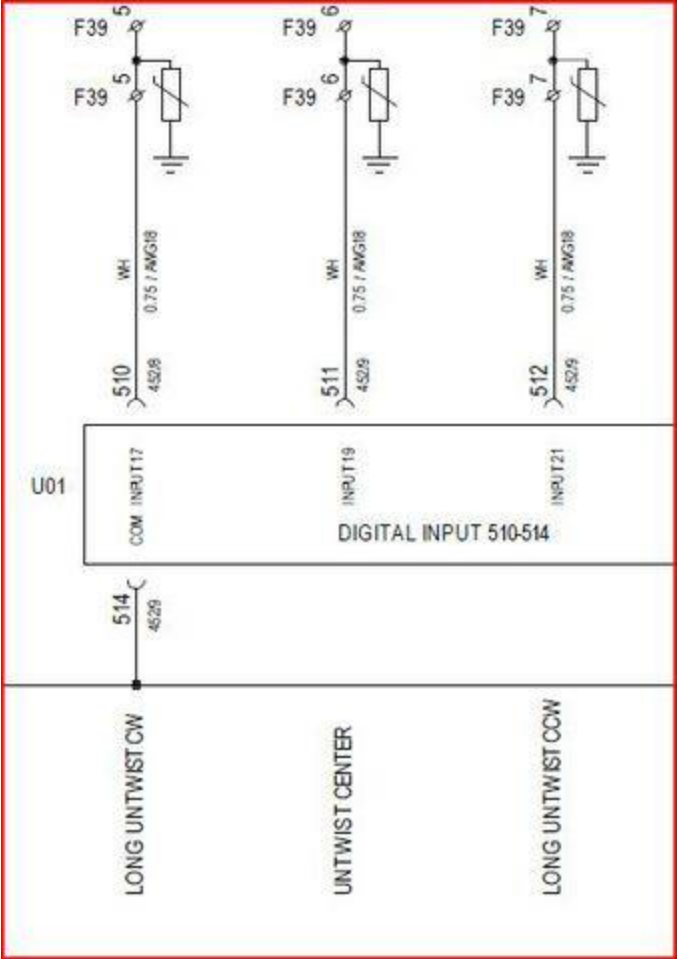
#### IN THE AN1 CABINET:

Check the TOI input connection 510, 511, 512.

If the signal is absent, check the connections from yaw box.

If the signal present, then the cause is likely a faulty nacelle TOI.

## Replace the defect Nacelle TOI
