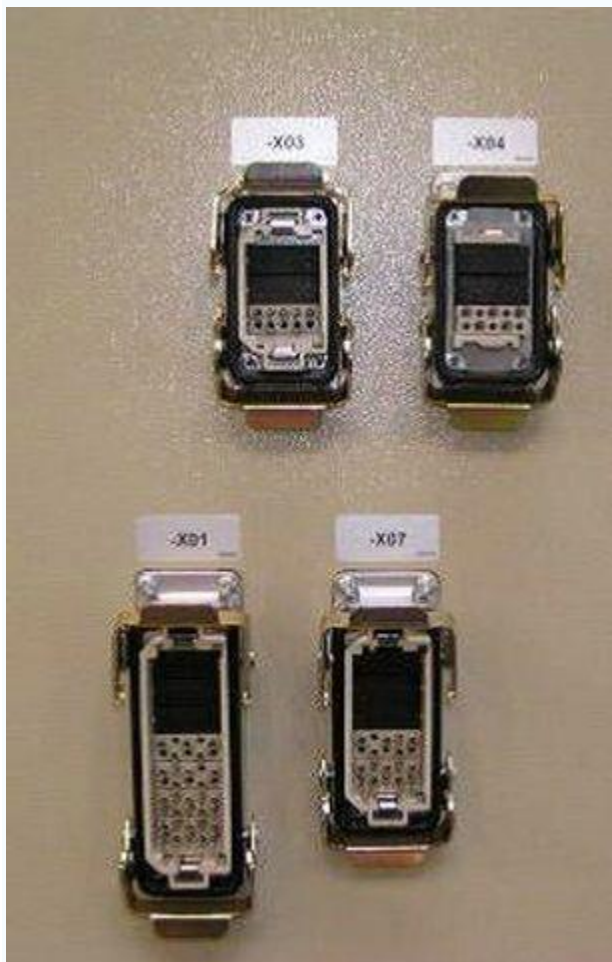
Check connections and tightness in +AT01 Main panel X01 connectors 11 and 12.

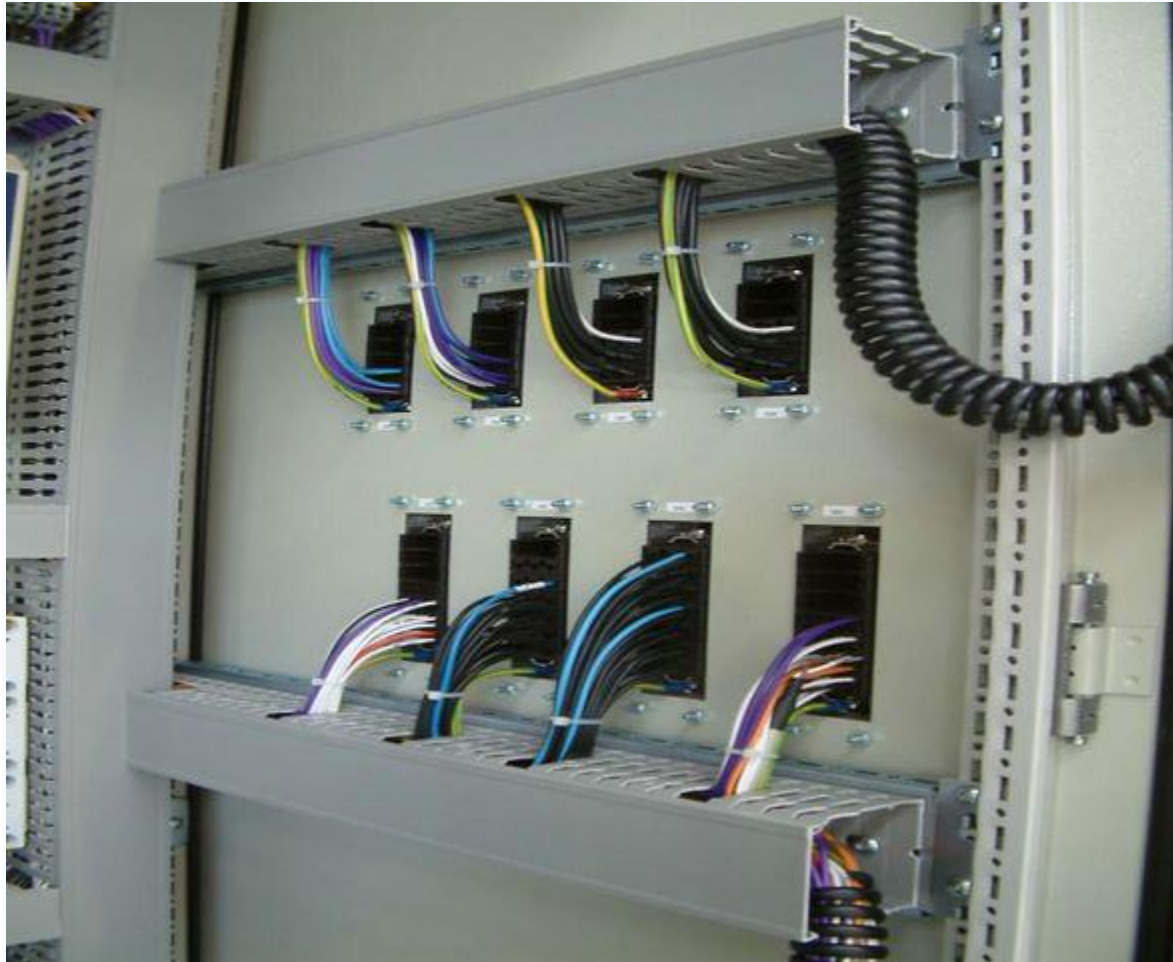
Check connections and tightness in +AT02 Control panel X07 connectors 11 and 12.

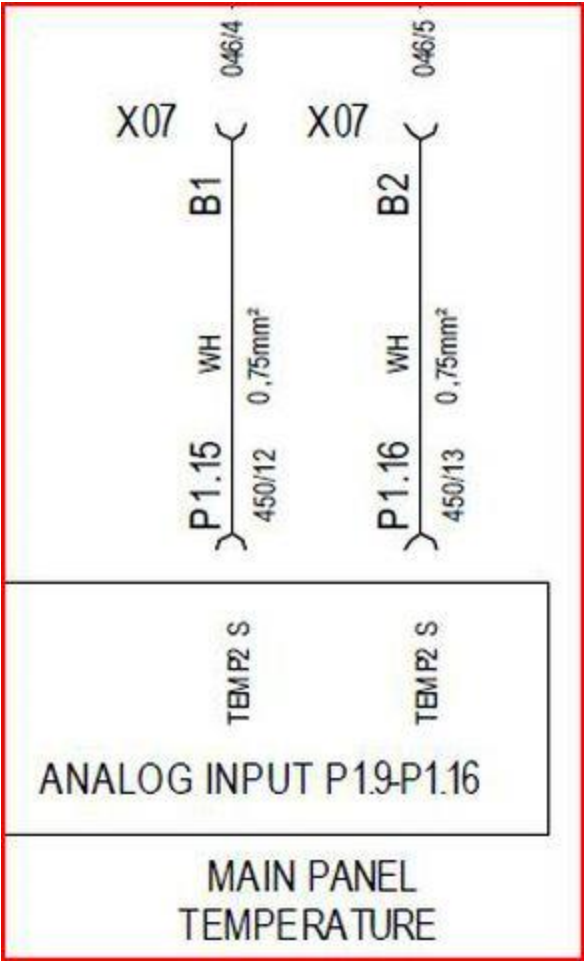
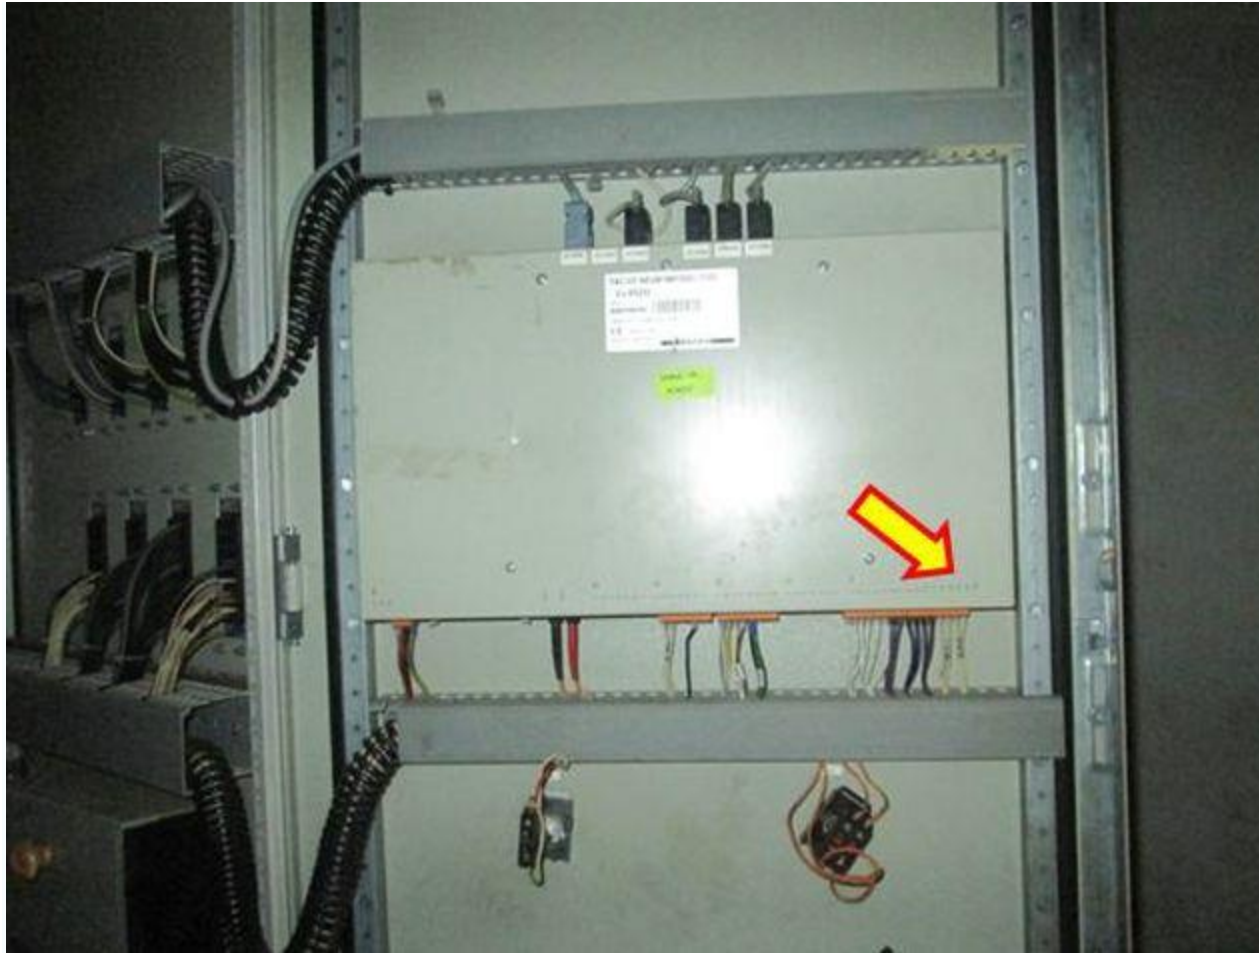
Check connections and tightness in +AT02 Control panel TAC computer connectors P1.5 and P1.6.

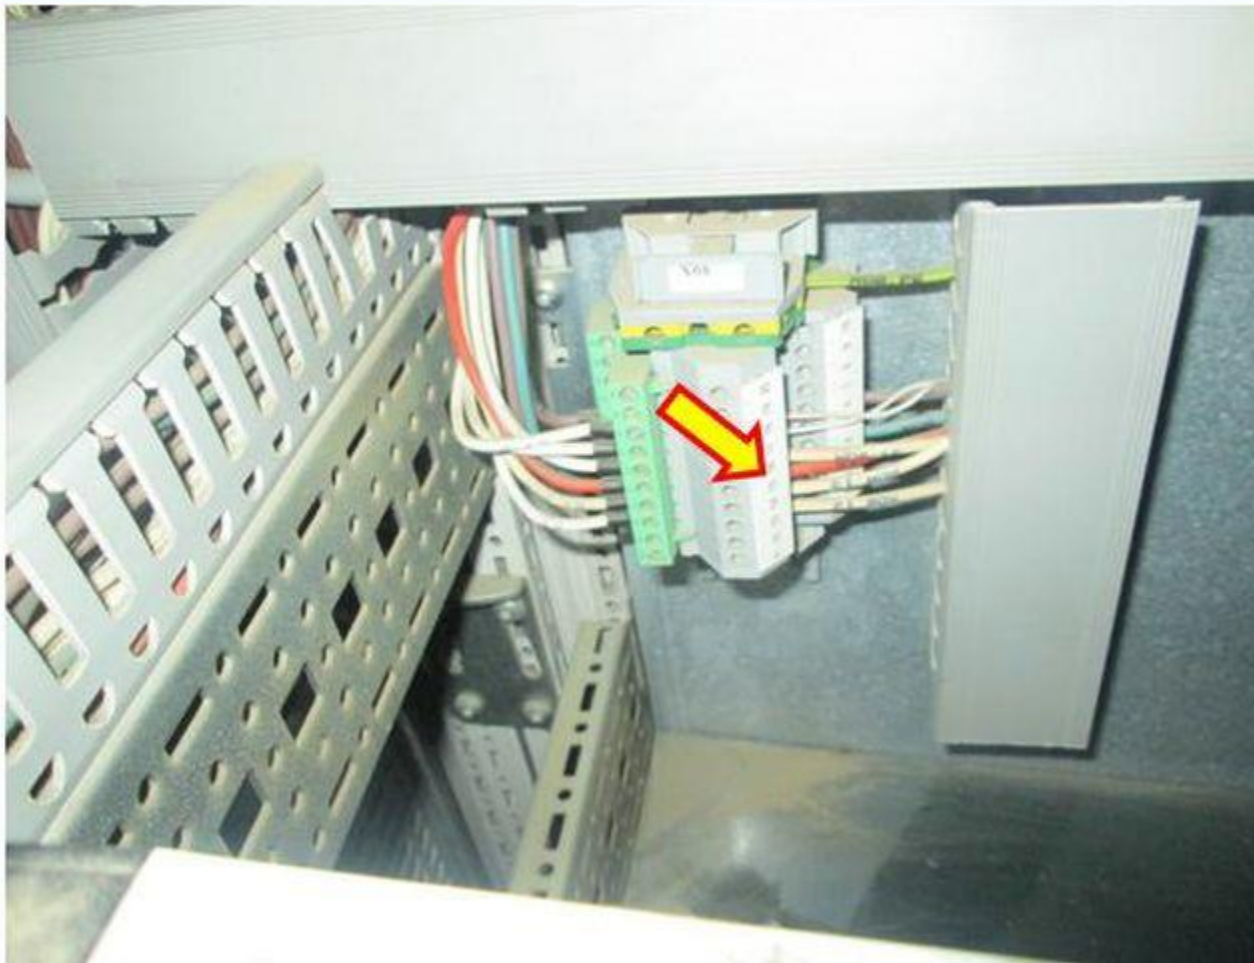
Check PT100 connections and tightness in +AT01 panel X08 connection 16 and 17.

Remove the PT100 wire connections from X08 terminals 16 & 17

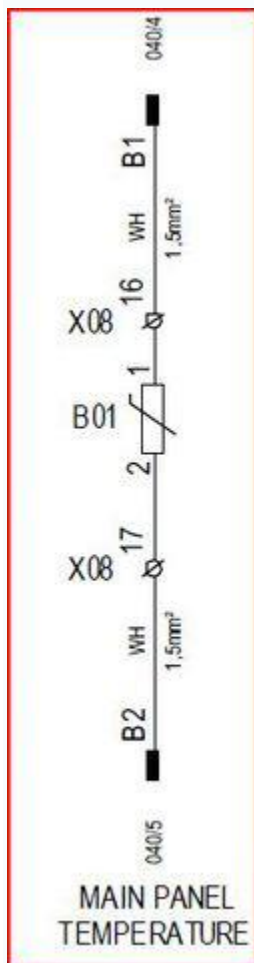
[60009279](#) PT100 180-4-2M Ø6x60mm

If the measured value from the PT100 is unreal, the sensor has failed and must be replaced (B01).

Replace the defect PT100

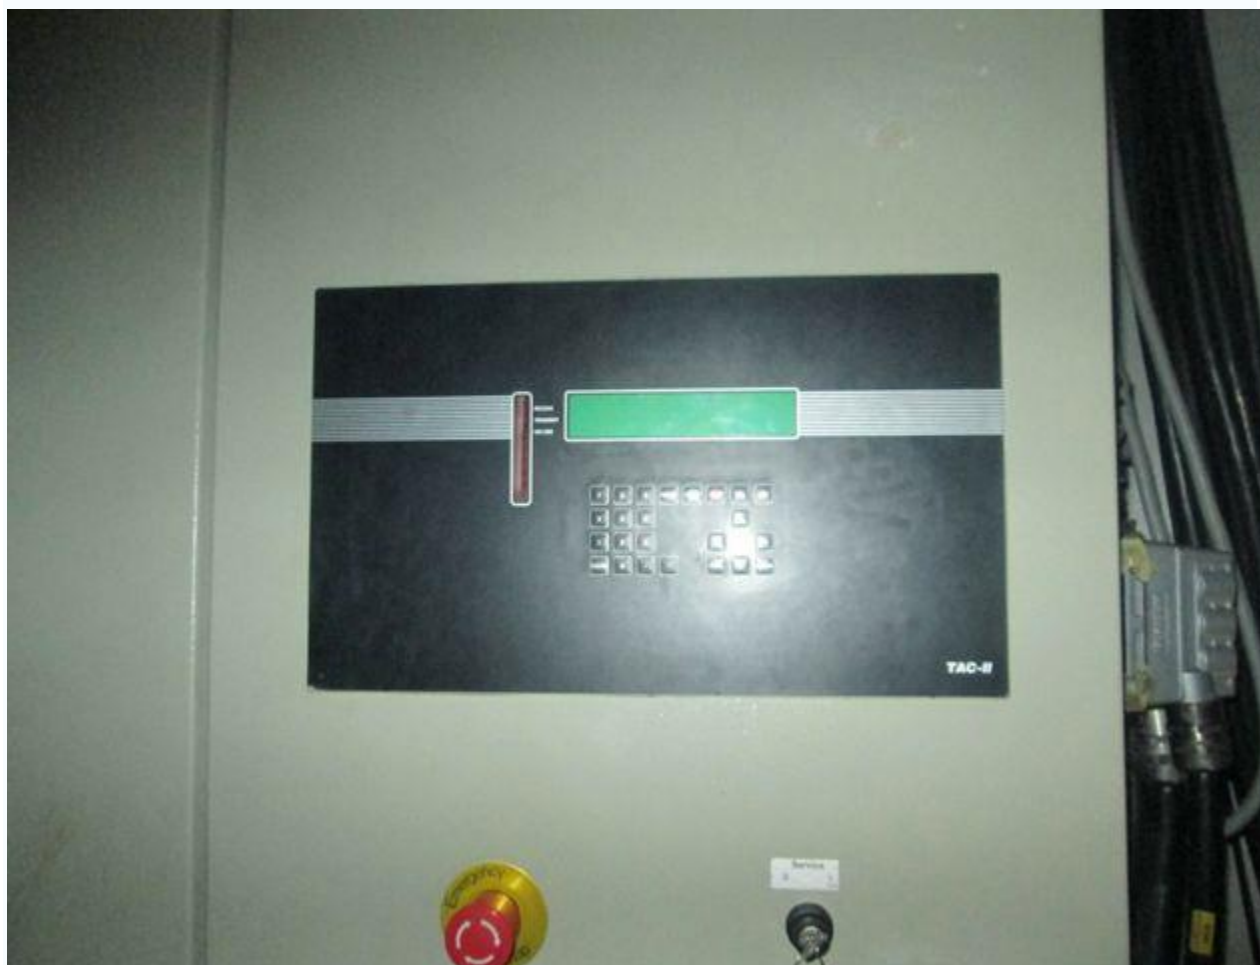
[51707301](#) TAC-II/F NEGM NM1500C/72/82

If the PT100 value does match with the PT100 chart values then the cause is likely a faulty TAC II controller, replace the defective TAC II computer.

Replace the defect TAC II computer
