Service action must be taken without delay

A “Gear oil filter clogged” alarm shall be understood as a very serious malfunction in the turbine. A service action must be taken without delay.

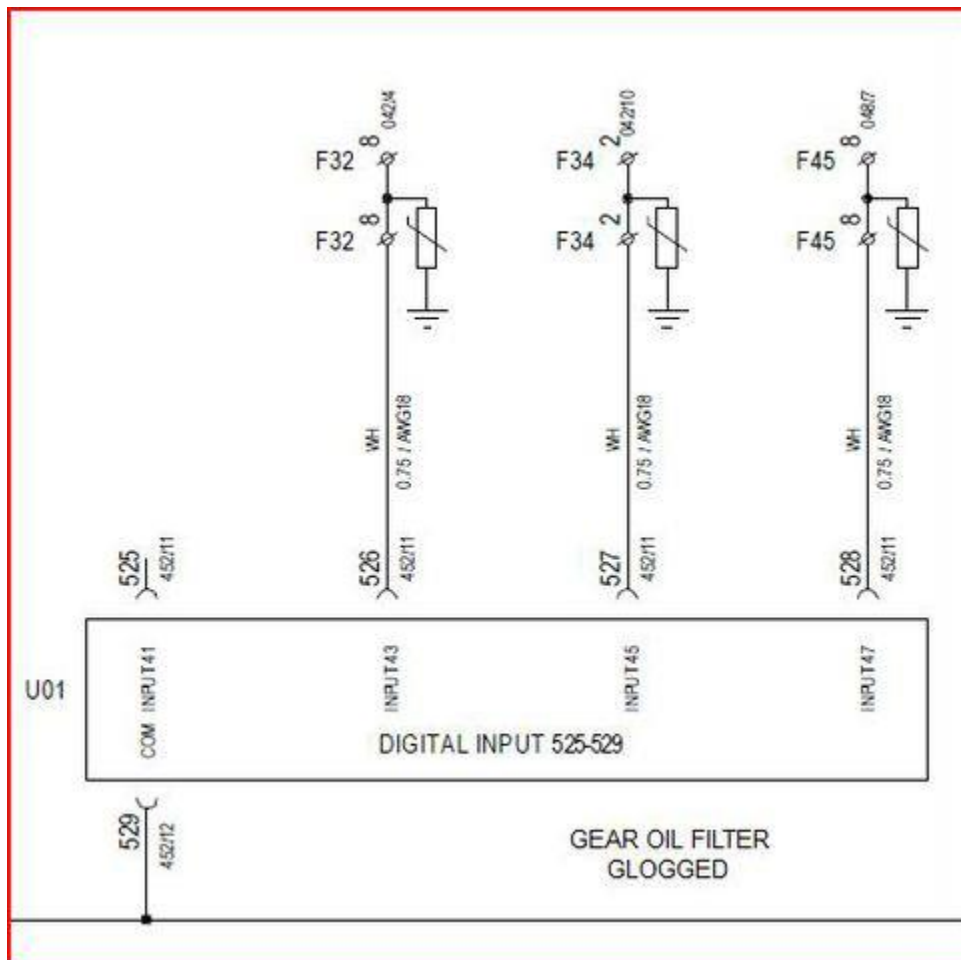
VARISTOR BOX F34:

Varistors (F34) can be tested individually by placing a multimeter (set to measure Ω) lead on the common (earth) side of the varistors and the other on the individual varistor terminals. The resistance value over the varistor should be ∞ or in the high M Ω range. If the resistance is lower, the varistor has been damaged by an overvoltage in the circuit and must be replaced.

Replace the defective varistor and tighten the loose wires

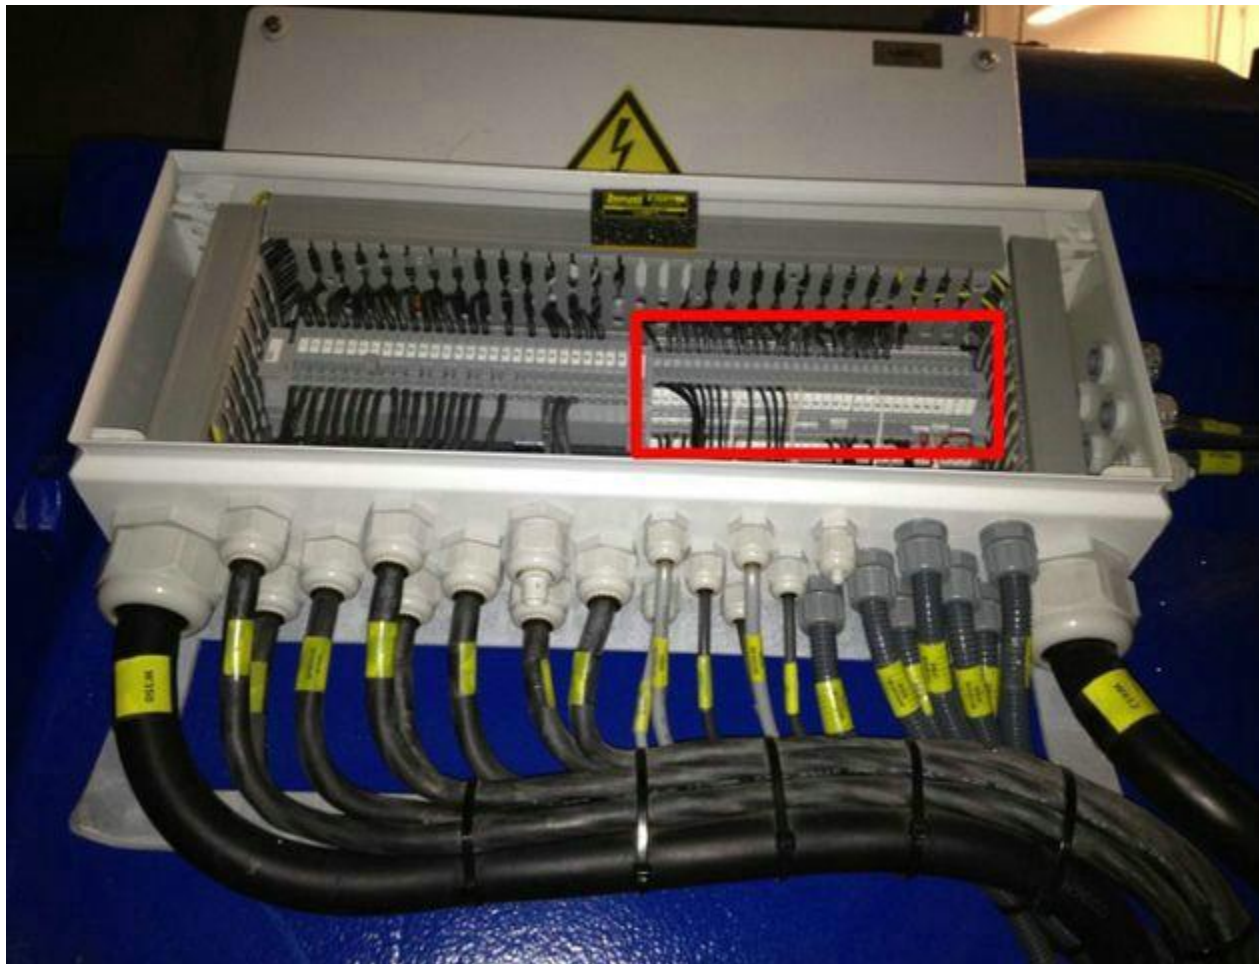
IN THE +AN12 CABINET:

Check connections and tightness in +AN12 panel X02 connection 01 and 18.

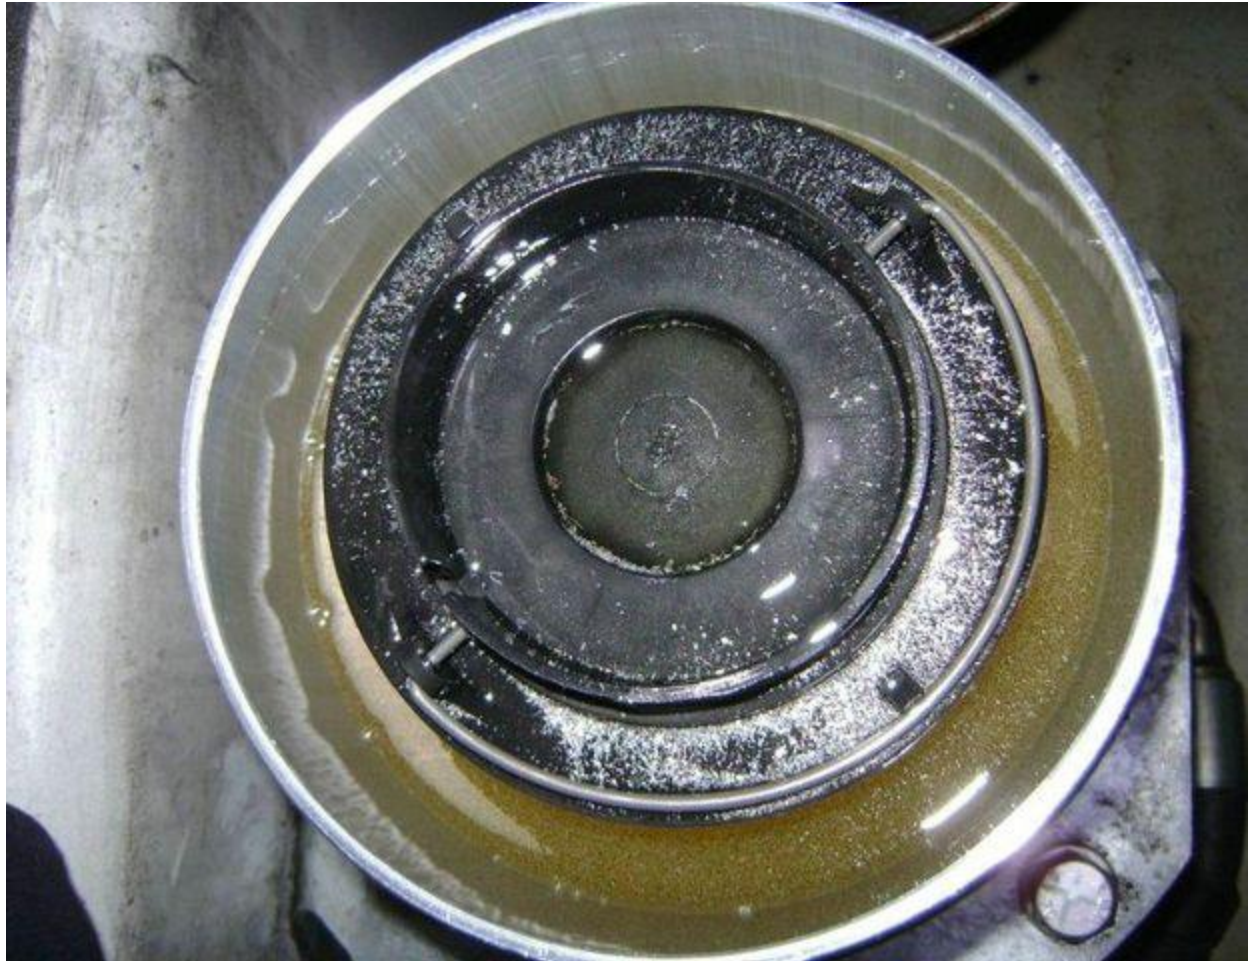
Contaminate Filter unit 1:

Open the filter cover and check for any metal particles present.

Replace the contaminated filter after cleaning the unit thoroughly.

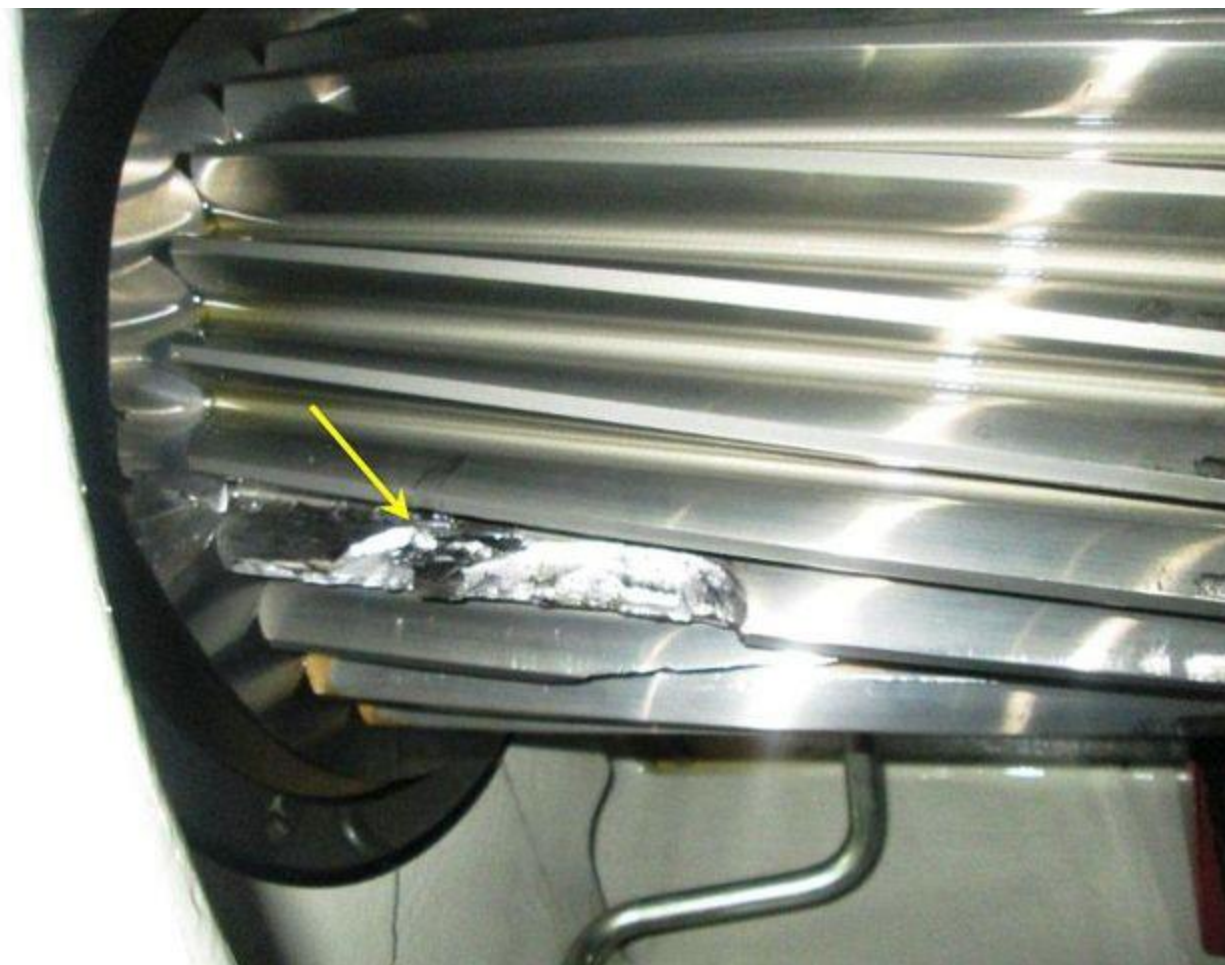
DEMAGE GEAR TOOTH 1 :

If there is wear on the tip, likely the outer race of the bearing has been rotating within the bore of the housing. Then proceed with repair solution with reference to CIM1312/CIM2217.

Prior to repairing the gearbox, a measurement is taken of the gap between the housing bore and the outer race of the bearing. If during repairing the gap between the outer race and housing is >0.23mm, mechanical lock solution will be required to prevent the outer race from spinning. Contact local Engineering department for instructions if the measurement taken is greater than the allowable limit.
