## Check amperage rating of FT sensor

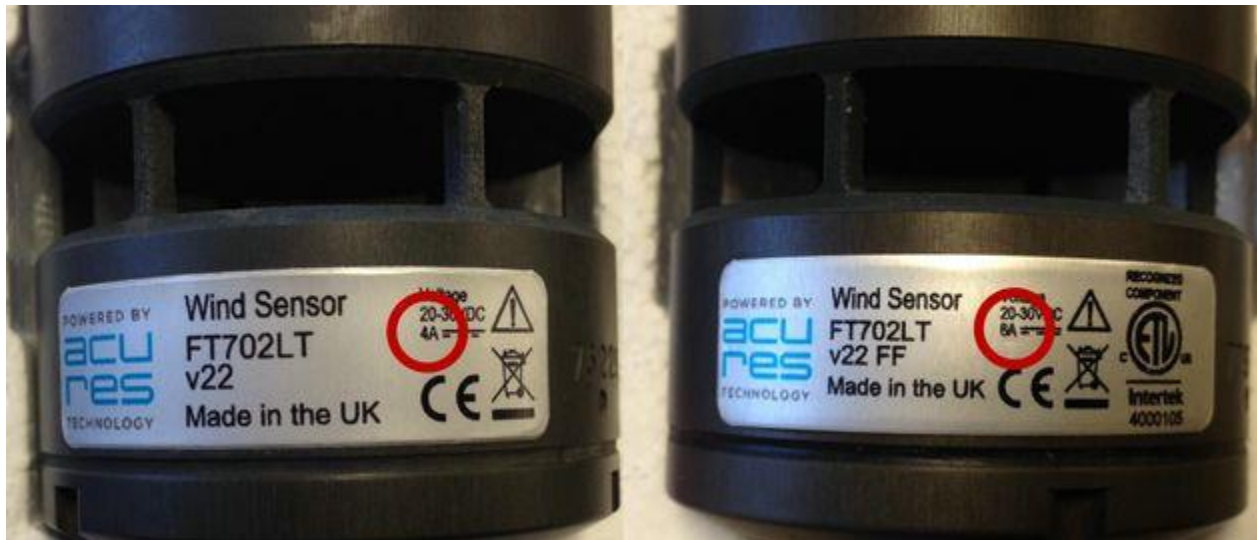
Check the amperage rating of the FT sensor. Typically the FT sensors supplied have been rated at 4 Amps, however in some sites have received sensors rated at 6 Amps.

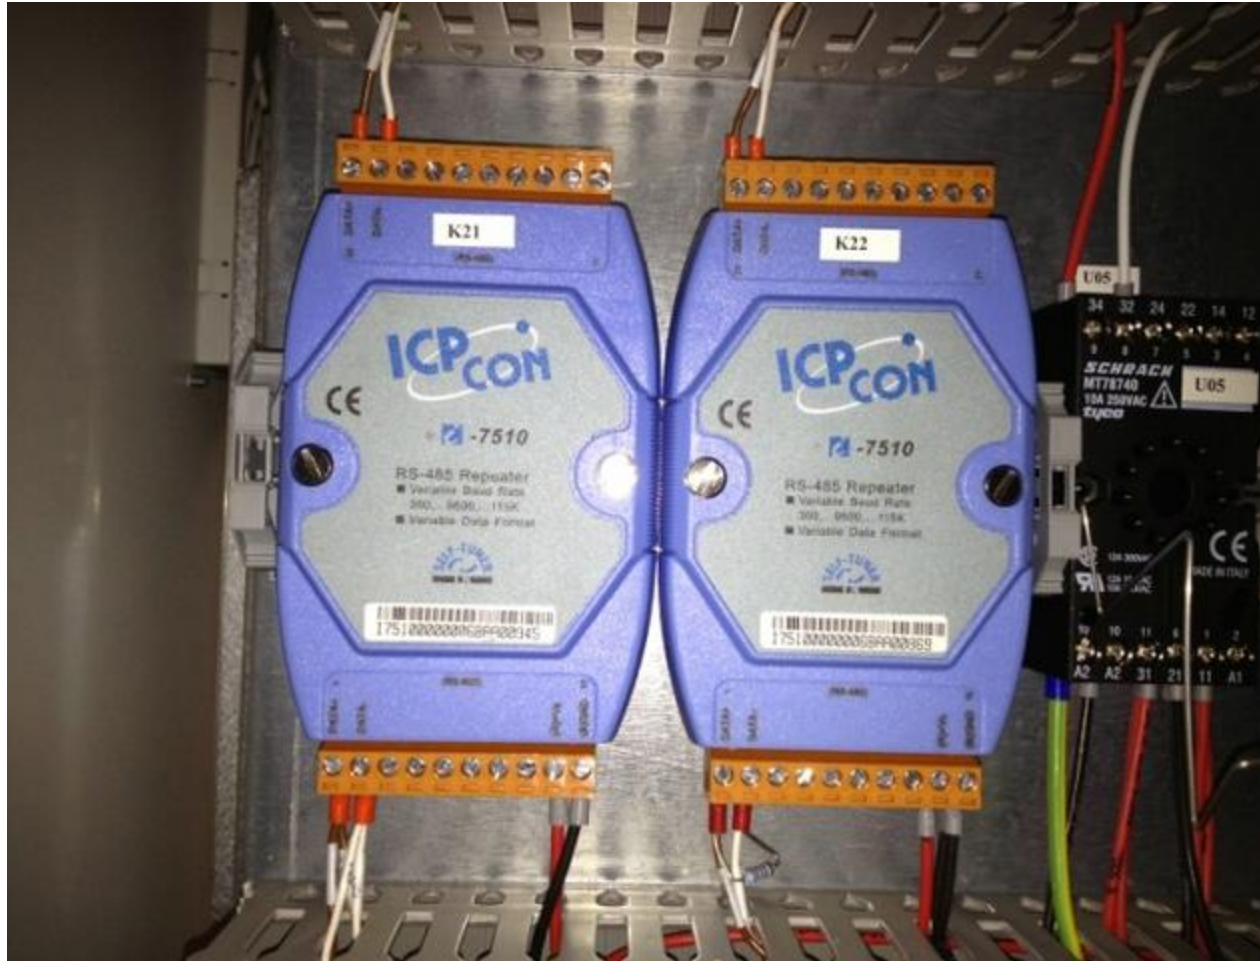
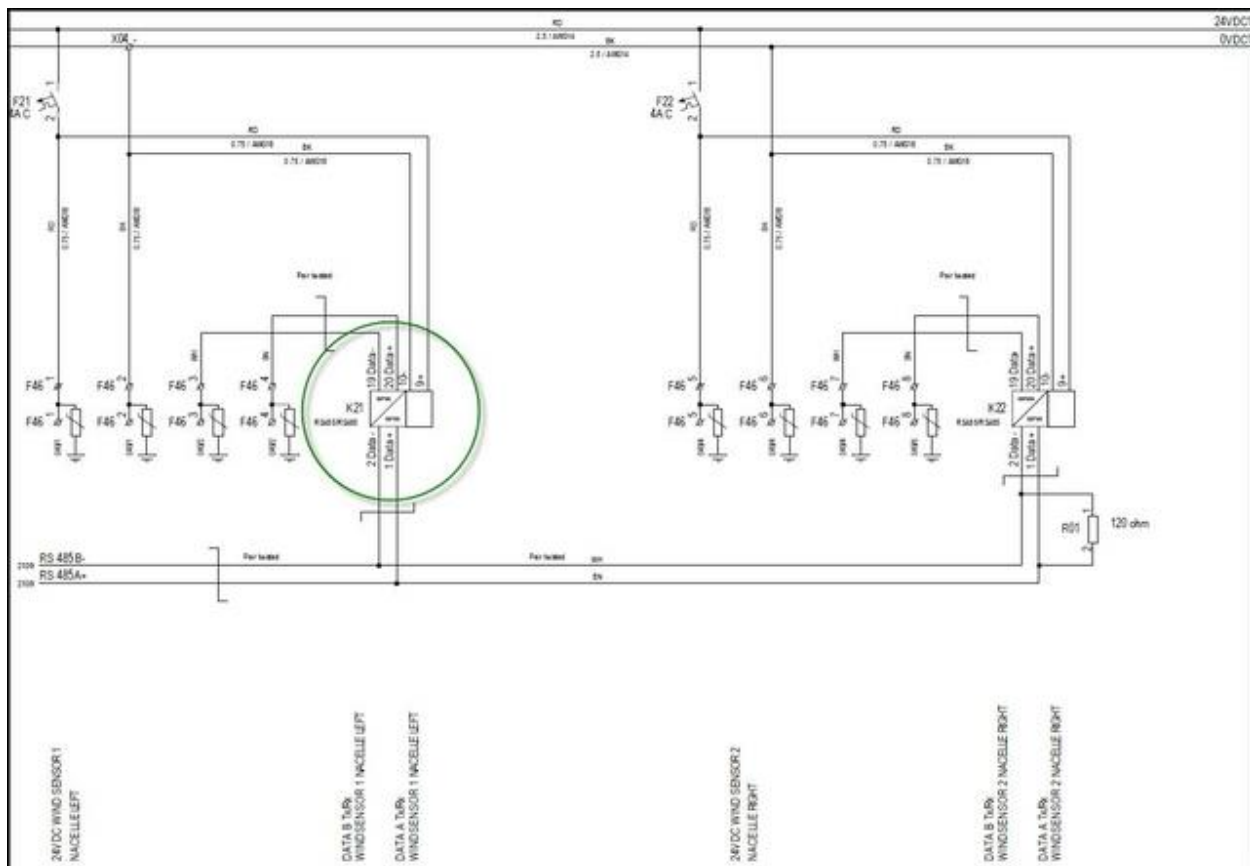
Check the connections at RS485(K21) repeater and Check led status, One LED for power "ON" glow continuously other LED for signal transmission blinks if the LED not glow change the RS485 repeater.

Relevant spare parts	
Description	Item No.
RS485/RS485 REPEATER I-75	<a href="#">60004933</a>

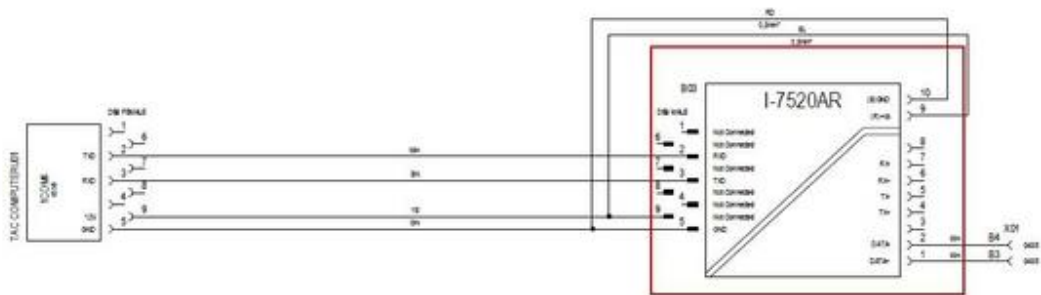
Check the connections at the ICP RS232/RS485 converter in the AT2 panel. Check for loose wires and plugs or corrosion at the converter.

The below errors also may occur due to this defective converter;

Description	Item No.
RS232/RS485 CONV I-7520 ICP	<a href="#">60004927</a>

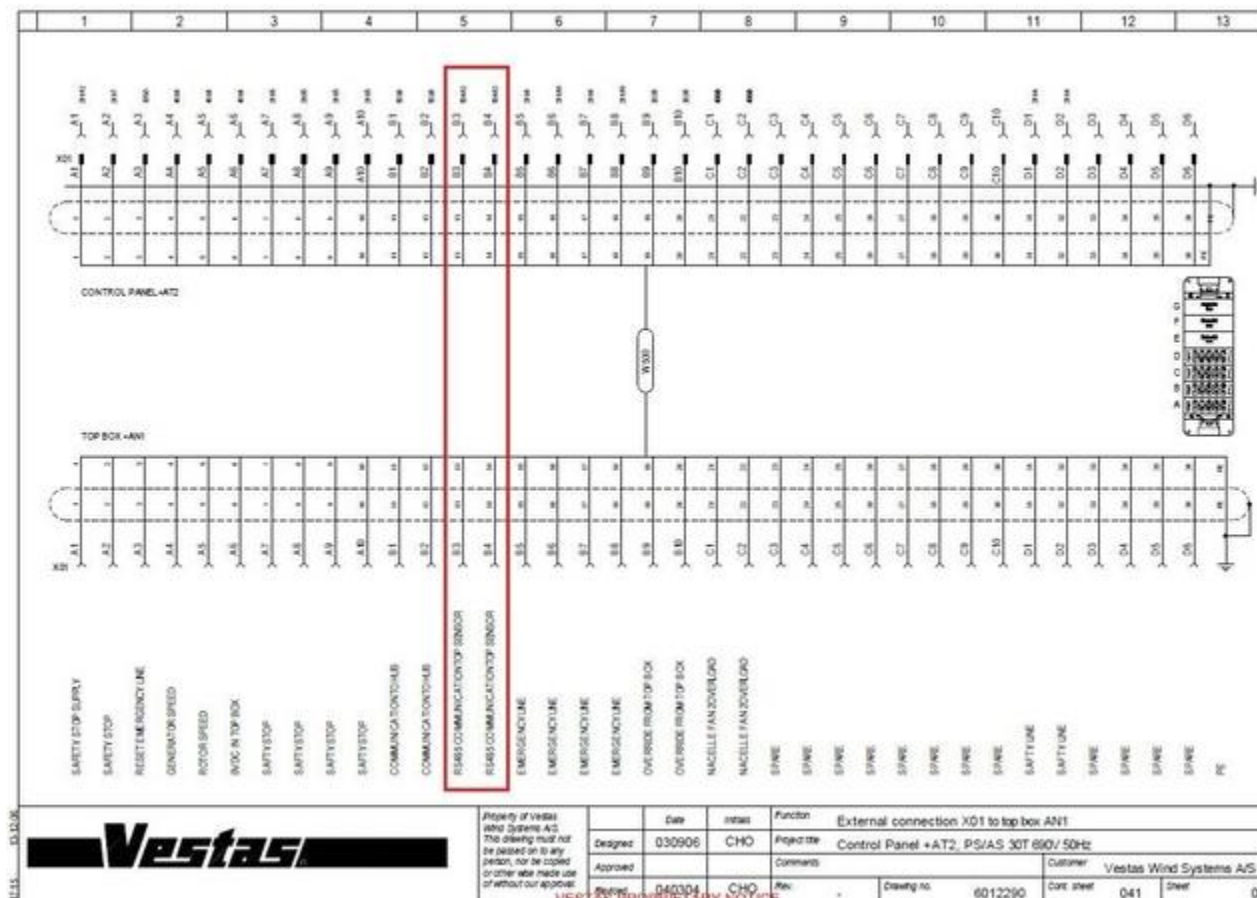
Check the continuity of B3 & B4 cores in cable W500 and replace with spare core, if no continuity.

The below errors also may occur due to this defective cable core;
