**Replace the defect TAC84 module**

## Replace the vibration sensor

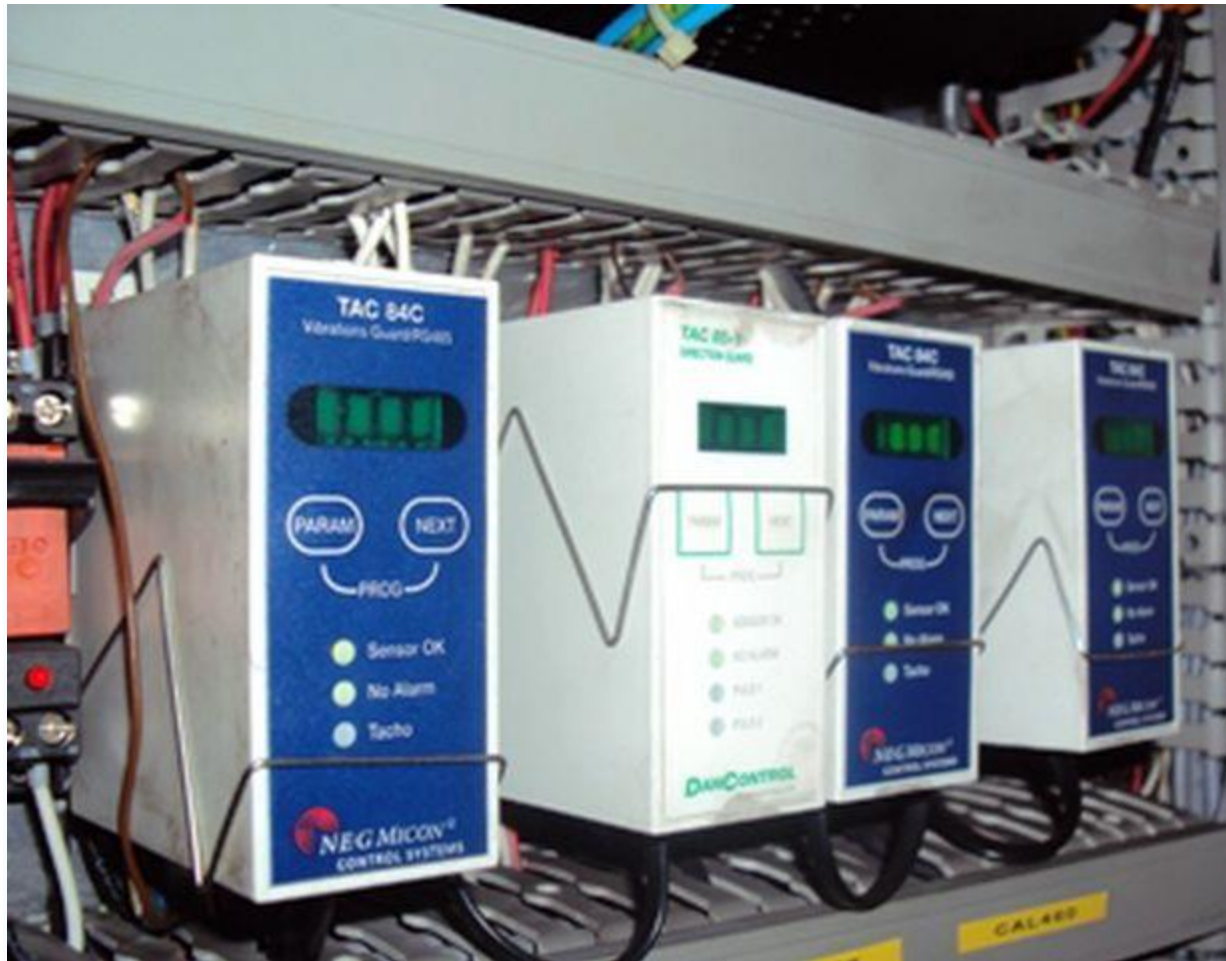
Check the TAC84 module parameters as per instruction

Settings for TAC 84 Edgewise blade vibrations

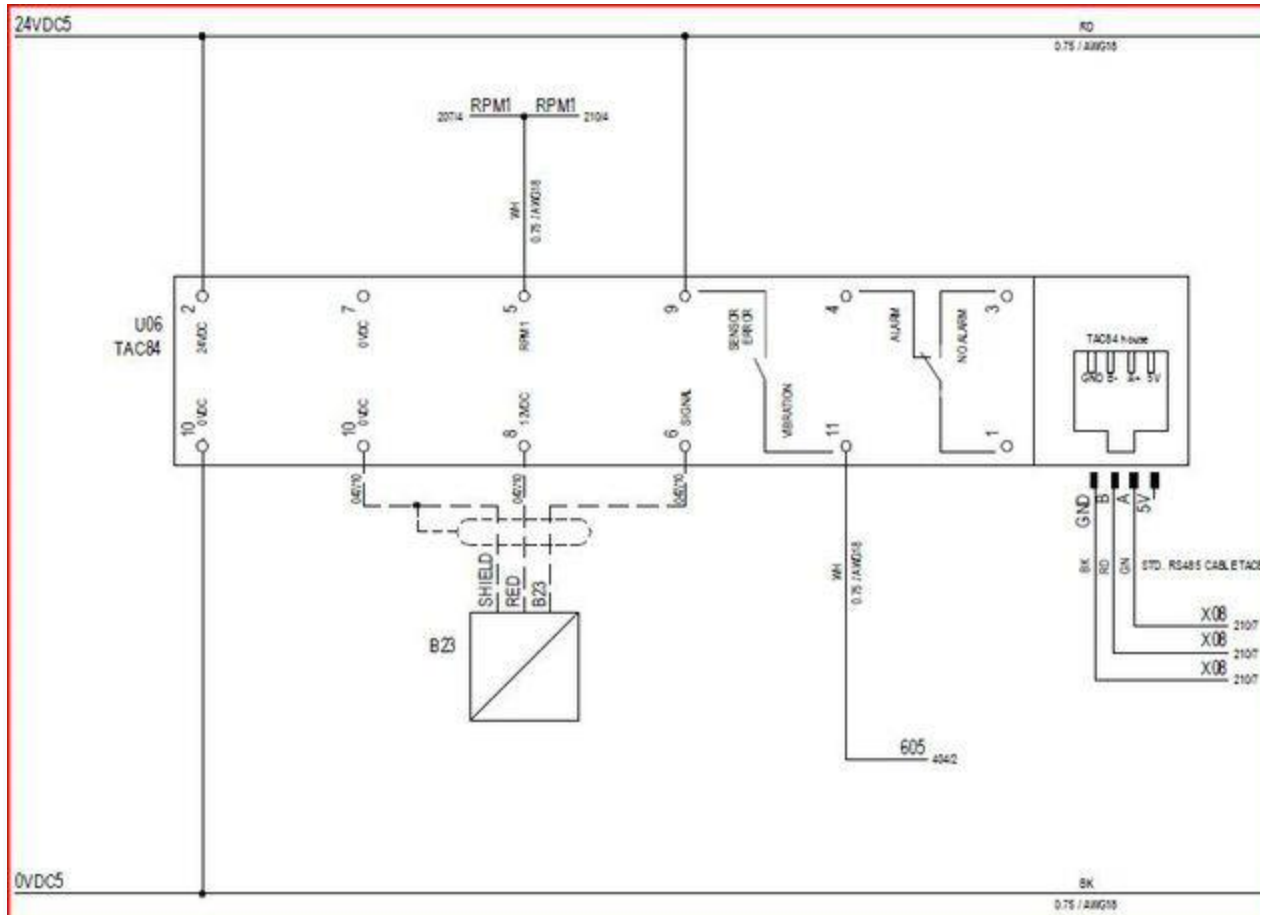
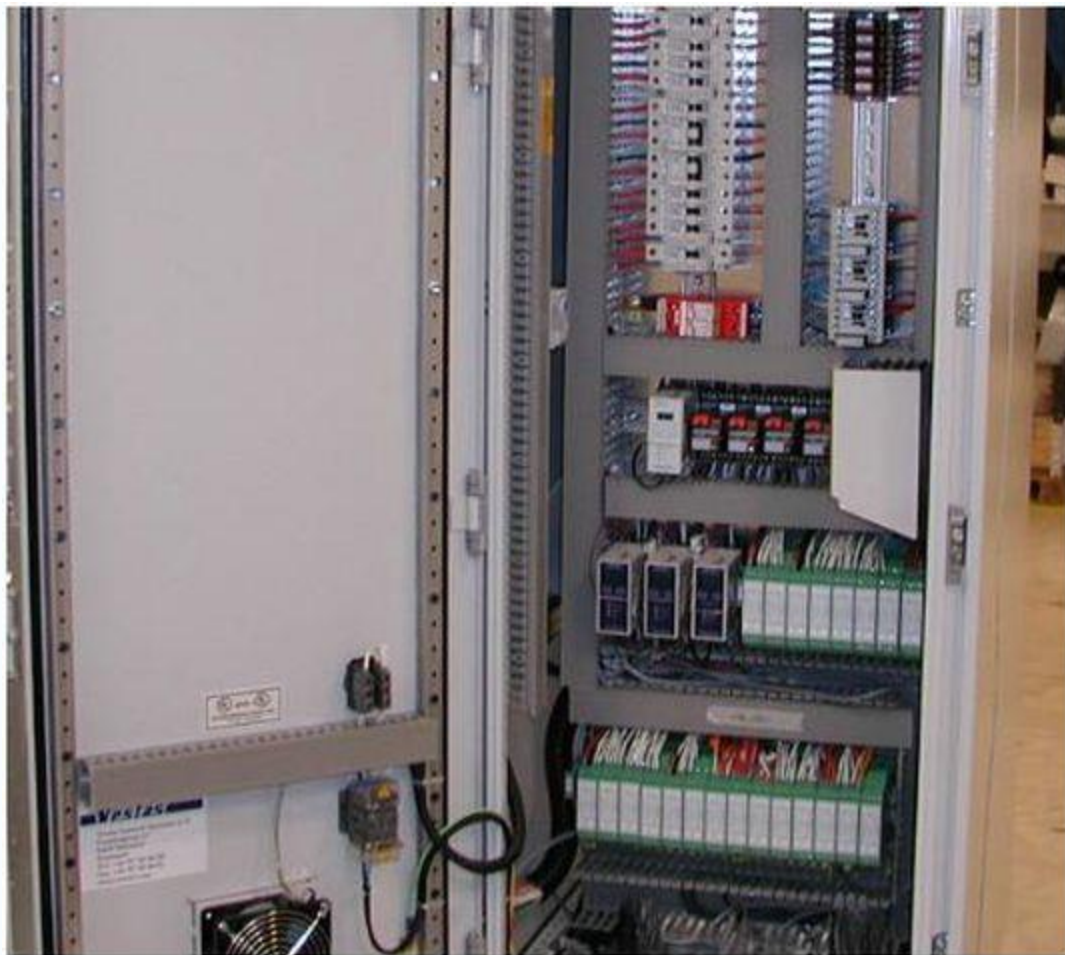
Check the TAC84 - Downwind module for any loose connections.

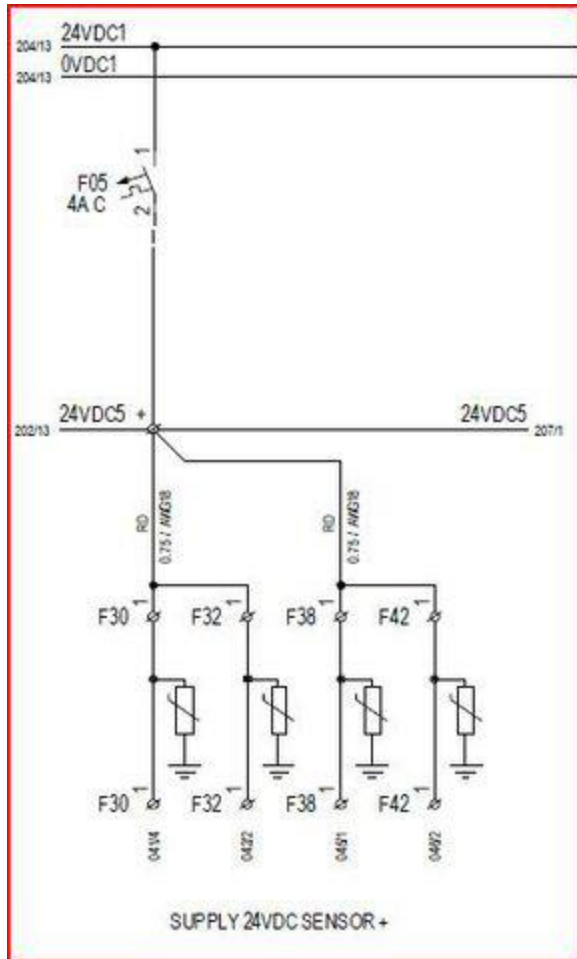
Check the 24VDC5 circuit including power supplies G05 & G06 and F05 circuit breaker in the +AN1.

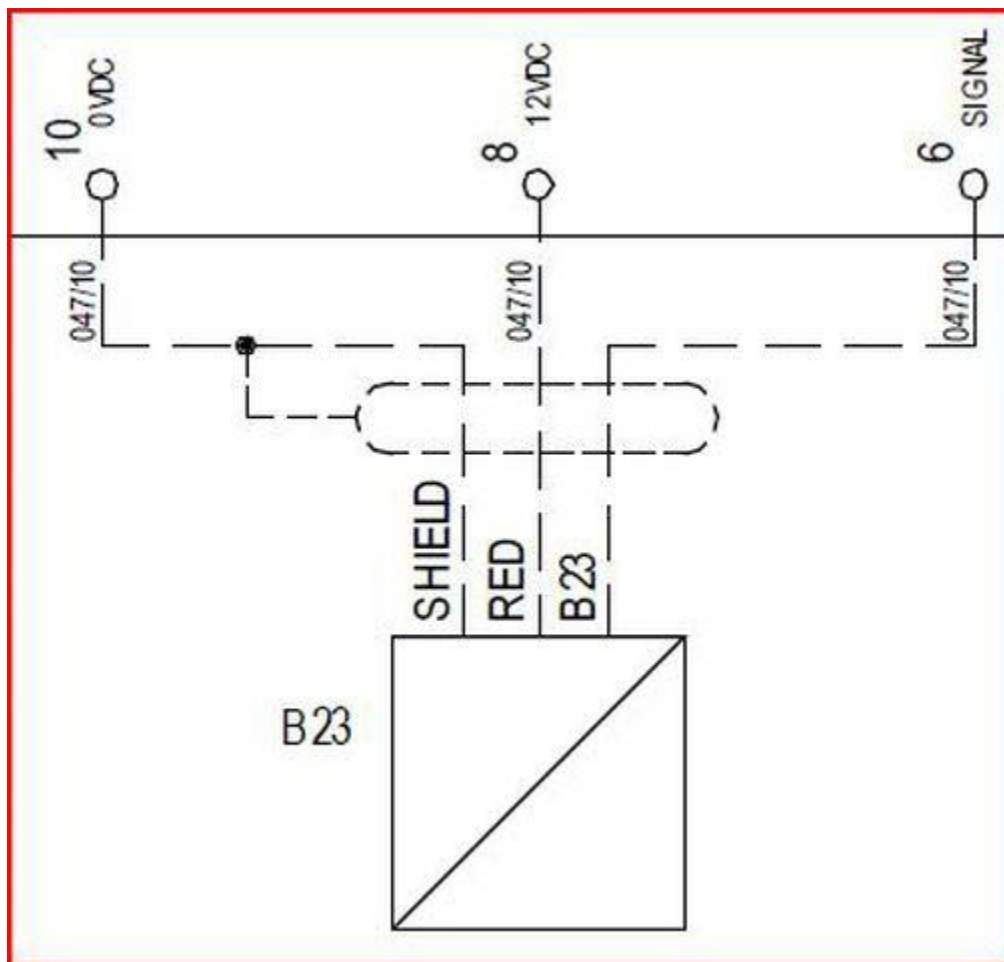
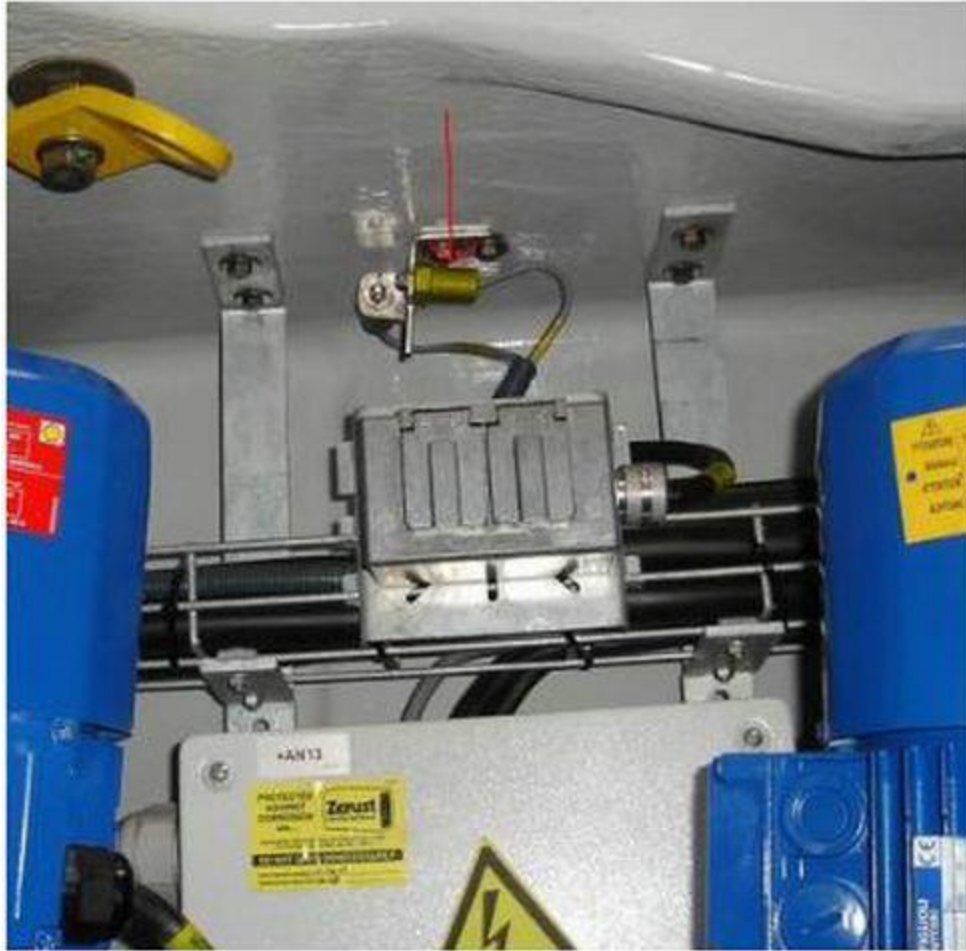
Check the vibration measured properly through TAC84 module.

If found defect replace the vibration sensors

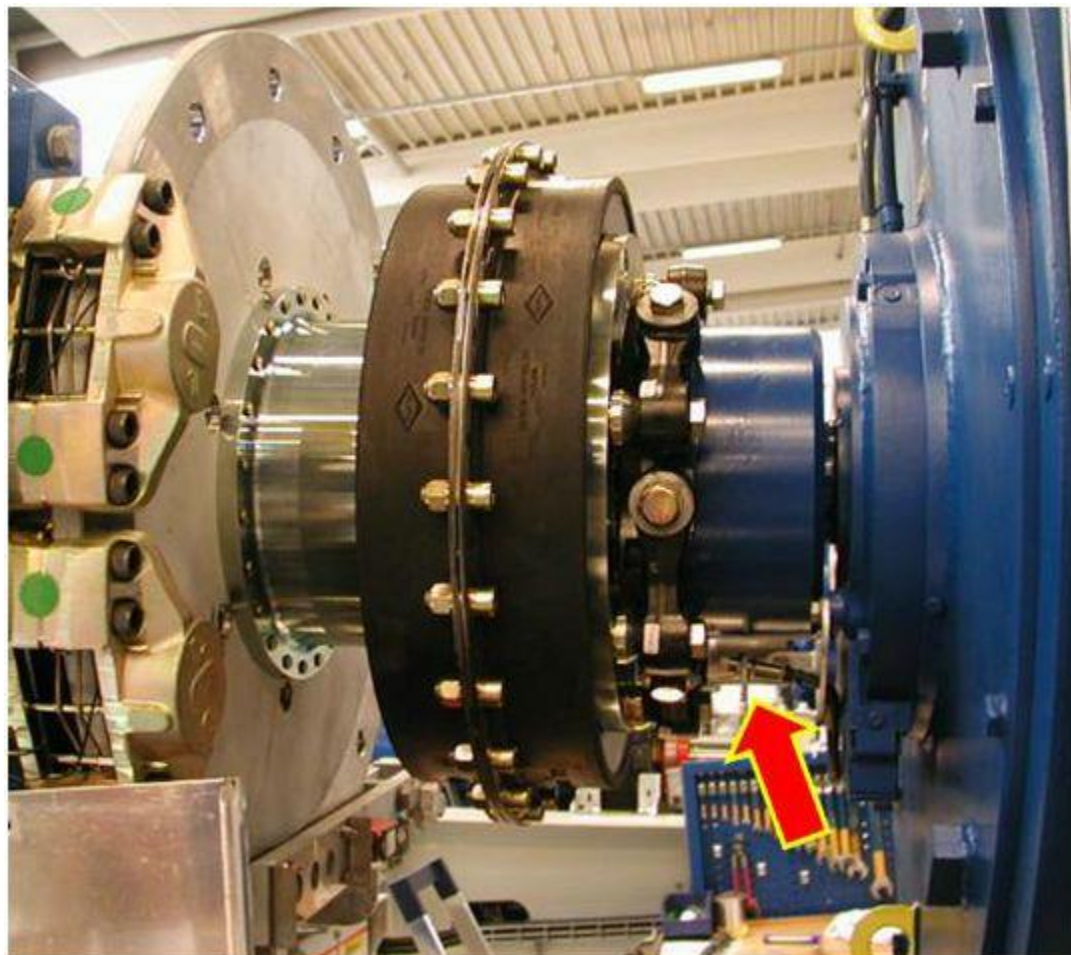
Check the generator speed sensor for any physical damage or dirt.

Check the speed measuring value through TAC84 Module

If found to be defective replace the sensor.

Adjust the distance between the Inductive sensor and the scanning points as per Instalation and service data.

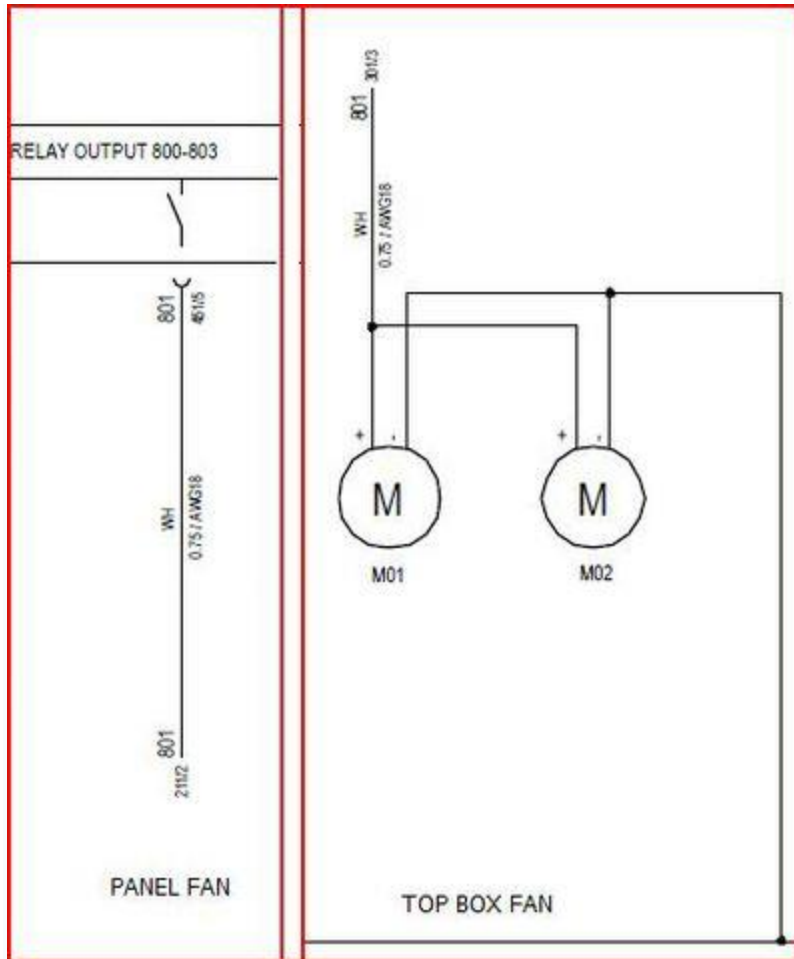
**MK1 and MK2: (24V DC)**

Check that the top box cooling fans are working as designed. High temperature in the AN1 cabinet may cause the relay inside the TAC84 module to malfunction.

If one or both of the AN1 cooling fans are found to be defective, replace them with new.
