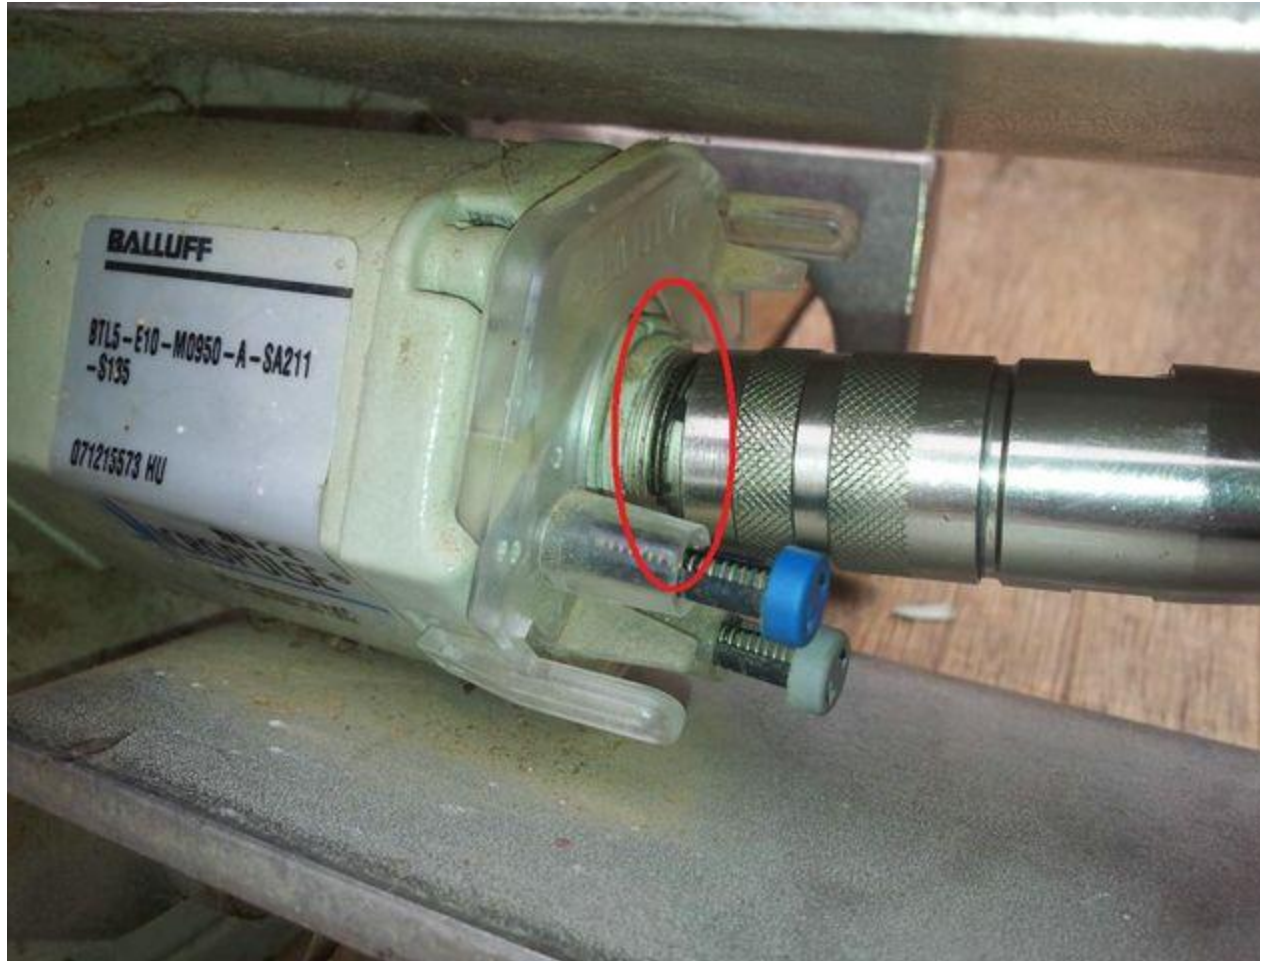
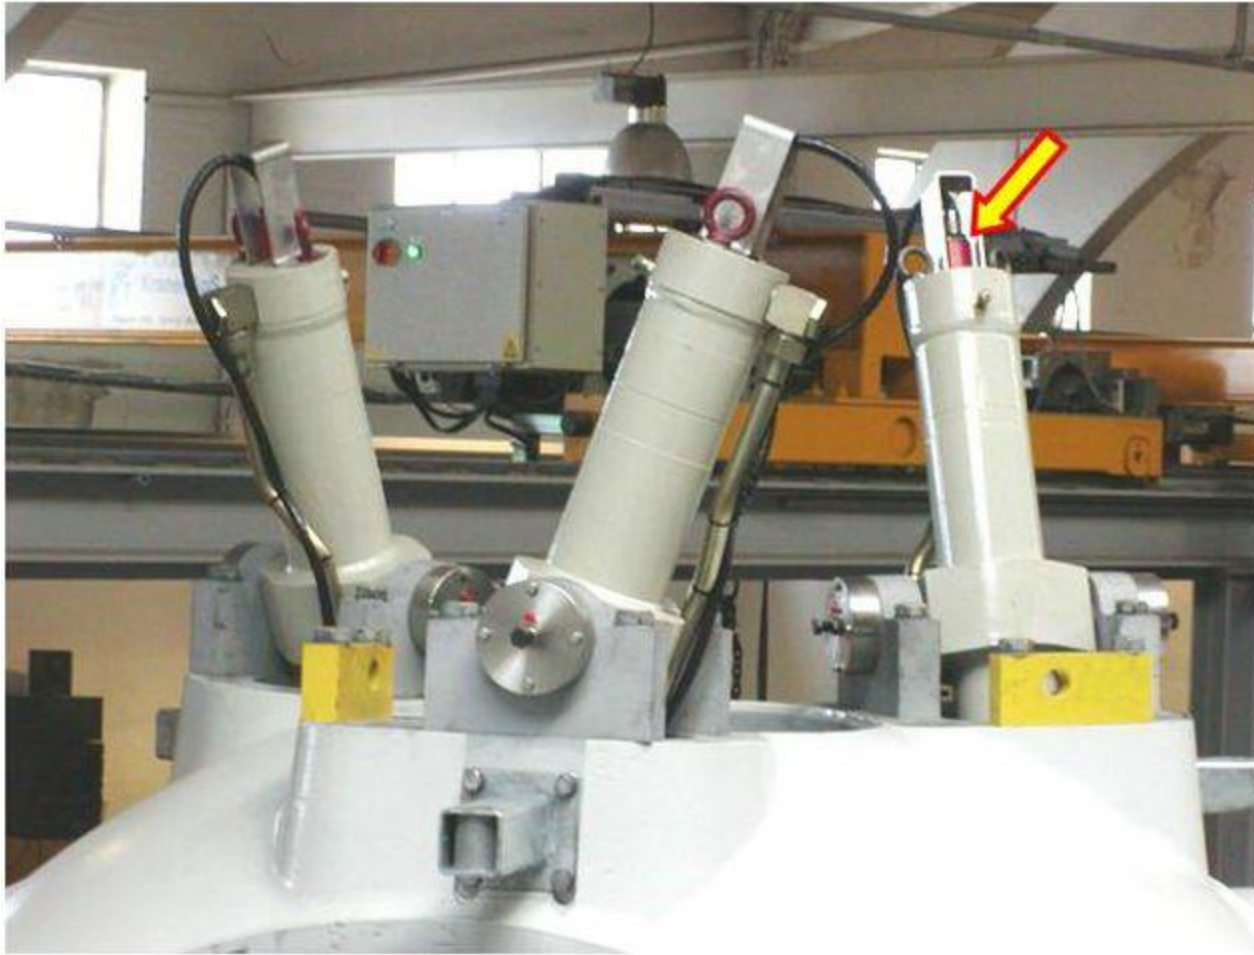
Check for any loose connections in the hub computer terminal X19.

Check for any loose connections on the Blade position sensor.

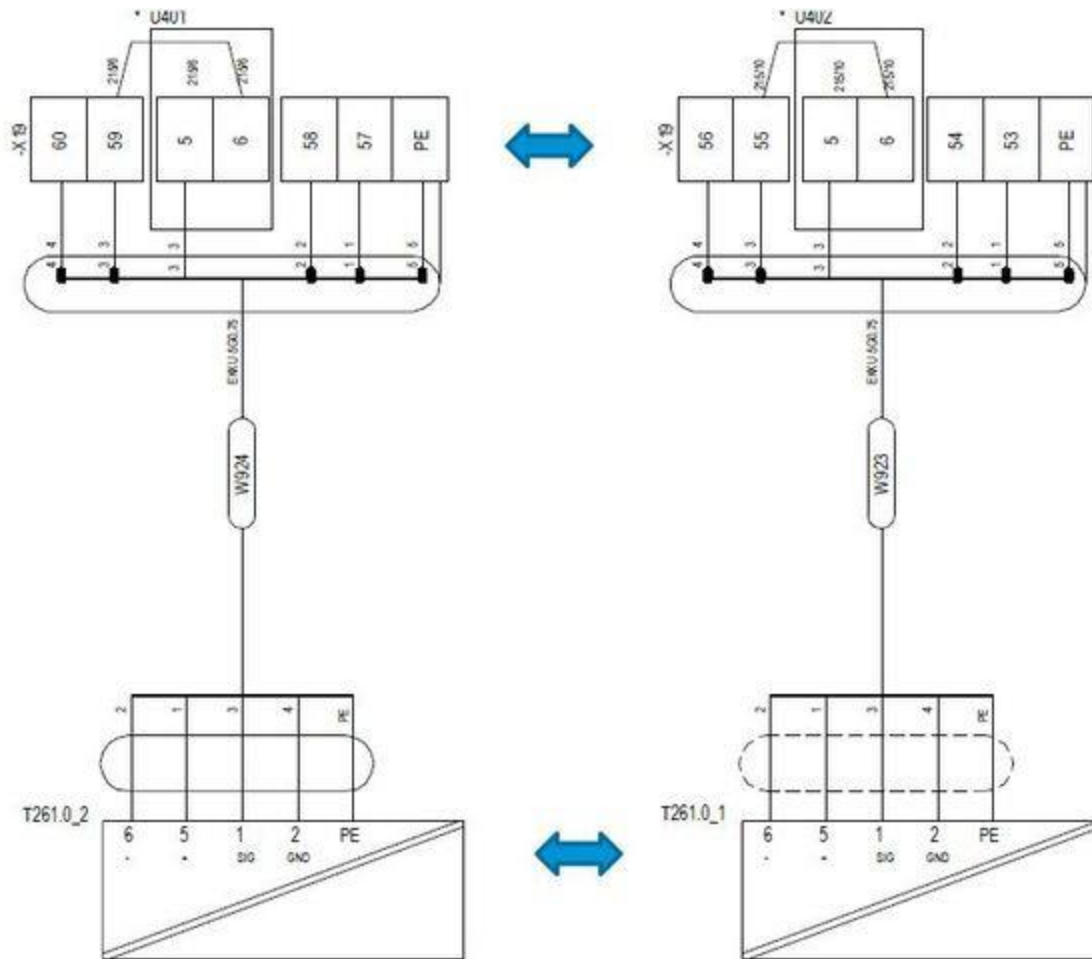
Swap the signal wire to the position transducer (Balluff) on the hub computer. If the fault follows to the new blade then the fault is either in the position transducer or one of the cables.

In the example below, we are swapping the plugs between blades C and B.

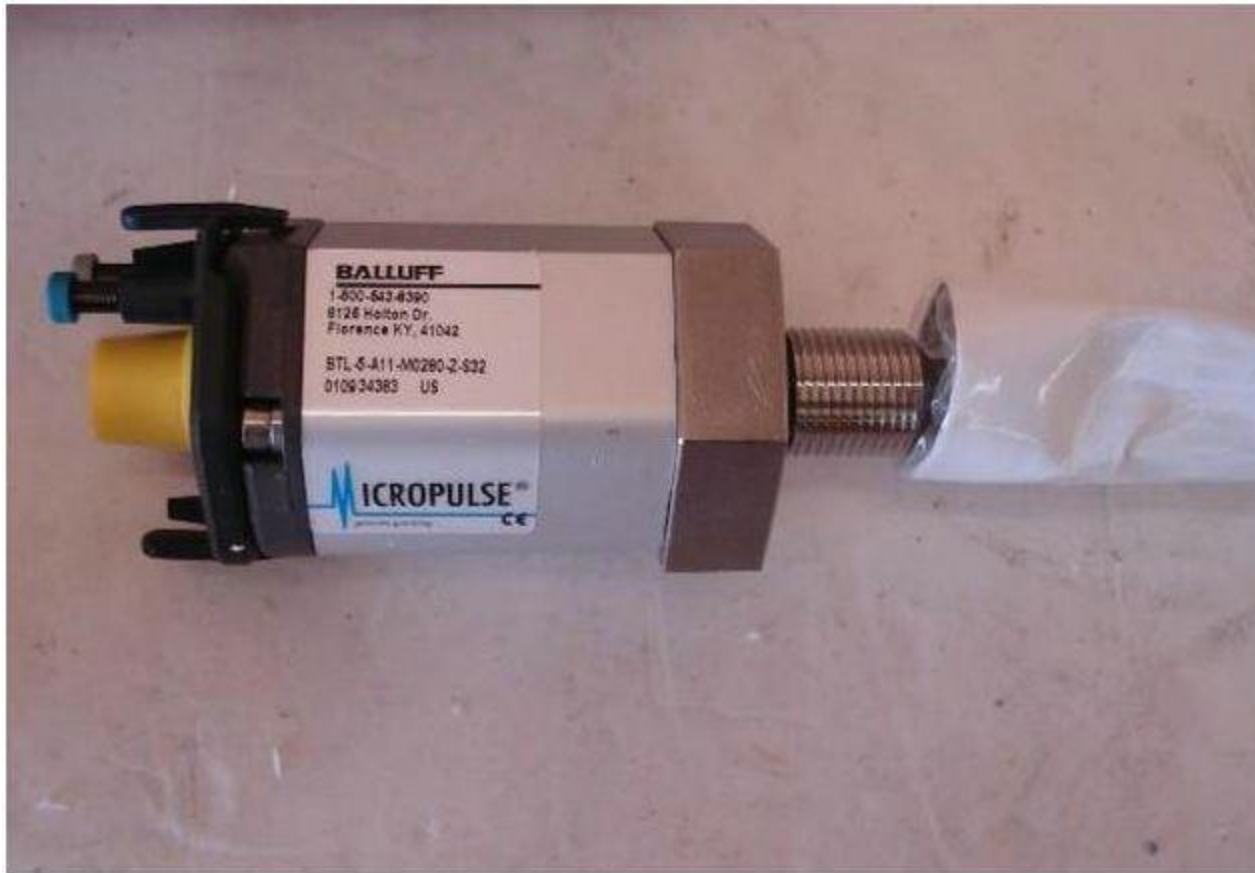
Pitch position sensor

Place the cables back to their original position and then swap pitch position sensor from affected blade to another working blade.

If the alarm follows the valve to the other blade, the pitch position sensor is defective.

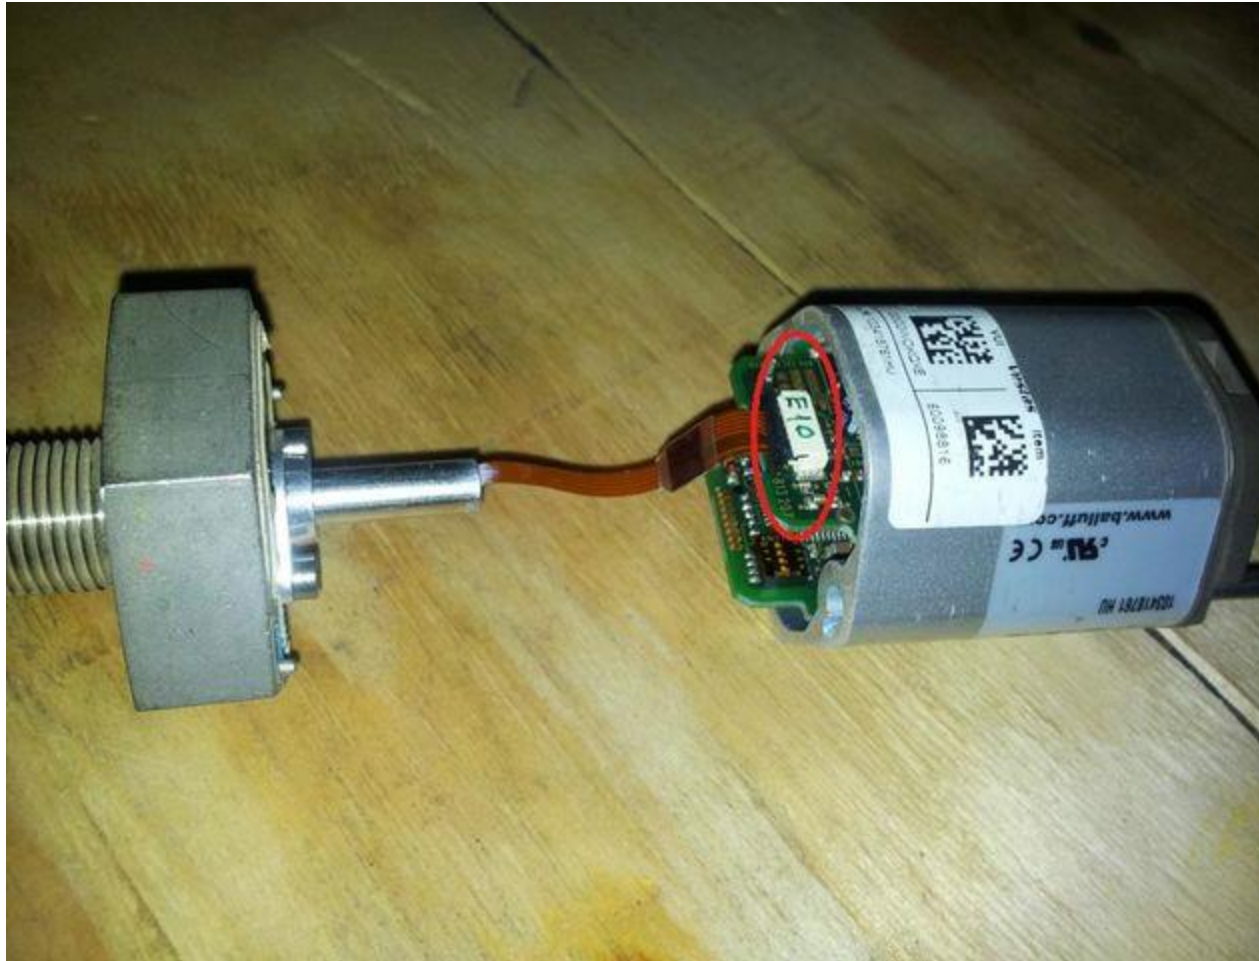
Service Module

Check the cable for any or short due to the cable rubbing near the hub casting or friction between the cable and the hydraulic hose.

Replace any defective cables.

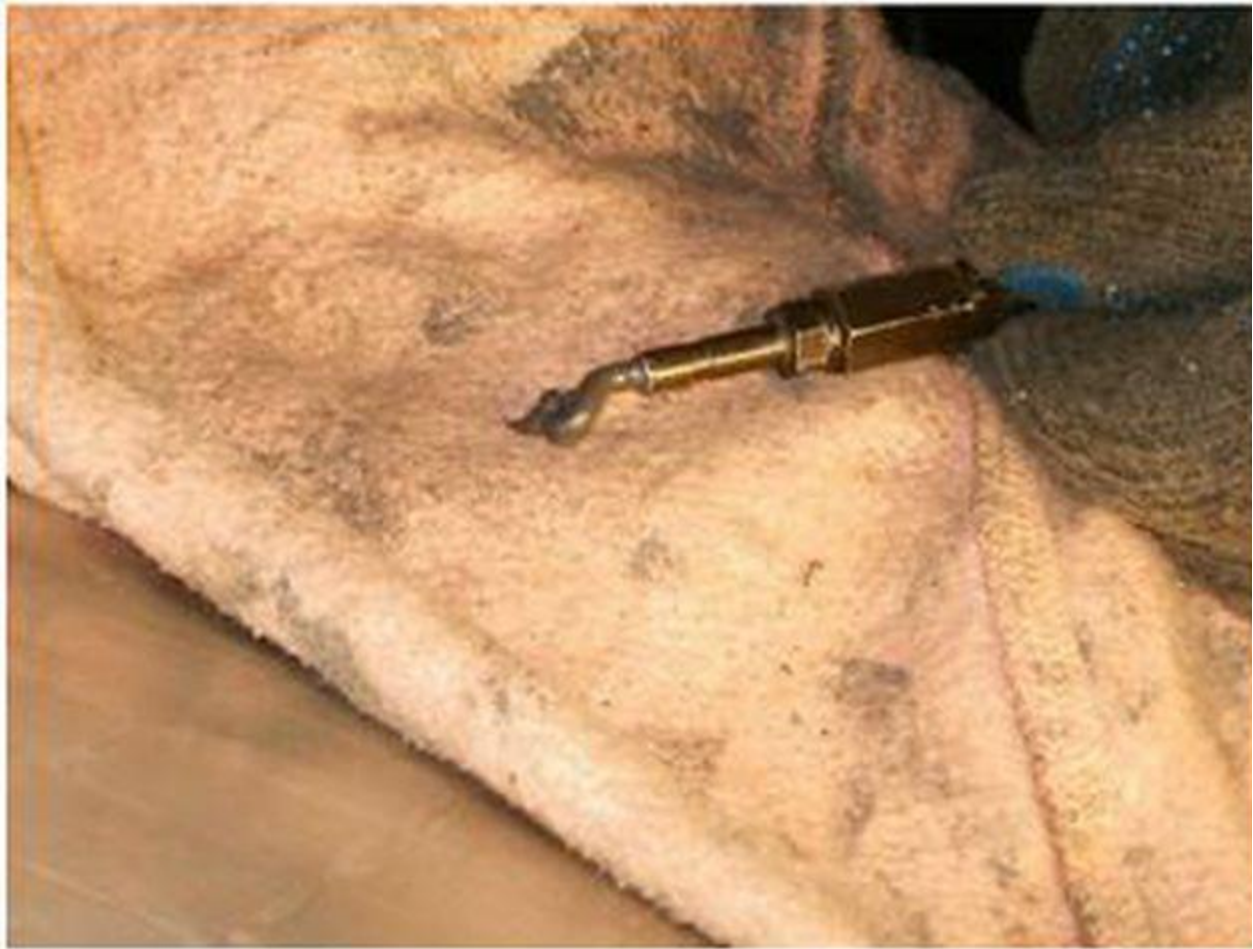
Check that the grease flows from all of the ports:

Inspect for any damaged hose fittings, manifold grease blockage or hose damage.

If necessary replace the manifolds and hoses.

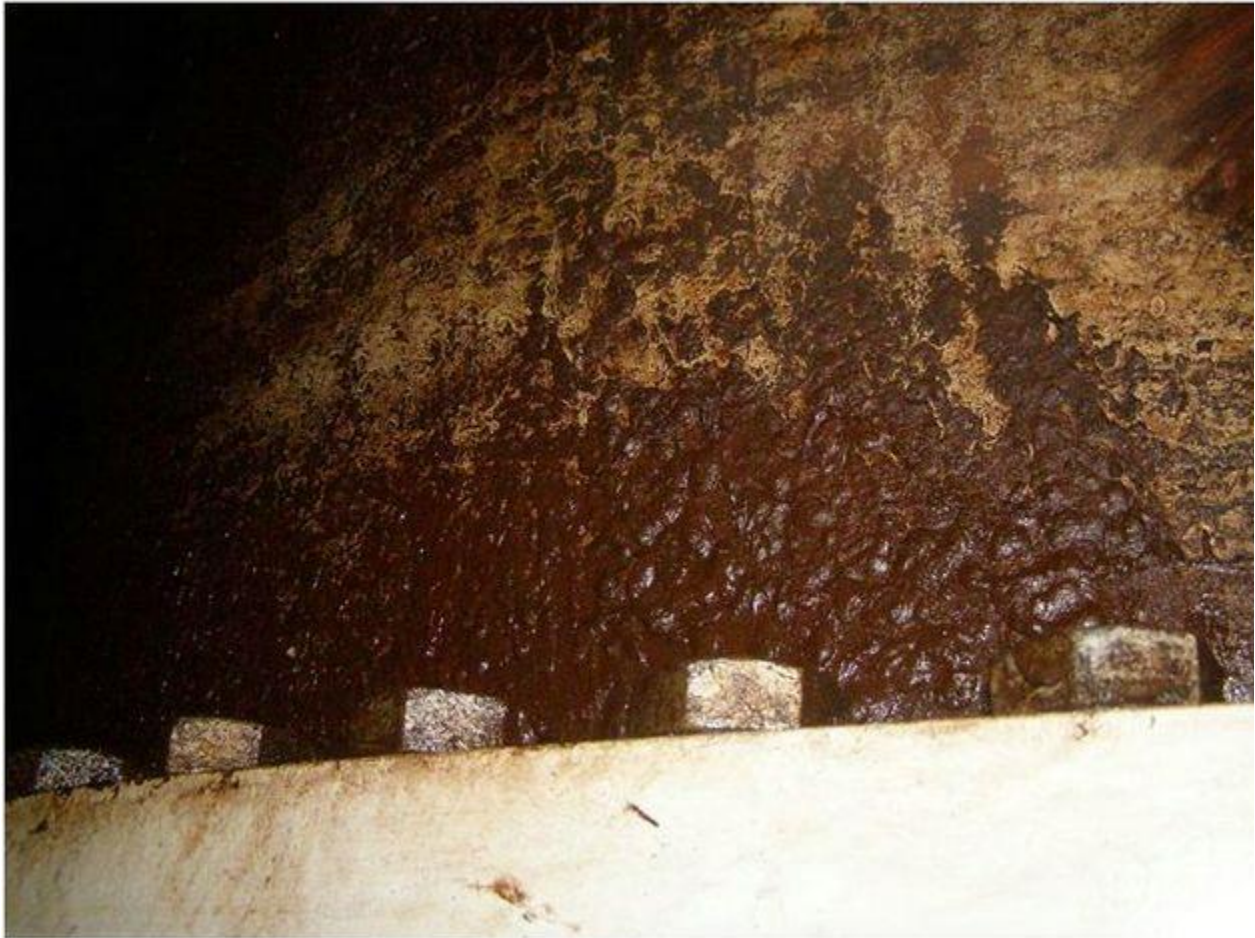
Check blade bearings for any grease leak.

Check for grease or oil stains on the blades and spinner.

Check the hydraulic system for any leaks, isolate and repair any leaks if found.

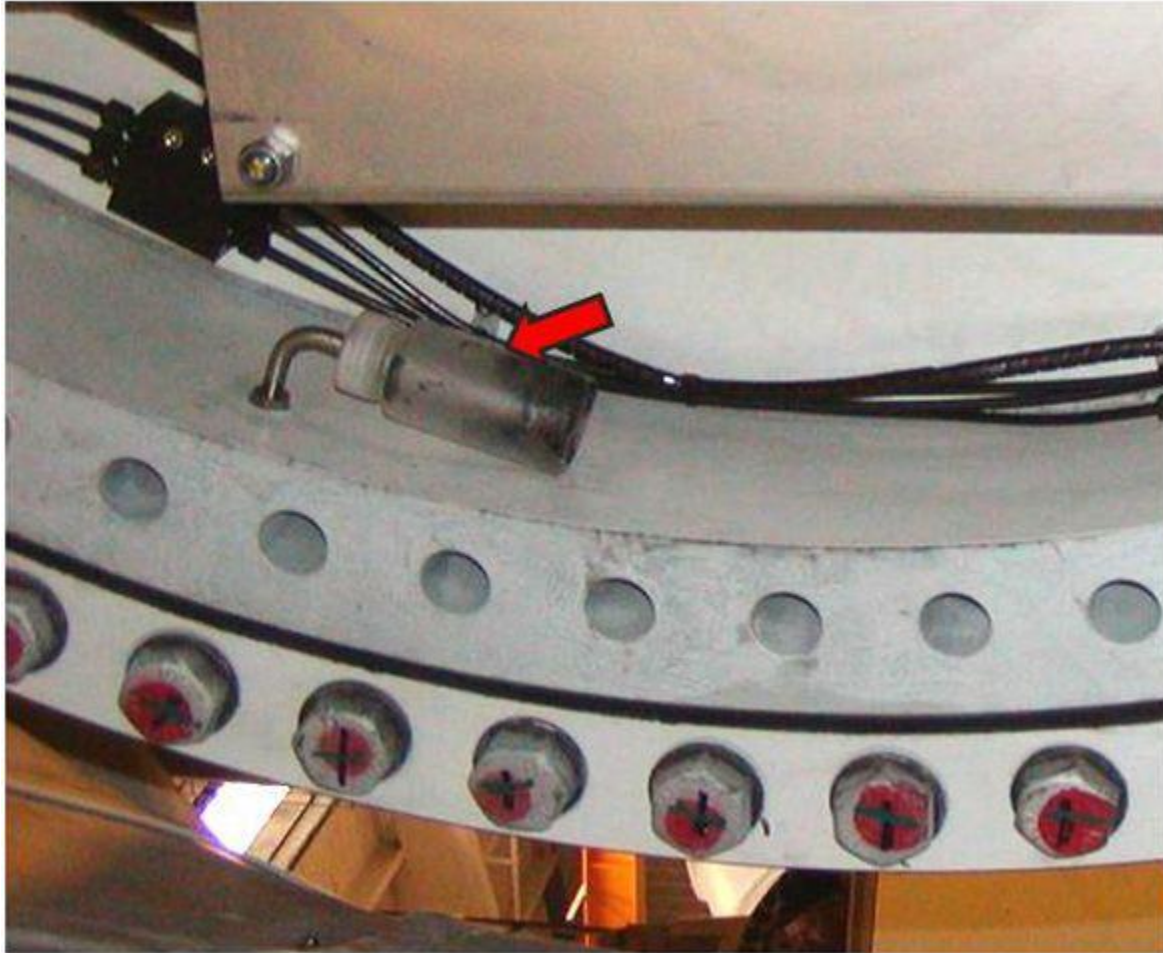
Check the grease collector bottles in all blade roots. If there is a large volume of oil in the hub or evidence that oil has

penetrated into the bearing, perform a manual greasing operation on all of the blades.

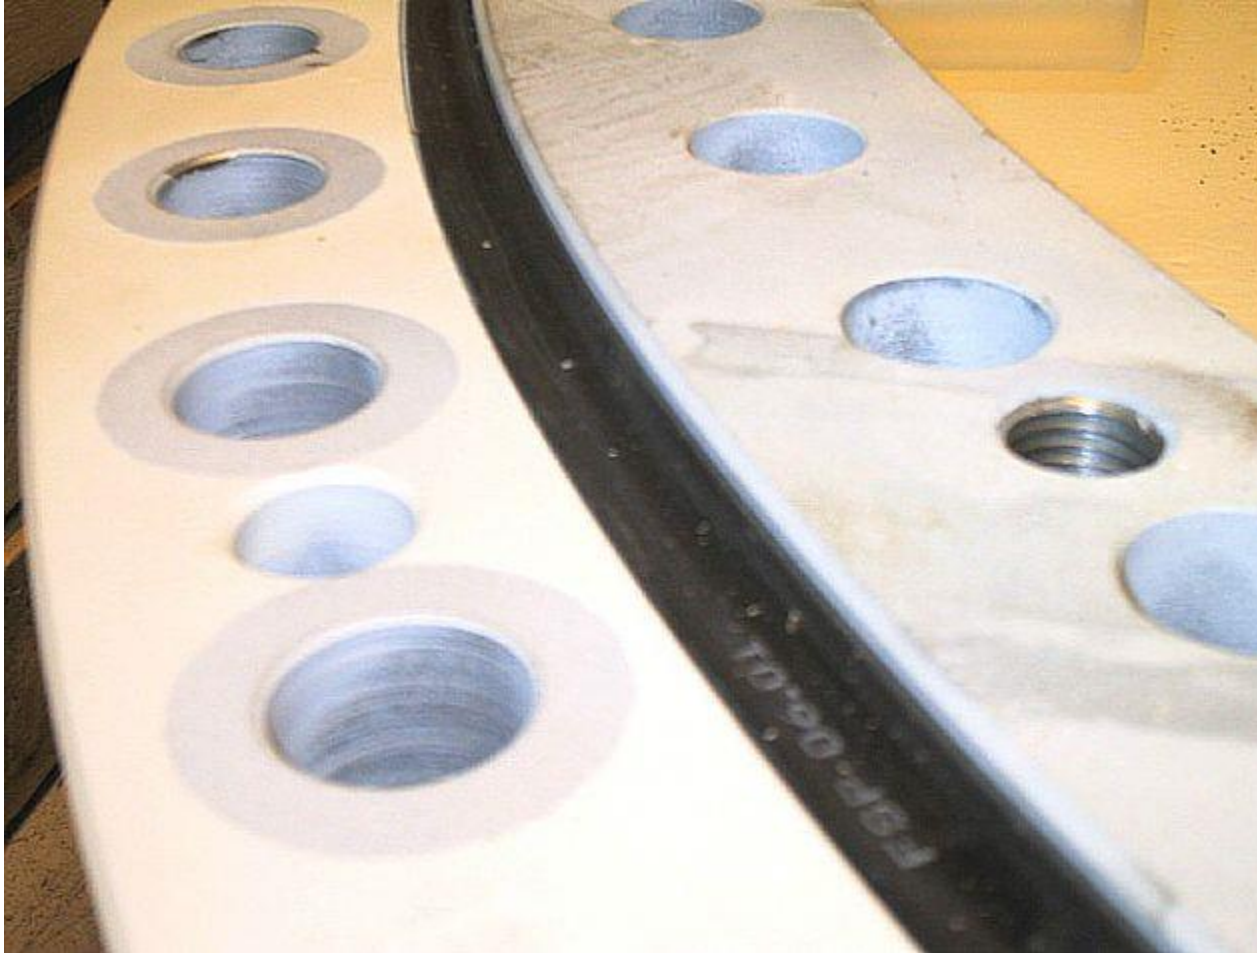
Check the inner and outer blade bearing seals.

If there is any damage or heavy grease leak replace the seals.
