Troubleshoot/Replace PT100

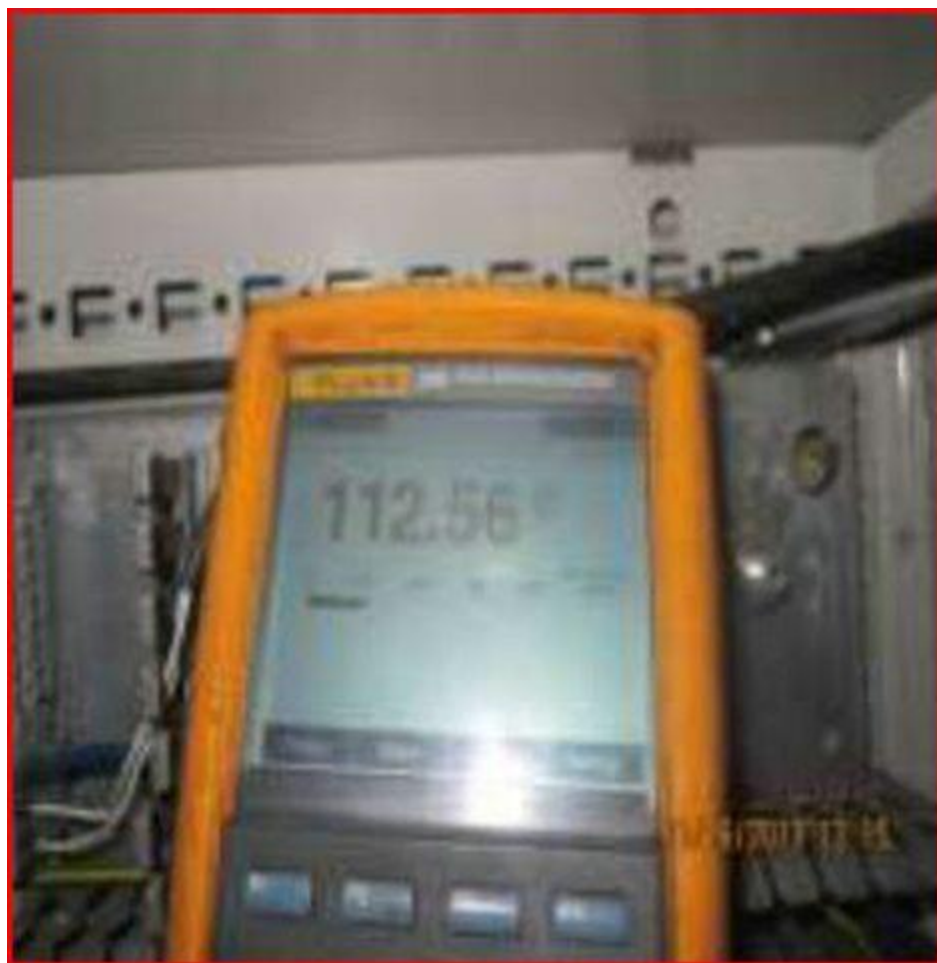
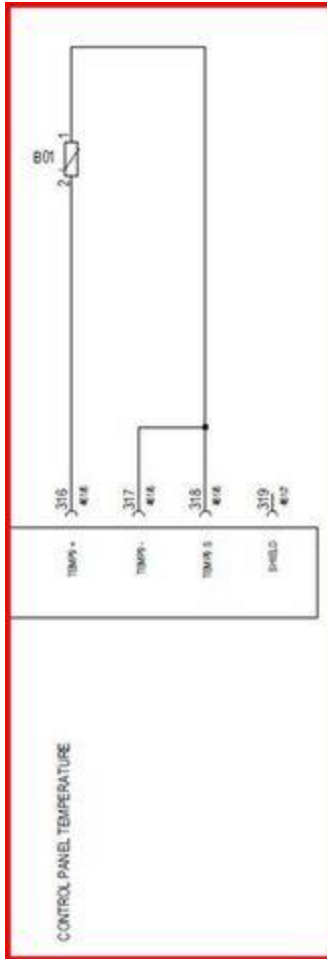
60009279- PT100 18042M Ø6x60mm

If the value is unreal (-40 to 200 °C), then the PT100 is faulty and must be replaced.
