Clean or repair Slipring

Replace the defective components

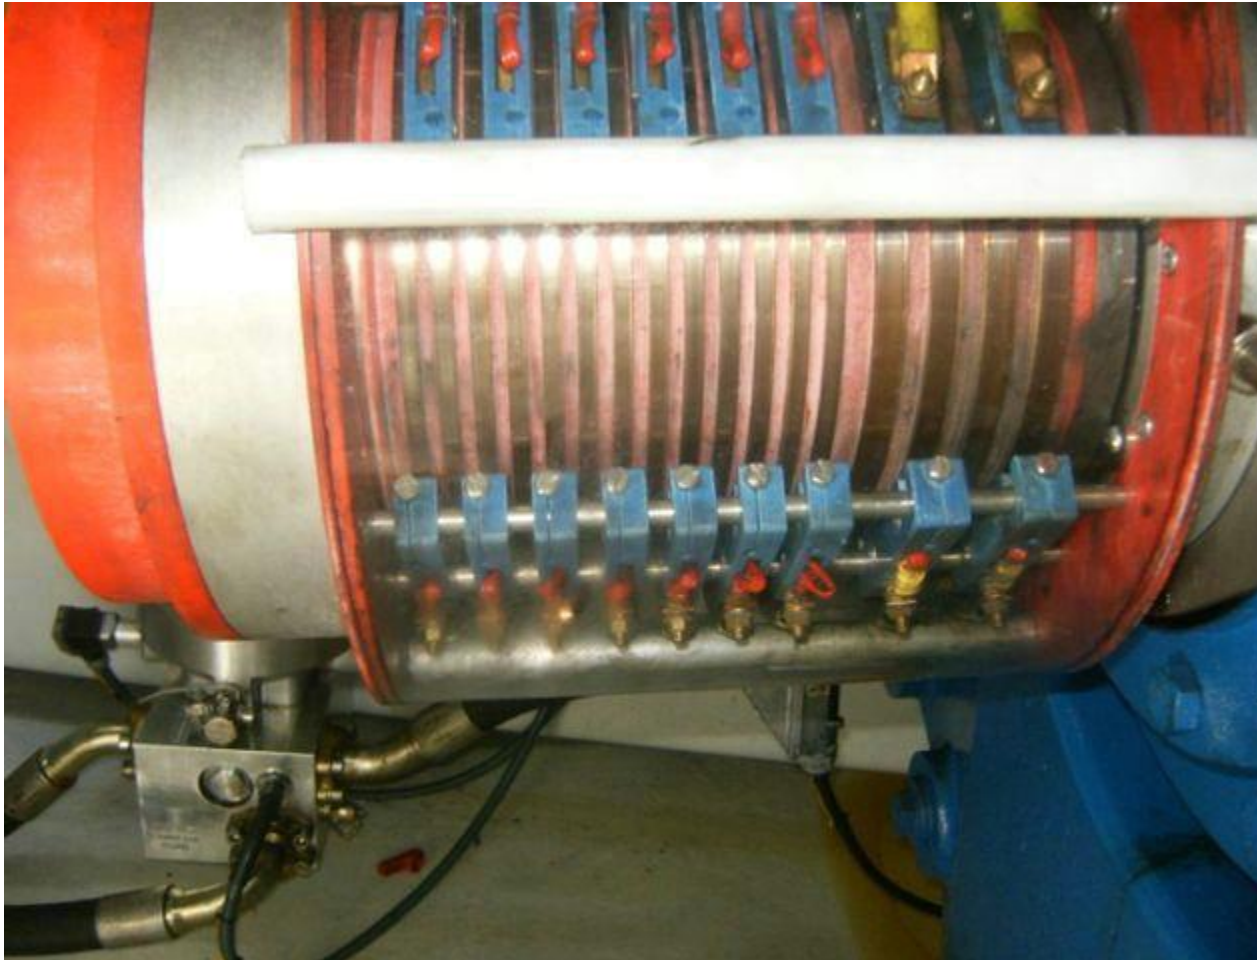
Check the condition of the Slipring, paying special attention to condition of brushes.

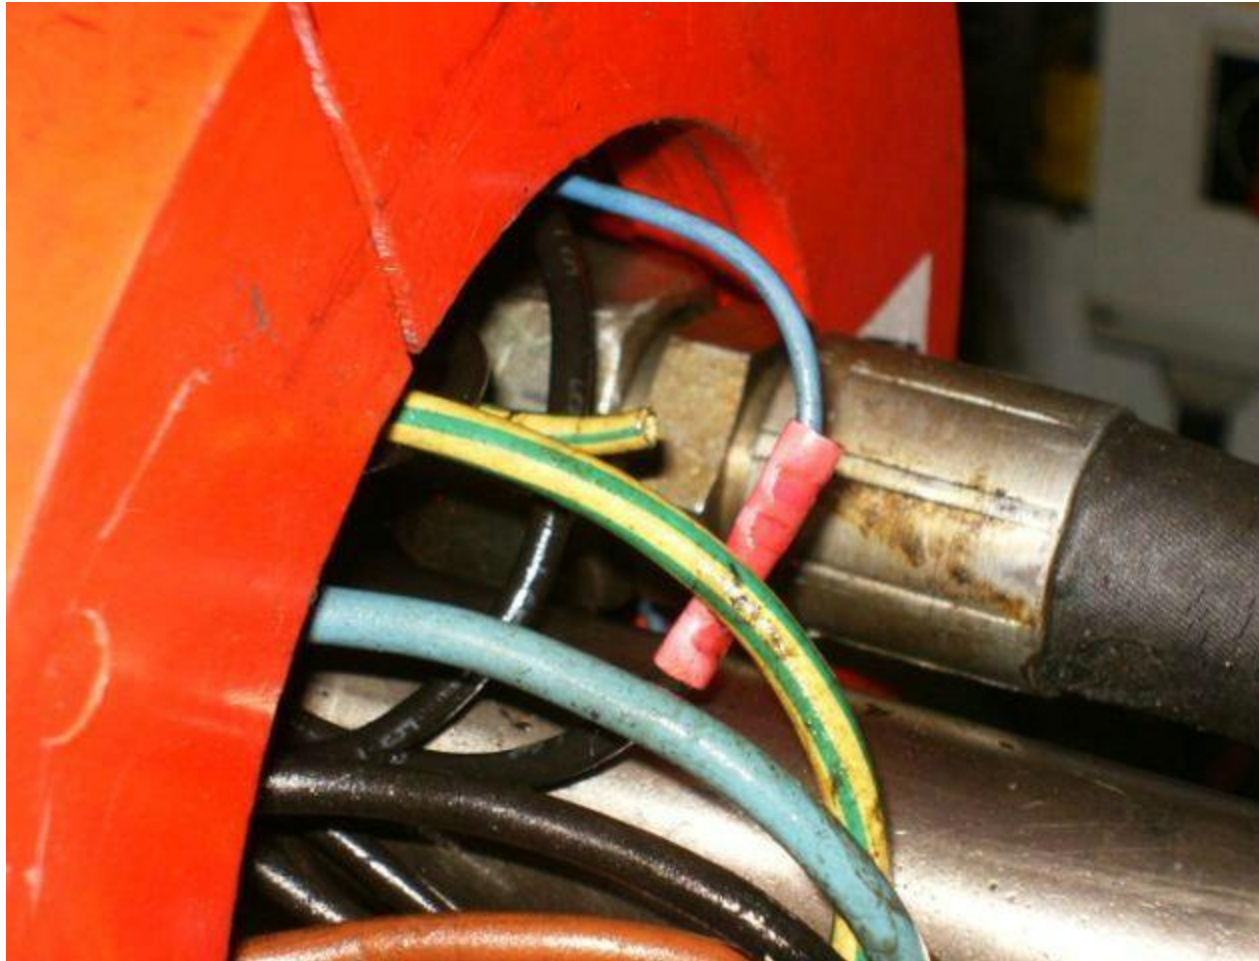
Check that the grub screws on the Slipring are tight and that the torsional retainer is not damaged. Inspect that the cables have not been pulled tight around feeder pipes inside the Slipring.

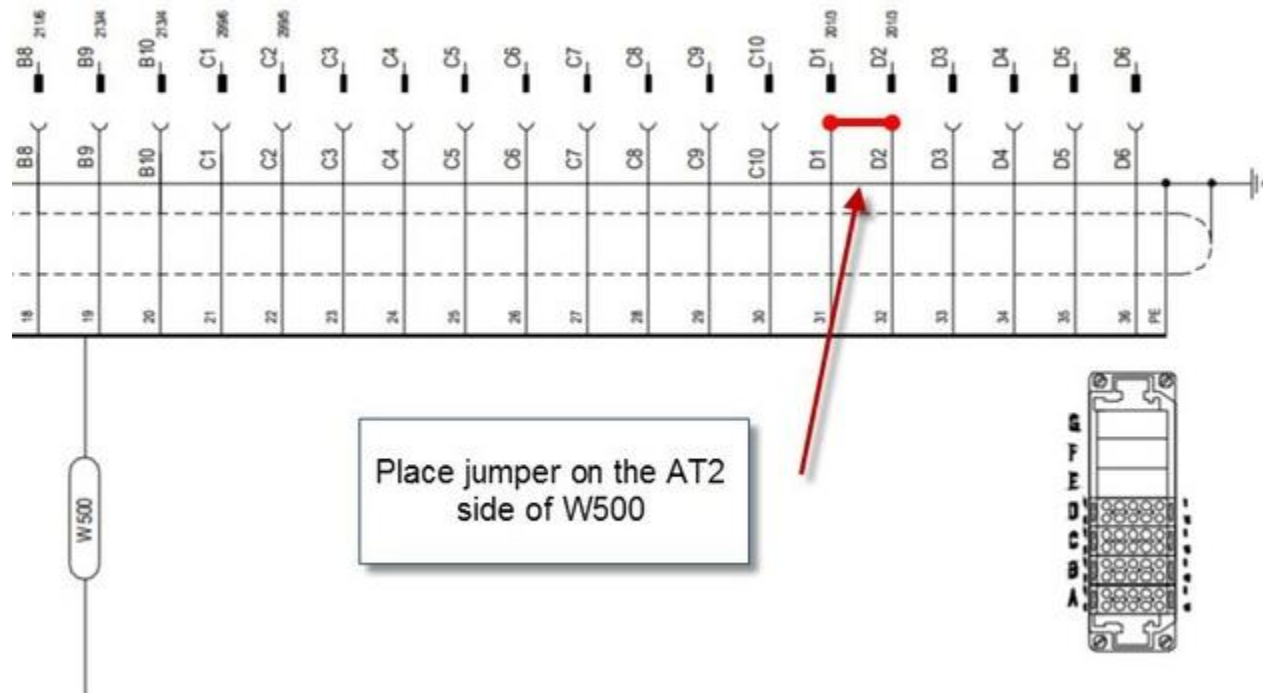
To verify whether there is a break in a wire, connect a jumper to the AT2 end of the W500 cable at terminals D1 and D2

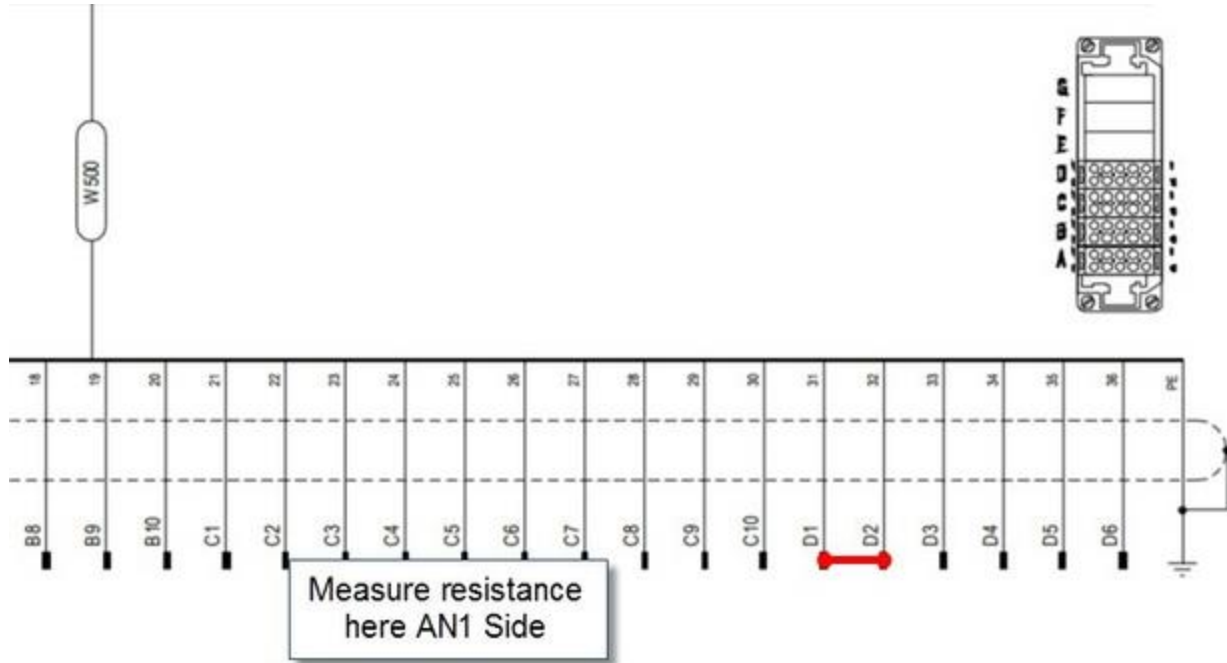
Measure resistance across pins D1 and D2 of the W500 on the AN1 side. Resistance should be small. If high resistance is measured, either wire 31 or 32 is broken. Use two of the spare wires (23-30 or 33-36) to bypass the break.

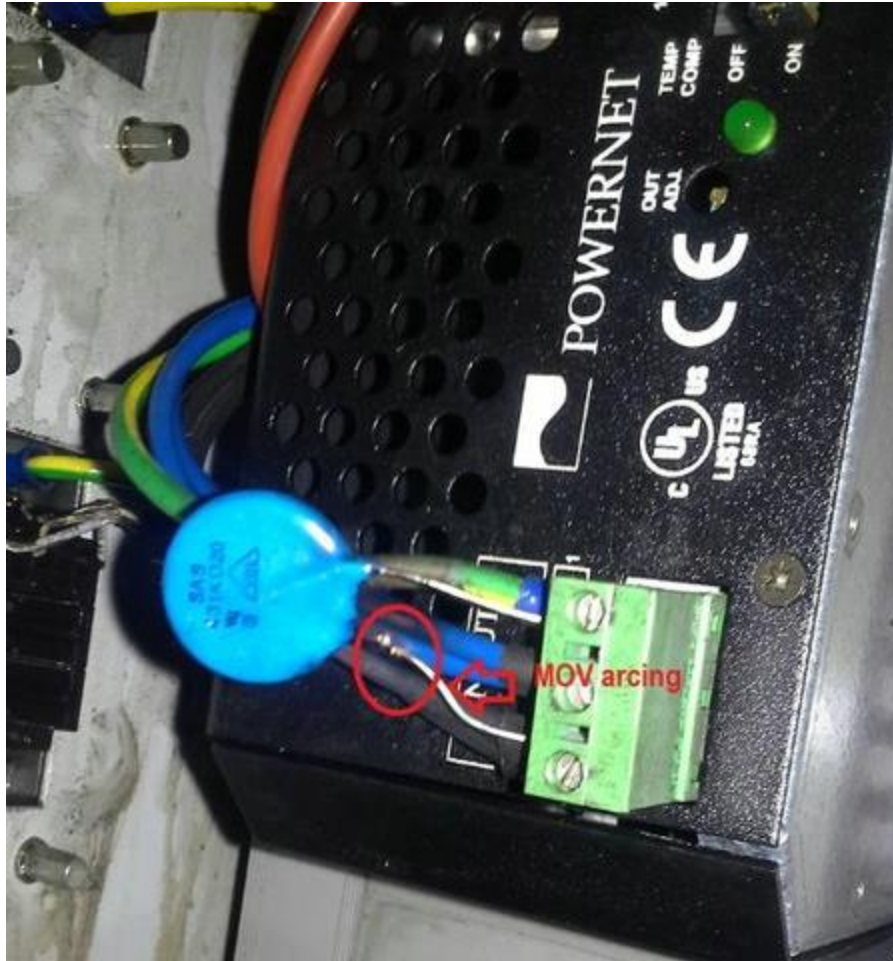
Check any loose connection and damage in the varistor fixed on G401 and replace if required

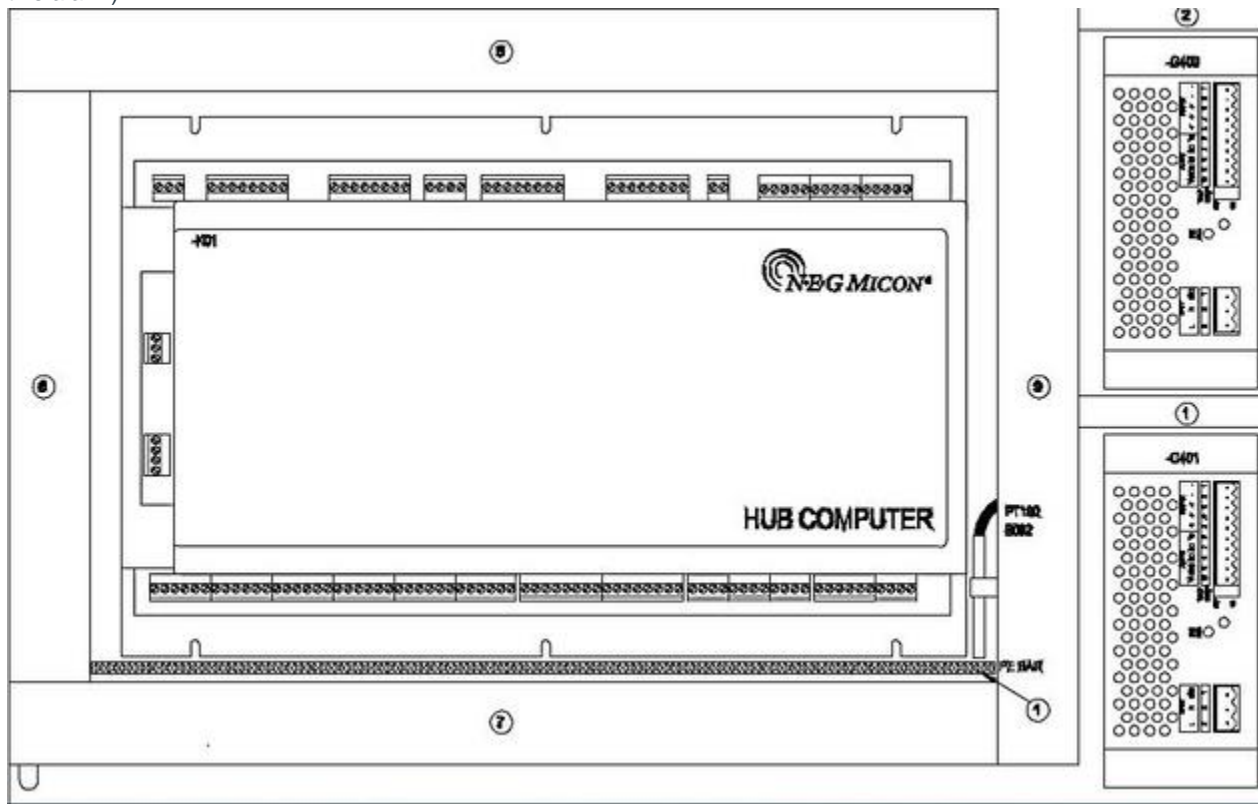
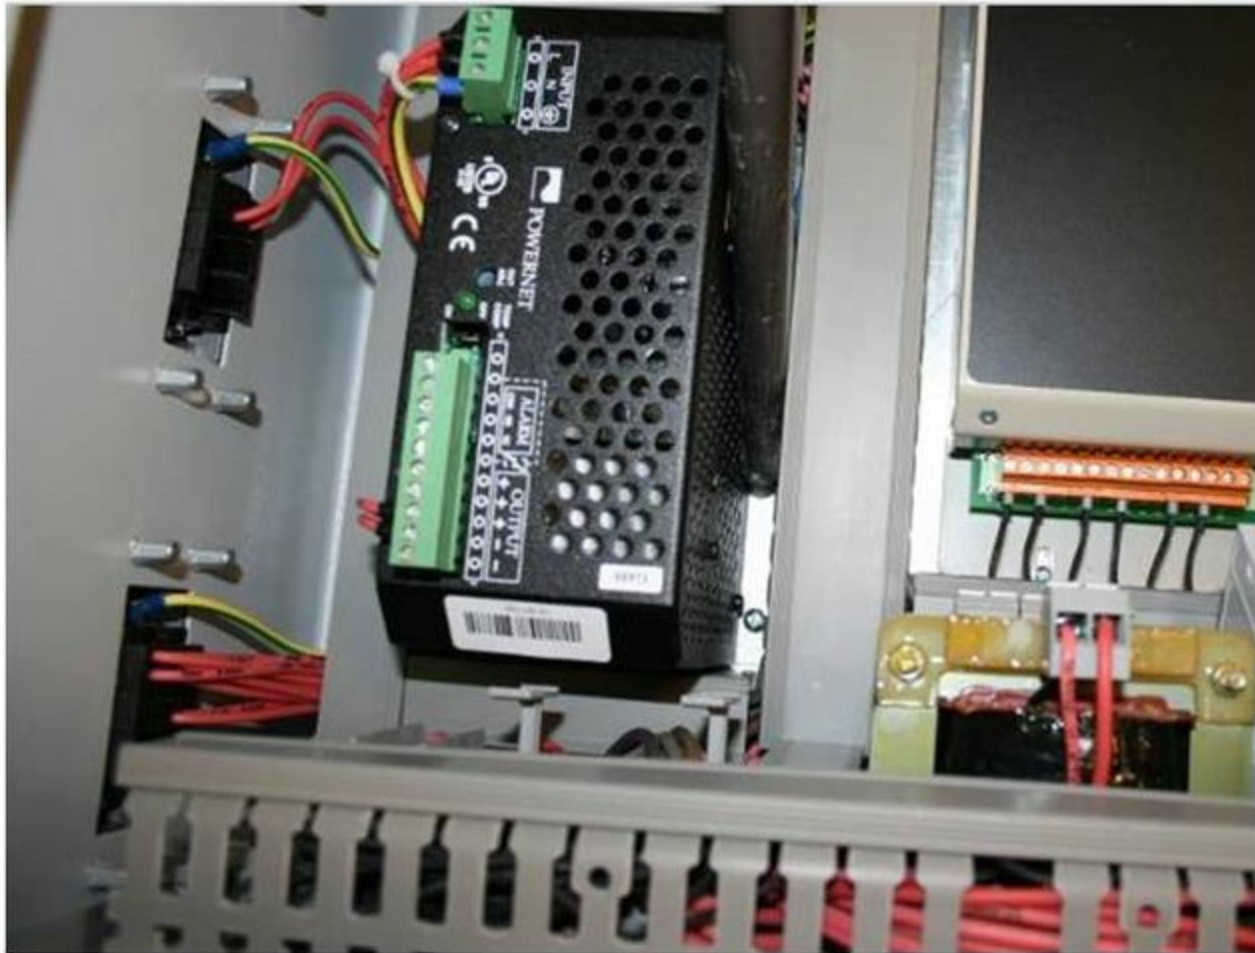
Power supply G401 supplies the shutdown and parking valves (215 & 210) for each of the three blades and is the most common cause for this fault.

Test the output voltage to the valves at the power supply for 24VDC. If the voltage is good, test down the circuit until reaching the valves (failing valve solenoids or shorts in the circuit/plug/cables can drag down the voltage and cause this alarm).

Check for any loose connections at the power net (Pos: G401)
Check the input and output voltage 230/115VAC => 24VDC
Replace the power net if it is defective.

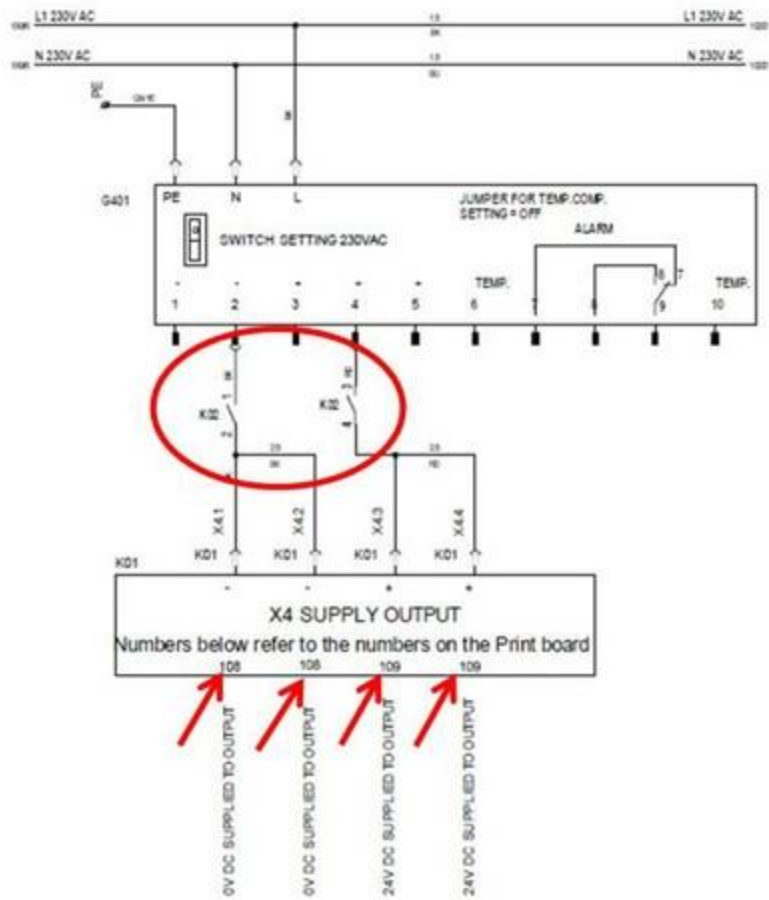
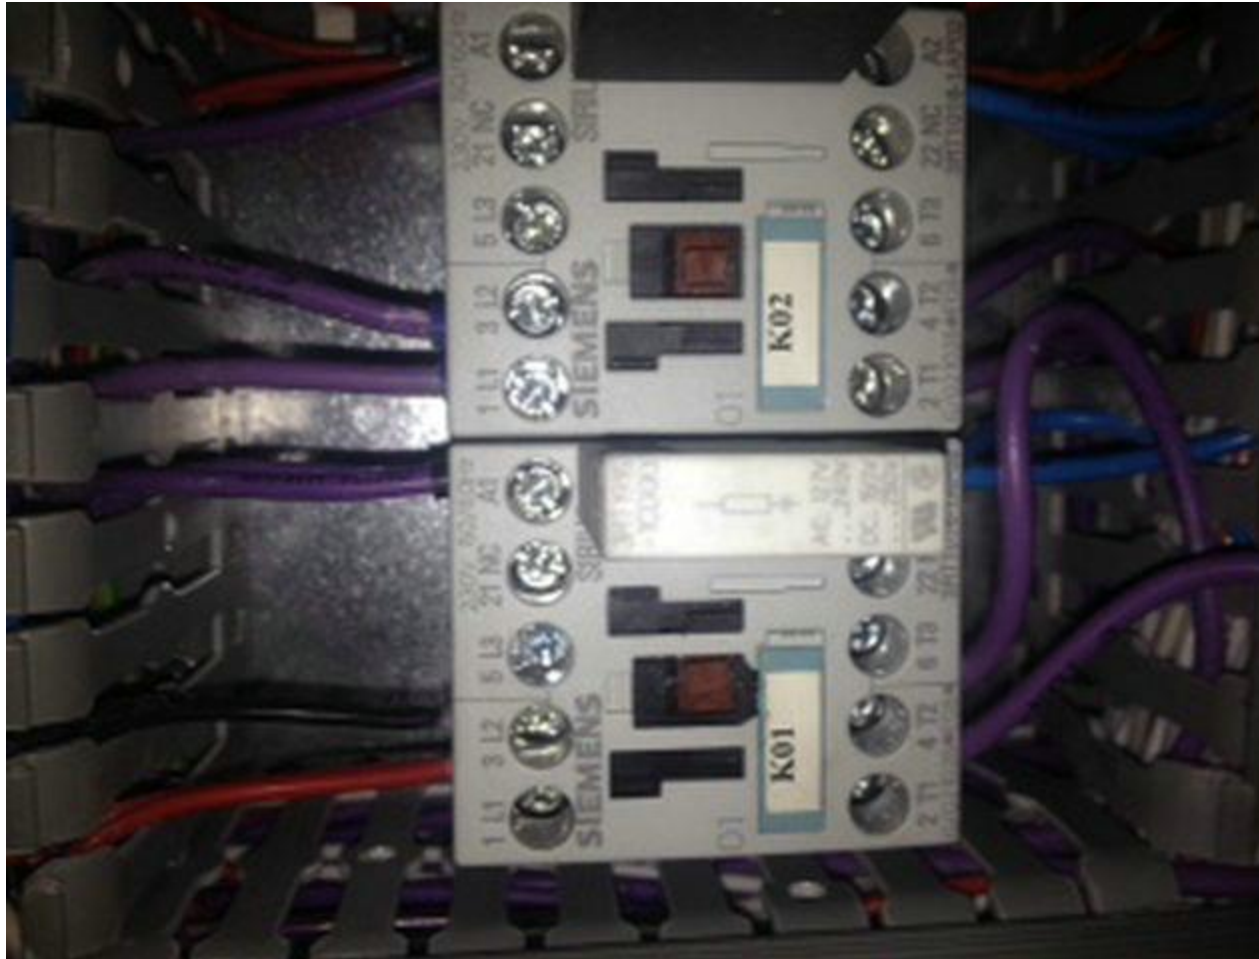
It is fairly common for foreign objects to wedge the AK4:K02 closed. It is in a rotating part of the turbine and remains in one state for extended periods. If the K02 doesn't fully open when unpowered, it needs to be replaced.

Check the AK4:K02 is in the proper state, replace if it is damaged

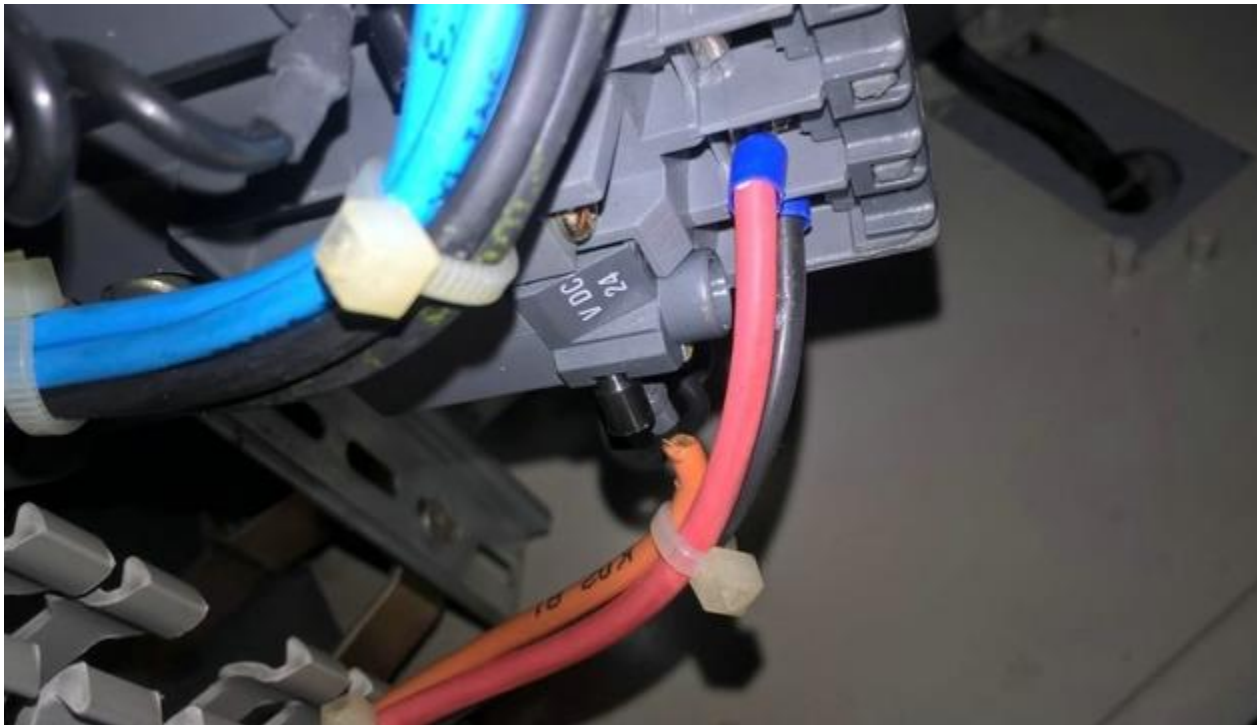
Alarm was detected due to a loose contactor (K02) power supply connection (A2) in +AK4 hub computer panel :

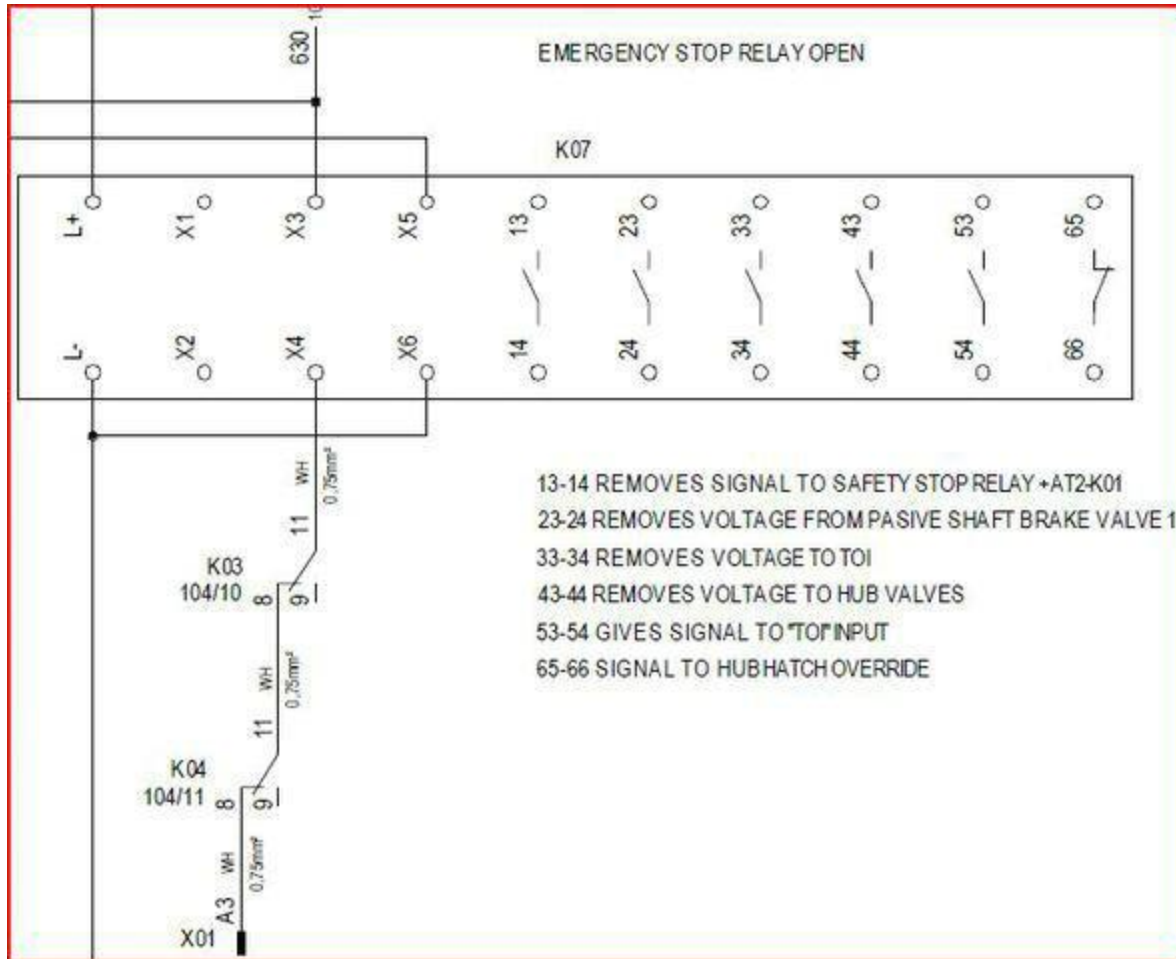
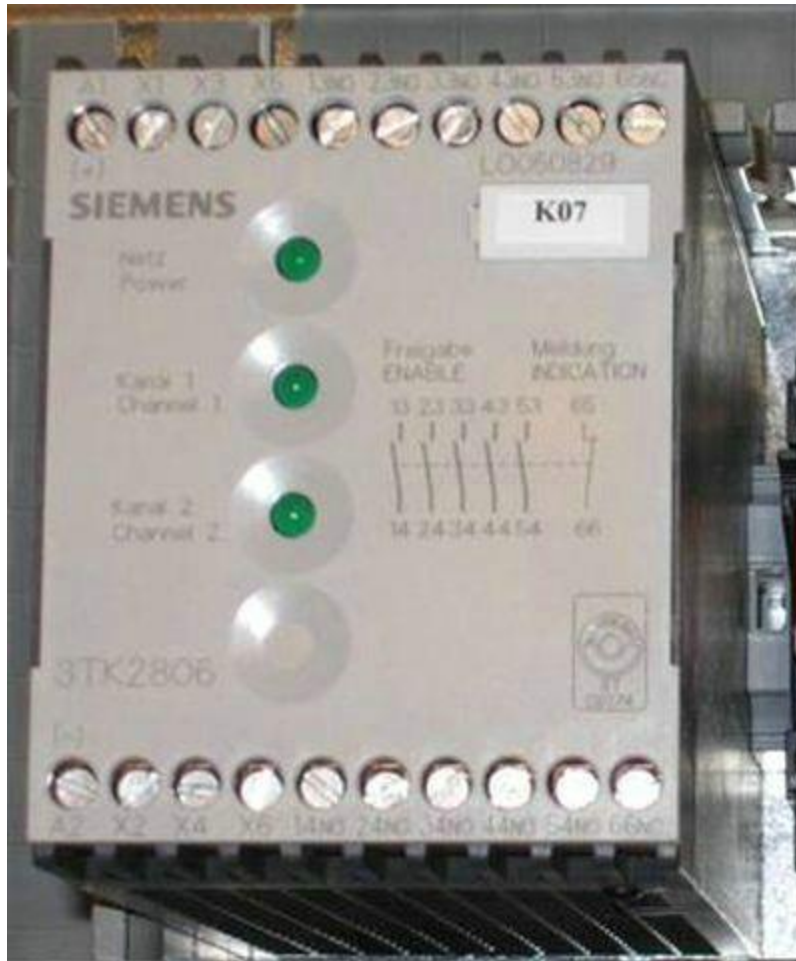
The Emergency Safety Relay in the AN1 panel stops the power to the hub valves at terminals 43-44, so check the continuity across the terminal and replace the relay, if continuity is missing.

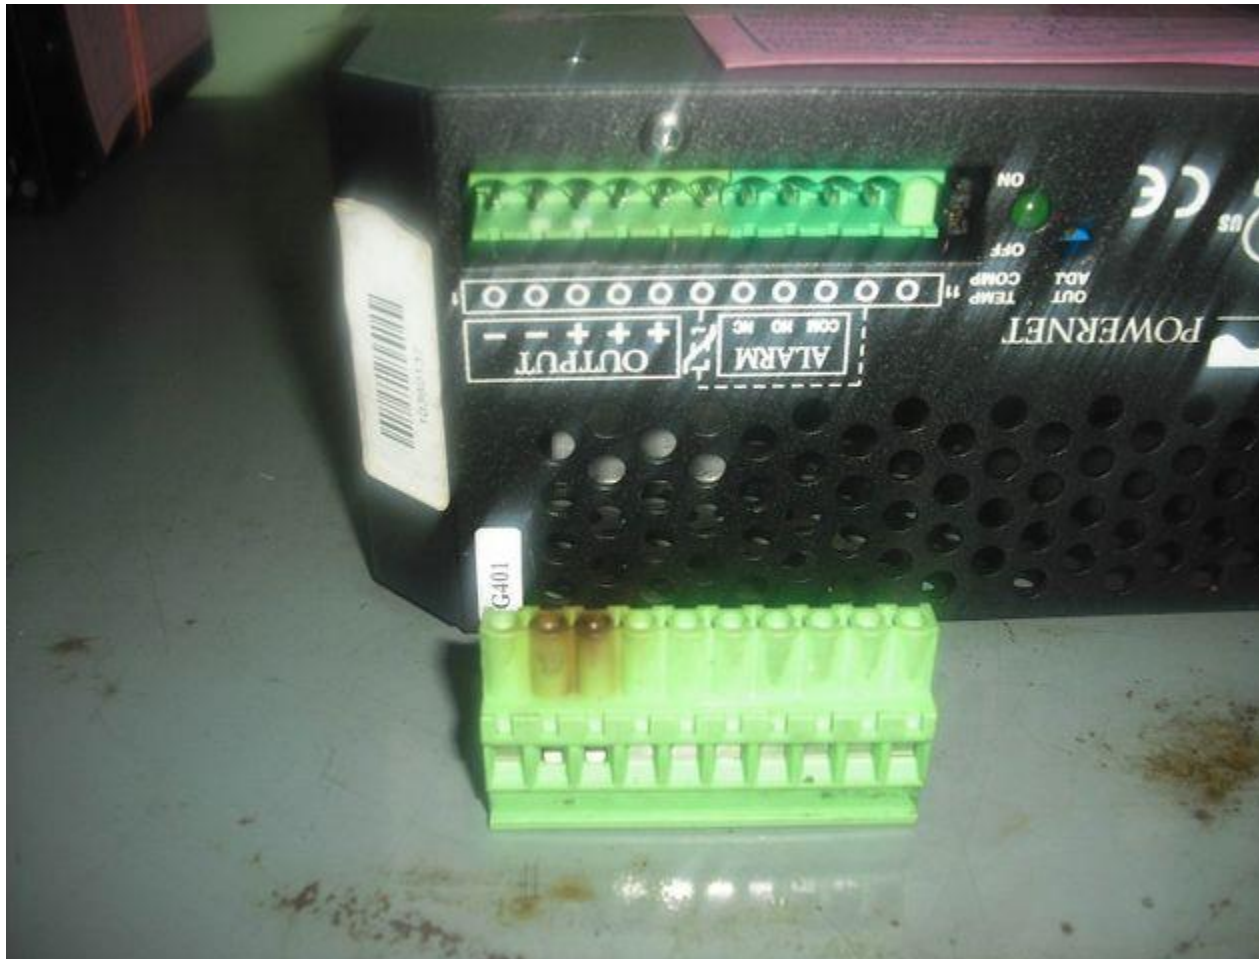
Power supply G401- 24V burnt plug:

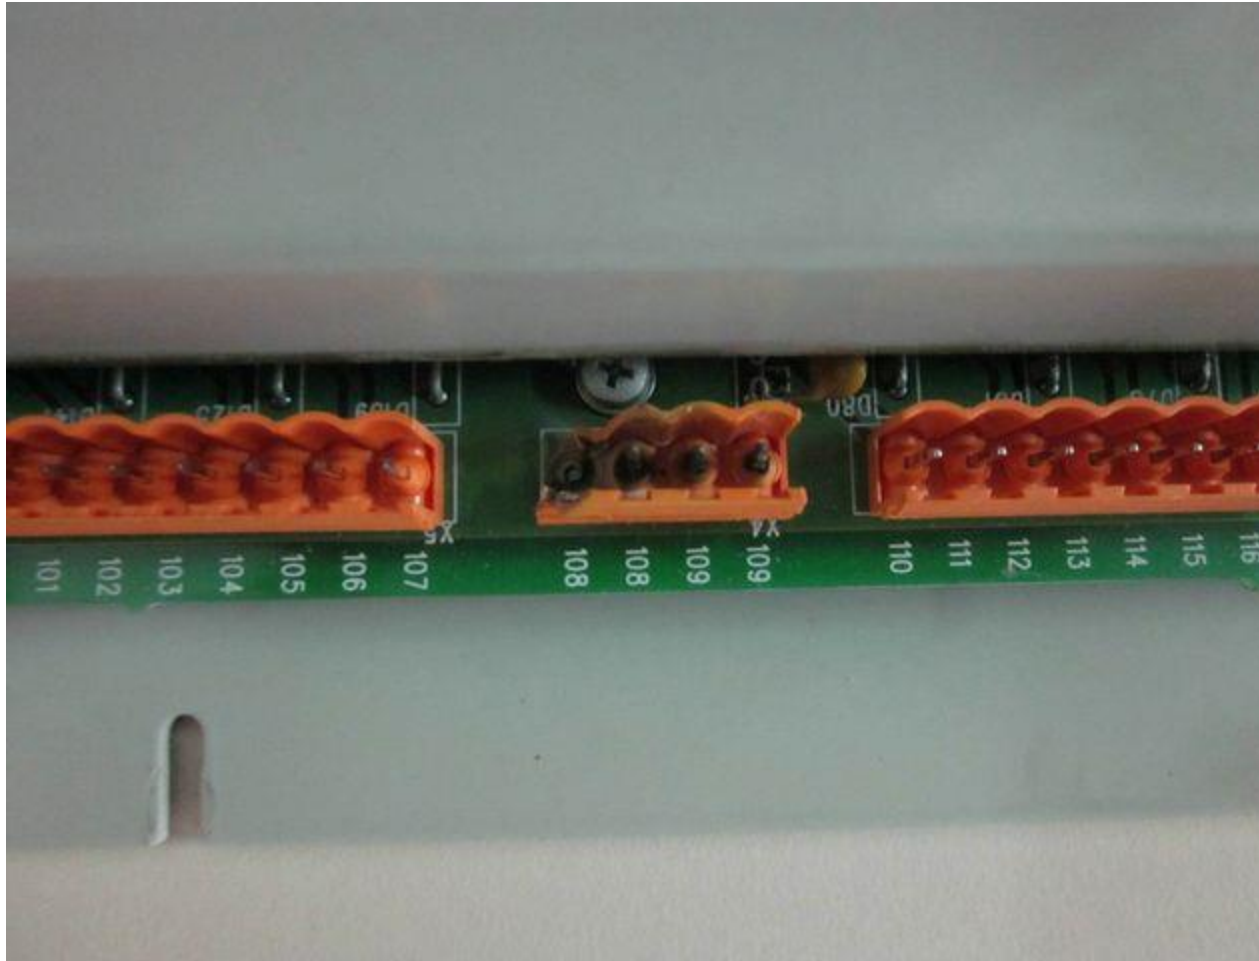
Burned pins:

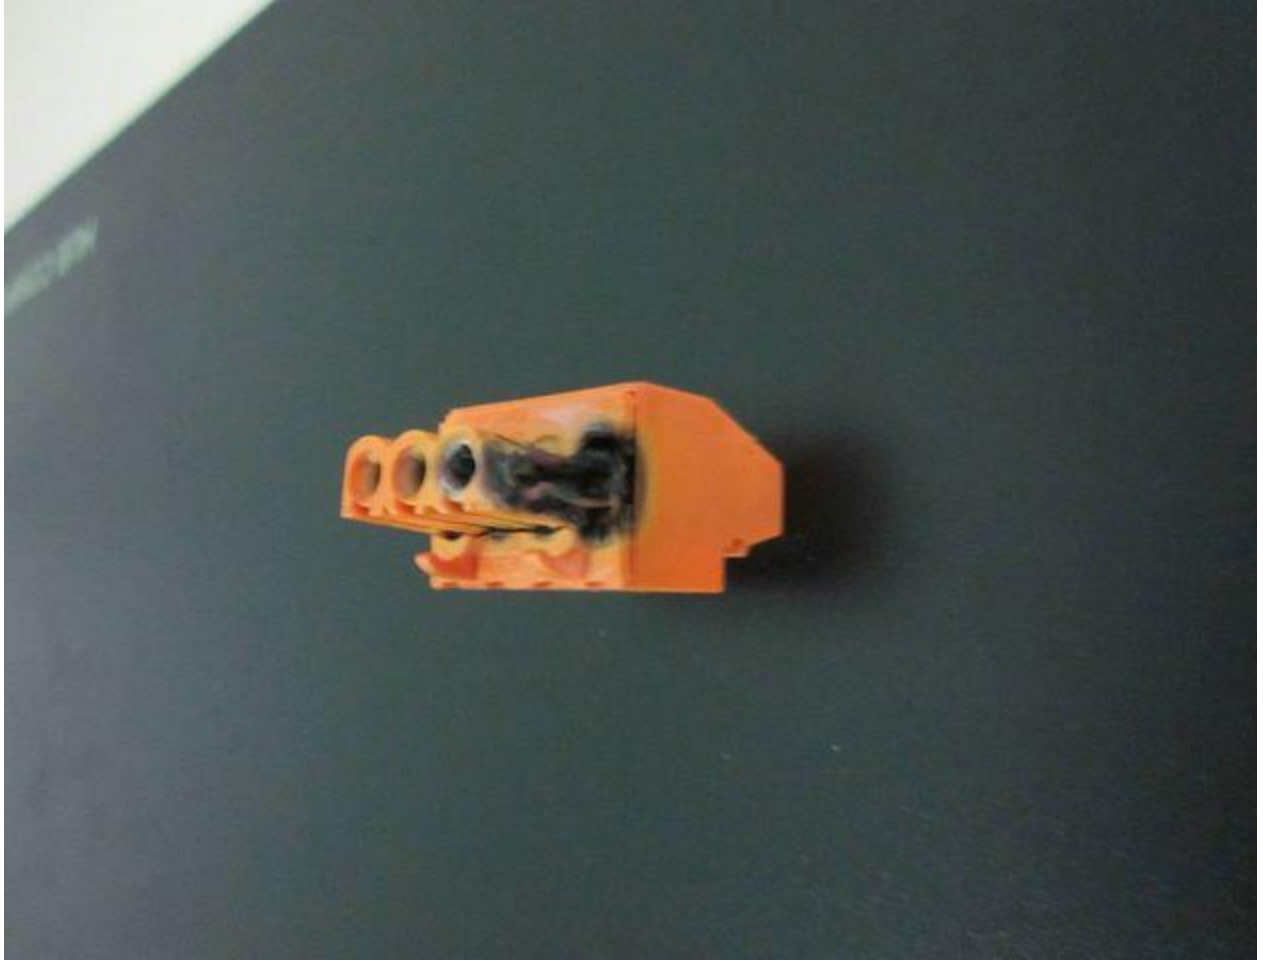
Burned plug:

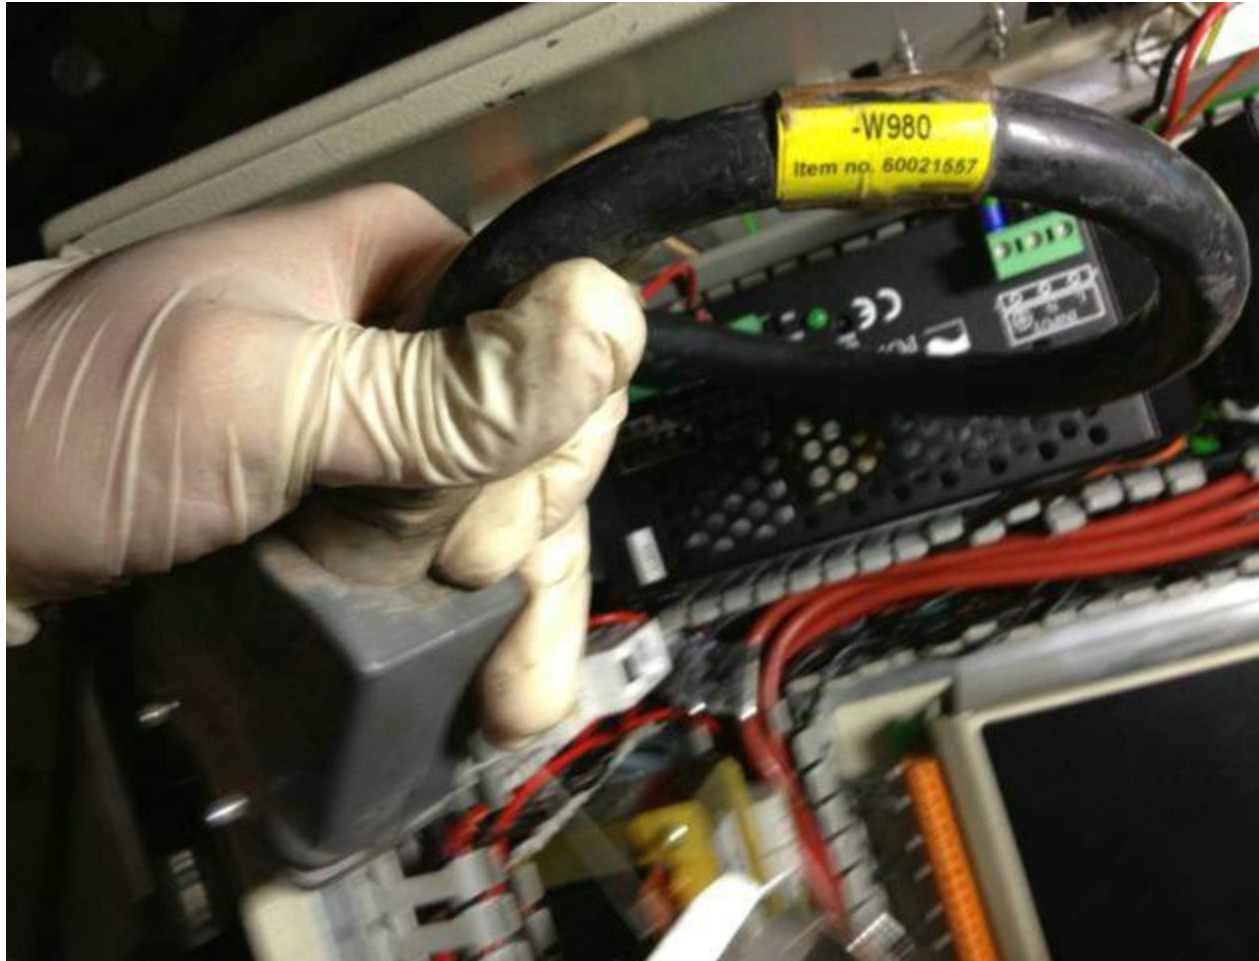
Check the condition of the –W980 cable in the hub.
Check for any cracks or wear on the cable.
Replace the cable if it is defective.

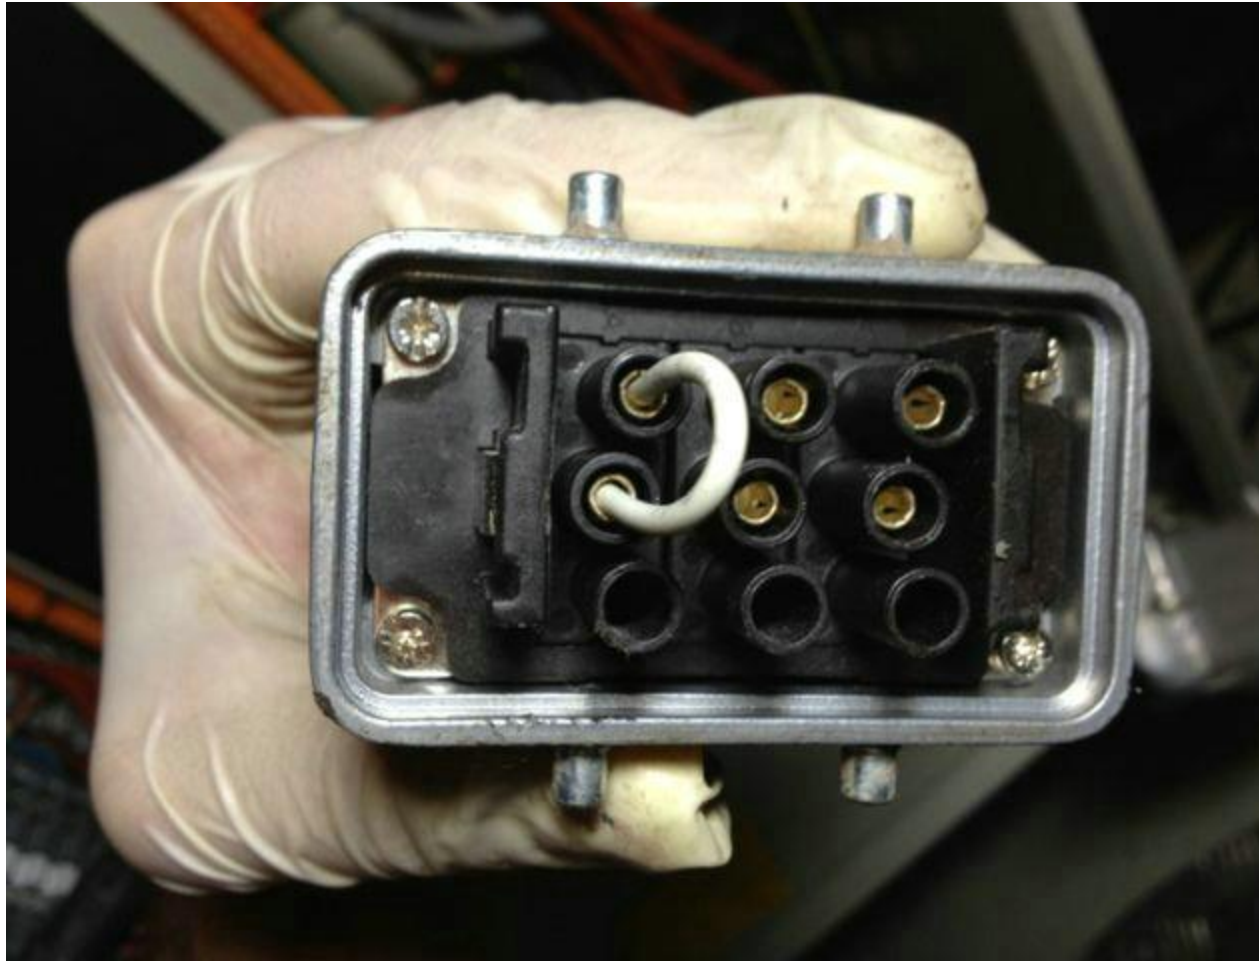
On the W980 cable place a jumper between Pins 1 & 2 in module A.

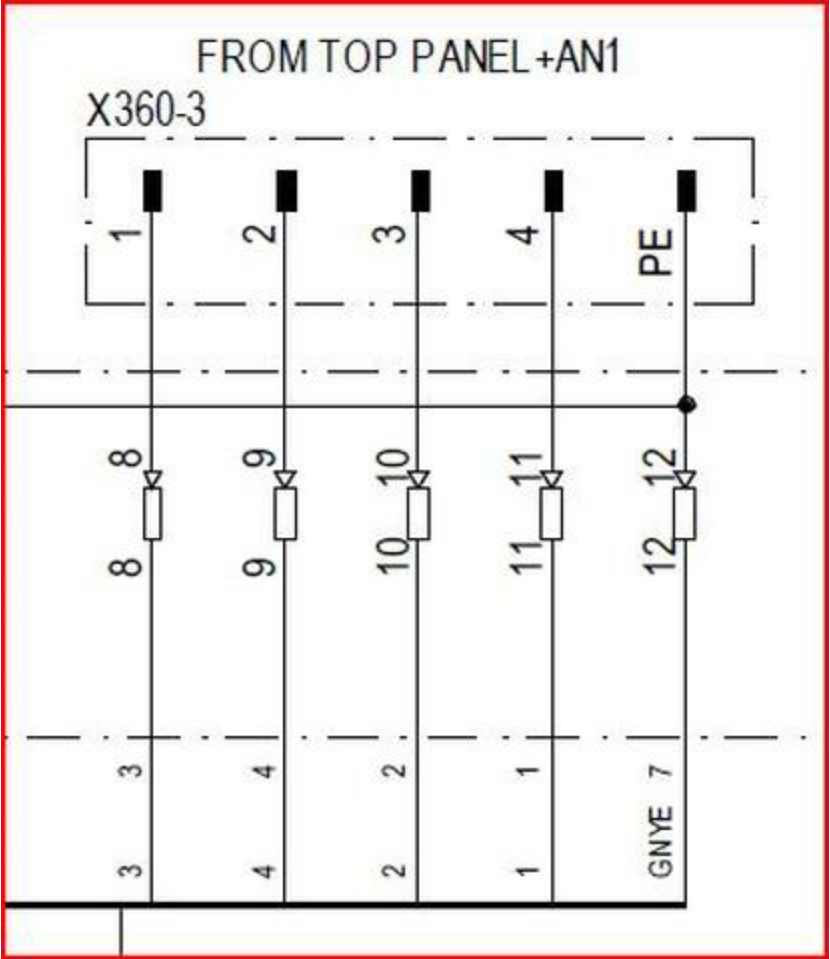
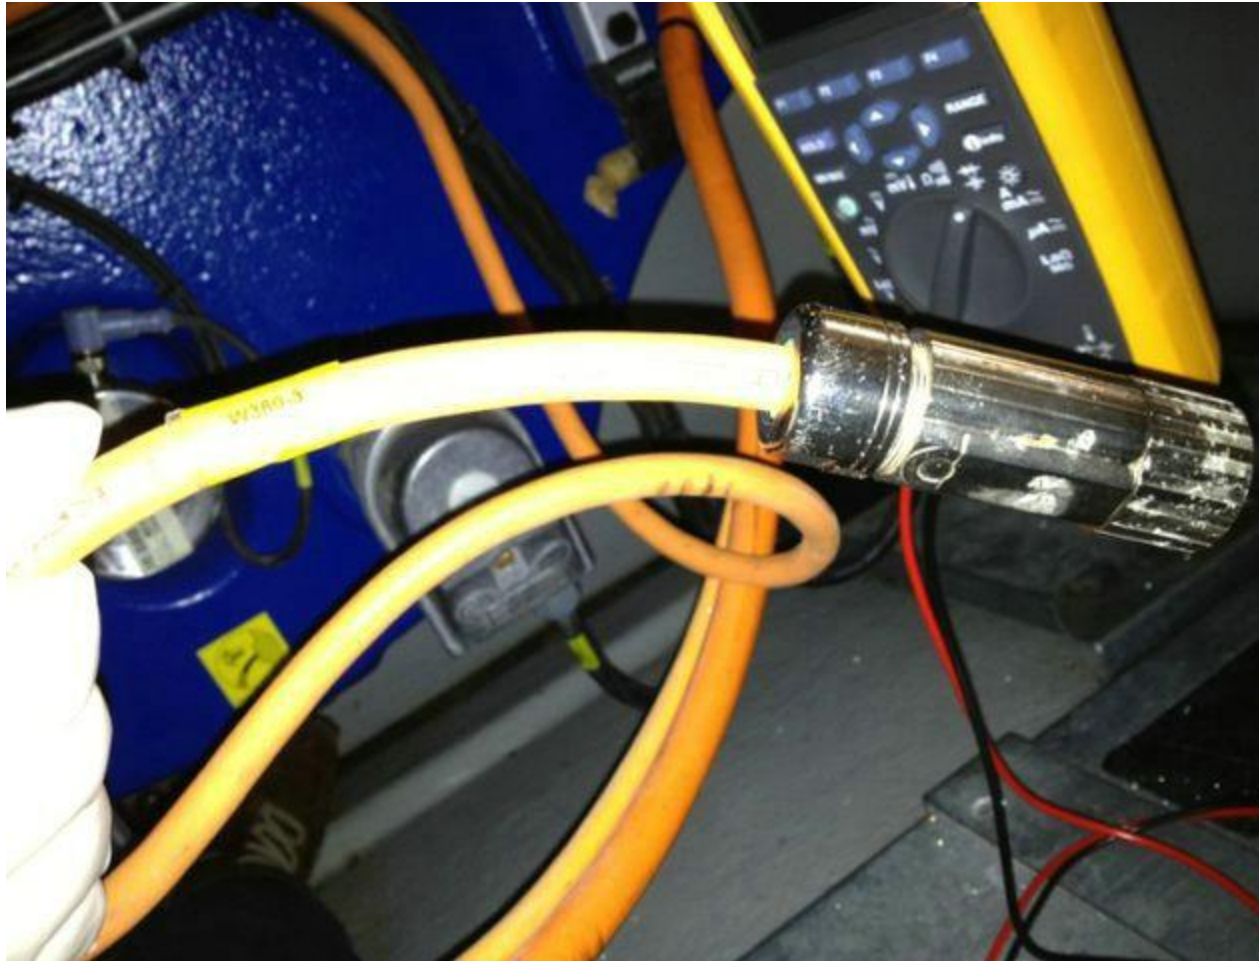
Remove the -X360-3 plug from the slip ring.

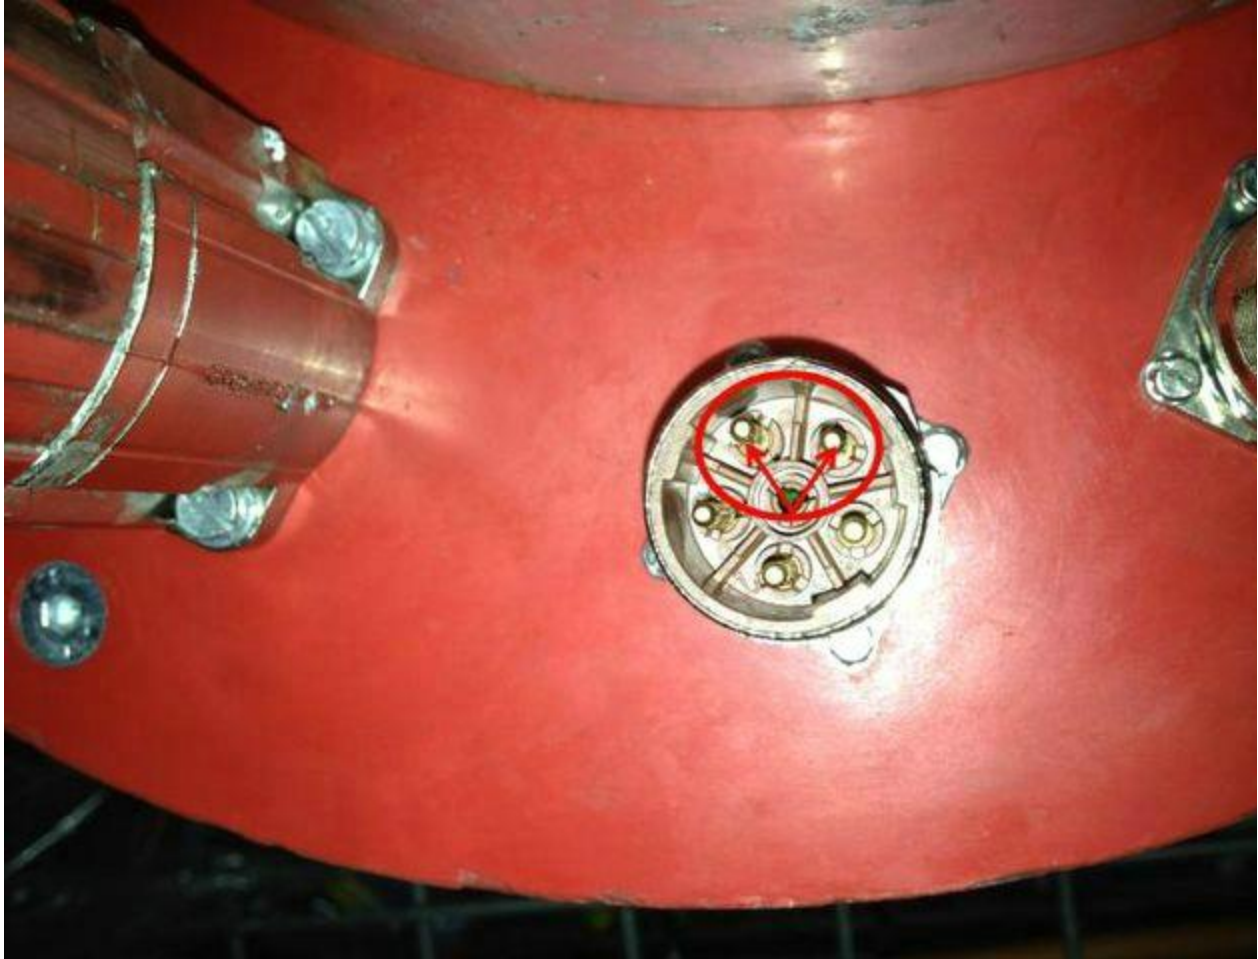
With a multimeter set to read Ω , measure between pins 1 & 2.

With the jumper in the hub, there should be a very low resistance value read by the meter.

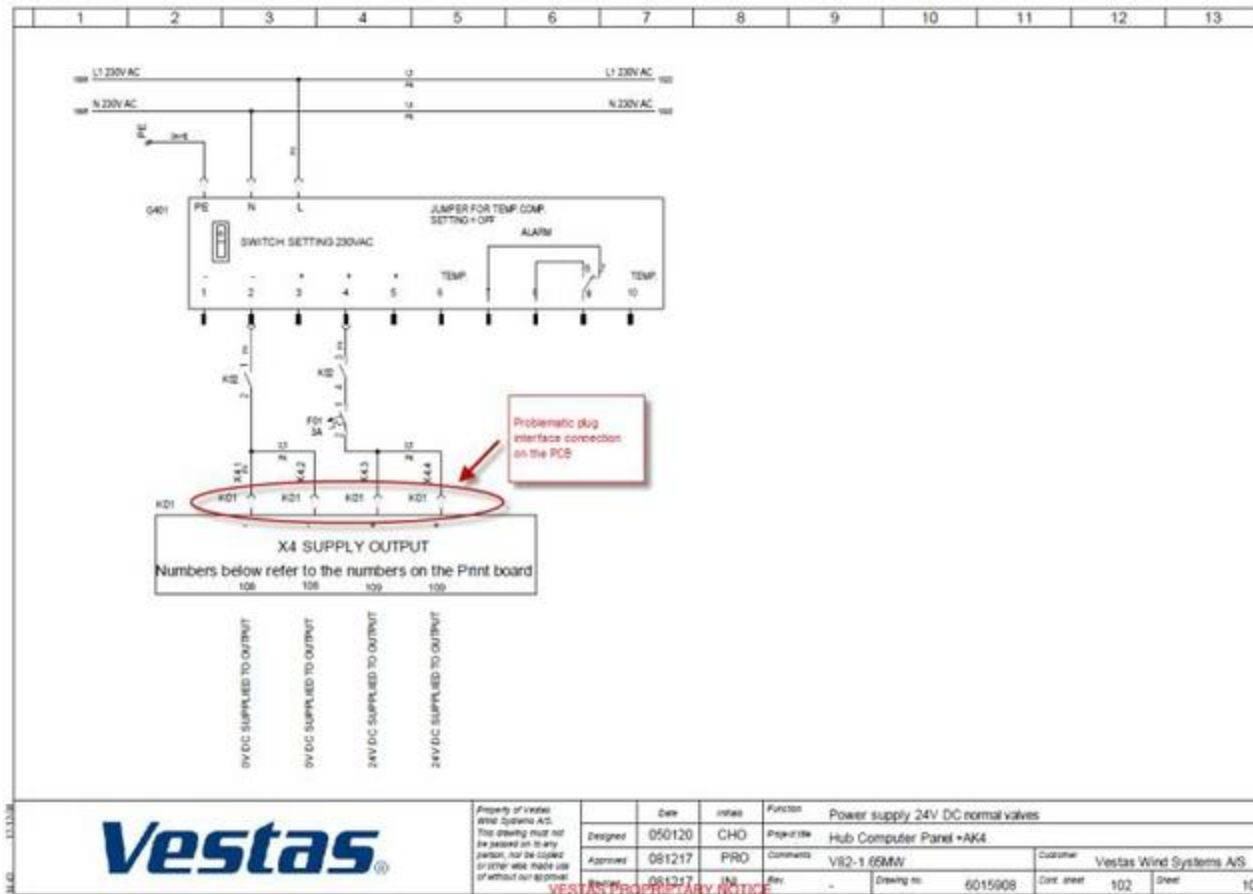
The problem is relating to the X4 plug connection where the 24VDC is supplied to the HUB Controller.
