Clean or repair Slipring

Replace the defective components

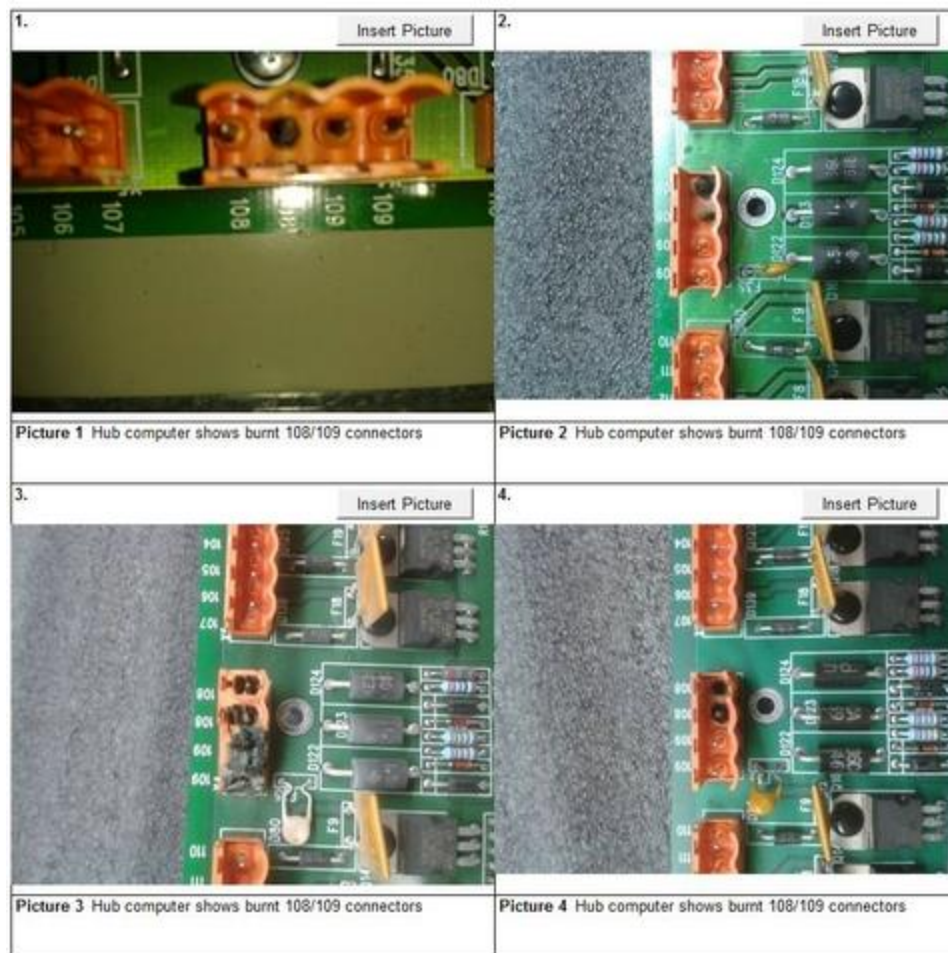
It has in many cases been seen that the plug connection have been overheated and burned as indicated on the below pictures.
