### Check wires between TAC40 and the thyristors

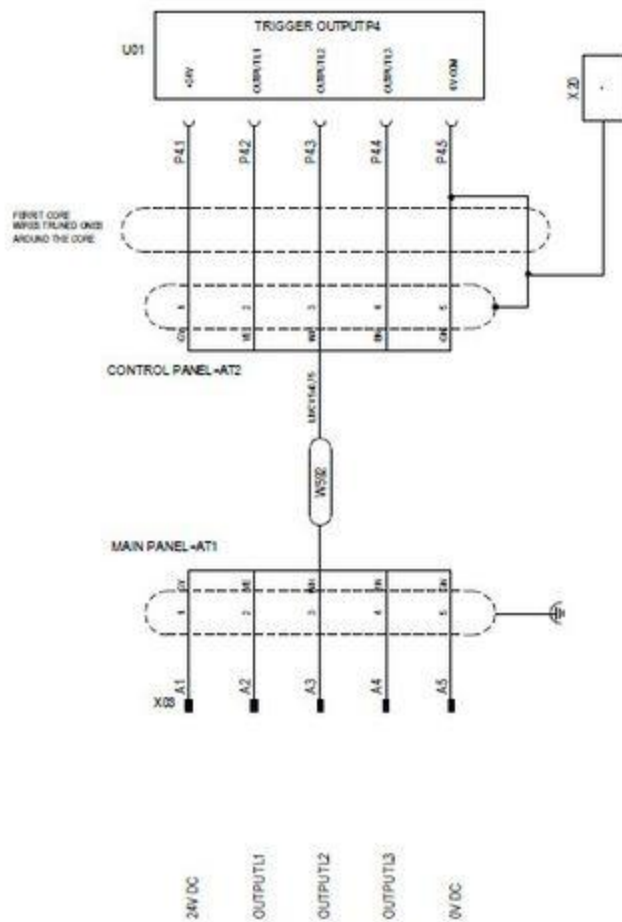
Check the X03 on the AT1. The trigger output from the TAC II may be lost in an open on the line.

### Repair or replace the X03 Amphenol connector

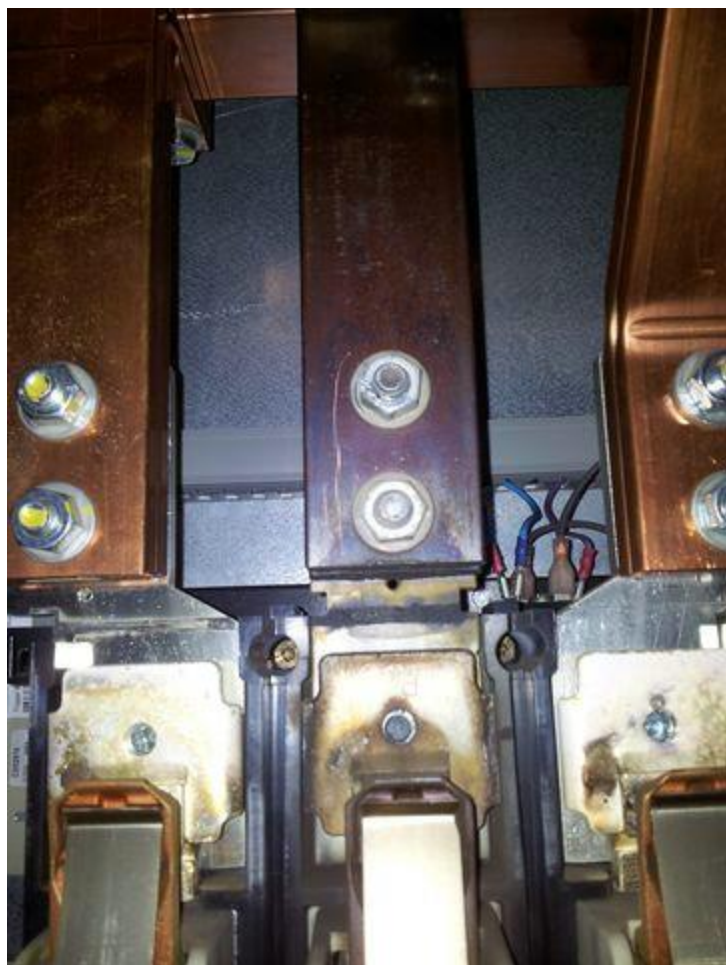
In the AT1 Main Panel, inspect the main contactors K02, K01, K03. Open the contactor front covers and check for any visible signs of damage and/or burn marks.

Also check the copper bus bars for any damage, signs of burns, overheating or arcing.

Sites have experienced contactor damage and heat transfer to bus bars as a result which have also been damaged. Replace any defective contactors and damaged bus bars as required.
