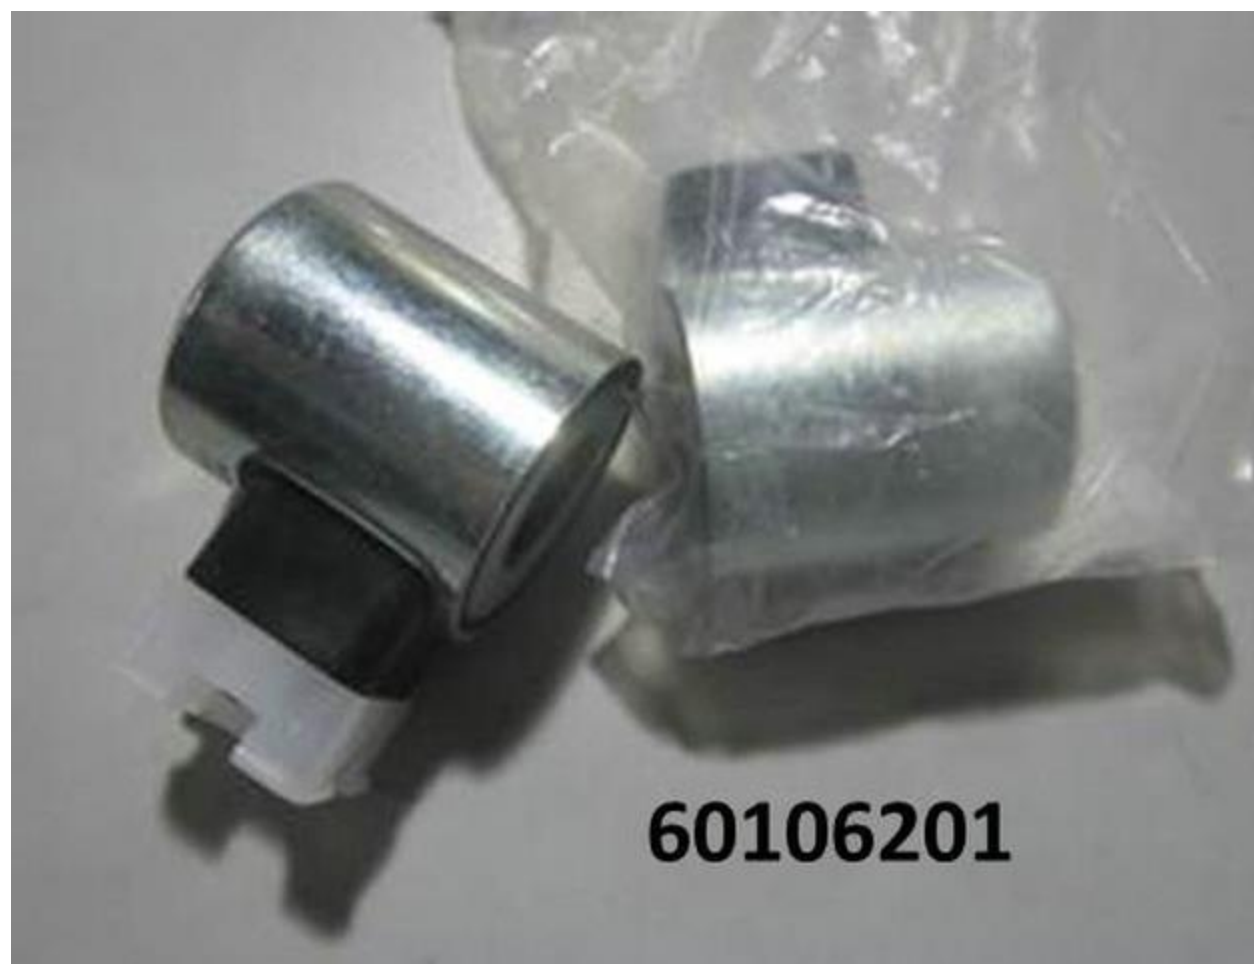
60106201

The part No.60096475 is phased out and henceforth replaced by 109795 & 60106201.

(Rexroth) Valve/Solenoid-
