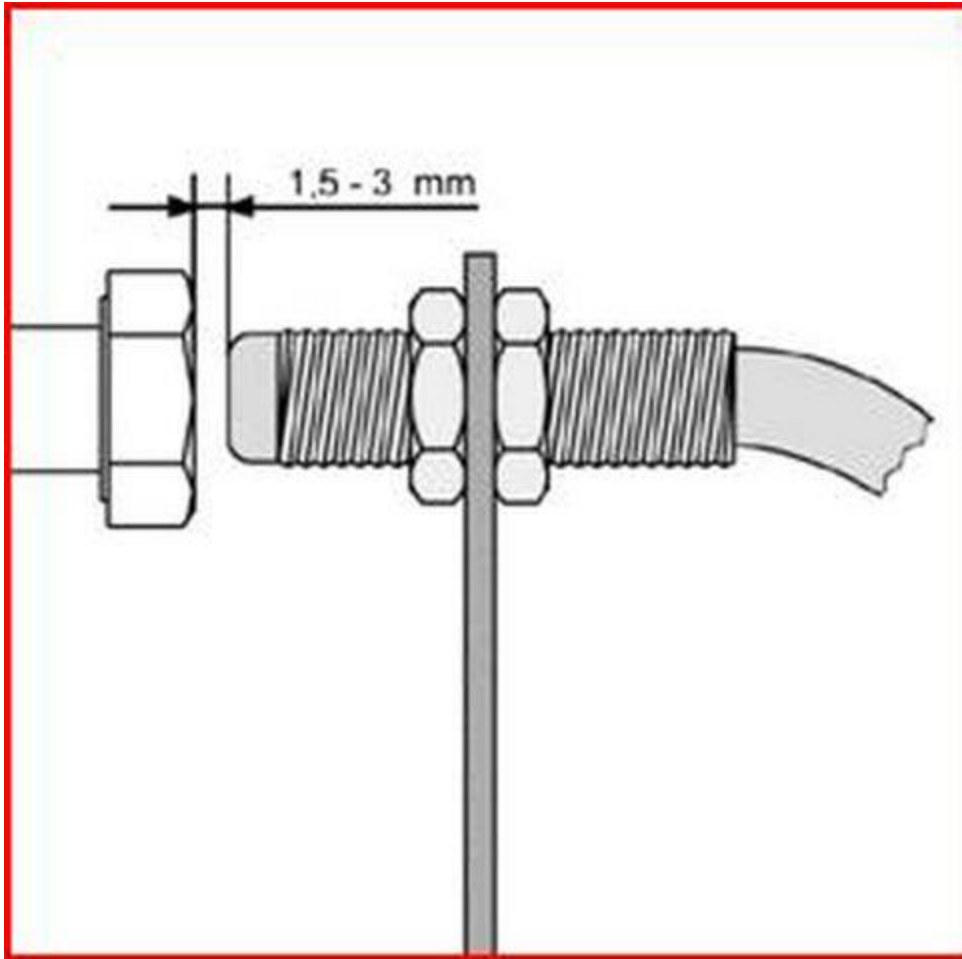
Check that the sensors are secure in the mounting bracket and are adjusted correctly,

Adjust the distance between the Inductive sensor and the scanning points as per Instalation & Service Data DMS : [5003033](#)

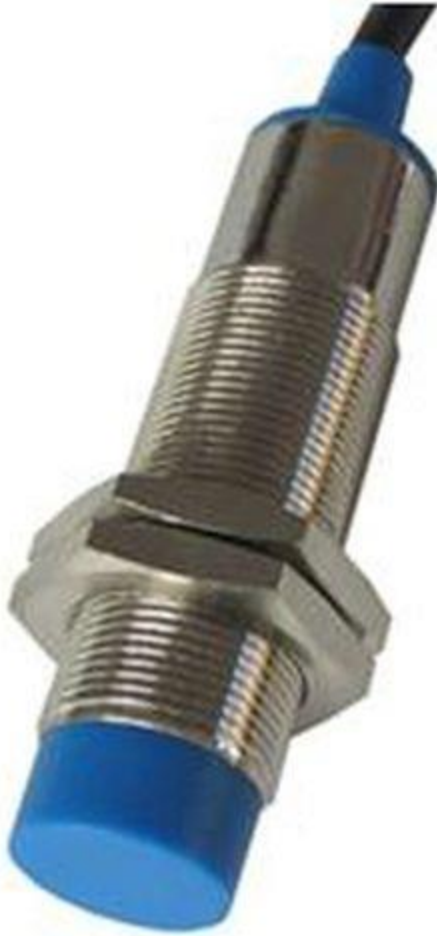
Unshield Sensor part number:

60009270 - PROXI SWITCH I1808PPOS1531 Ø18

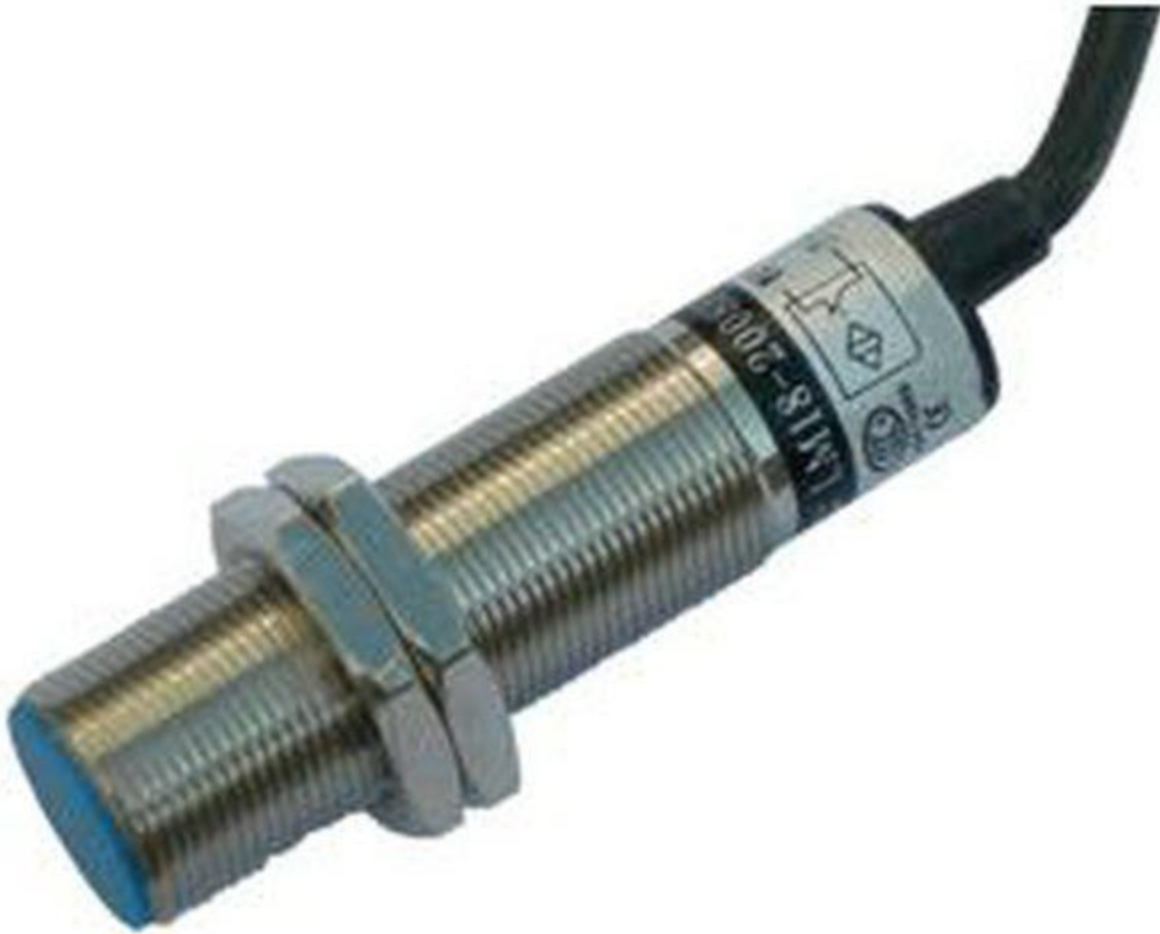
Shield Sensor part numbers:

60009264	PROXI 1A18DLF05PO Ø18
60009263	PROXI S 1A18DLF05PO Ø18
