Test/Replace PT100

Clean grease from bearing

Inspect generator shaft Does this solve the problem?

Change the faulty TOI-2 Tower, Water pump motor and Contactor

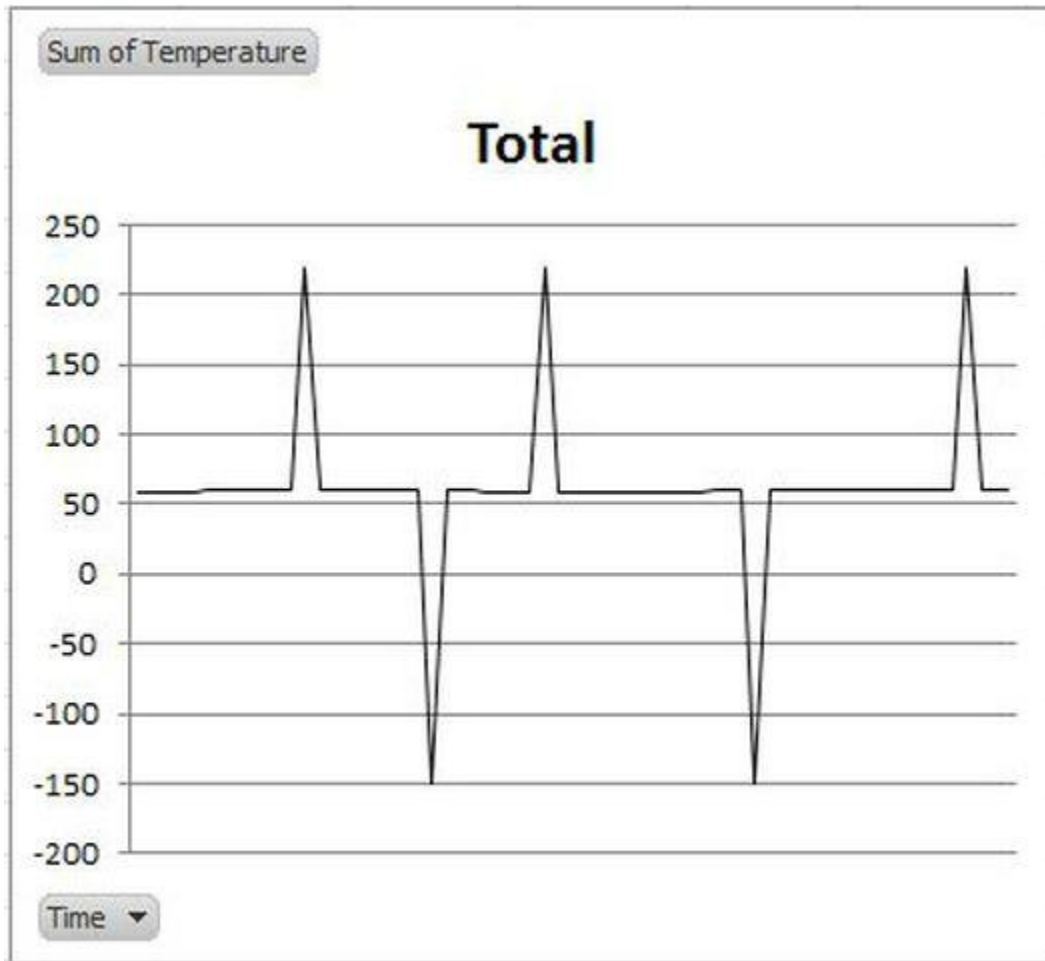
In the Collected Data Viewer, check the temperature measurement going back several days if needed. Collect the minimum and maximum temperatures.

In the data, look for momentary spikes in temperature (<30 Seconds- durations longer than 30 seconds will cause alarm 876- Pt100 fault gen. bear. Front).

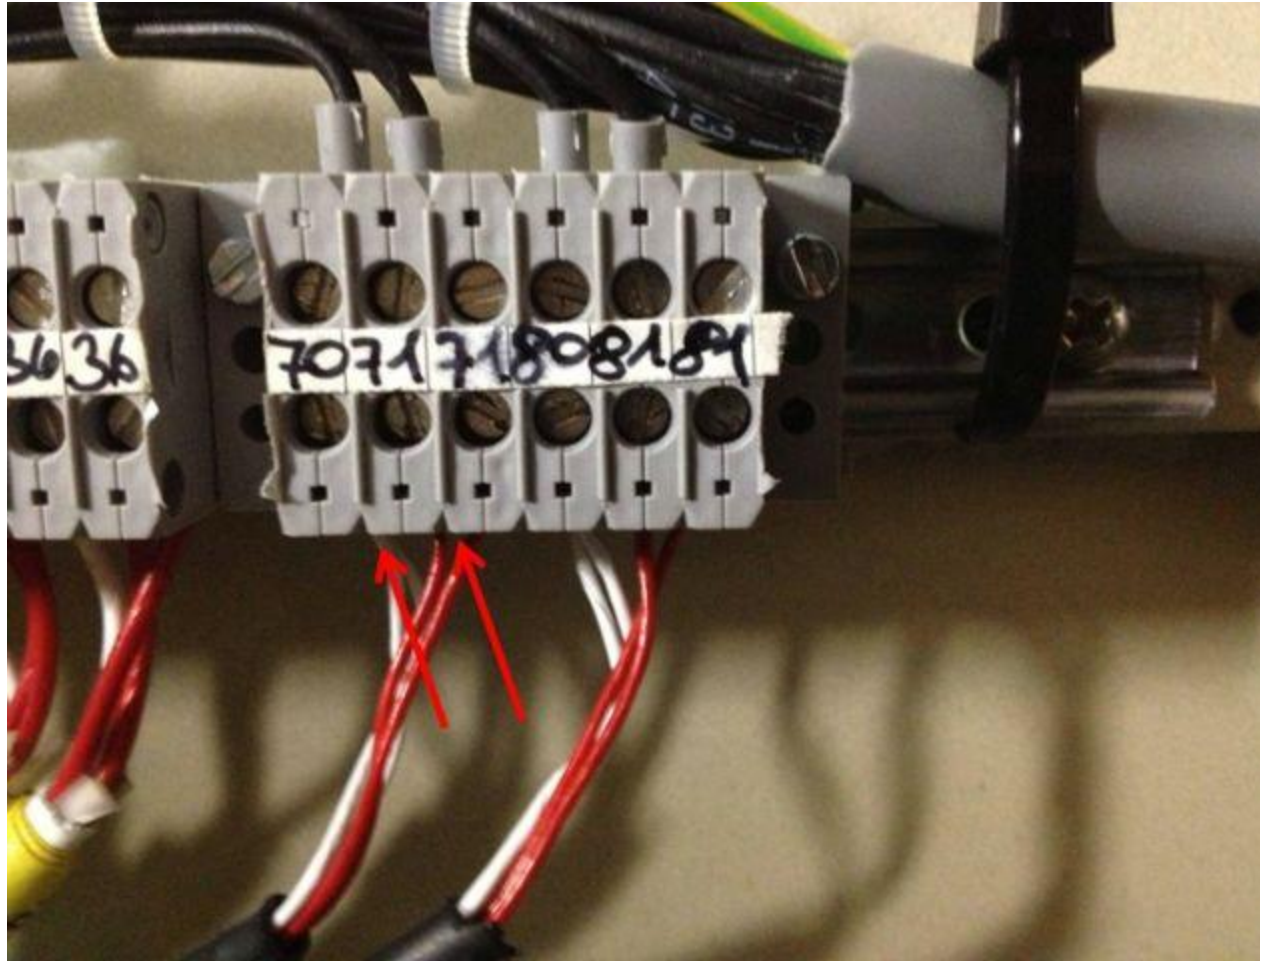
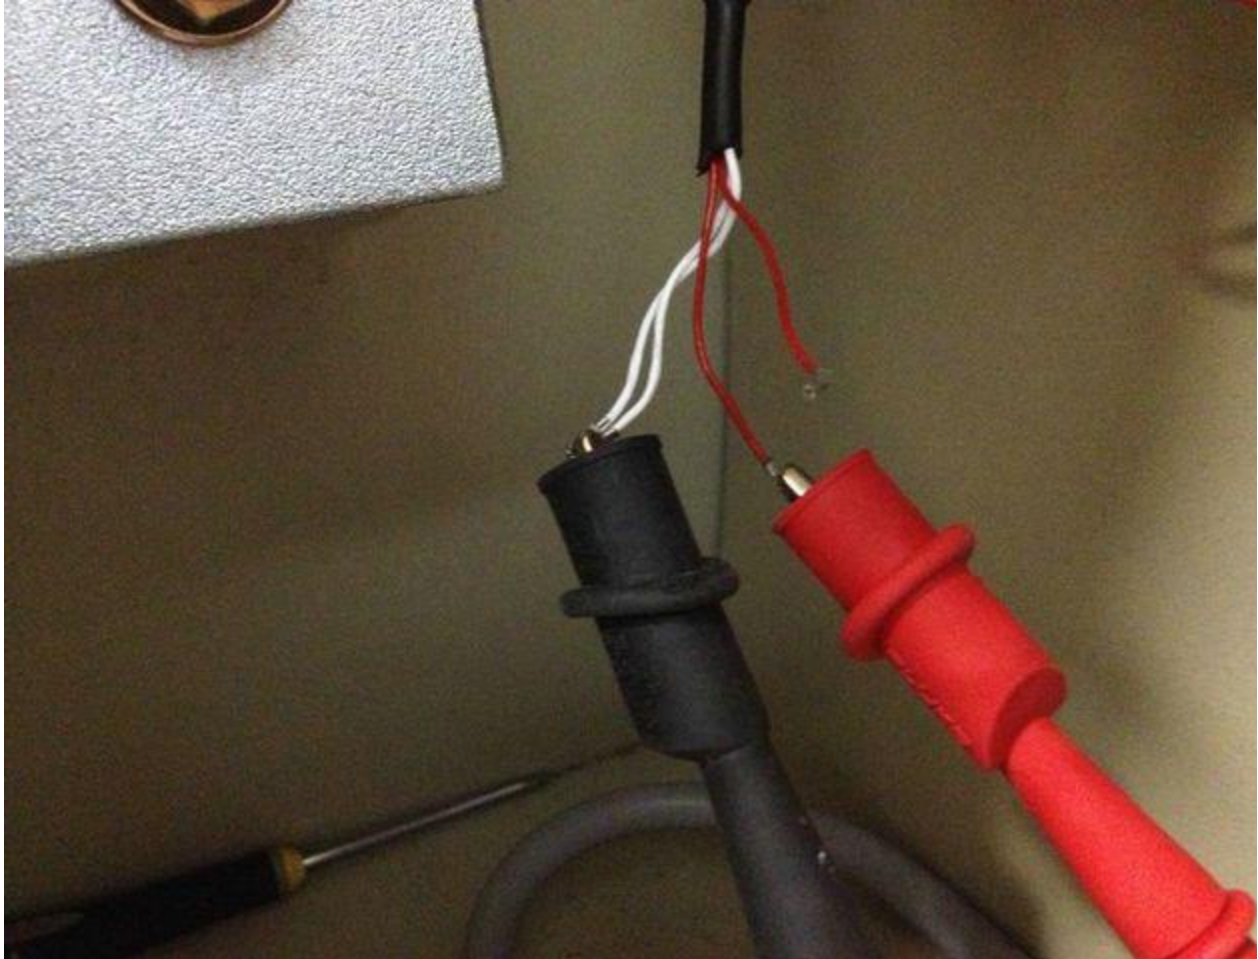
Sensors can be tested in the generator junction box. Generator bearing front sensor wires are at terminals 70 (white), 71 (red) & 71 (#2 red).

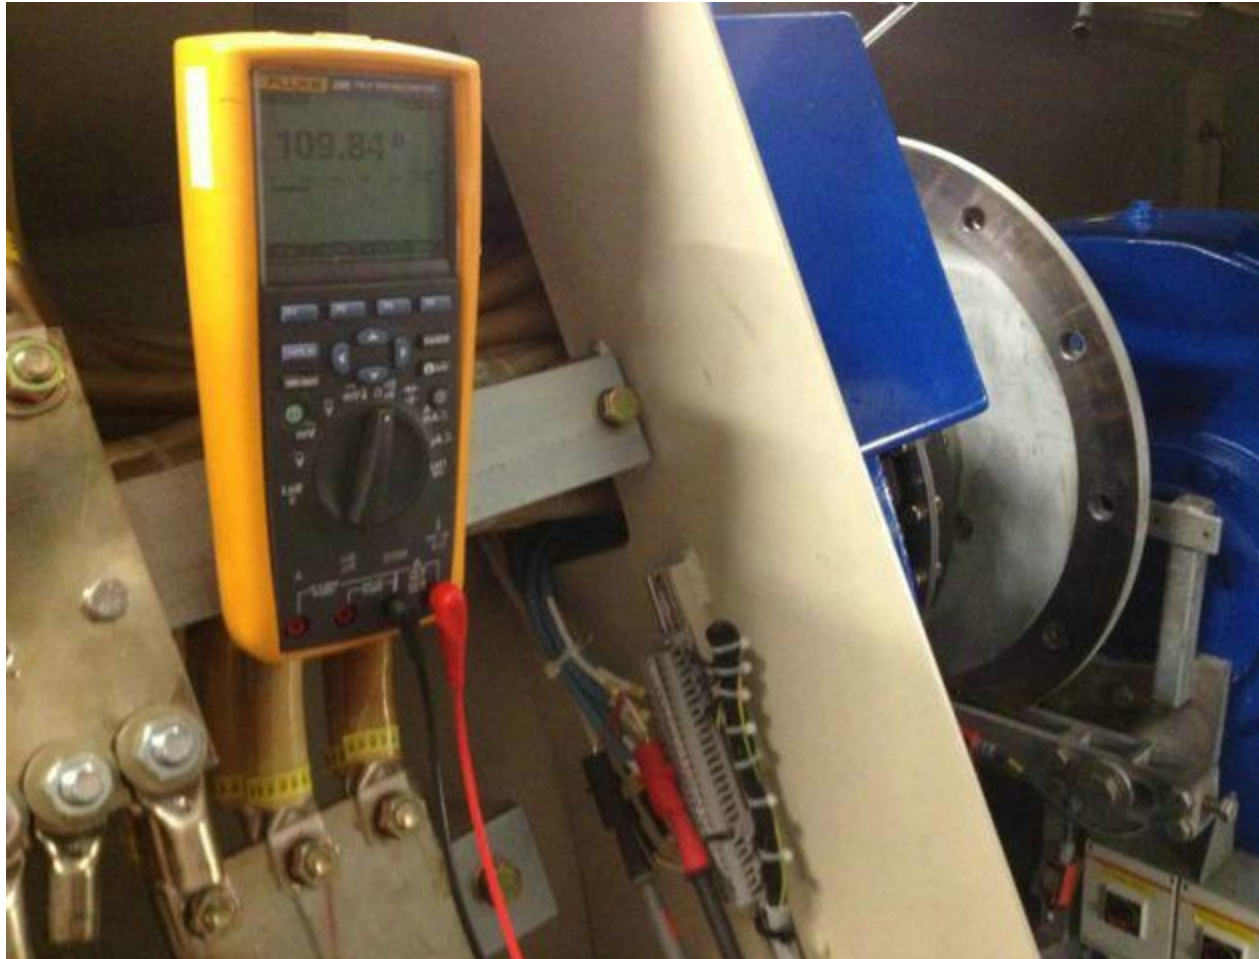
Connect a multi-meter to the PT100 wires in the generator junction box.

With the multi-meter set to read Ω , check the resistance value against the resistance/temperature conversion chart.

Compare the temperature to the value in the TAC controller. If the resistance value equates to a temperature out of range, the sensor is faulty and must be replaced.

Relevant spare parts	
Description	Item No.
PT100 GEN.BEARING ELIN	105232

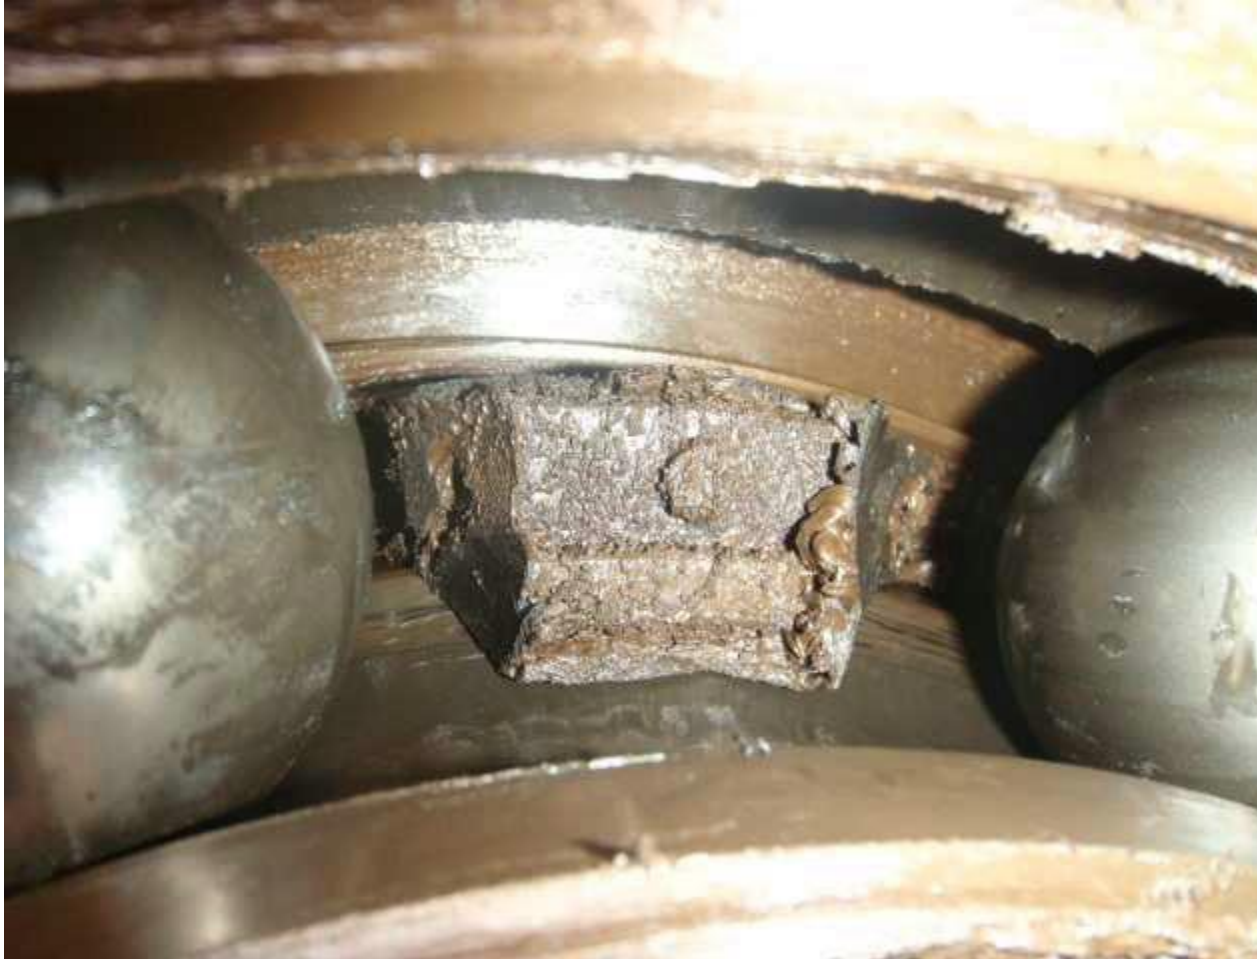
Damaged Bearing:

Generally, a bearing that is rotating on the shaft (and a failed bearing) can be heard down tower when the turbine is operating.

If it is suspected that the bearing is rotating or has failed, allow the turbine to freewheel while listening closely to the generator.

If abnormal noise can be heard from the bearings, remove the bearing covers and inspect 1. The bearing and 2. The inner bearing race on the shaft for signs of rotation.

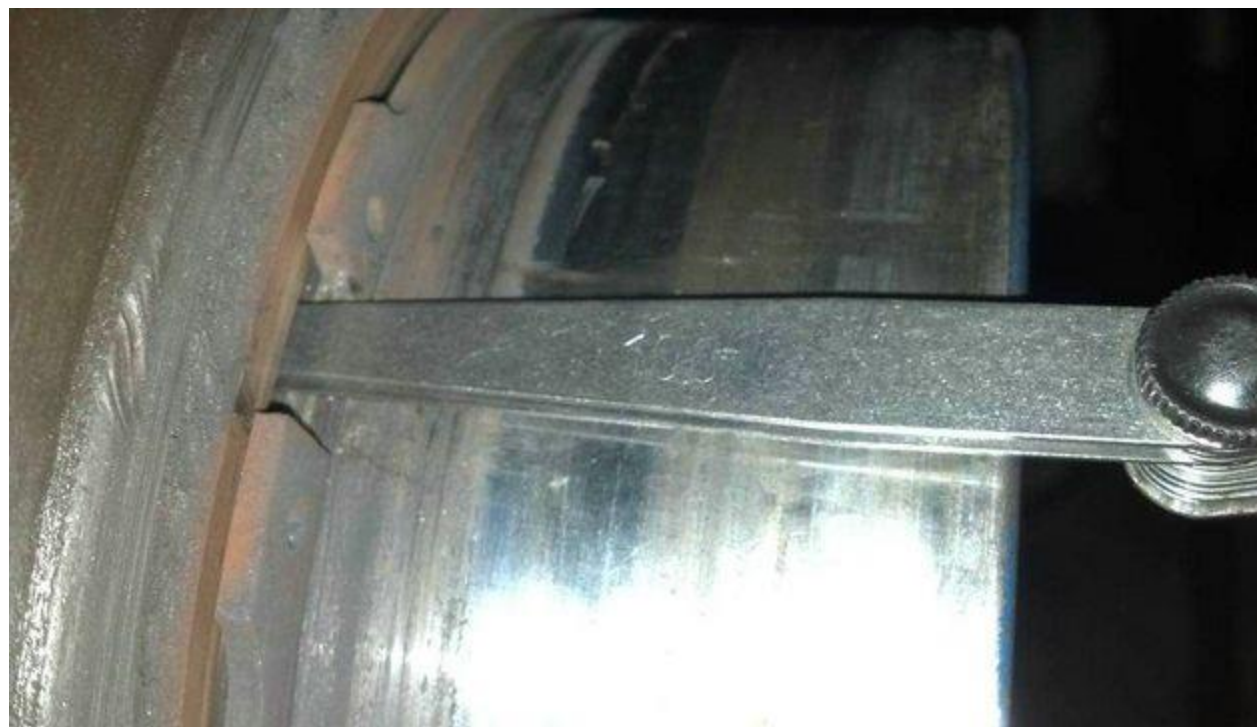
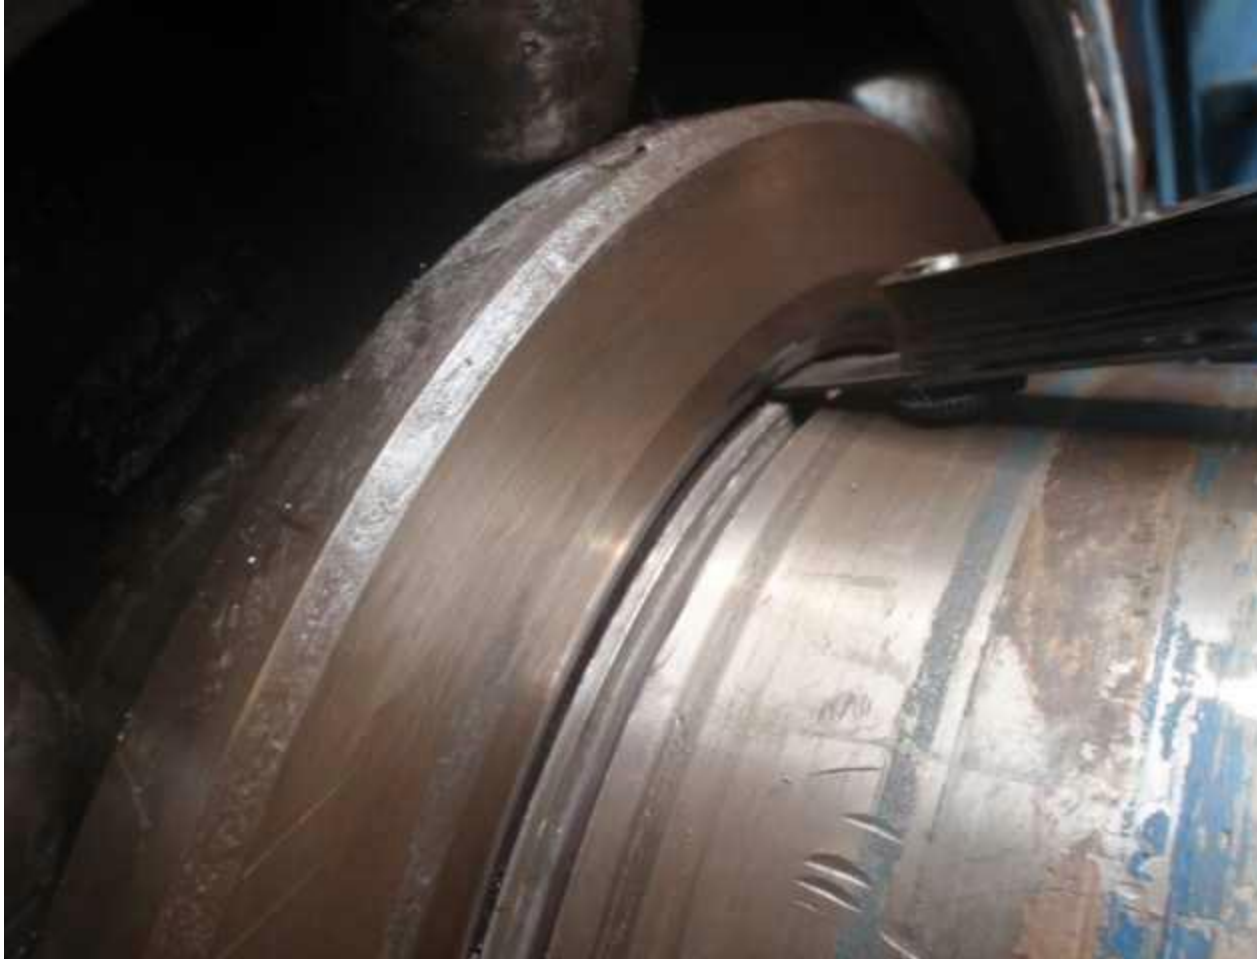
When the cover is removed and the bearing is exposed, a feeler gauge can be placed between the shaft and inner race to determine if spinning has caused wear on the shaft.

Using a feeler gauge to check for a gap between the rotor shaft and inner bearing race.

There should be zero clearance between the shaft and the bearing inner race. If there is any measurable gap between the inner race and the shaft, the bearing is spinning and the generator must be repaired (In accordance with the latest [CIM2020](#) solution) or replaced. If the bearing is found to be spinning on the shaft, complete a CIR for CIM 2020 and consult Engineering on how to proceed.

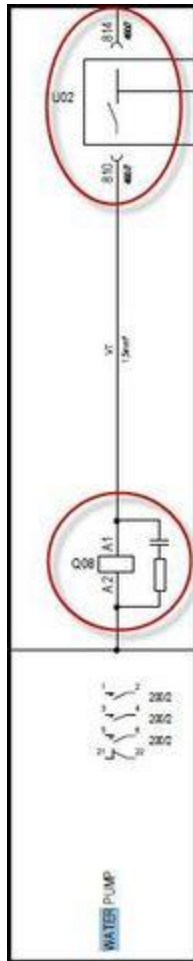
50Hz

AT2 Cabinet Check the TOI-2 Tower out put 810 Water pump, if there is no out put while testing change the TOI-2 tower Check the motor contactor Q8/K04 coil supply and terminal out puts and if there is not output change the conctactor.
