Check the signal from the AT1:T07

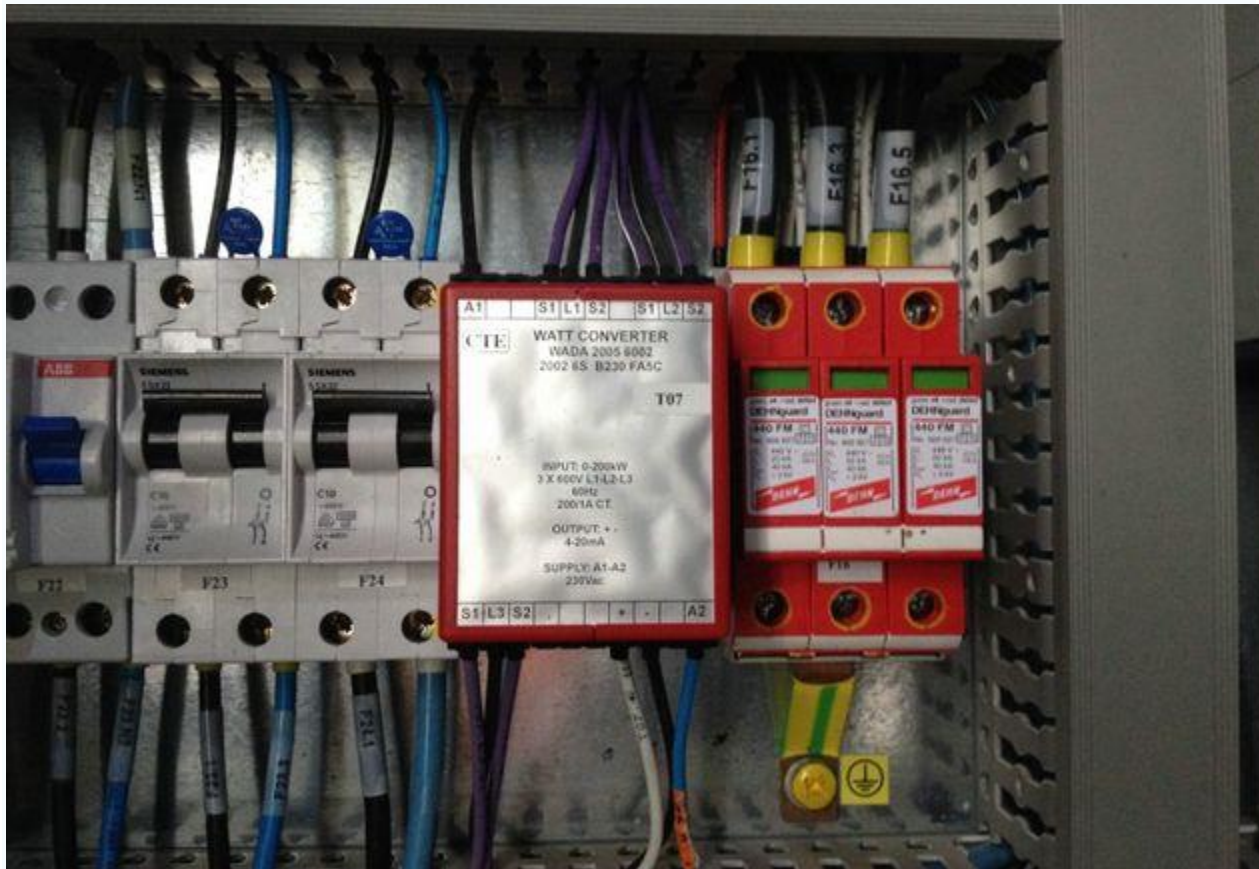
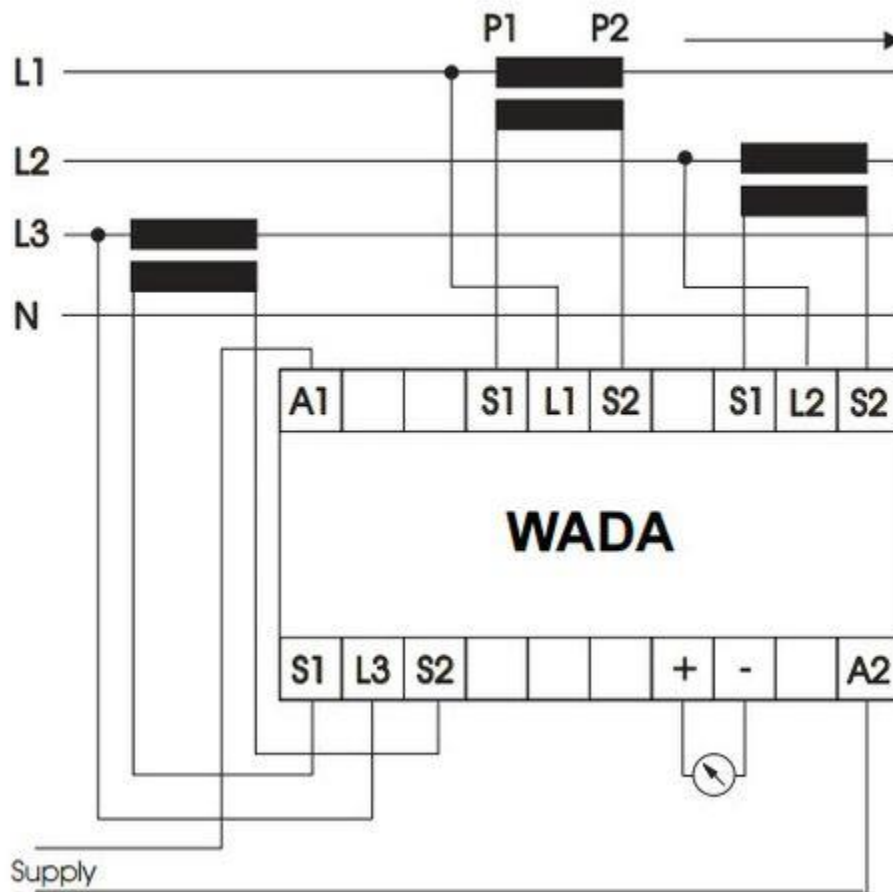
T07 Connection Diagram.

The power consumption signal comes from the AT1:T07 and travels through the W590 cable to the AT2:U2. Inspect the circuit path and verify there are no opens from the CTs to the T07 and from the line side of the F17 to the T07.

Verify that the T07 has supply power by measuring for 230VAC between terminals A1 and A2.

If the power supply is good and the current and voltage inputs are all connected, then try replacing the T07.

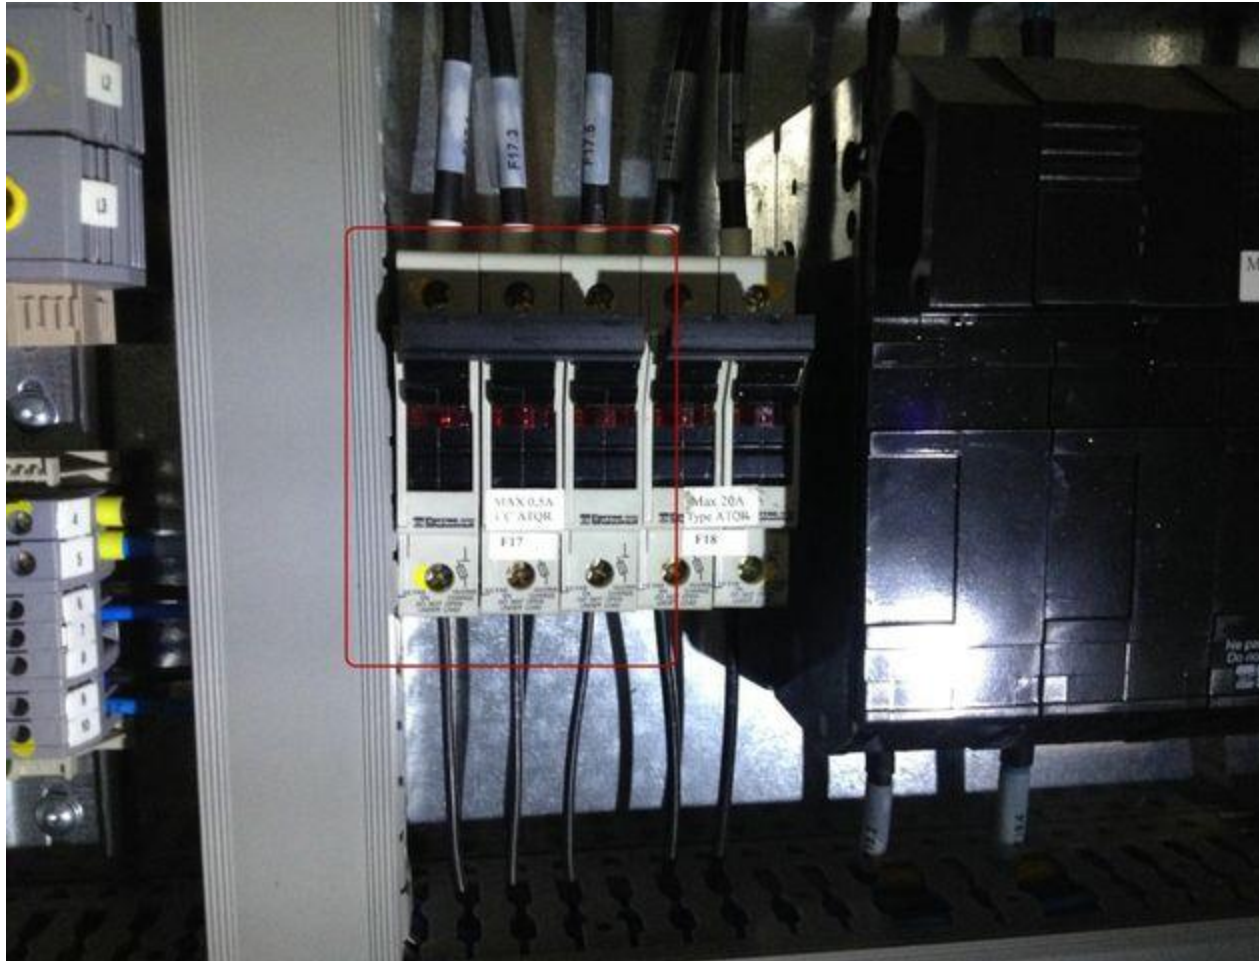
- **Explanation**
This alarm can be caused by a faulty measurement. The voltage inputs have to cross the F17 to get to the T07.

Use a meter to check the AT1: F17 for continuity across the fuses. Measure from AT1:T07:L1, L2, and L3 to AT1:X06:L1, L2 and L3 respectively. Replace any fuses found defective.
