982 - Cut-in frequency fault - V82

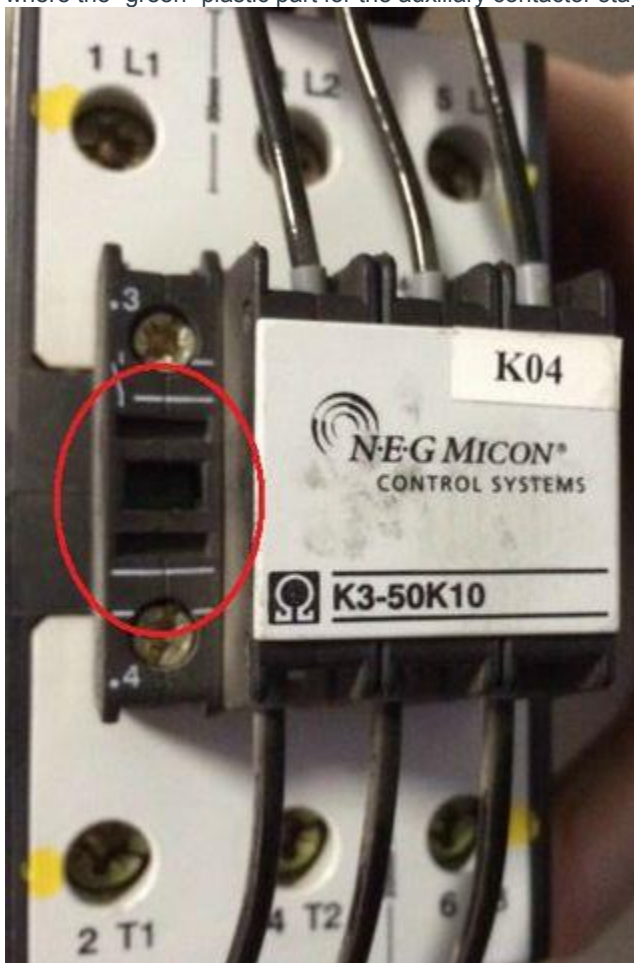
If the contactor is blocked, burned or welded, the turbine will have problems to connect to the grid, especially at low wind it will be more affected. On first hand a defect contactor can be detected visually, as in this example where the “green” plastic part for the auxiliary contactor stays inside:

Change the contactor

Always measure all the contactors for correct function.

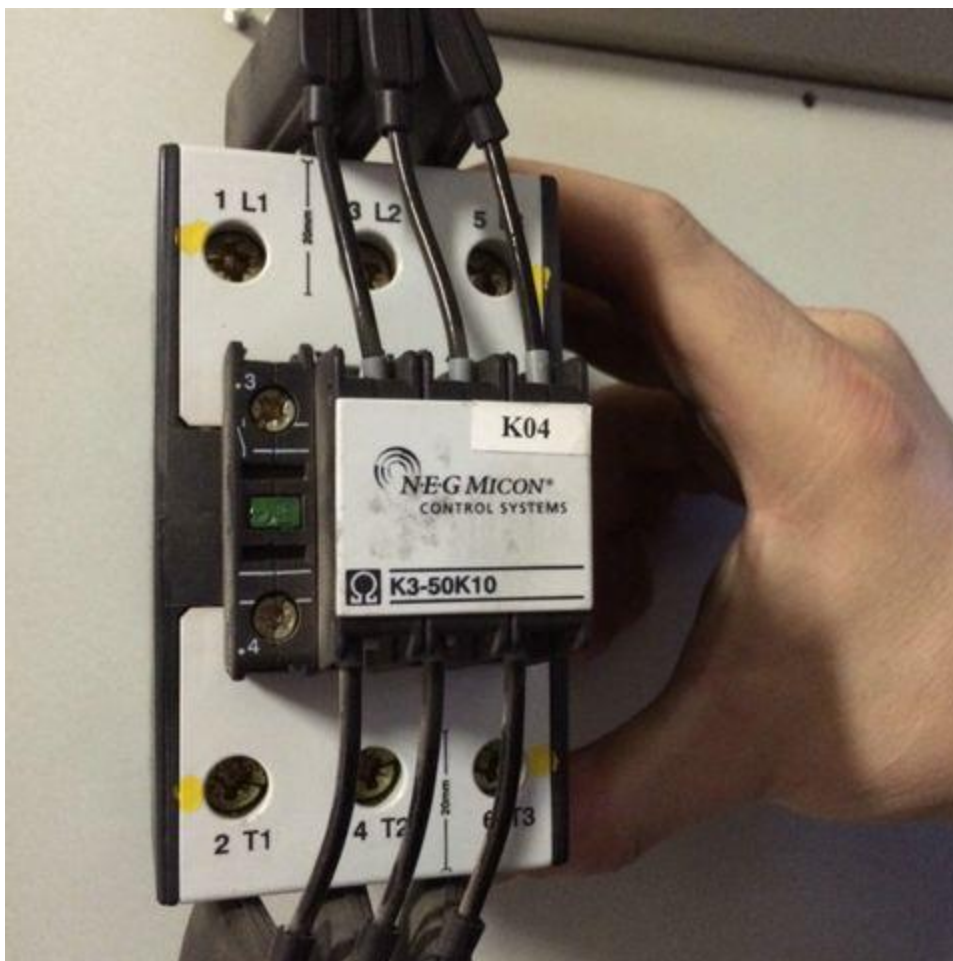
Looks like this when OK:

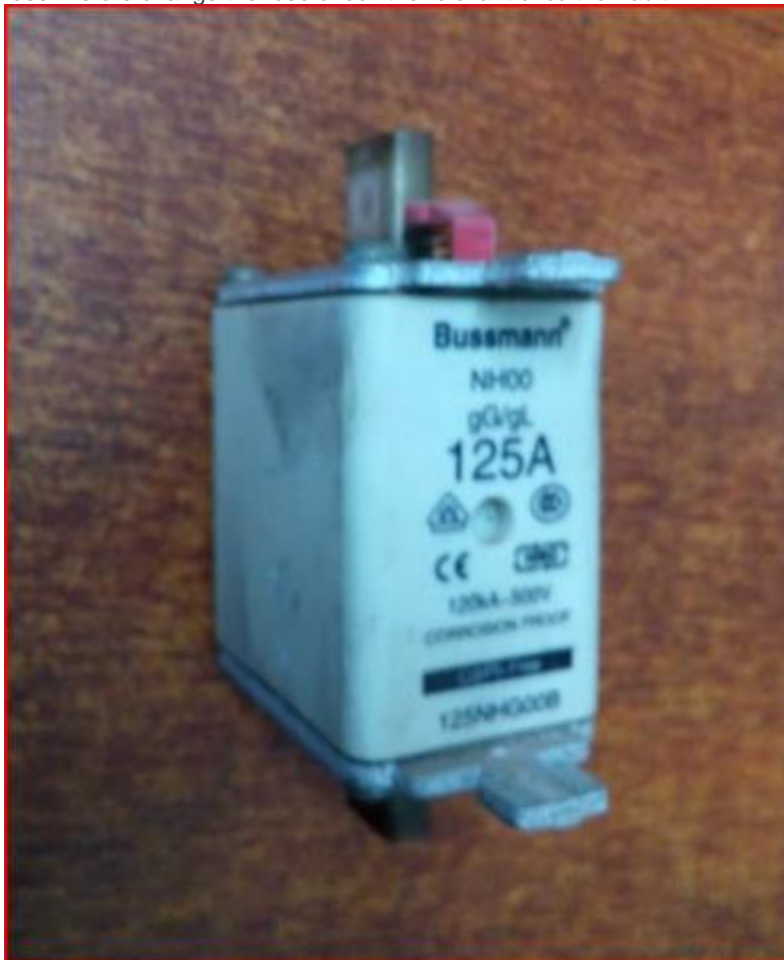
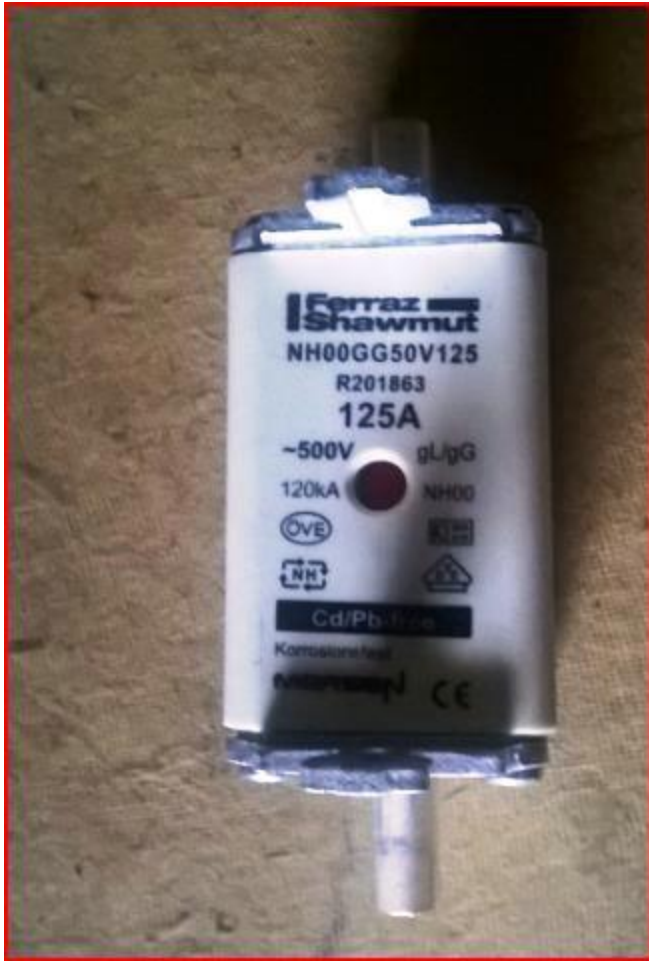
Visually check module unit fuses, if fuse switch opens change the fuse. Check the continuity if break change the fuse. Before change the fuse check the relevant circuit for fault.

Replace the fuse

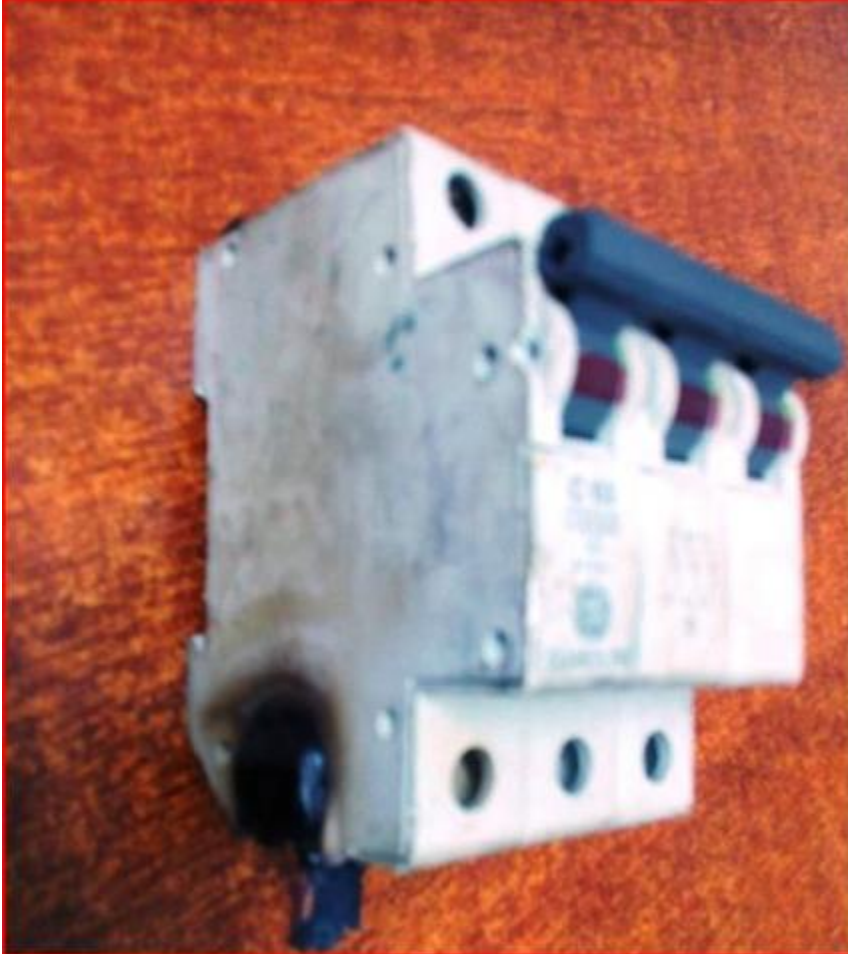
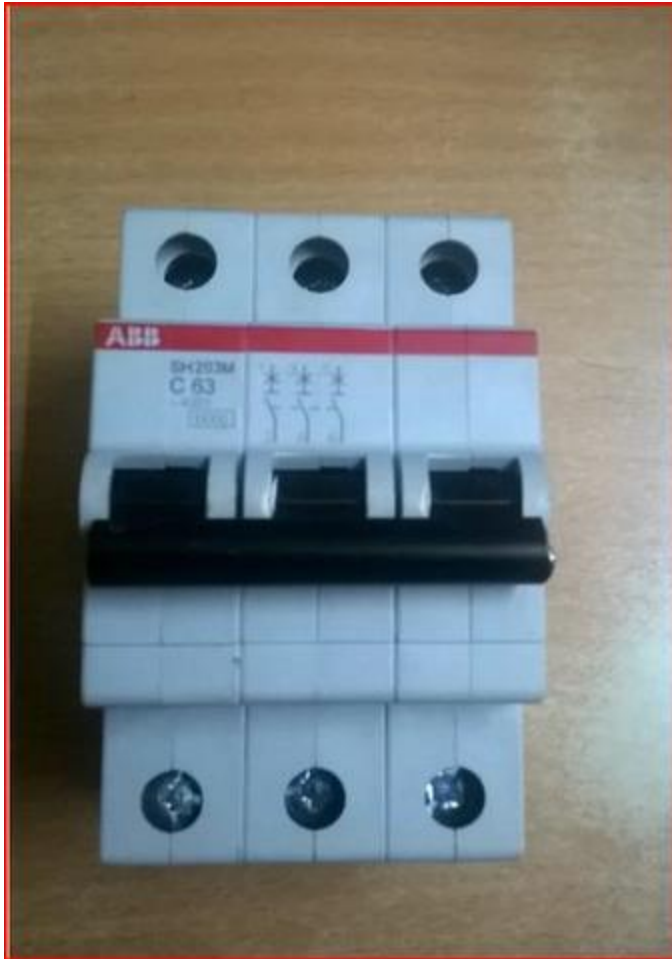
Check the MCB continuity & visual inspection any phase found damage replace it

Change the damaged MCB
Does this solve the problem?

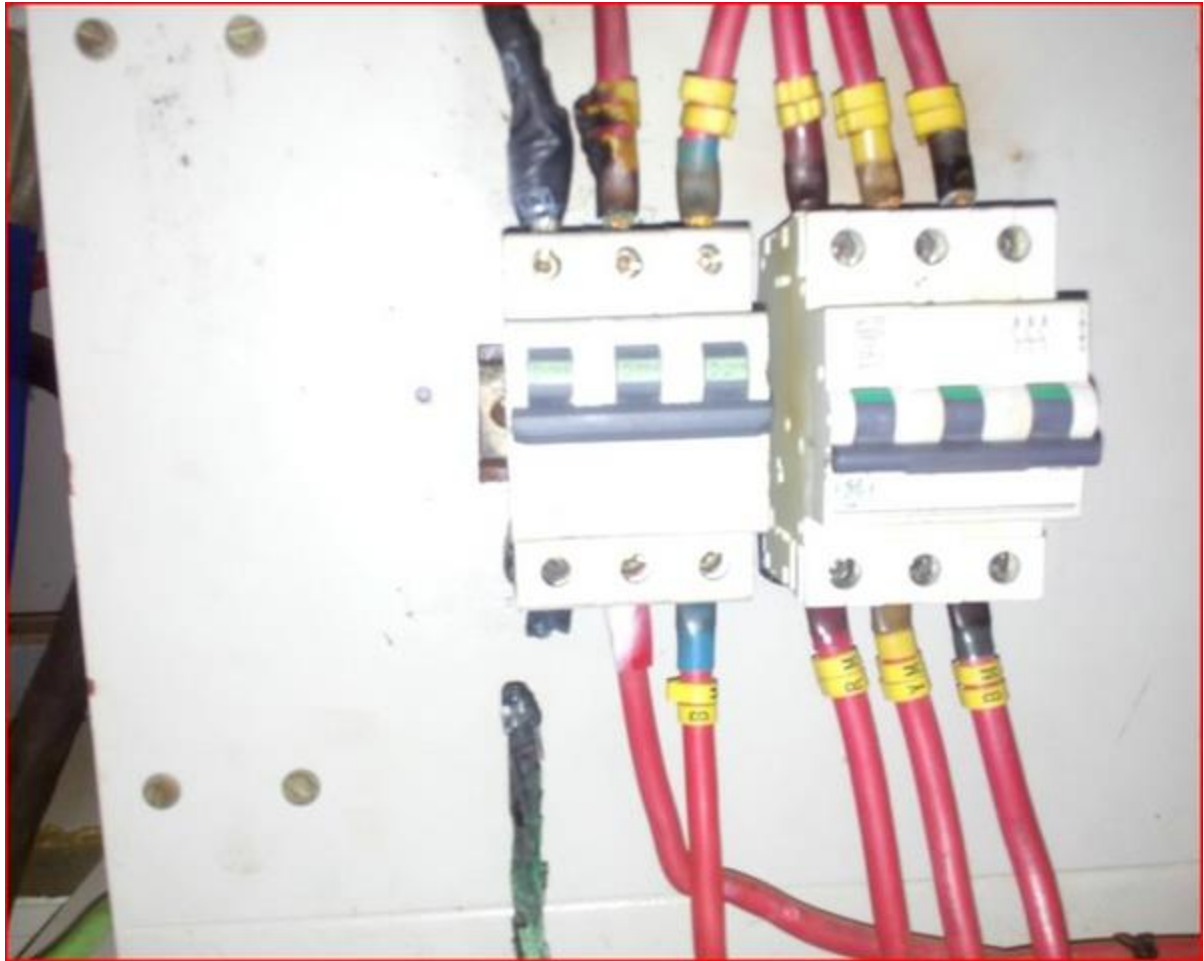
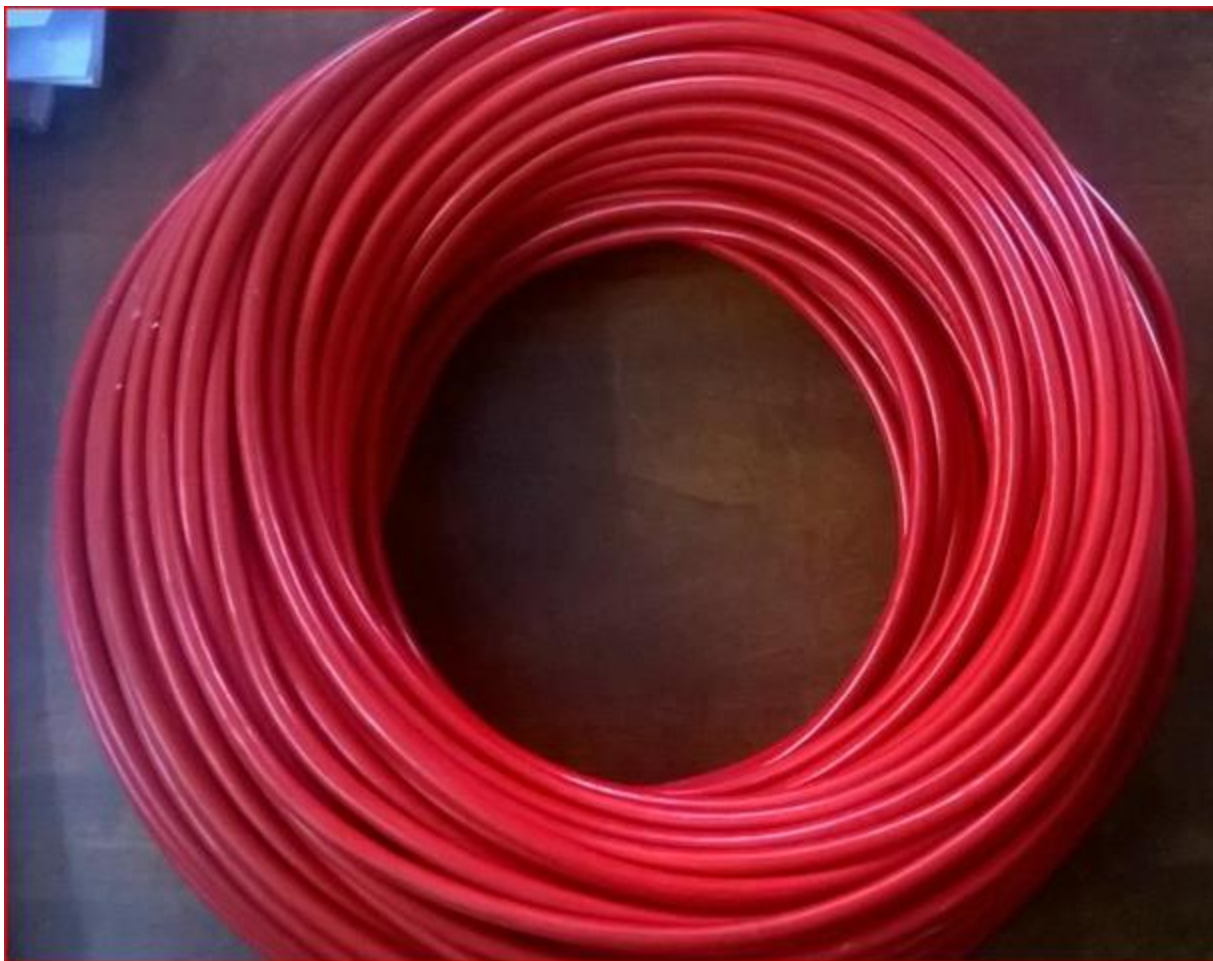
Check the additional PFC(ICDS) panel Idle bank MCB incoming cable condition if cable found damage replace the cable and redo the crimping

Change the cable
