## Replace the defect contactor

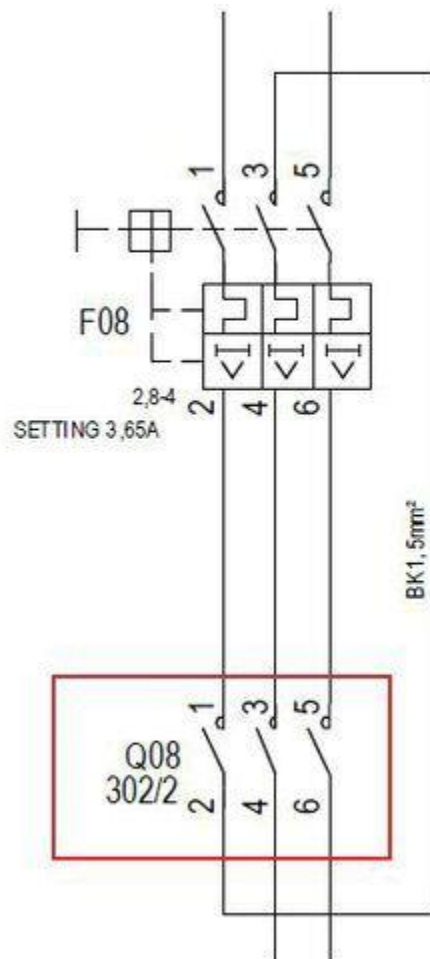
50 Hz

Check the contactor function Q08/K04.

If defective replace the contactor (Item number -60004394)

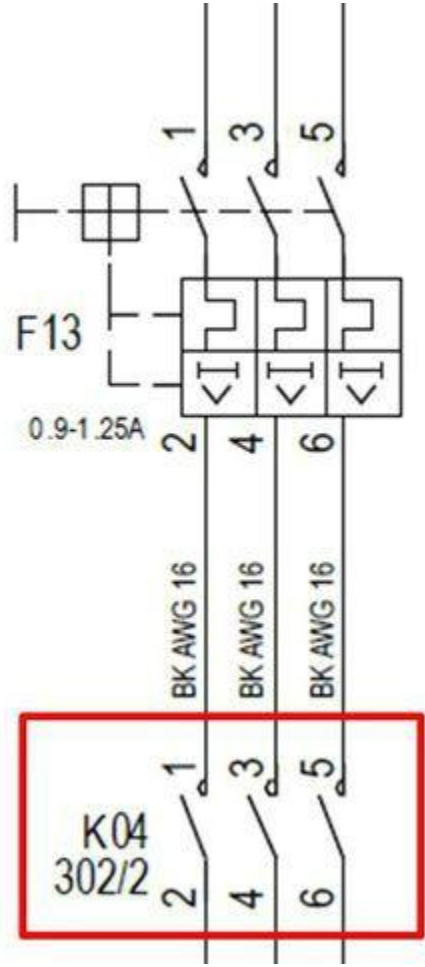
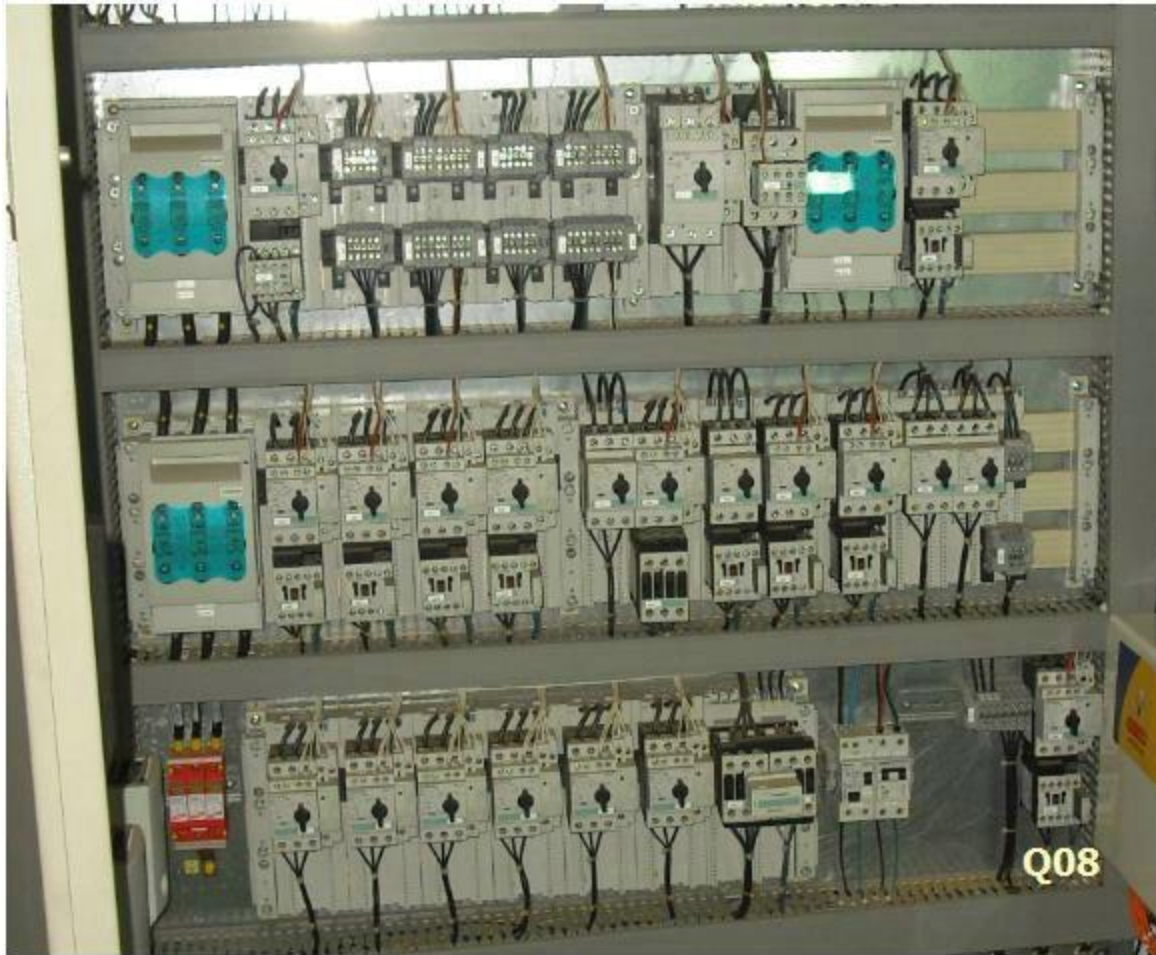
60 Hz

Check the INPUT/ OUTPUT voltage.

Check for loose connection at the terminations.

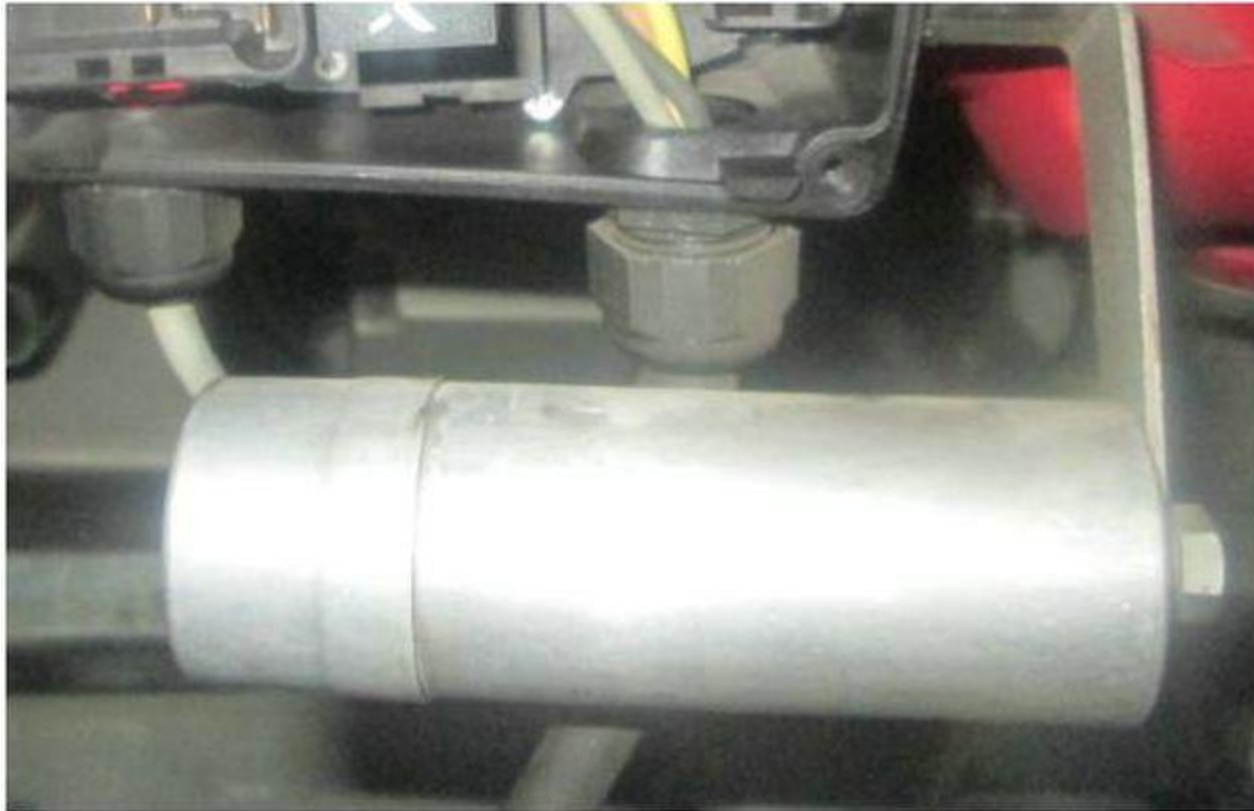
Check the single phase capacitor condition (if present).

**Replace the defect capacitor (If present)**

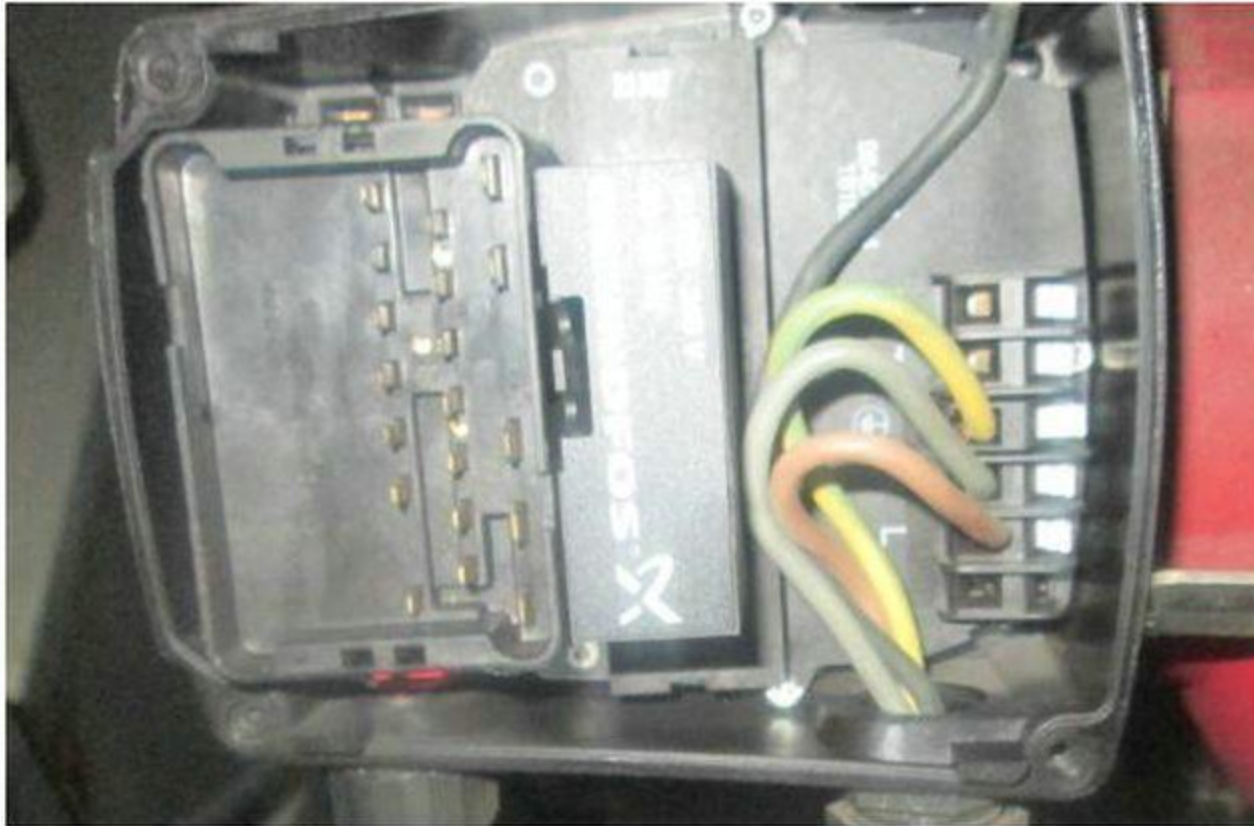
Operate the fan and listen for faulty bearings or abnormal noise of any kind.

Check the input voltage (FAN Position Number : M06)

If the Motor is found to be defective replace the motor.

(Item number : 60061710)

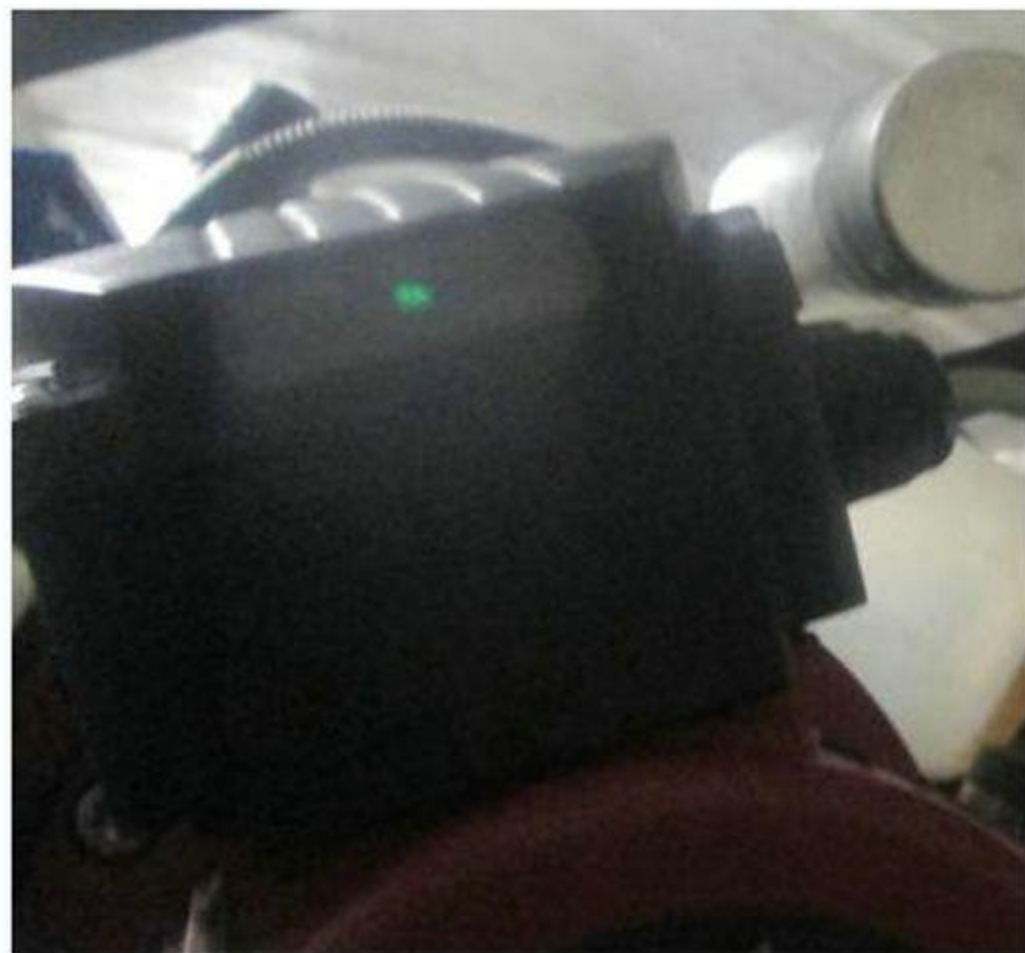
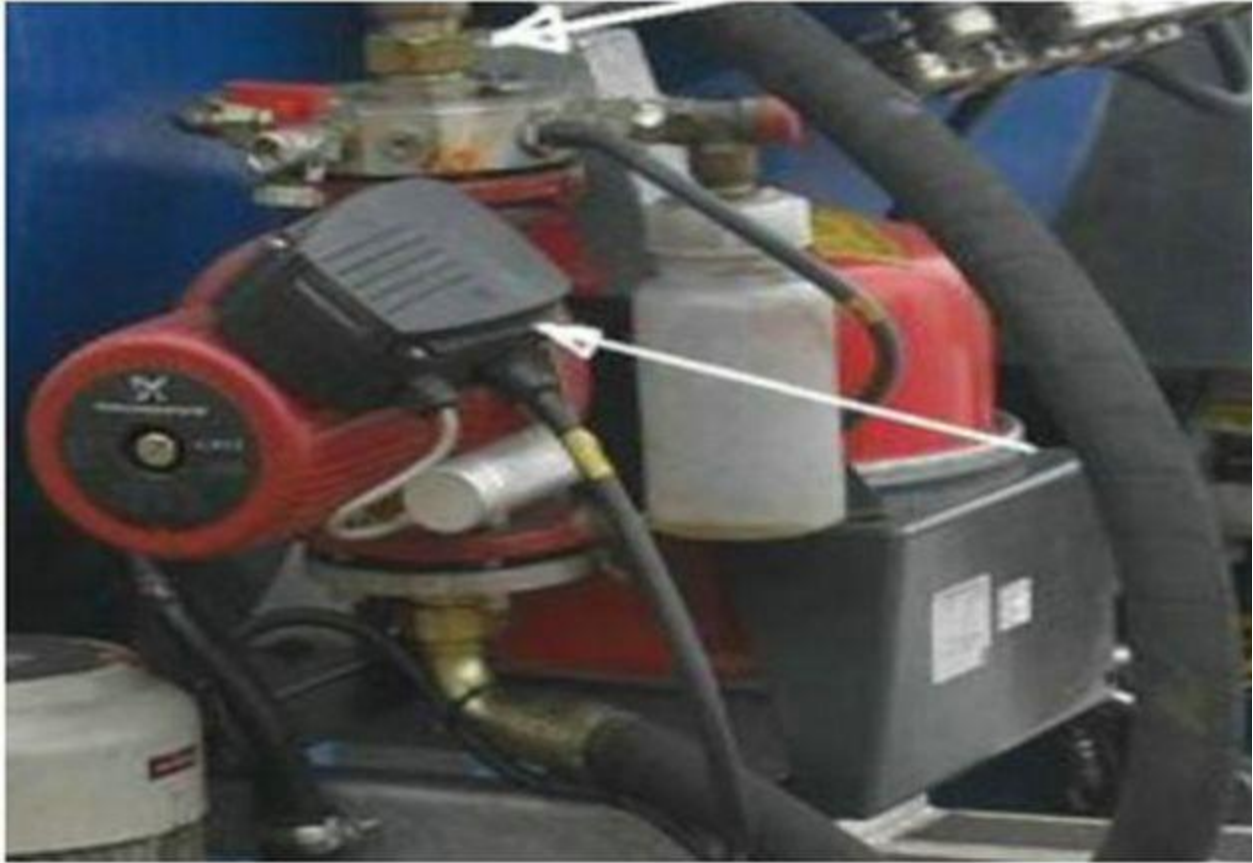
Operate the fan and check the lamp indication is shows as 'RED' (Defect) or 'GREEN' (Good)

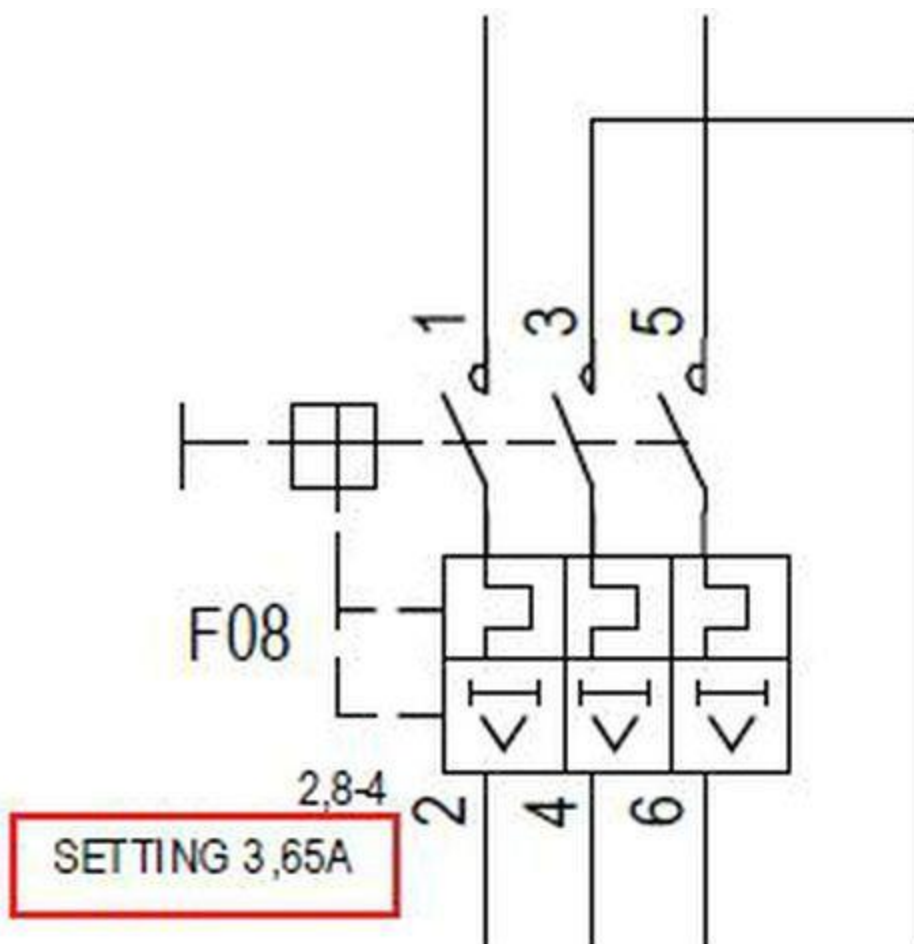
Check the INPUT/OUTPUT voltage (F08/F13) and MCB function.

Check the required current setting in the MCB (use latest turbine electrical schematics for correct current settings):

If defective replace the MCB (Item number -60004750 50 Hz / 60004745 60 Hz)

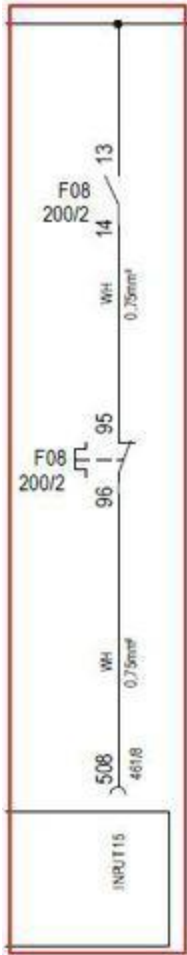
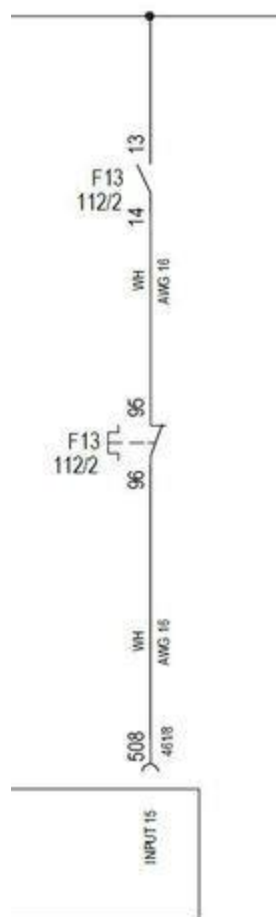
60 Hz

Check the auxiliary relay (Item number - 60004778) function input to TOI.

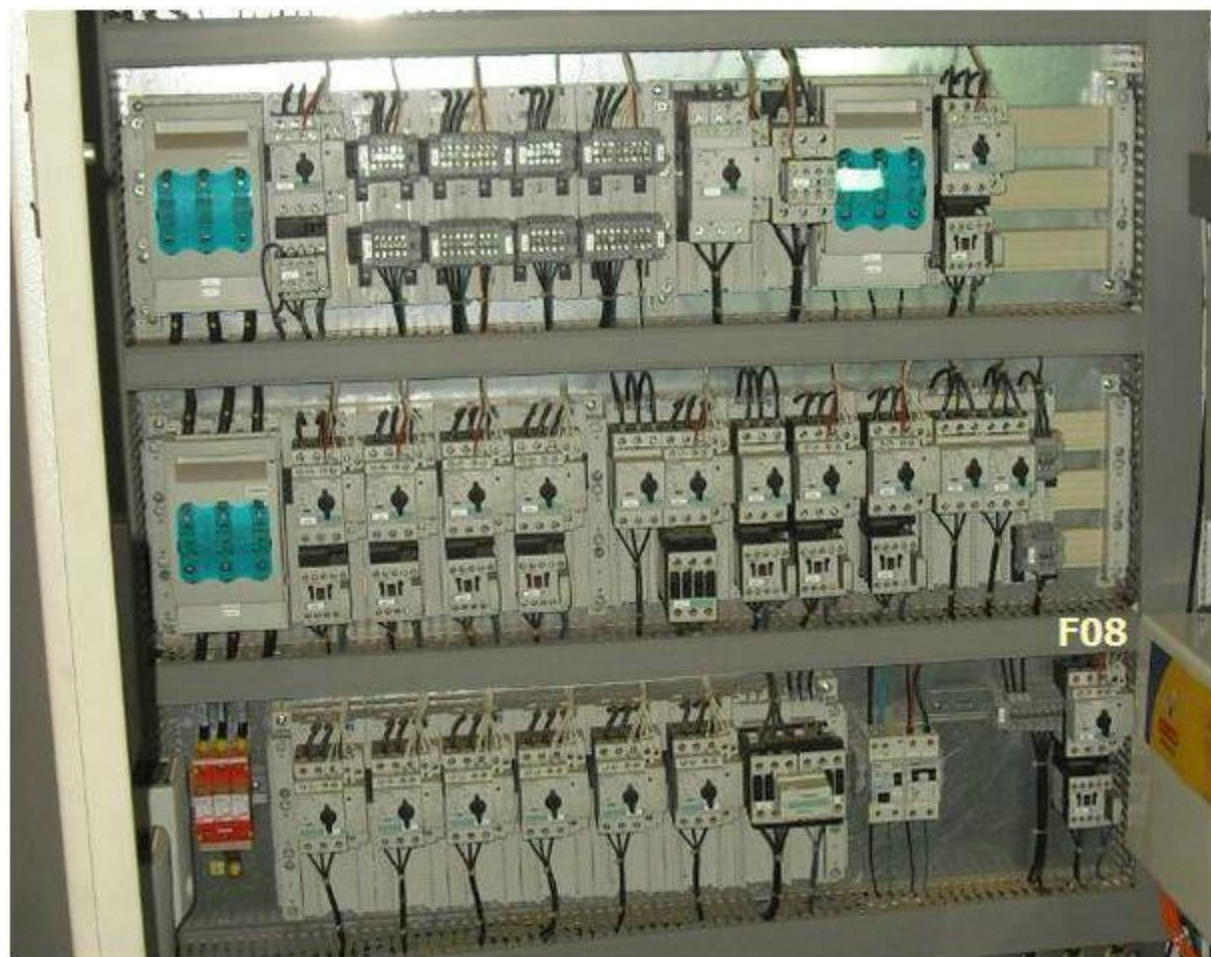
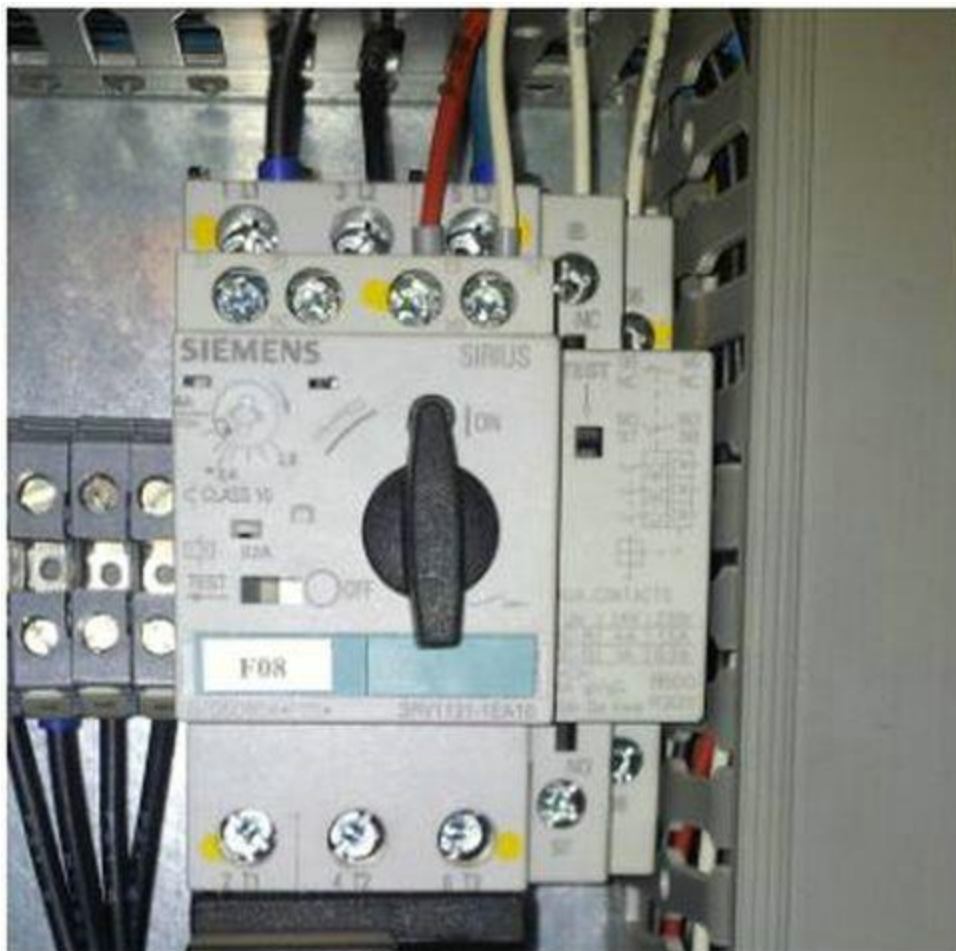
Check for loose connections at all terminals.

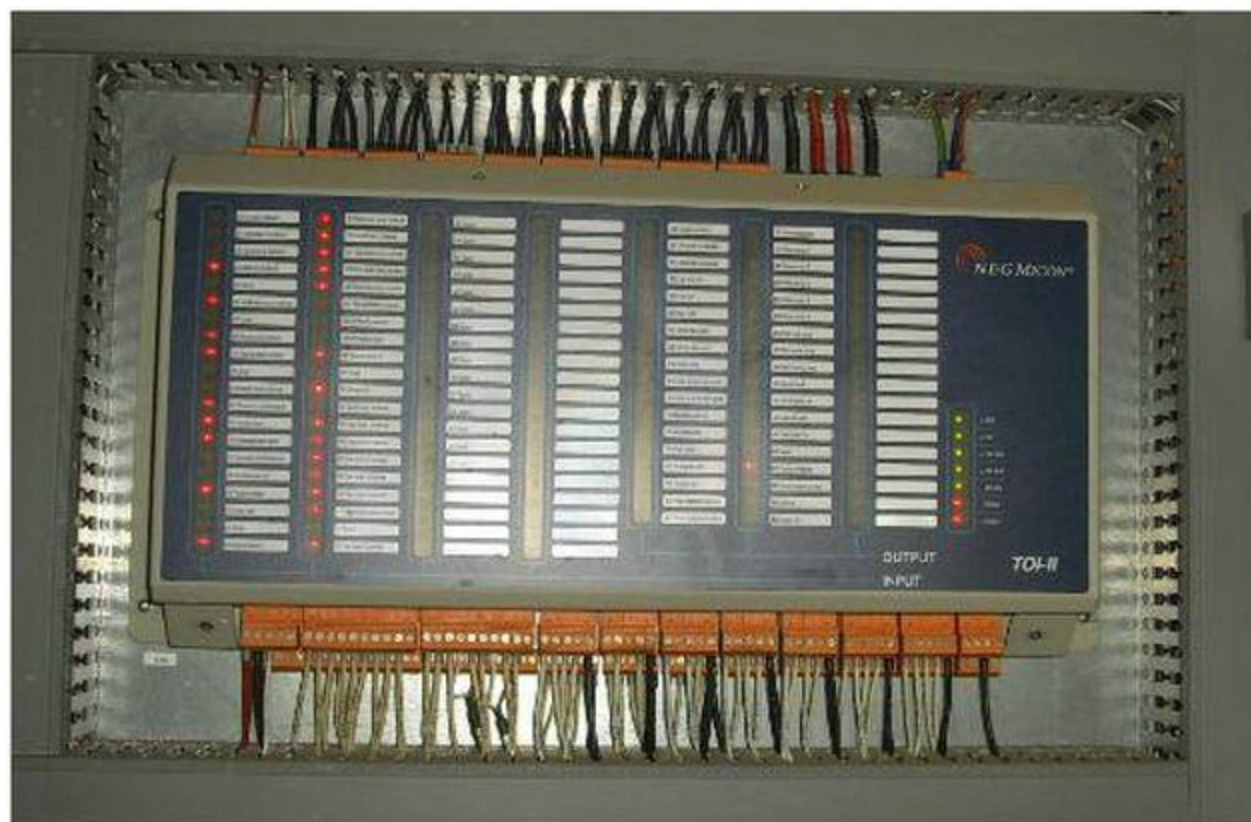
51701501- TOIII Interface NM1500 Tower

Check the voltage at TOI output (RELAY OUTPUT 810). If voltage is not present, replace the TOI.
