486 - Unbalanced Pitch - V82

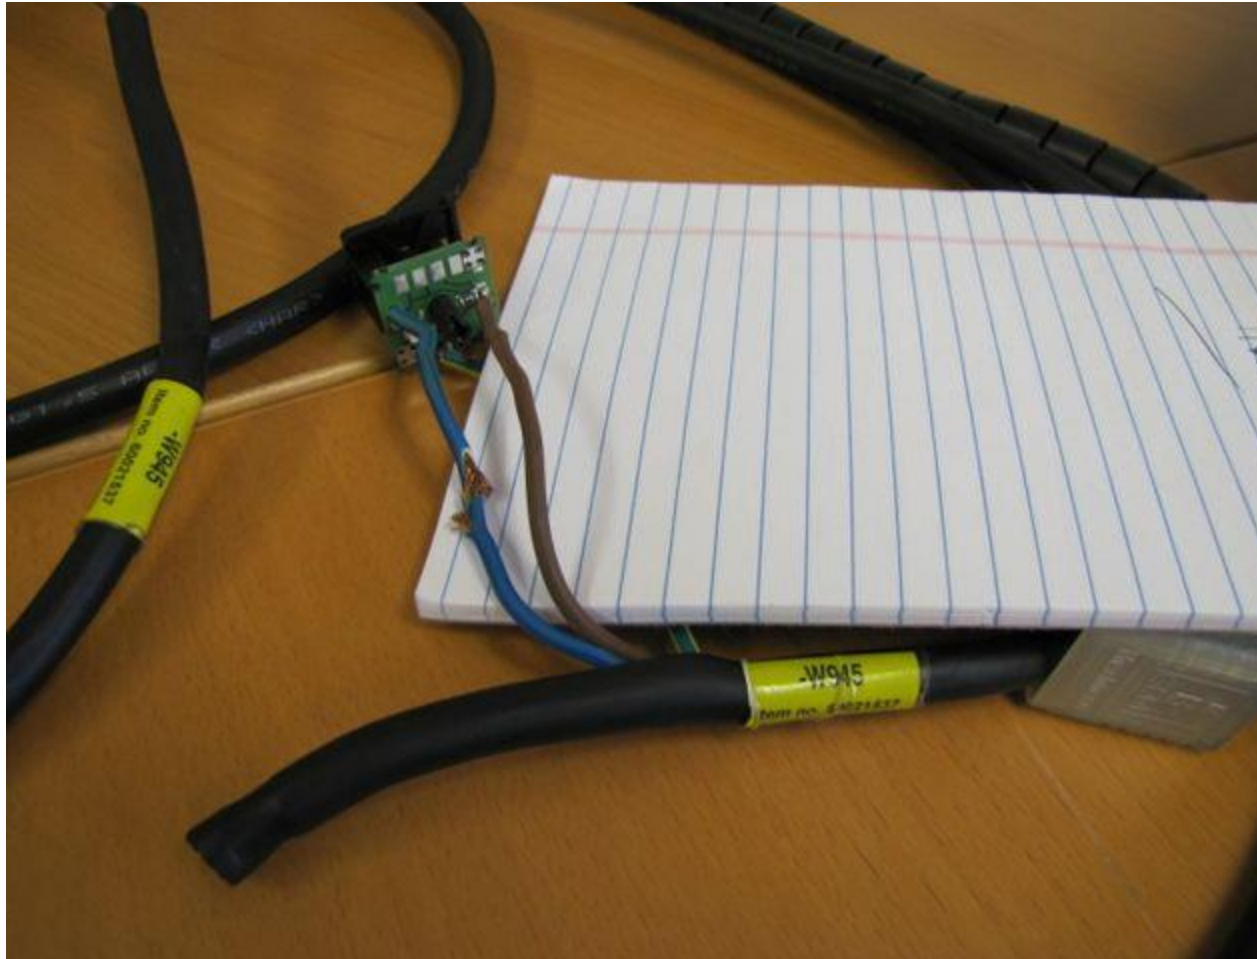
Check that there is a secure connection for the power cord for the proportional valve, valve 210, 215 and the position transducer (Balluff).

While pitching pull on the wire harness for the defective blade's proportional and solenoid valves (205, 210 and 215) and Position Transducer.

During operation the offending blade "flutters" a bit as the wire flexes in the hub.

If it is broken badly enough you will hear the blade "hammer" as it faults.

If a data logger is armed you will see the blade position flutter.

If you are watching real time on the TAC it is usually in perfect unison with rotor revolution (1 flutter per revolution)

Check for loose connections and test / replace power cable

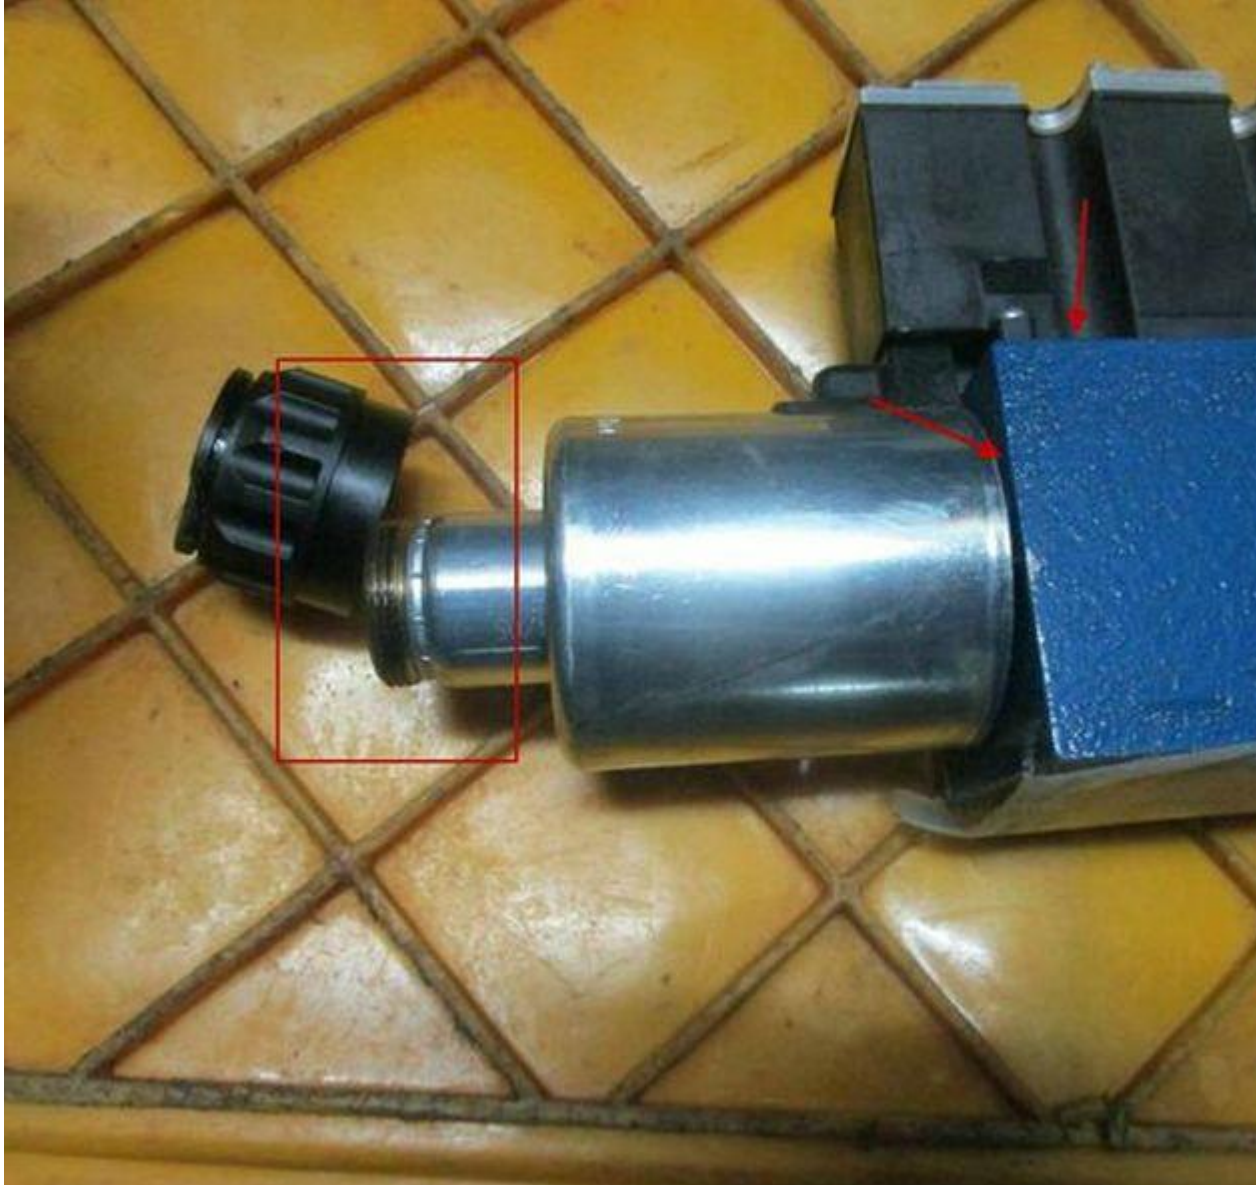
Check the proportional valve for any oil leakage and repair/replace the valve if leakage or loose components are found.

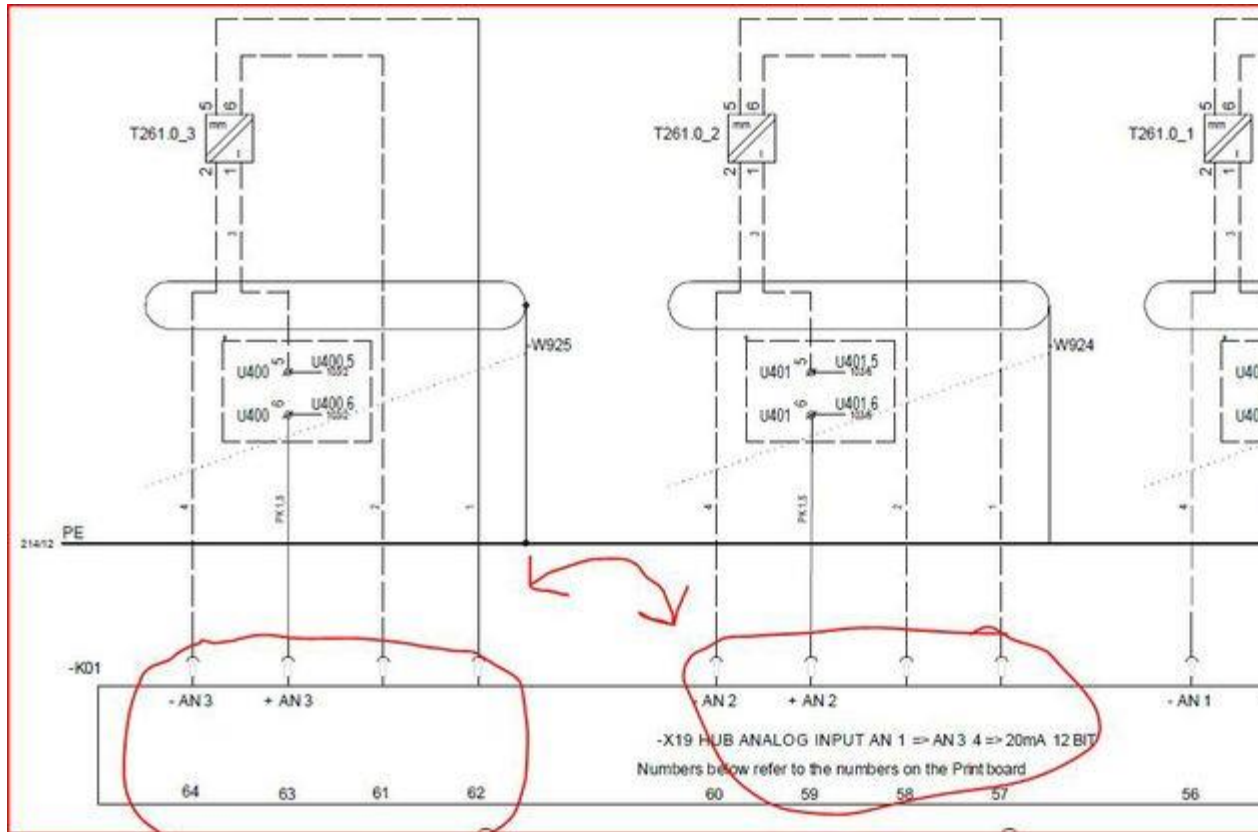
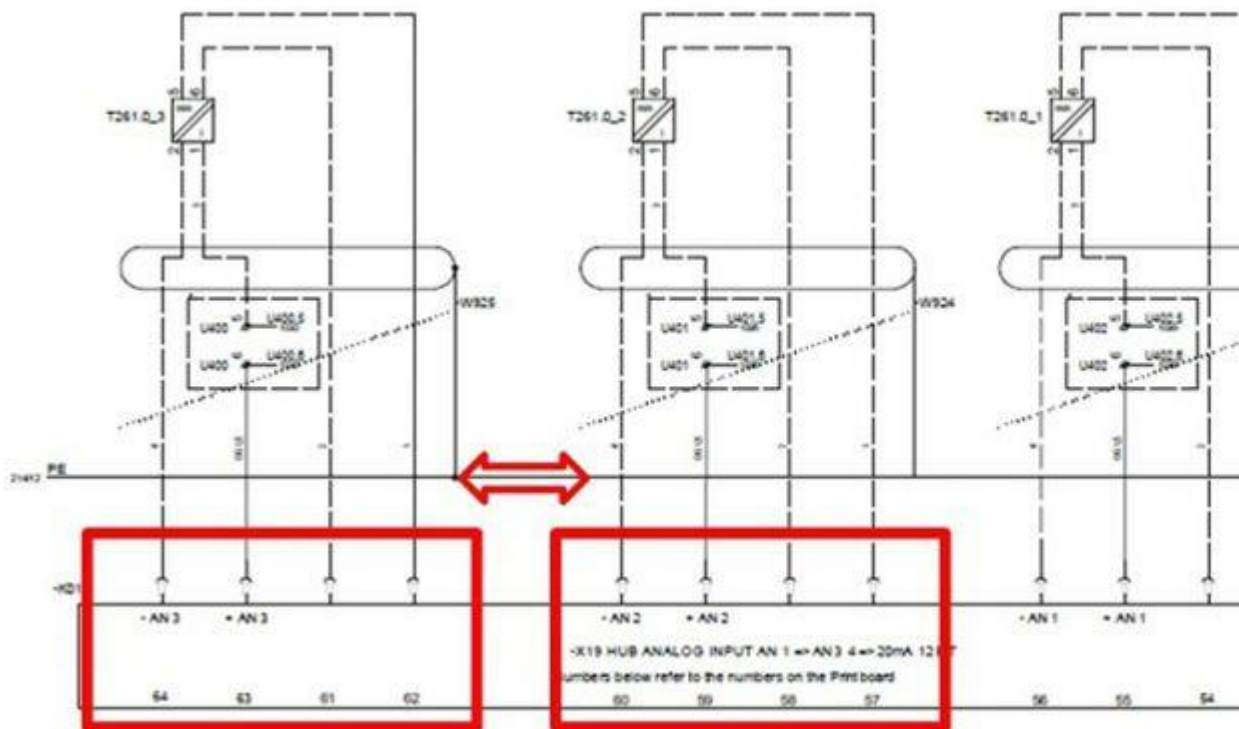
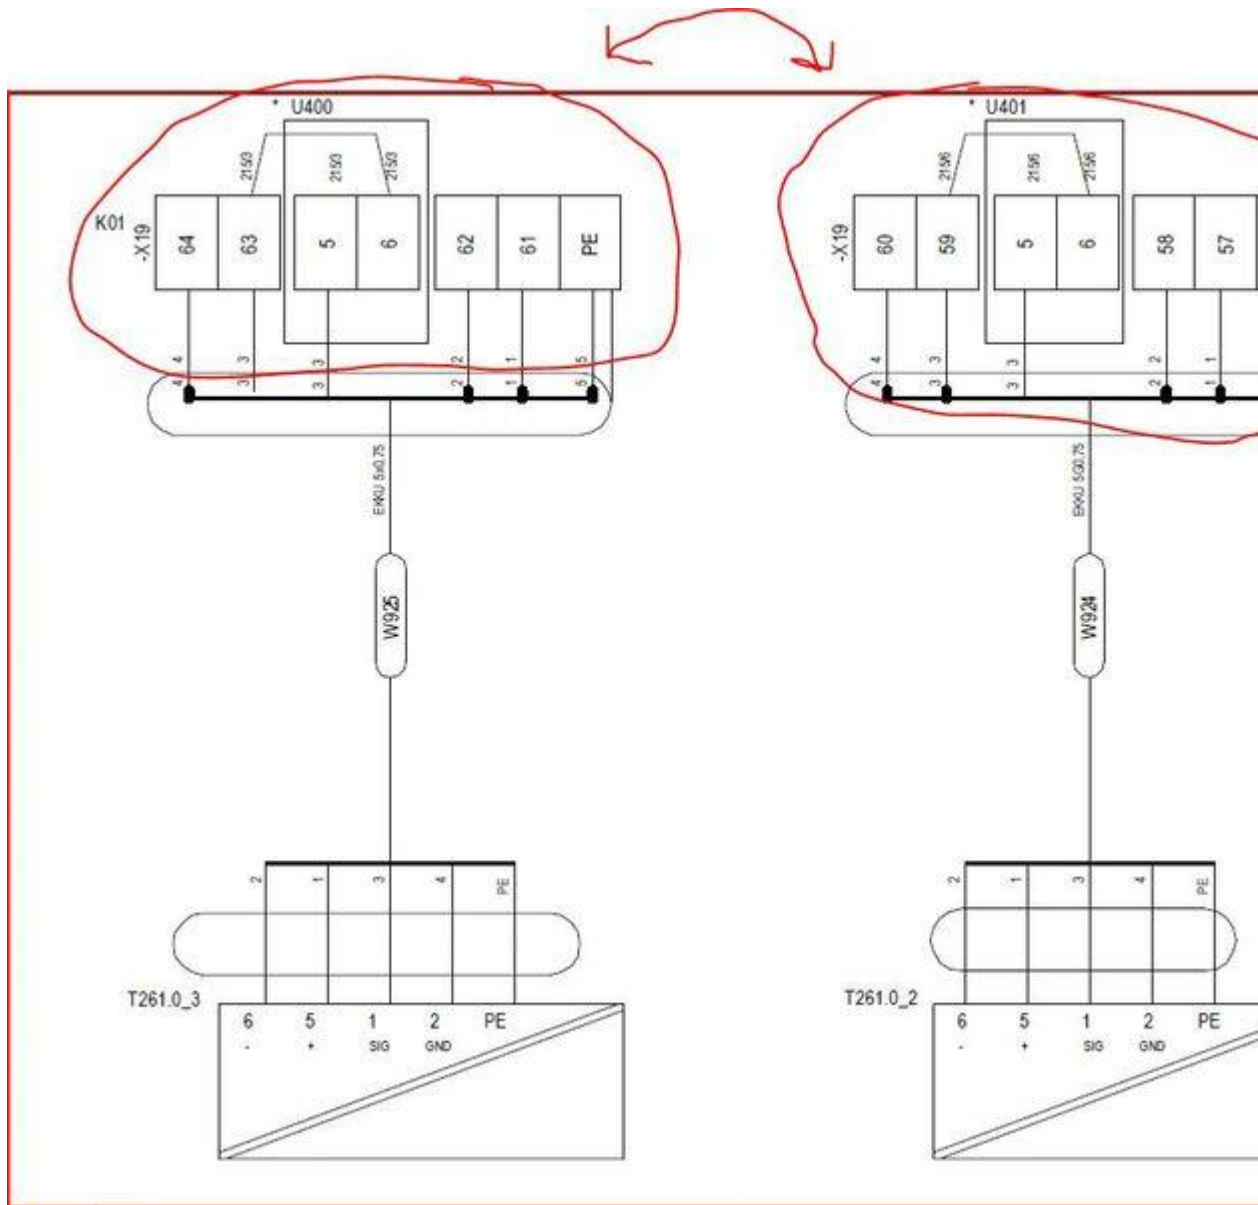
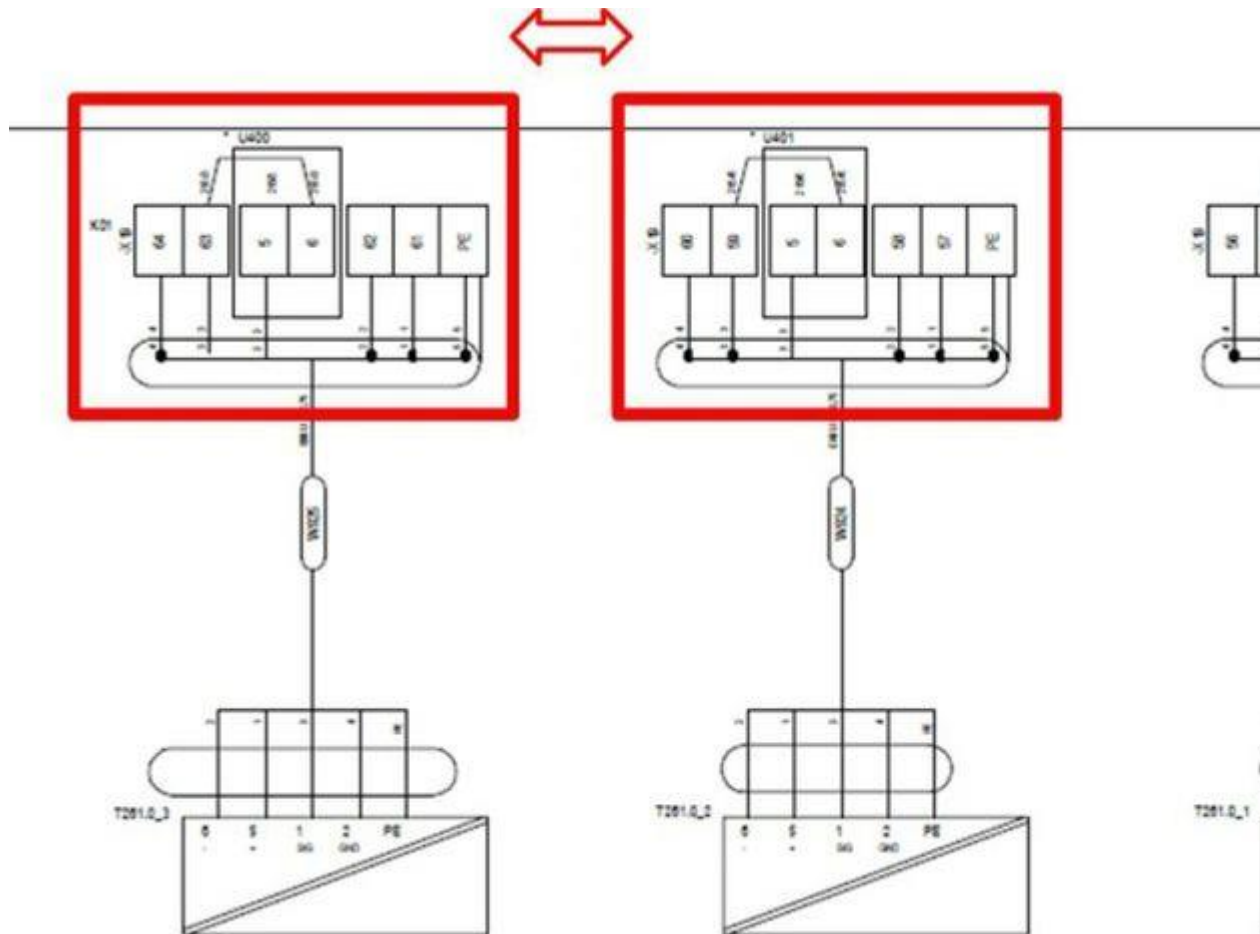
Swap the signal wire to the proportional valve and position transducer (Balluff) on the hub computer. If the fault follows to the new blade then the fault is either in the proportional valve or one of the cables. In the example below, we are swapping the plugs between blades B and C.

Place the cables back to their original position and then swap proportional valve from affected blade to another working blade.

If the alarm follows the valve to the other blade, the proportional valve is defective.

If it does not, the proportional valve is likely not the cause.

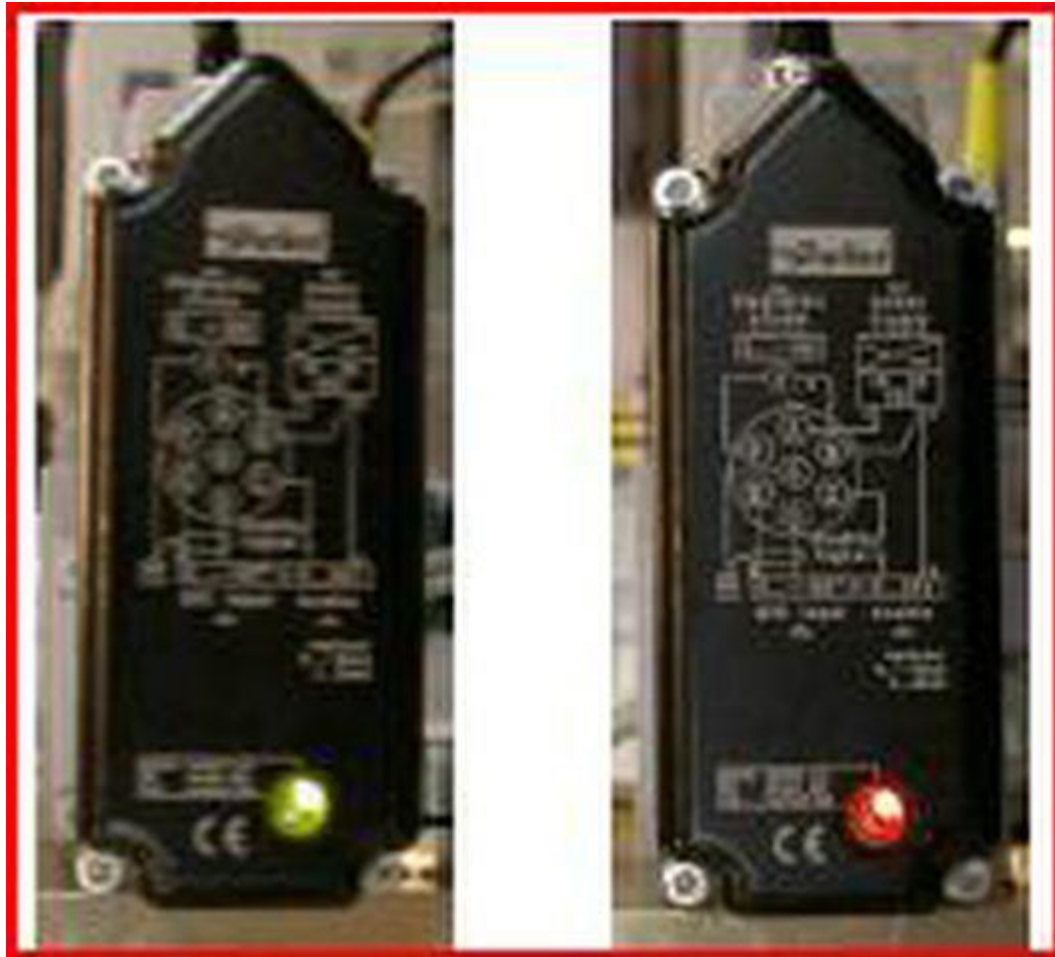
For Parker proportional valves check to see the color of the LED on the valve circuit board.

The LED should be green with the pitch system pressurised.

If it is red and there is pressure verified on test port MP, then the valve may also be defective.

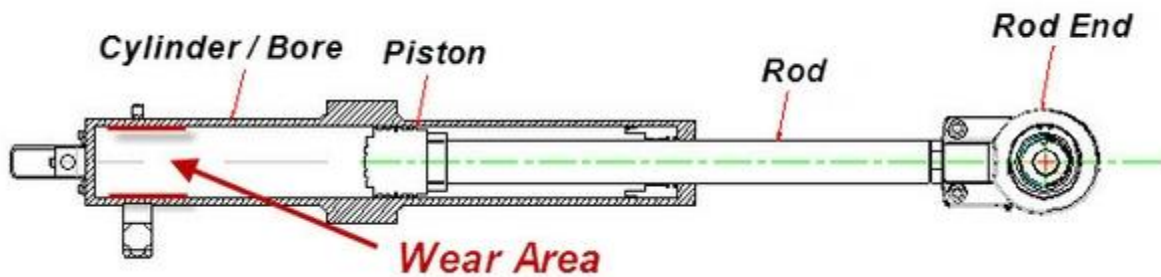
The back 250 mm of the pitch cylinder bore may be susceptible to excessive wear. This area of the cylinder is where the piston operates during production. When excessive wear occurs in the cylinder barrel, the piston seals are also subjected to accelerated wear, and internal leakage will occur in both run and stop positions. The effect of this leakage is excessive pump run time during operation as well as during stop. In the event of a pump failure, grid outage or certain turbine faults, pressure within the accumulators will bleed off, and blades may be at risk of being pushed into the run position under high wind conditions. Check the back of the bore for abnormal wear.

Refer to DMS doc 0059-1574 for inspection instructions and criteria for running the turbine if wear is found.
