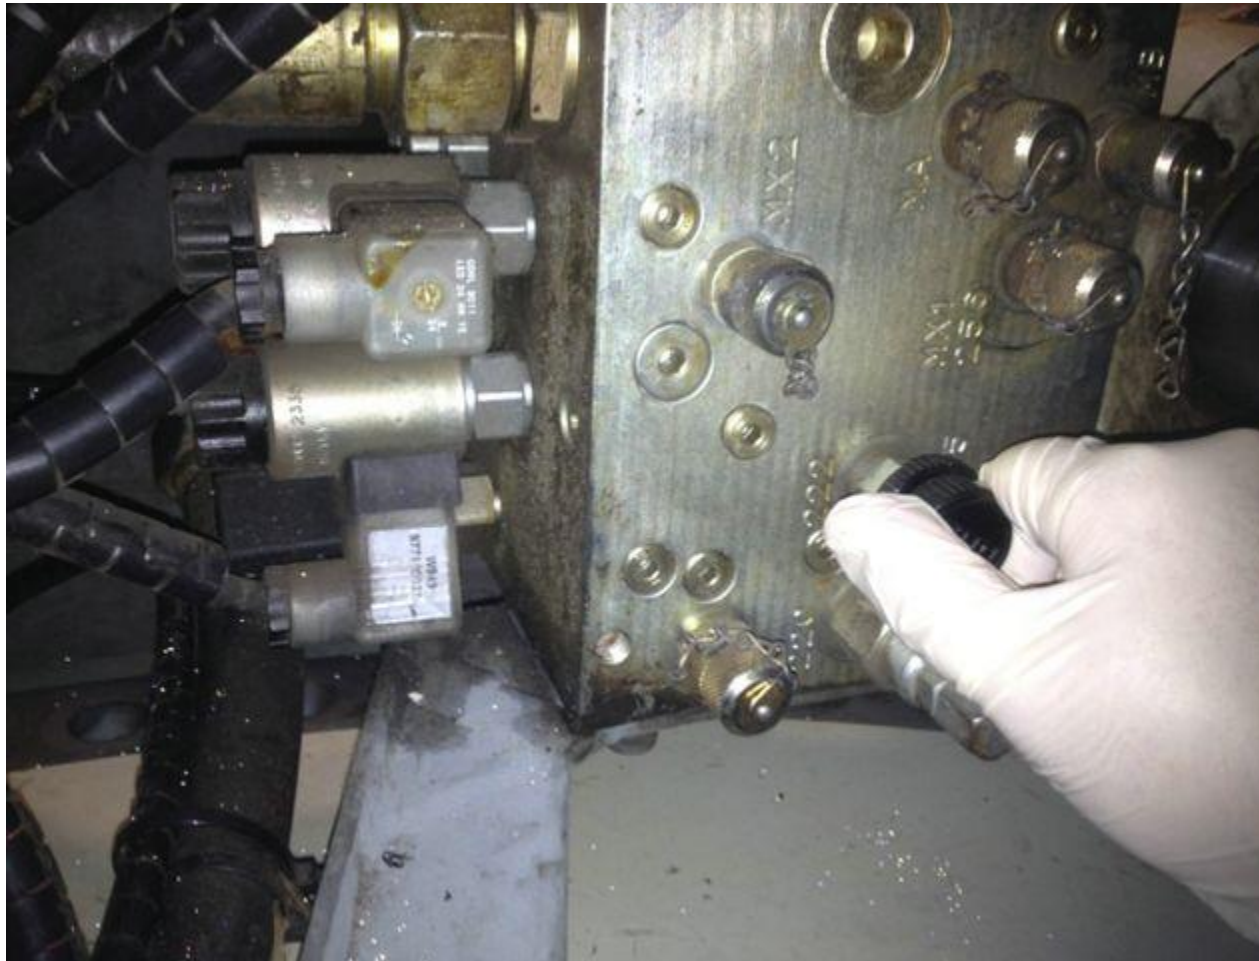
Check/replace needle valve 222

Loosen the plastic jam nut on valve 222. Tighten the valve handle to determine if the valve was left partially open.

If the valve was closed, but you suspect the valve is leaking- charge the accumulators.

Listen for a whistling sound coming from the valve.

If possible, have someone monitor the blade pressure at the controller or remotely to monitor for a drop in pressure.
Replace the valve if found to be faulty.

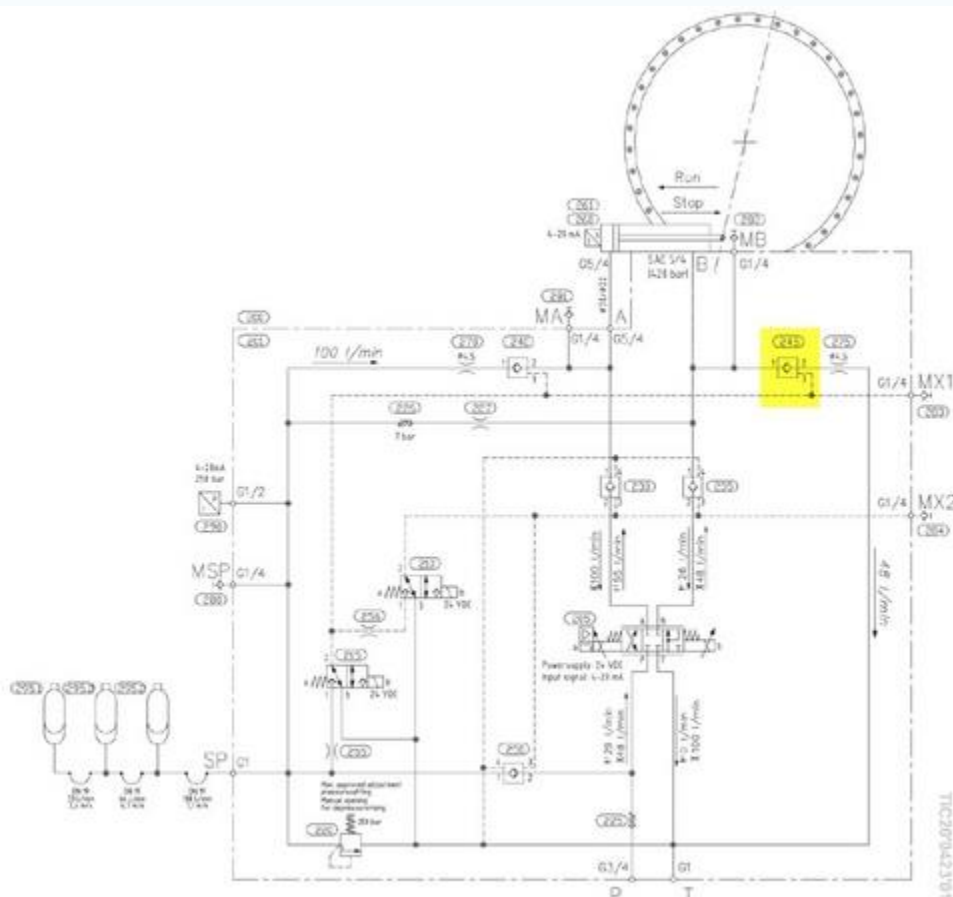
Figure 13-3: Fast Active Stall System (Bosch-Rexroth).

Check the below valve positions.

Swap the valves one by one in to other manifolds and check valve operation.

If the fault shifts to other blades the valve is likely defective. If not continue to check the other valves.

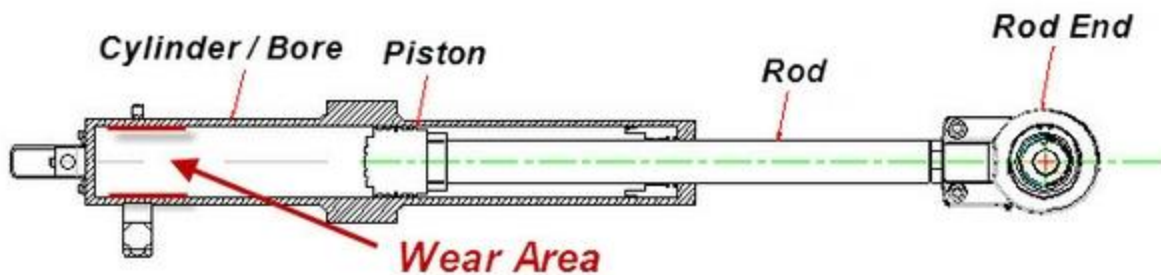
Perform a visual inspection of the back of the cylinder bore

The back 250 mm of the pitch cylinder bore may be susceptible to excessive wear. This area of the cylinder is where the piston operates during production. When excessive wear occurs in the cylinder barrel, the piston seals are also subjected to accelerated wear, and internal leakage will occur in both run and stop positions. The effect of this leakage is excessive pump run time during operation as well as during stop. In the event of a pump failure, grid outage or certain turbine faults, pressure within the accumulators will bleed off, and blades may be at risk of being pushed into the run position under high wind conditions. Check the back of the bore for abnormal wear.

Refer to DMS doc 0059-1574 for inspection instructions and criteria for running the turbine if wear is found.
