Inspection of Main Bearing to assess damage severity and replacement needs

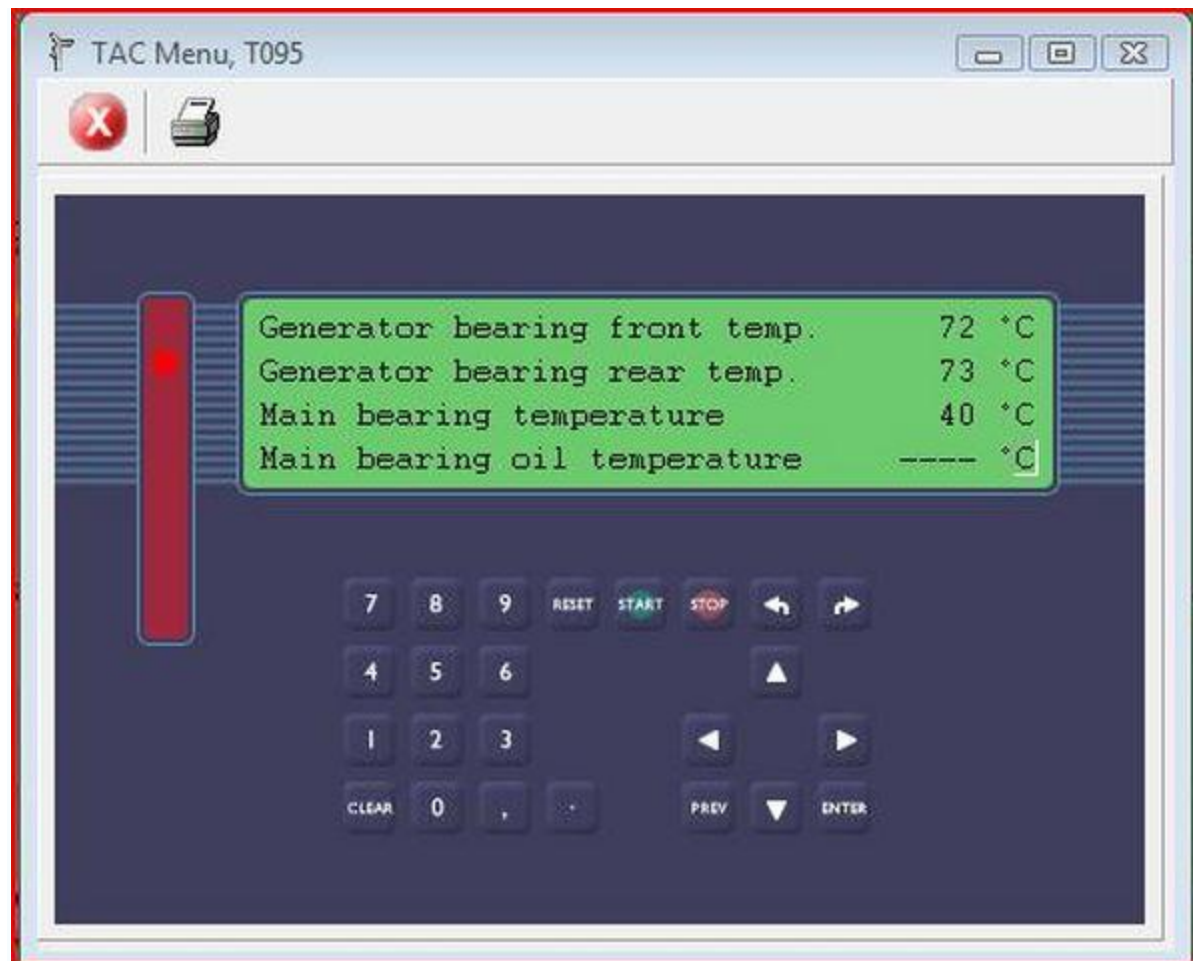
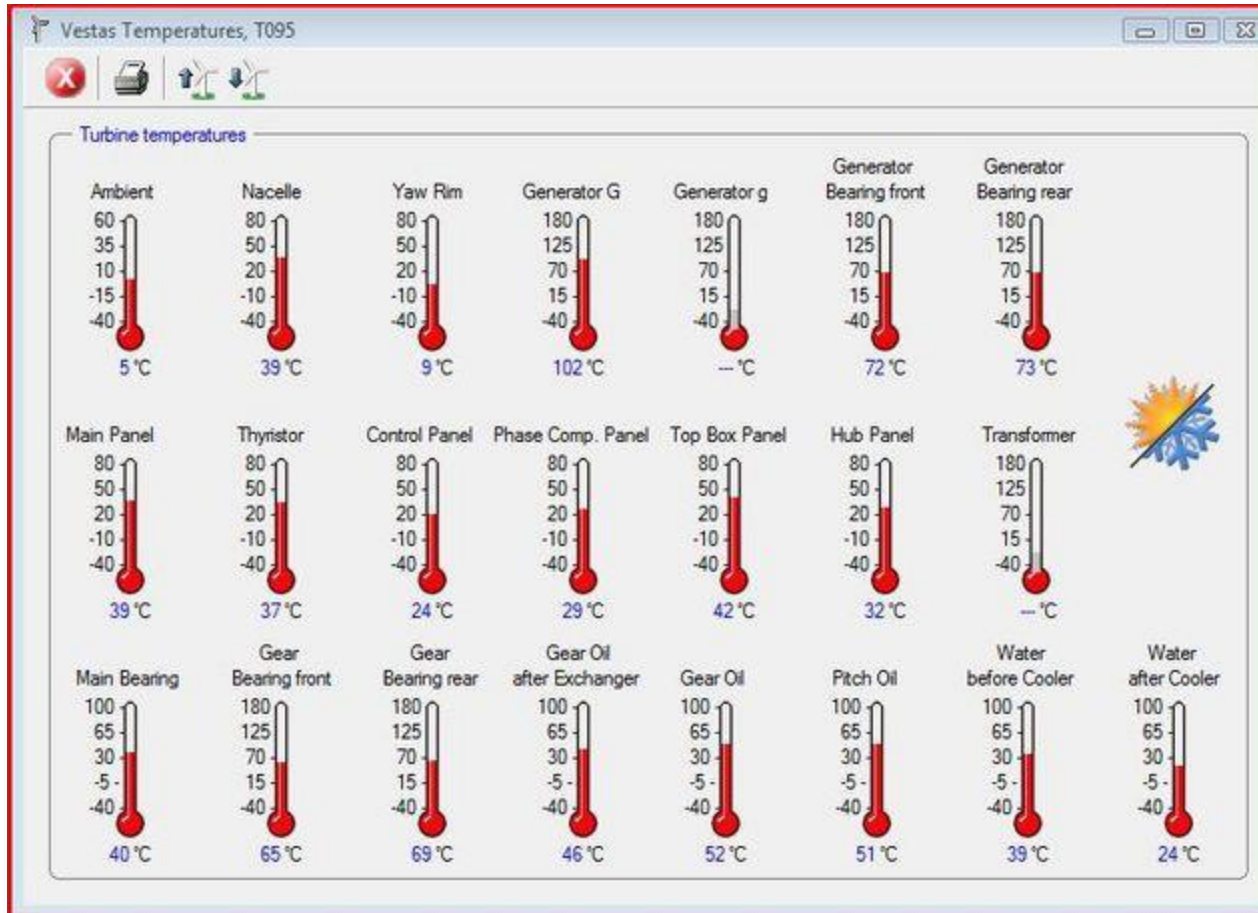
Check the temperature display on the TAC computer or in VOB. An open in the sensor or wire will cause a temperature of 205C to be displayed.

Replace temperature sensor or TOI

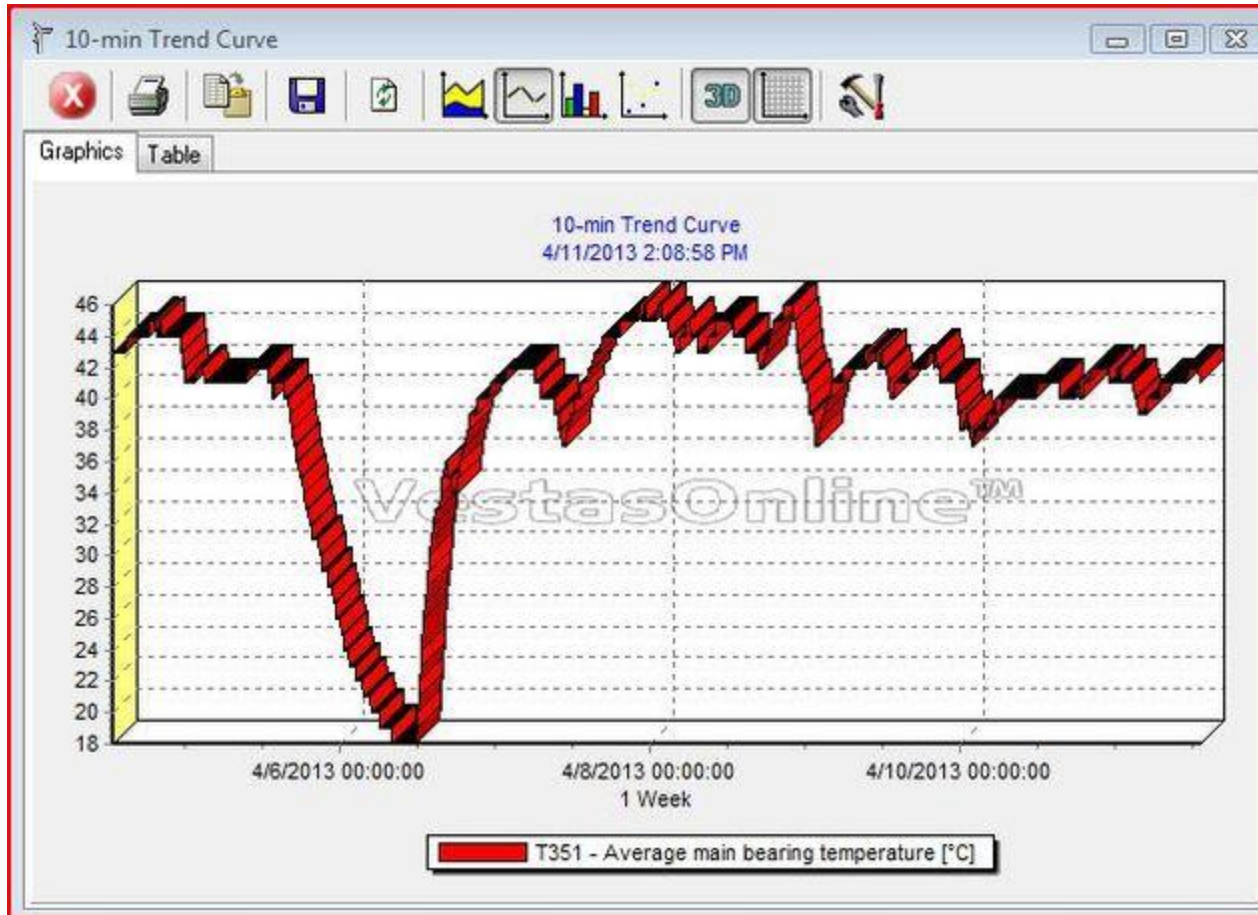
Also look at the average temperature values for the main bearing. A smooth change in temperature means that the pt100 is likely operating correctly while sudden spikes in temperature mean a defective pt100 or a loose connection in the circuit.

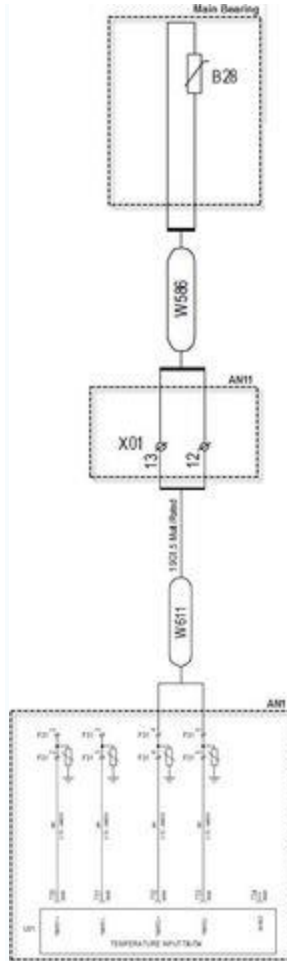
1. If the sensor is suspected to be reading inaccurately, check the resistance of the PT100.
 - a. Disconnect the wires of the Pt100 sensor from terminals 12 & 13 in AN11.
 - b. Measure the resistance of the PT100 across the leads.
 - c. Using the PT100 Resistance-Temperature conversion chart, determine if the sensor is operating within range.
 - d. If the sensor is good, check for faulty connections in the rest of the circuit.
2. If connections are good and the PT100 is working then check the TOI.
 - a. Remove wires from TOI terminal 732 and 733 and switch them with another temperature input (e.g. 734 and 735).
 - b. Observe temperature with the wires in the new input. If it is the same as it was with the wires in 732 and 733 then the TOI is likely working.
 - c. If temperature is different, TOI is defective.

PT100 part number 60009279
TOI part number 60015648
