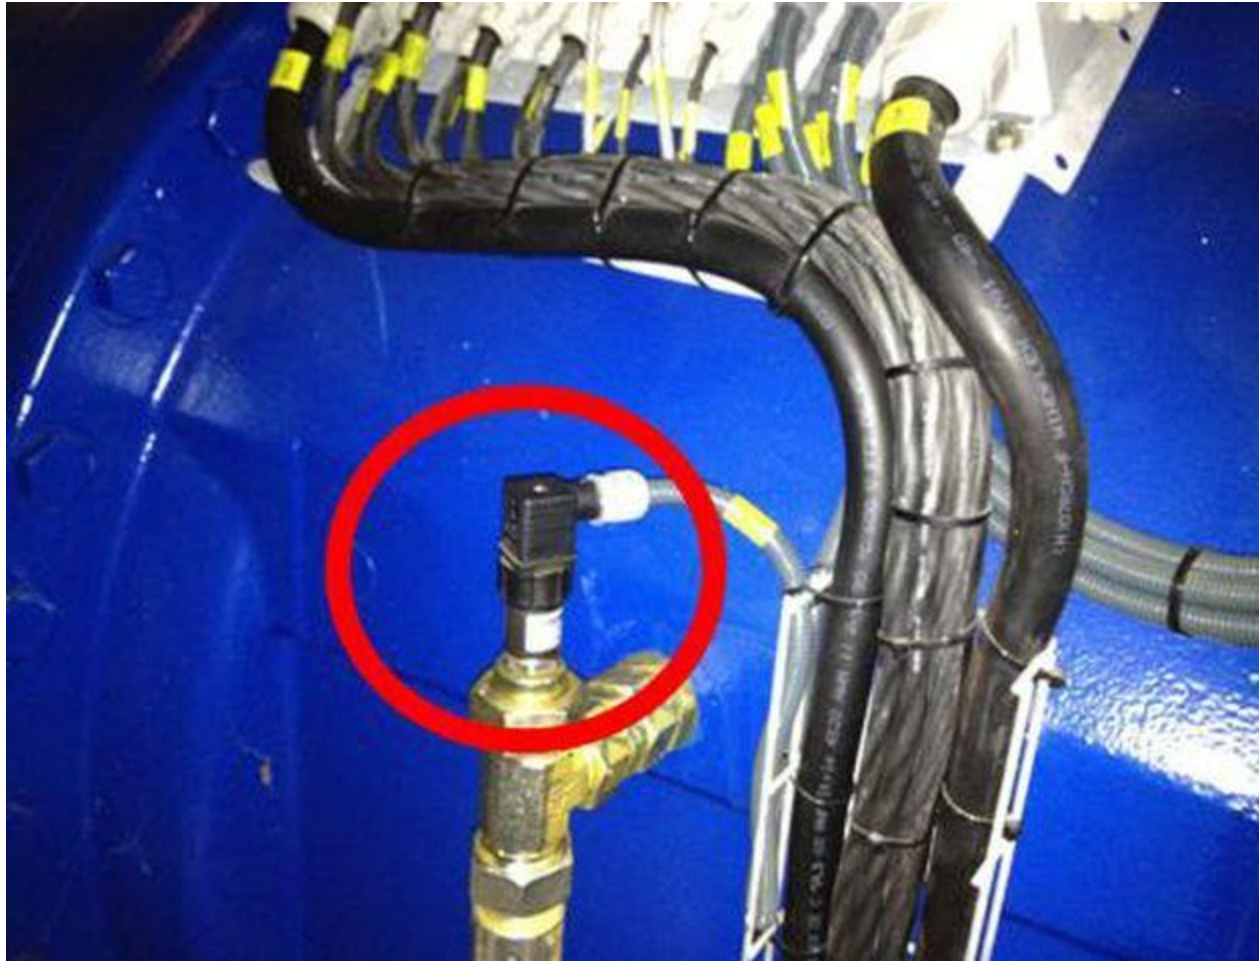
Pressure Transmitter:

If the displayed pressure shows a negative value the pressure transmitter is likely defective and has to be changed (Item no.: 60065489- PRESSURE TRANSDUCER 0-10 BAR).

Allow system pressure to build for several seconds. Observe that the pressure rises in the TACII controller. If the pressure does not rise or shows negative, replace the pressure transmitter.

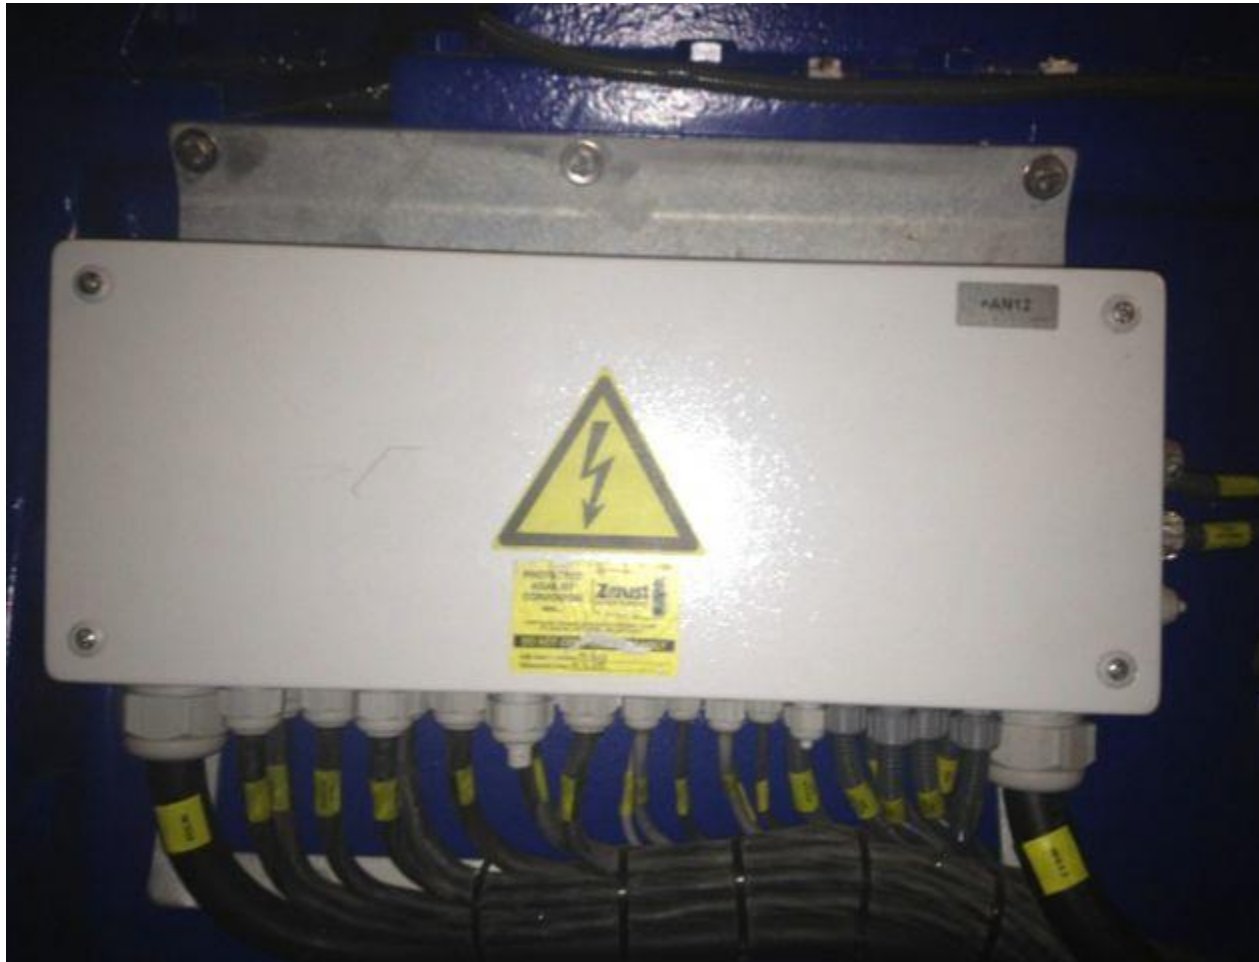
AN12:

The cable for the transmitter is W537. You can perform a continuity check on the cable by removing the wires from terminal 17 and terminal 1 (immediately below terminal 17) on the -X02 terminal block in the AN12 terminal box. Twist the two wire-ends together and using a small flat screwdriver to remove the plug from the pressure transducer. When the plug is removed, slide the driver into the slot on the plug. Lightly pry down and the plug cover will come loose of the plug body. Set the multi-meter to read  $\Omega$  and measure between terminals 1 & 2. The value should be less than 1 $\Omega$ . If it is greater than this the cable is damaged and must be replaced. (Item no.: 60103096 Cable -W537 NM30t. Module 2x1).

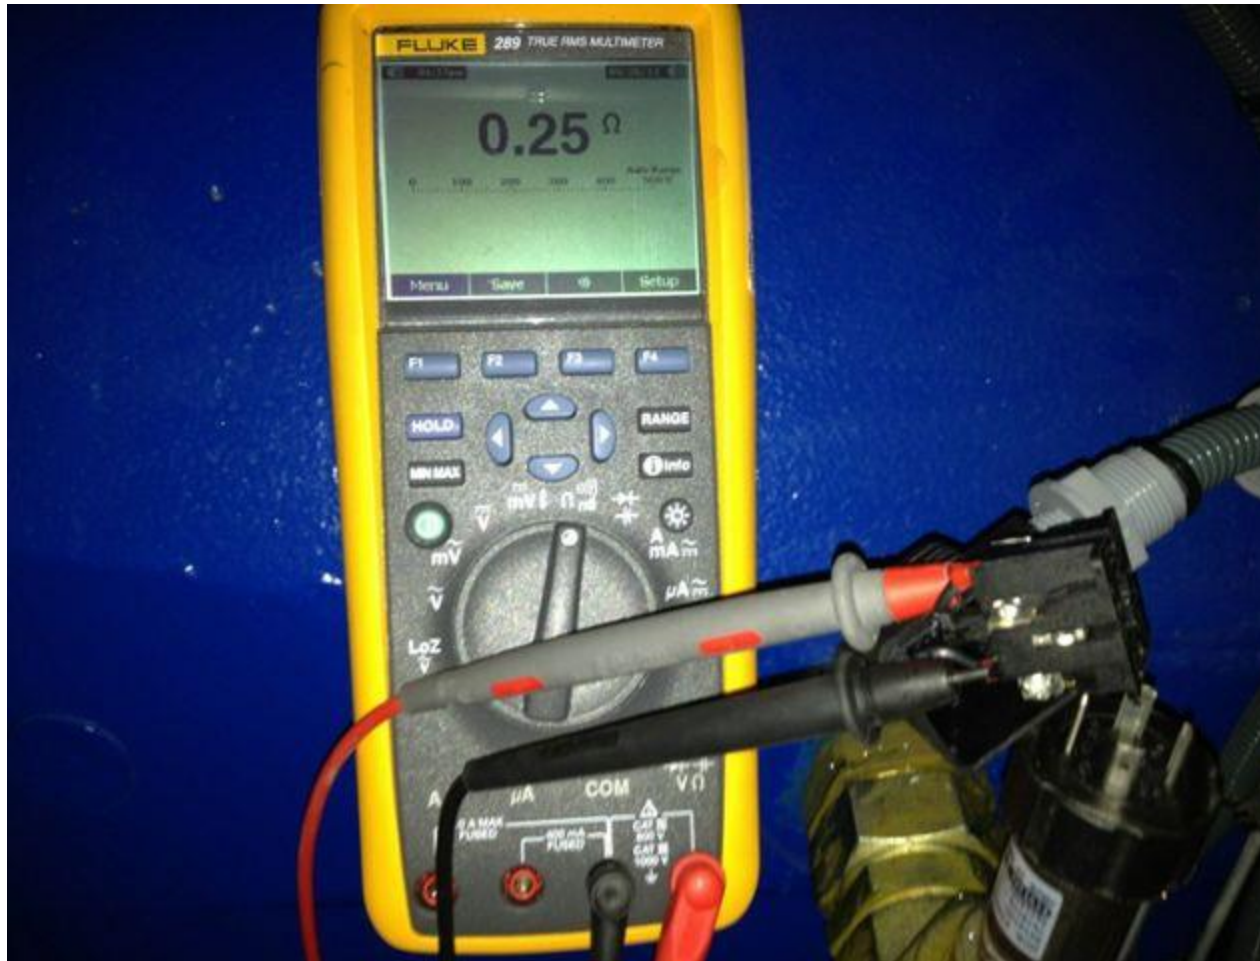
Measuring resistance between terminals 1 & 2 on the sensor plug body:

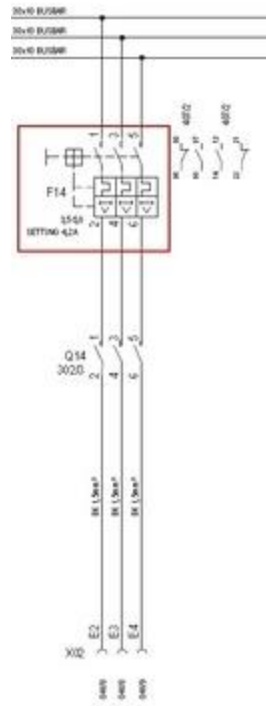
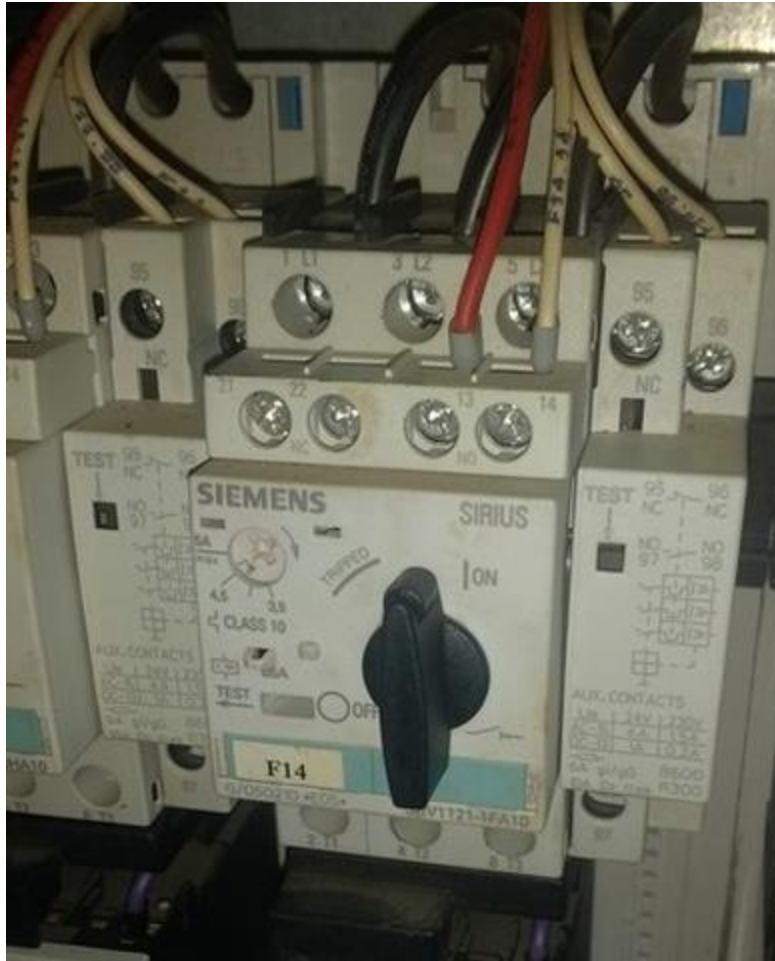
GEAR OIL PUMP LOW SPEED  
3WV 63V 42A

Circuit breaker or contactor failure in AT2 panel will cause this error.

Relevant spare parts	
Description	Item No.
CIRCUIT BREAKER 3RV1021-1FA10	<a href="#">60004663</a>
CONT 3RT10161AP02 230V 50/60HZ	<a href="#">60004394</a>

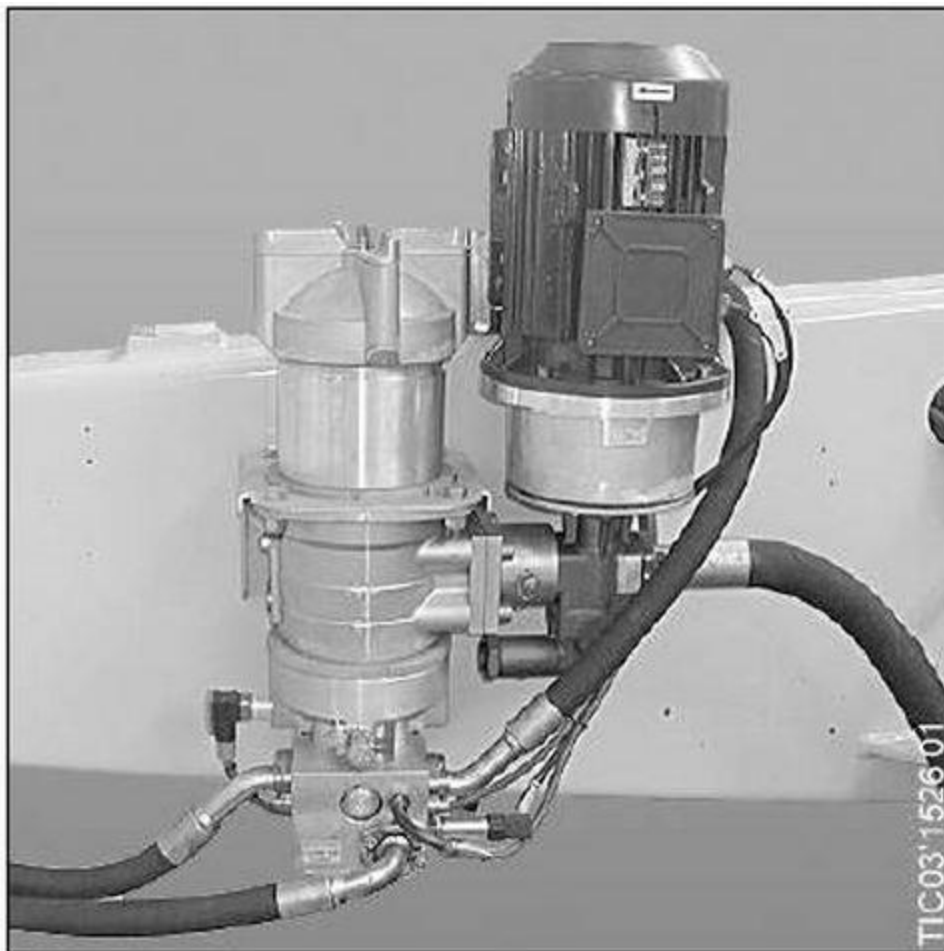
Run the gear oil pump via the controller. Listen for abnormal noise coming from the pump or motor. Remove gear oil pump motor and inspect the lovejoy coupling (**Item no.: 60097505- COUPLING CPL. 28/38-38/24**). Replace coupling if damaged. Replace pump (**Item no.: 60111058- OIL PUMP KF50RF2-D15 14BAR 60(60Hz)**) or (**Item no.: 60103477- Oil pump KF63RF2-D15, 14 bar 50Hz**) or motor (**Item no.: 60093993- MOTOR FOR OIL PUMP (50&60Hz)**) accordingly if failed.

Relevant spare parts	
Description	Item No.
COUPLING CPL. 28/38-38/24	<a href="#">60097505</a>
OIL PUMP KF50RF2-D15 14BAR 60(60Hz)	<a href="#">60111058</a>
Oil pump KF63RF2-D15, 14 bar 50Hz	<a href="#">60103477</a>
MOTOR FOR OIL PUMP (50&60Hz)	<a href="#">60093993</a>
